CRIPPLE CREEK & VICTOR GOLD MINING Co. Squaw Gulch (VLF), HWY 67 Realignment Field Monitoring Summary Weekly Report

Owner:	Cripple Creek & Victor Gold Mining Co.	Project Number:	Date
Project:	Squaw Gulch (VLF), Hwy 67 Realignment	74201125N0. ****. ****	1.25.2014
Location:	Cripple Creek & Victor Gold Mine, Colorado		
Contractor:	Ames Construction Co. Inc.

Reporting Period: 1.19.14 thru 1.25.14

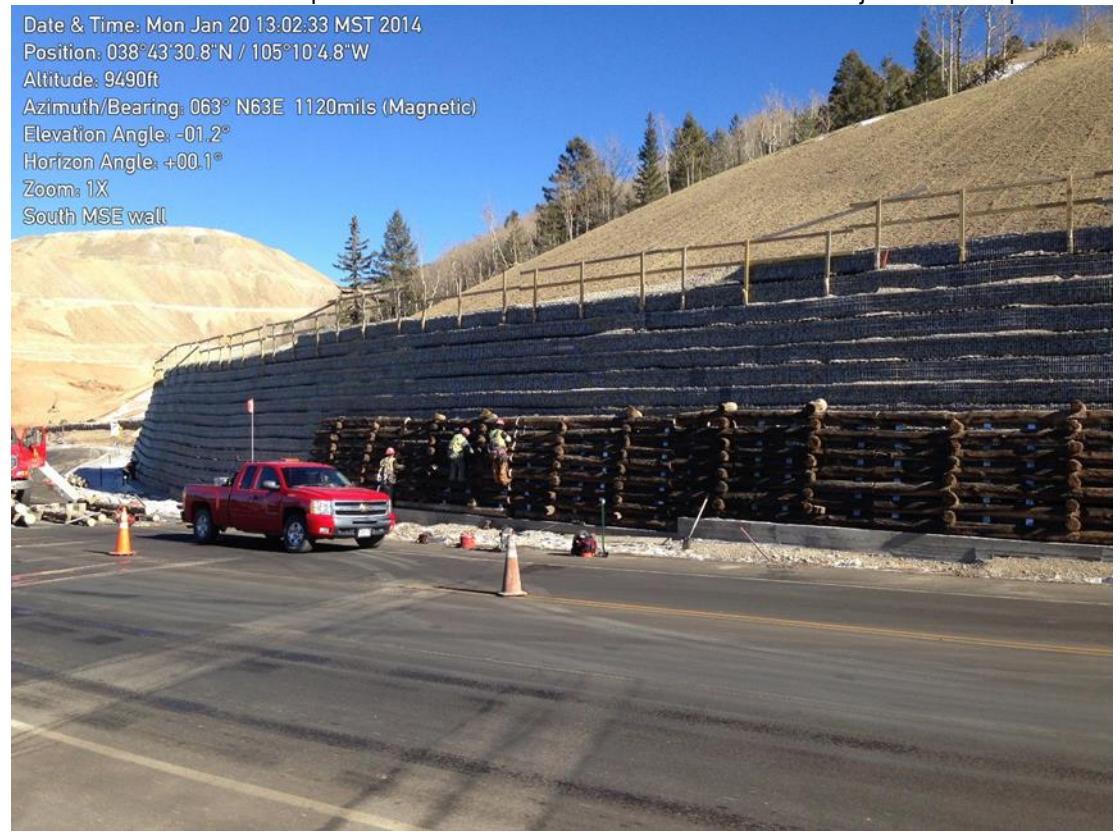
Photo 2: Installed timber panels at the South MSE Wall.

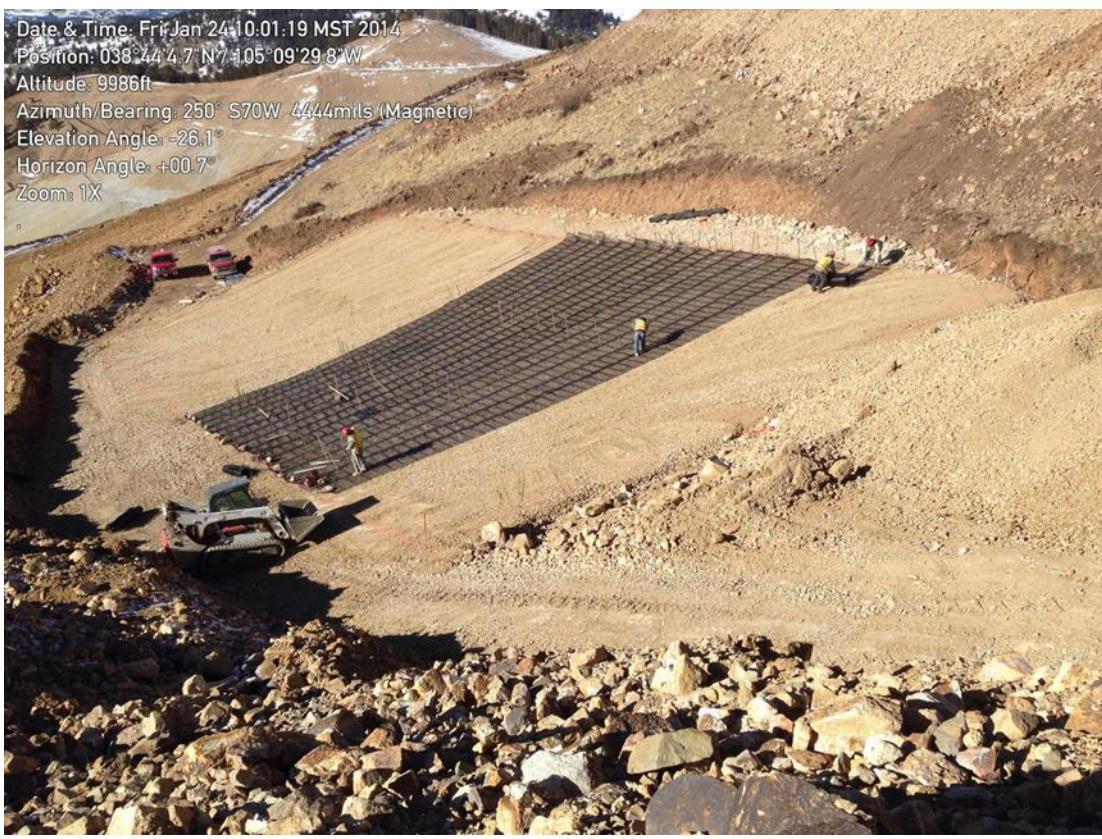
Two layers of geogrid and select structural fill were installed at Working UG # 6123. Work is to continue.

Photo 3: Placement of the second layer of geogrid at Underground Working UG 6123.

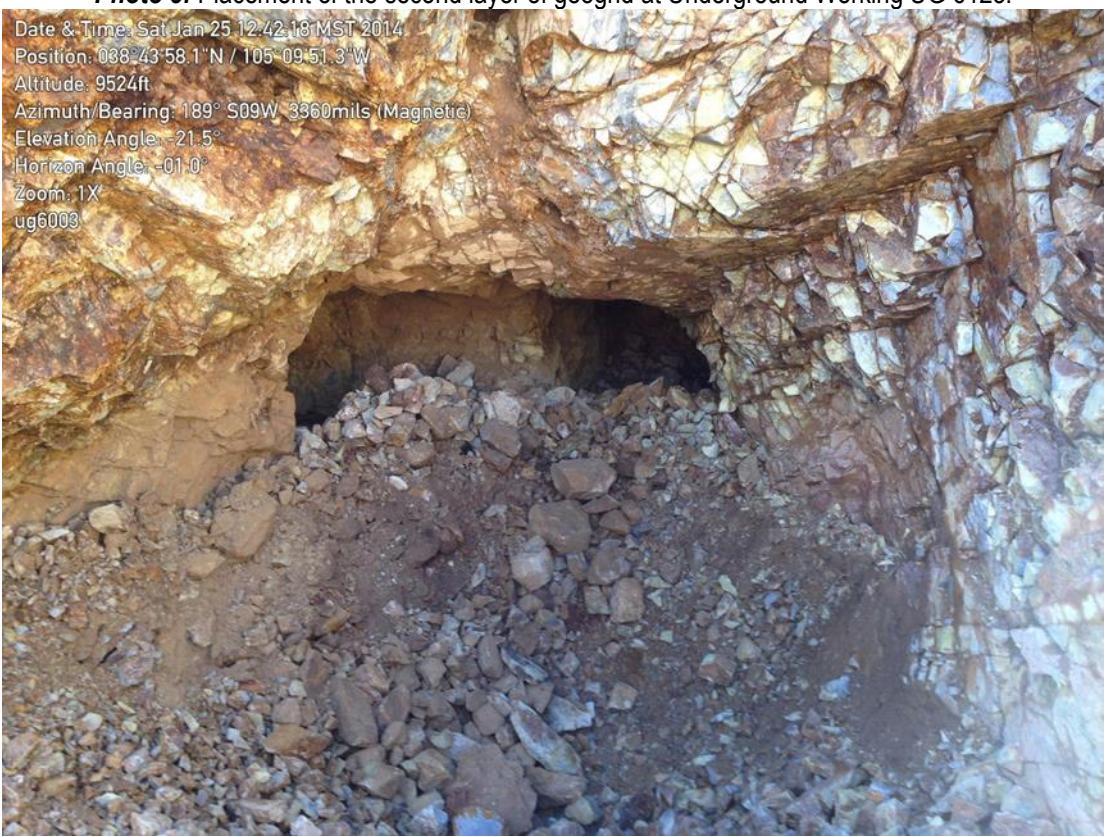
A Cat 345 excavator removed shot rock from the adit at UG #6003. Two additional adits were located and will require confirmatory drilling to isolate them.

Photo 4: Newly discovered adits at Underground Working UG 6003.

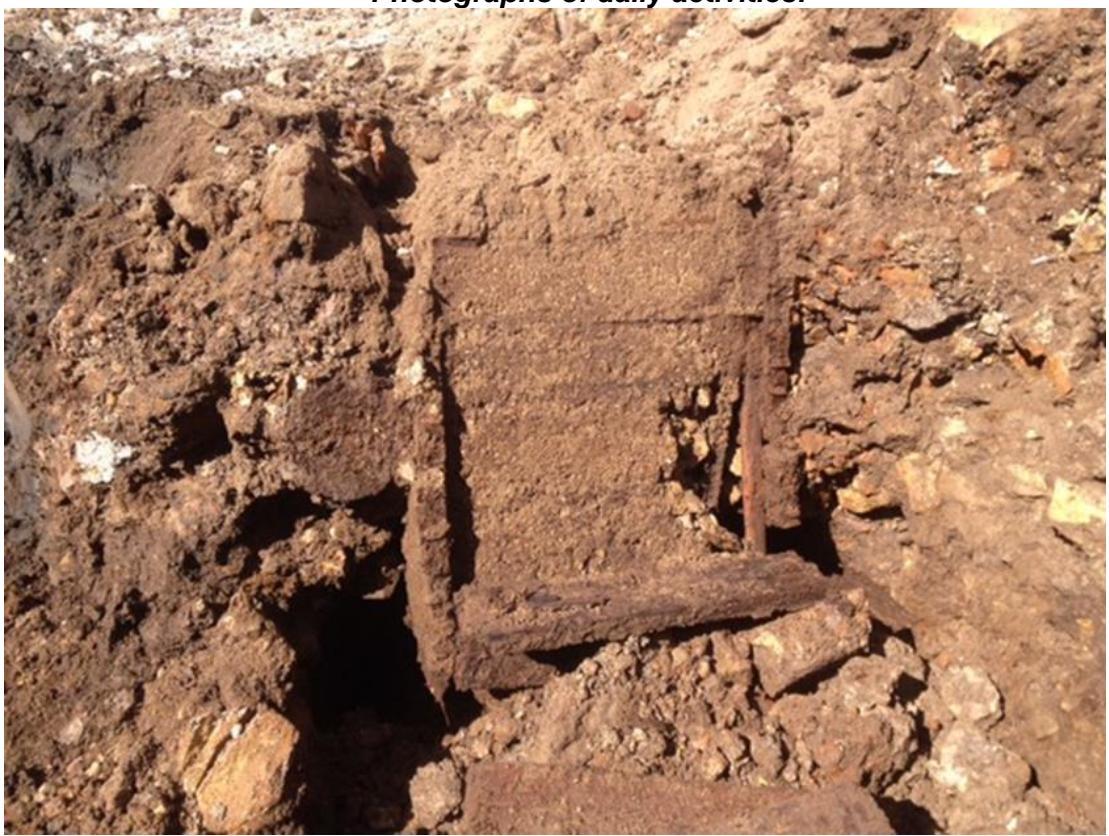
At working UG # U6334 (formerly U6394) a timbered drainage culvert was removed for approximately 100 lineal feet. The drainage culvert terminated at an apparent sediment pond and wooden drop structure. An appreciable amount of organic silt and some trash were found and removed. The working is considered remediated.

Photo 1: UG # U6334 near the termination of the wood and timbered drainage culvert.

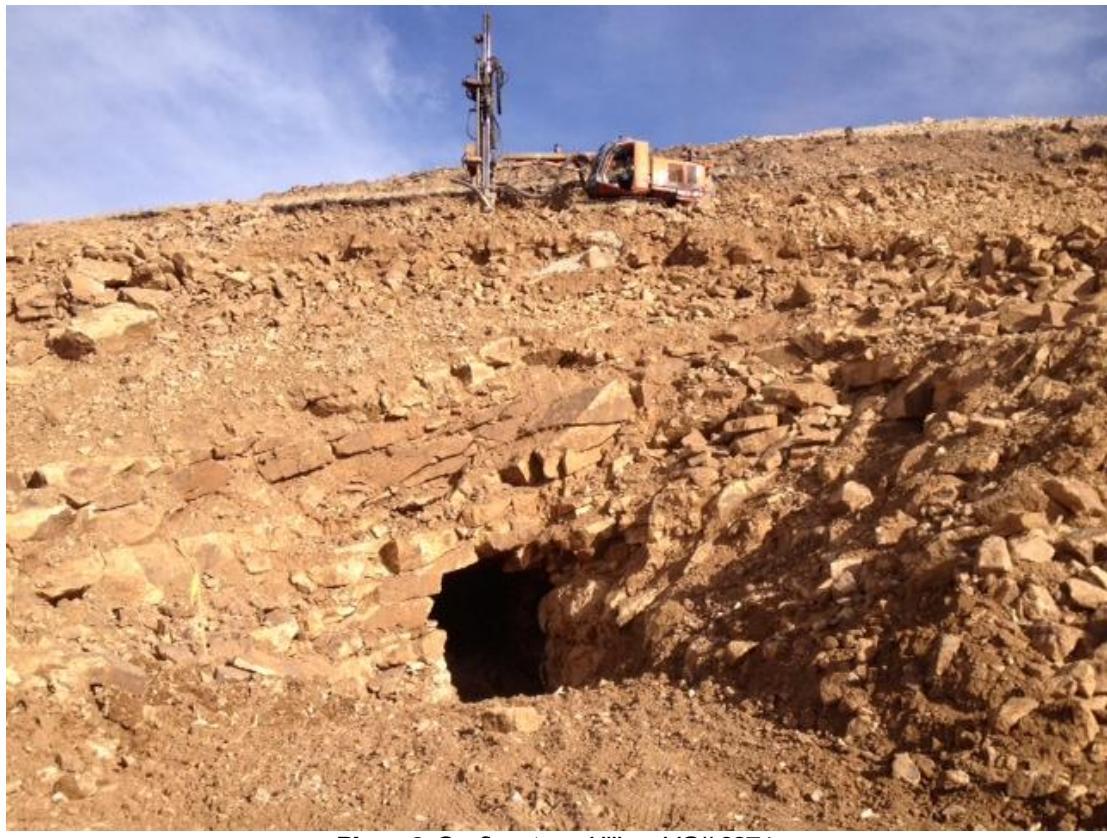
Photo 3: Confirmatory drilling; UG# 6274.

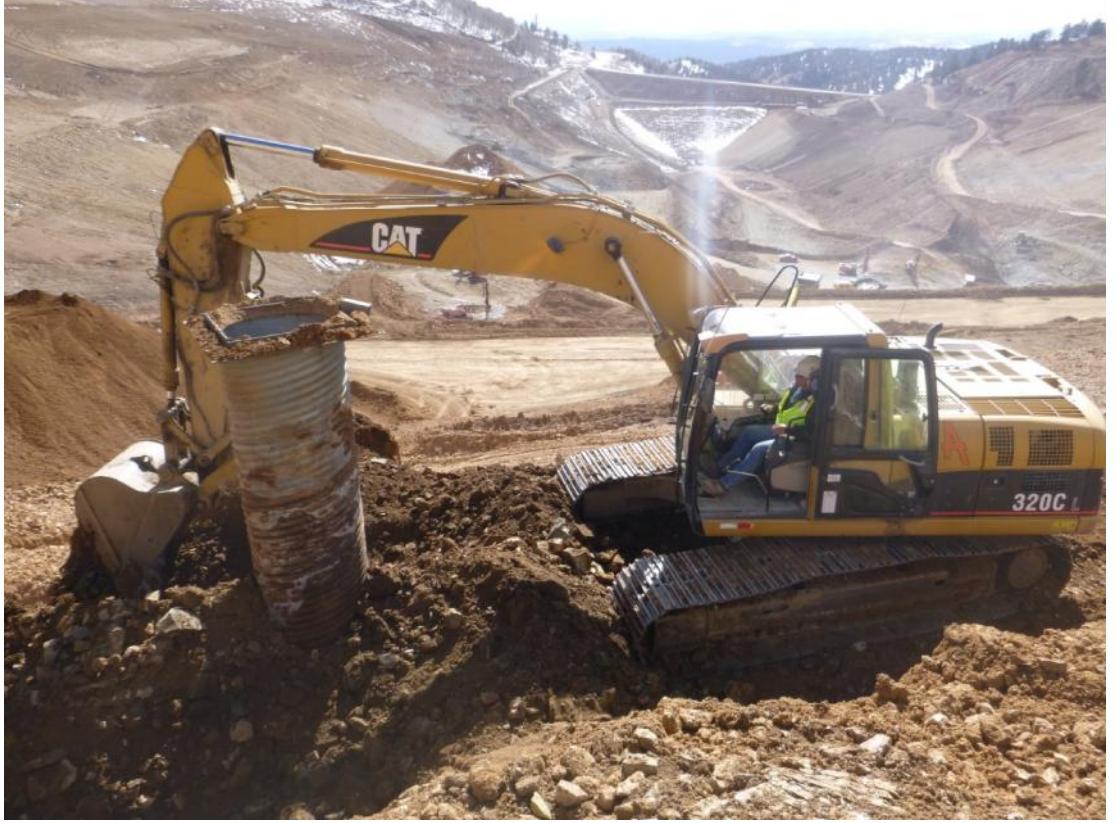
Photo 4: UG#6153; removing CMP, prepping for concrete plug.

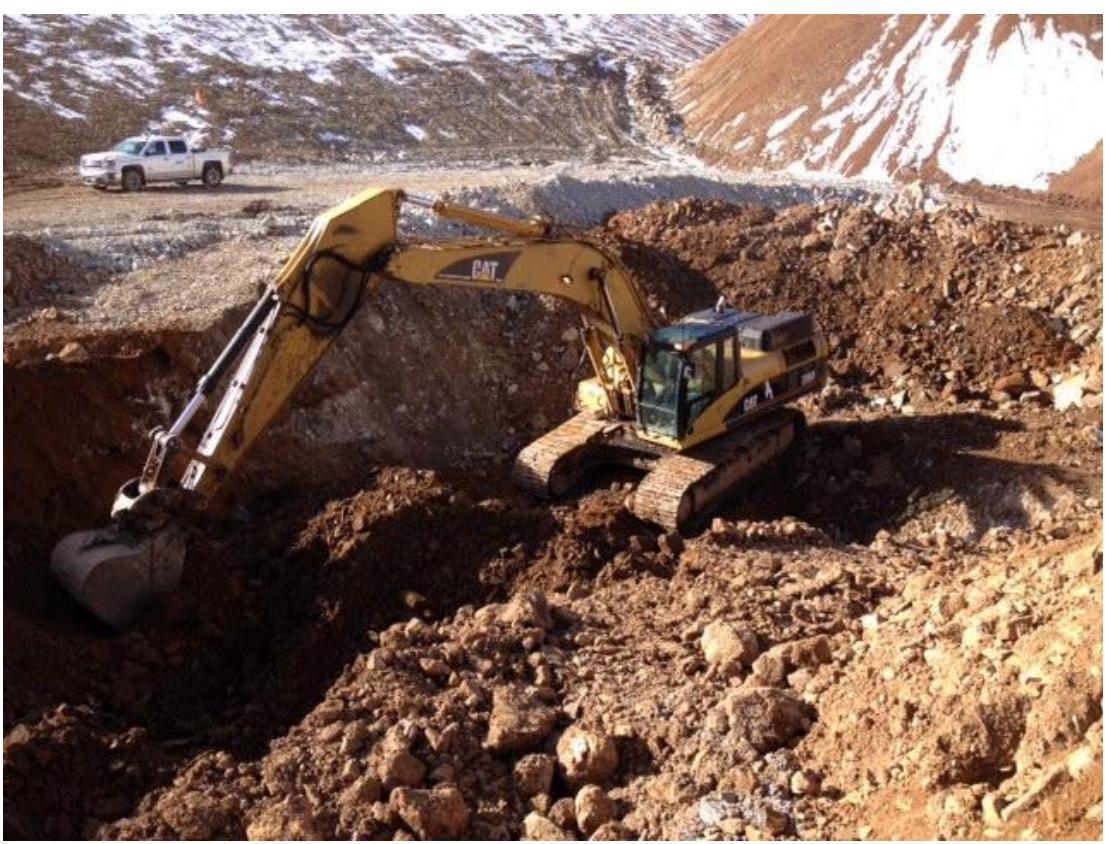
Photo 3: Shot rock removal from UG #U6273.
