CRIPPLE CREEK & VICTOR GOLD MINING Co. ANGLOGOLD ASHANTI (COLORADO) SQUAW GULCH (VLF) & HWY 67 RE-ALIGNMENT MONITORING WEEKLY REPORT

Owner:	Cripple Creek & Victor Gold Mining Co.	Project Number:	74201125N0
Project:	Squaw Gulch Valley Leach Fill (VLF)	Week Ending:	July 19, 2014
Location:	Cripple Creek & Victor Gold Mine, CO		
Contractor:	Ames Construction, Inc.

Reporting Period: 07.12.2014 through 07.19.2014

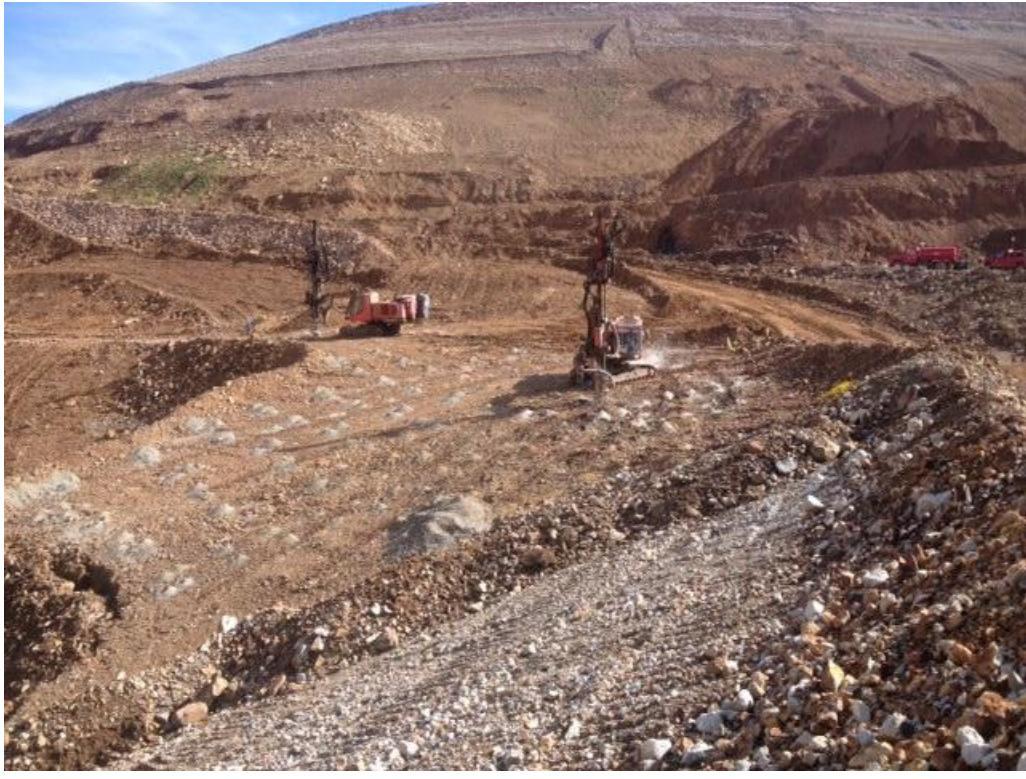
Photo 1: Production drilling along Bench A (9450')

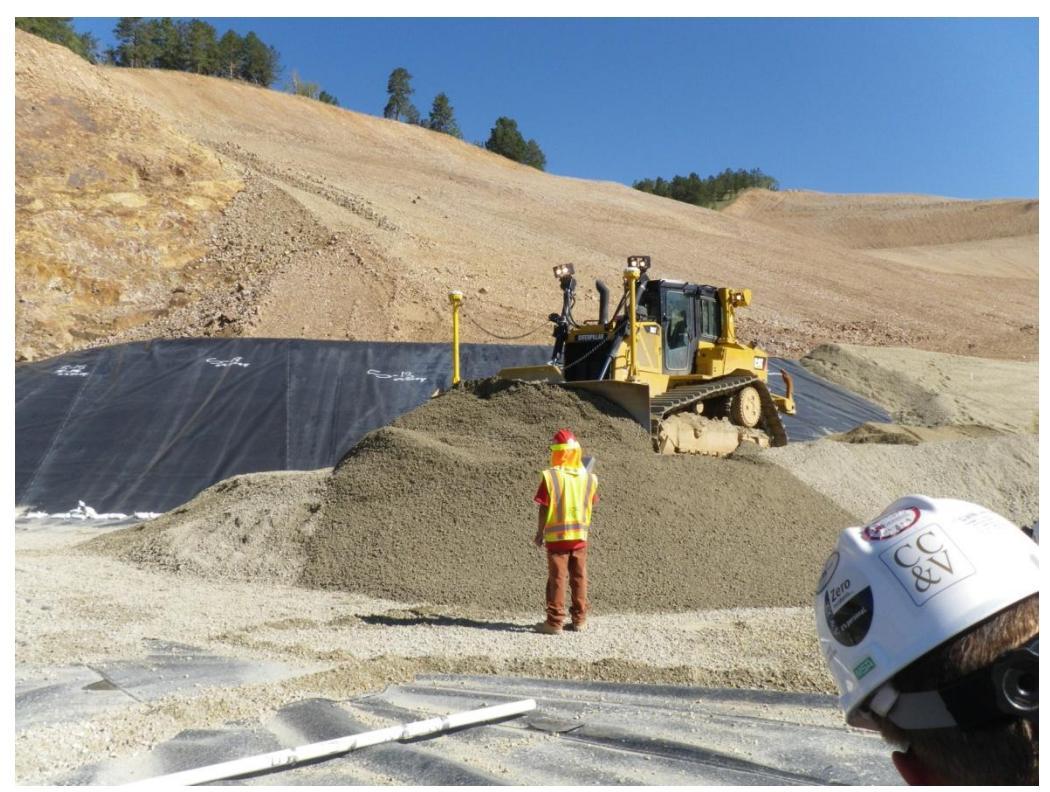
Photo 2: Low volume material placement at the PSSA

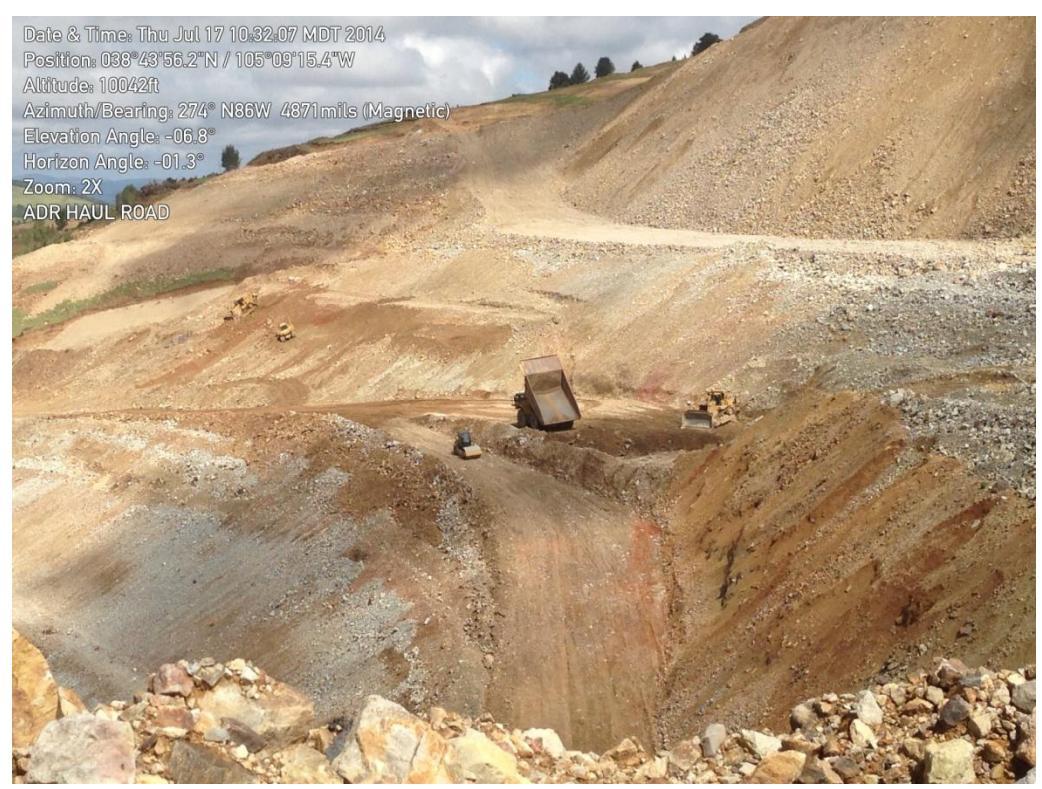
Photo 3: ADR haul road: Structural fill in foreground and slope grading in background

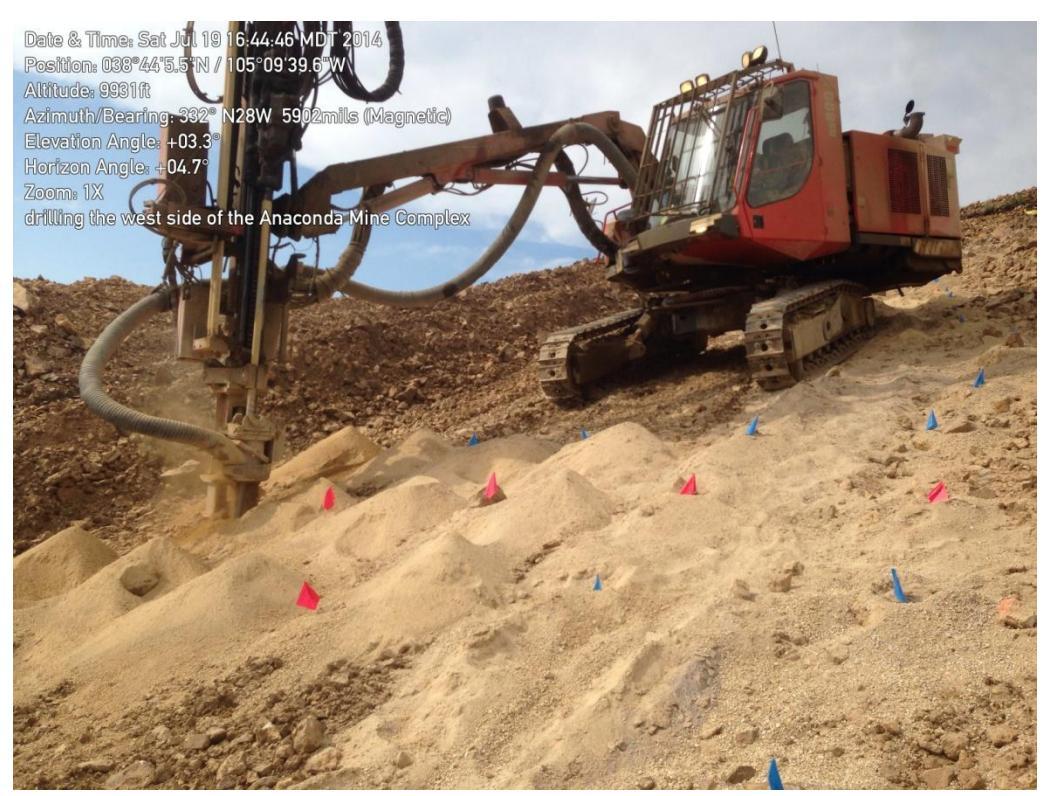
Confirmatory drilling of the Anaconda Mine Complex began. Additional confirmatory drilling and remediation is required.

Photo 4: Confirmatory Drilling at the Anaconda Mine Complex

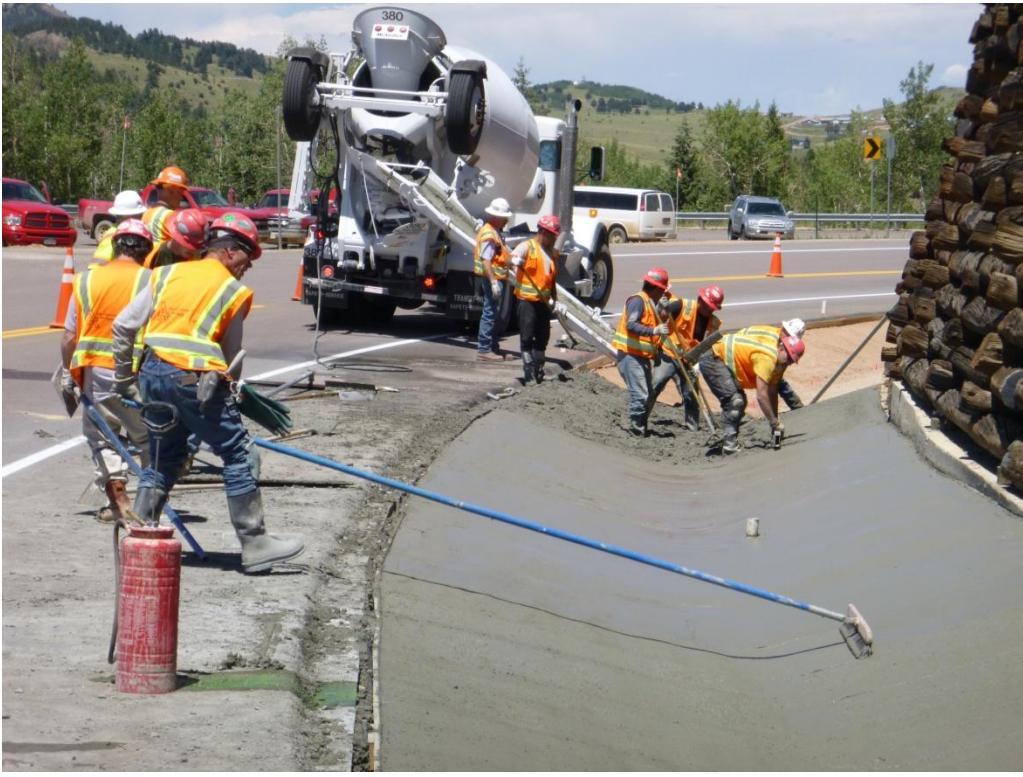
Photo 1: Concrete placement at Highway 67

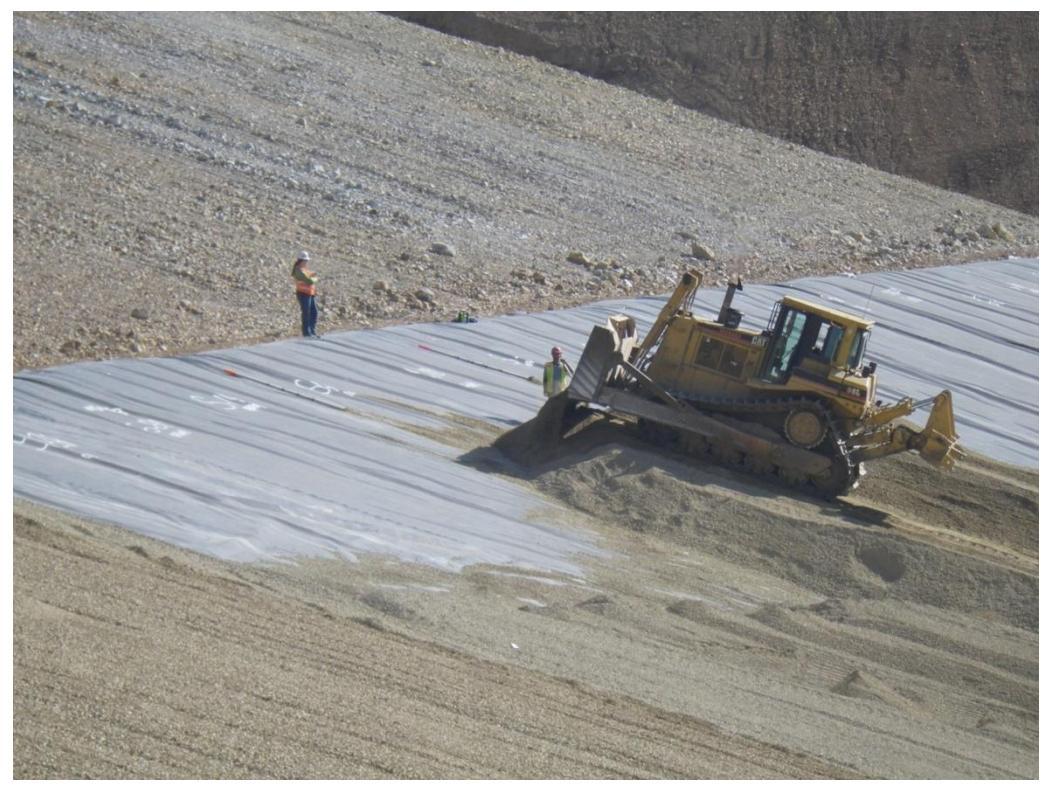
Photo 2: Low volume material placement at the PSSA

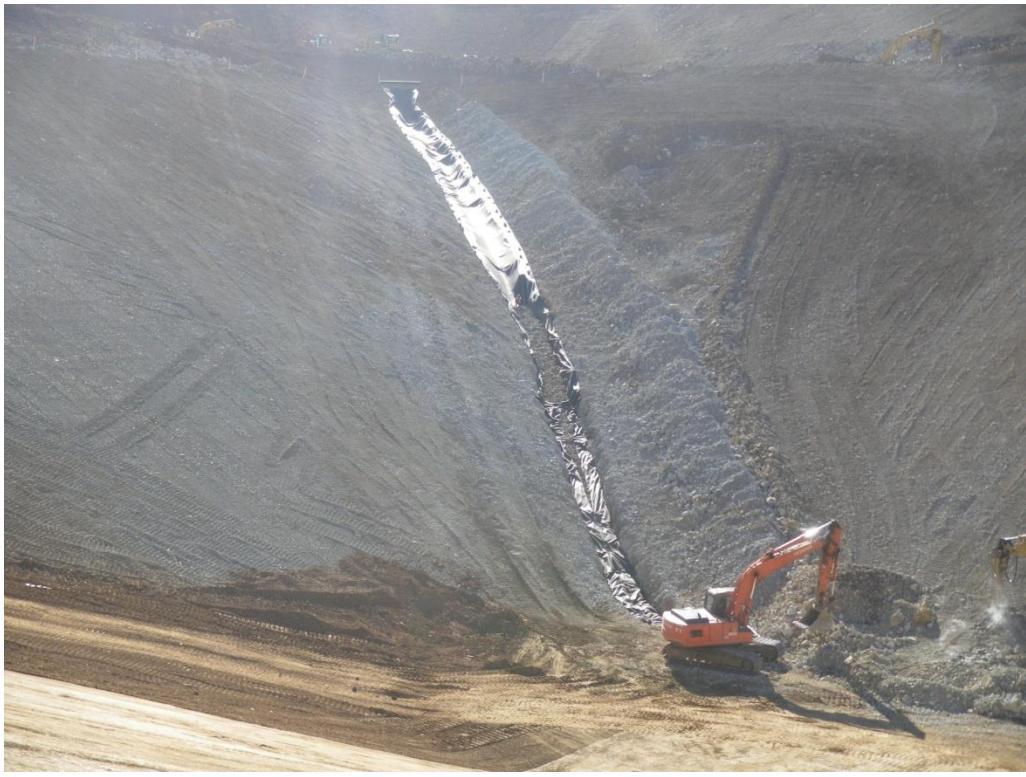
Photo 3: Secondary Underdrain Installation

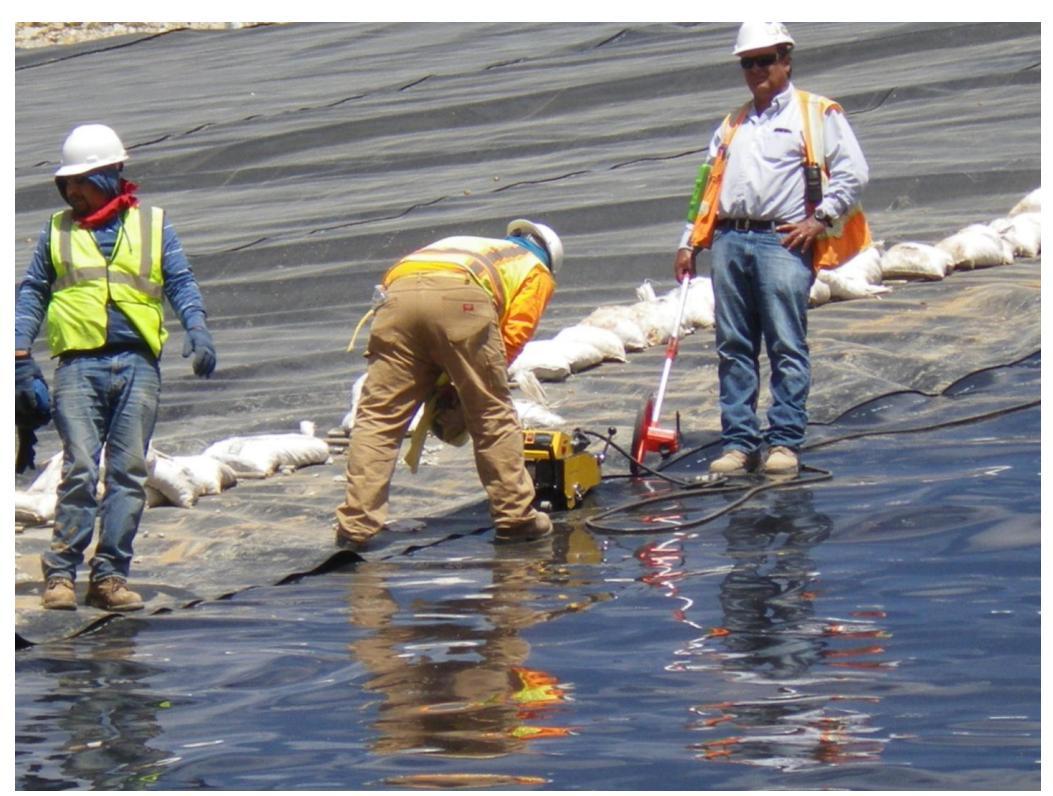
Photo 4: Fusion welding liner at the PSSA

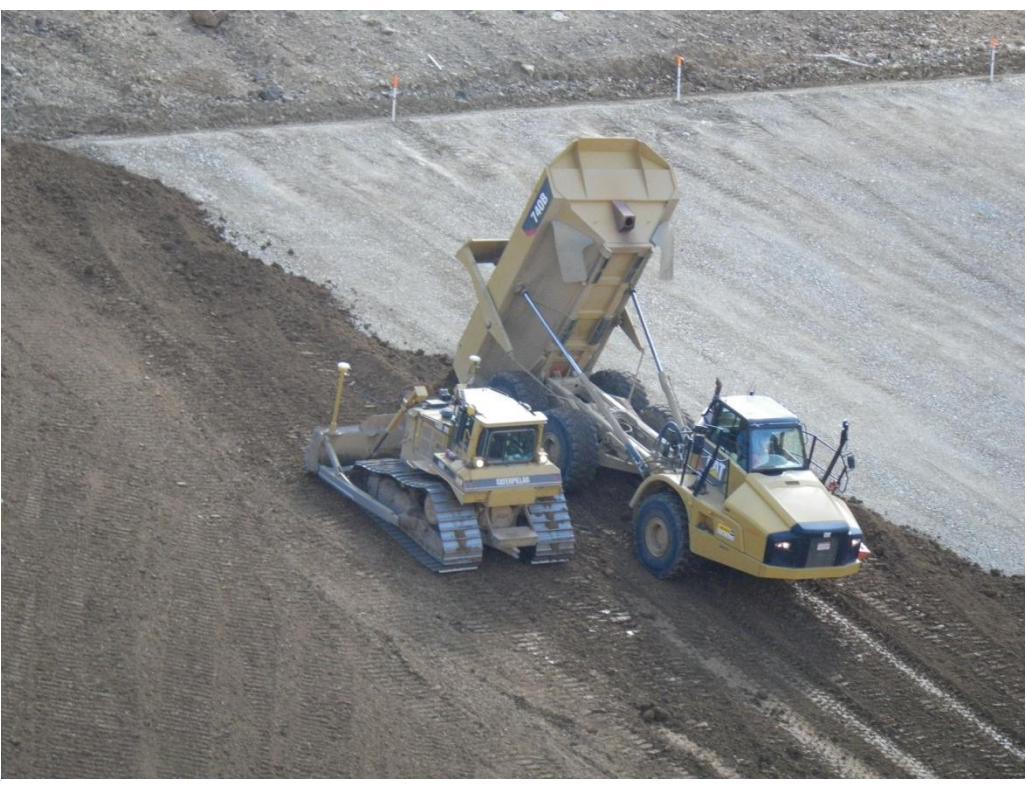
Photo 1: Soil Liner Fill placement below Station A18+00

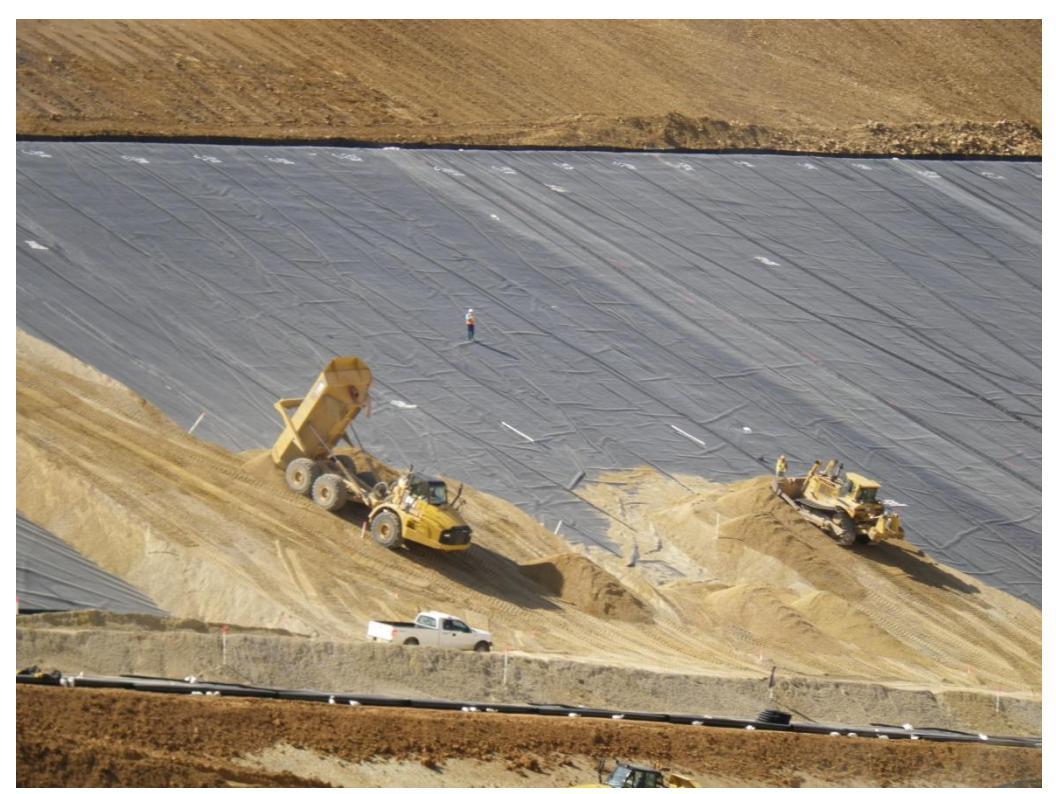
Photo 2: Low volume material placement at the PSSA

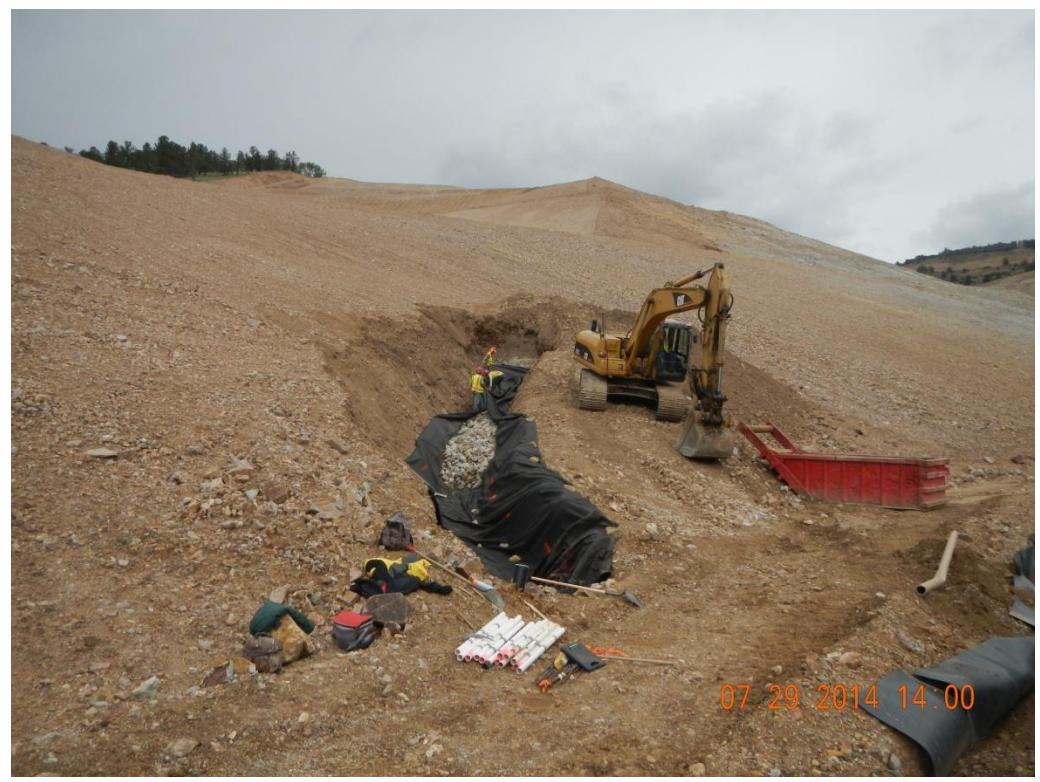
Photo 3: Tertiary Underdrain Installation above Station A4+00

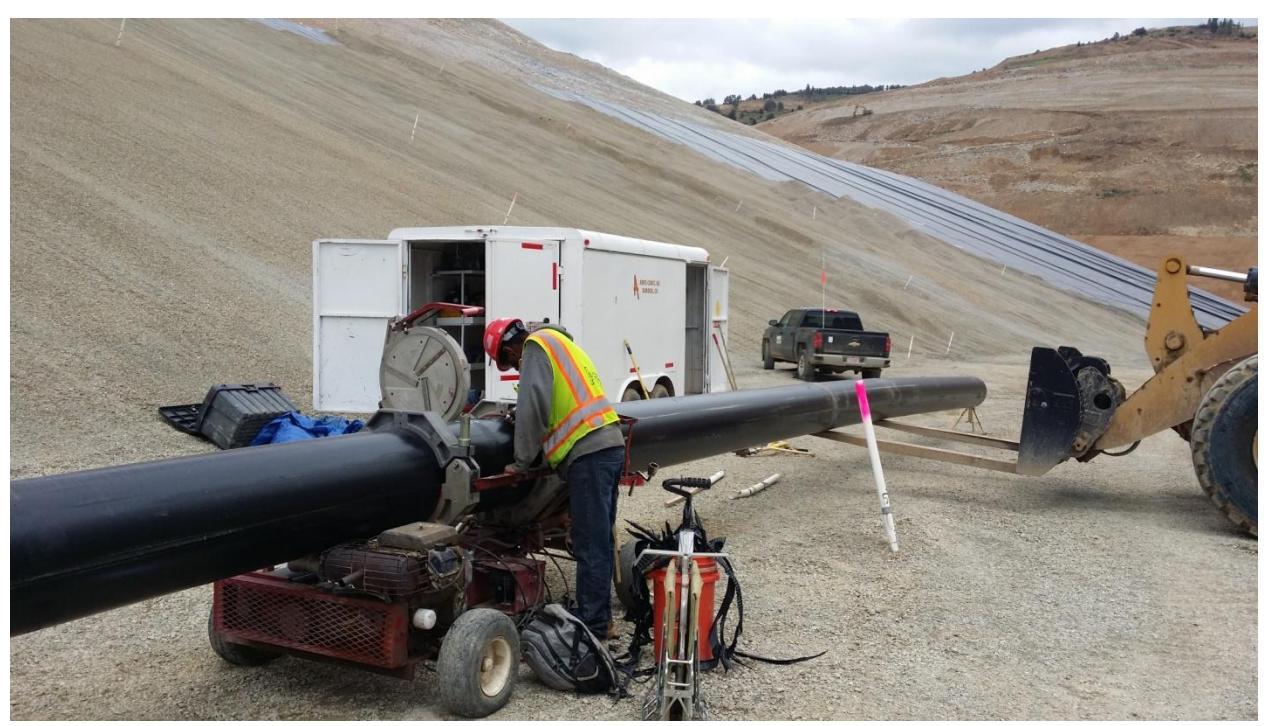
Photo 4: Pipe Fusing in the PSSA

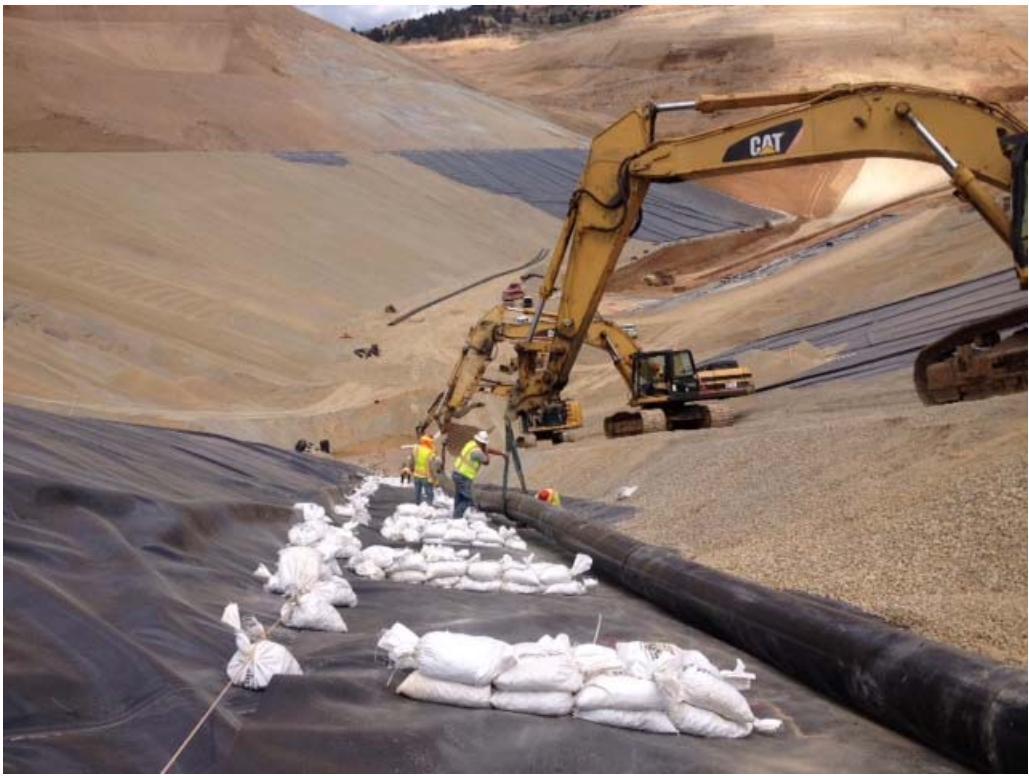
Photo 1: Placing the LVSC 18-inch DR11 HDPE pipe in the pipe corridor

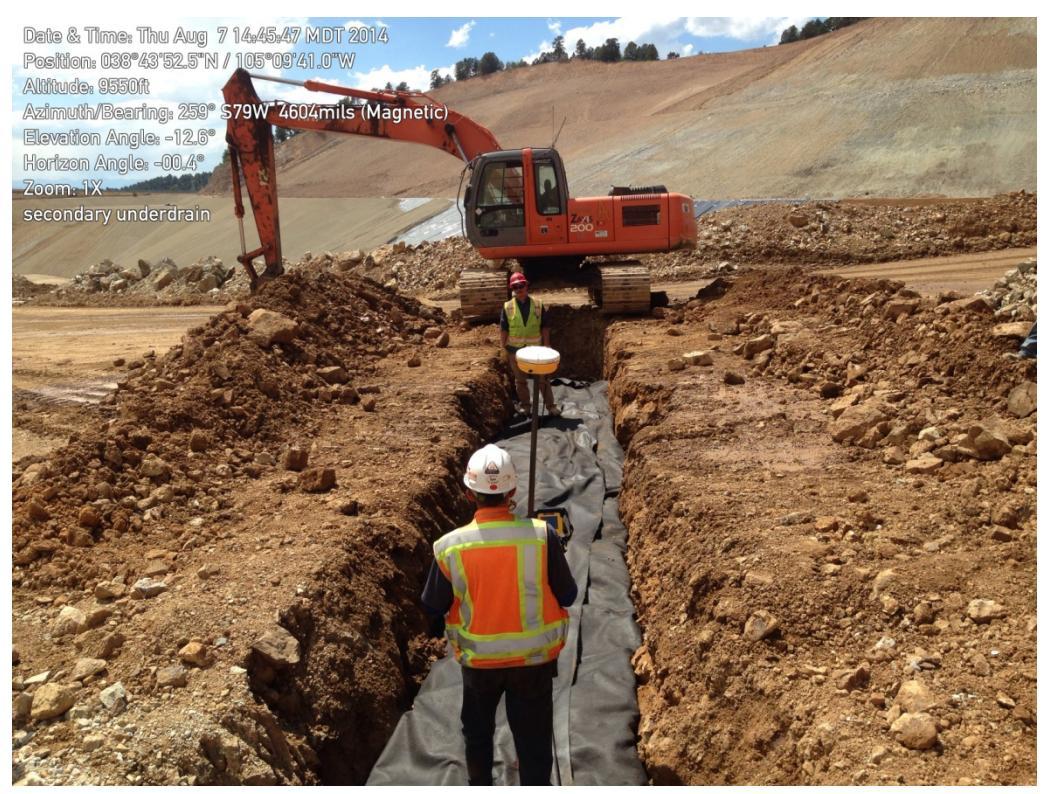
Photo 2: Secondary underdrain installation near ADR haul road station 15+00

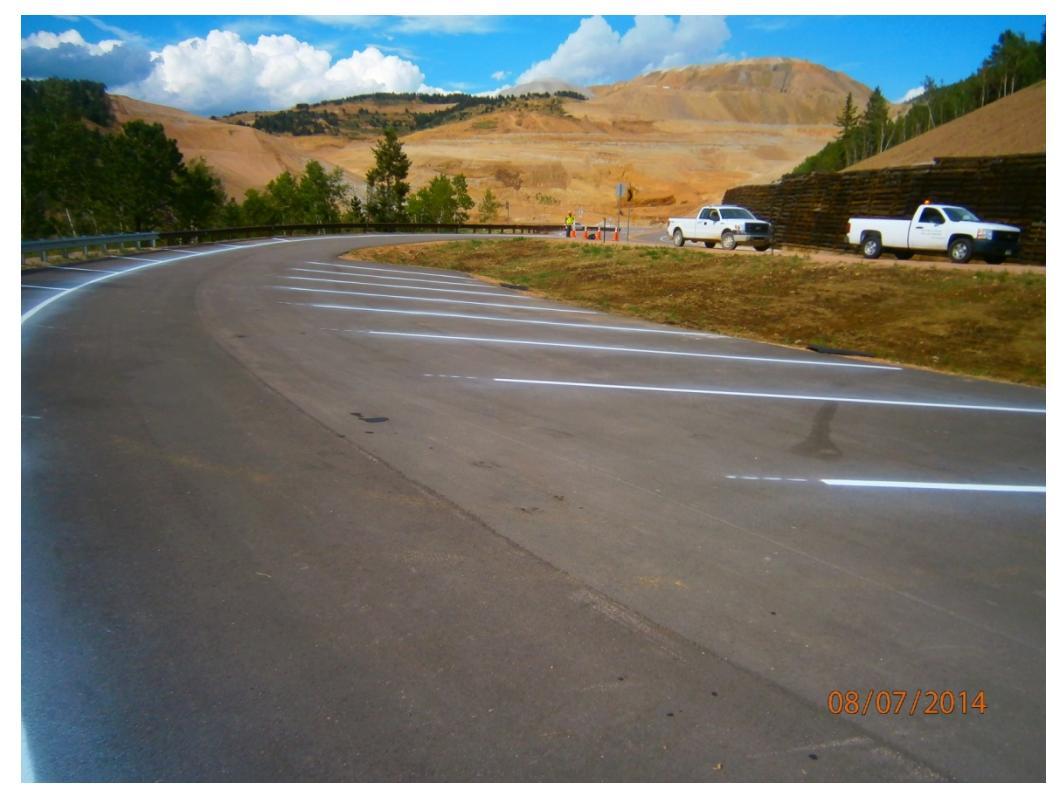
Photo 3: Paint striping at the Highway 67 overlook.

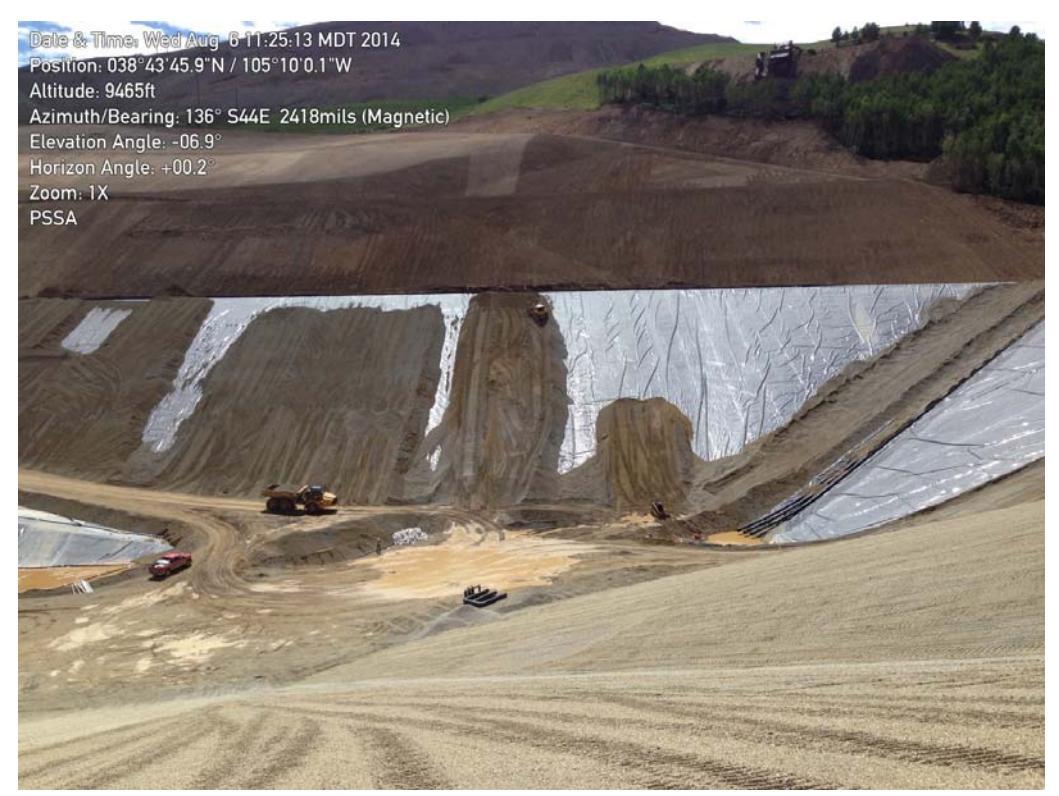
Photo 4: Placing Low Volume Fill at the PSSA

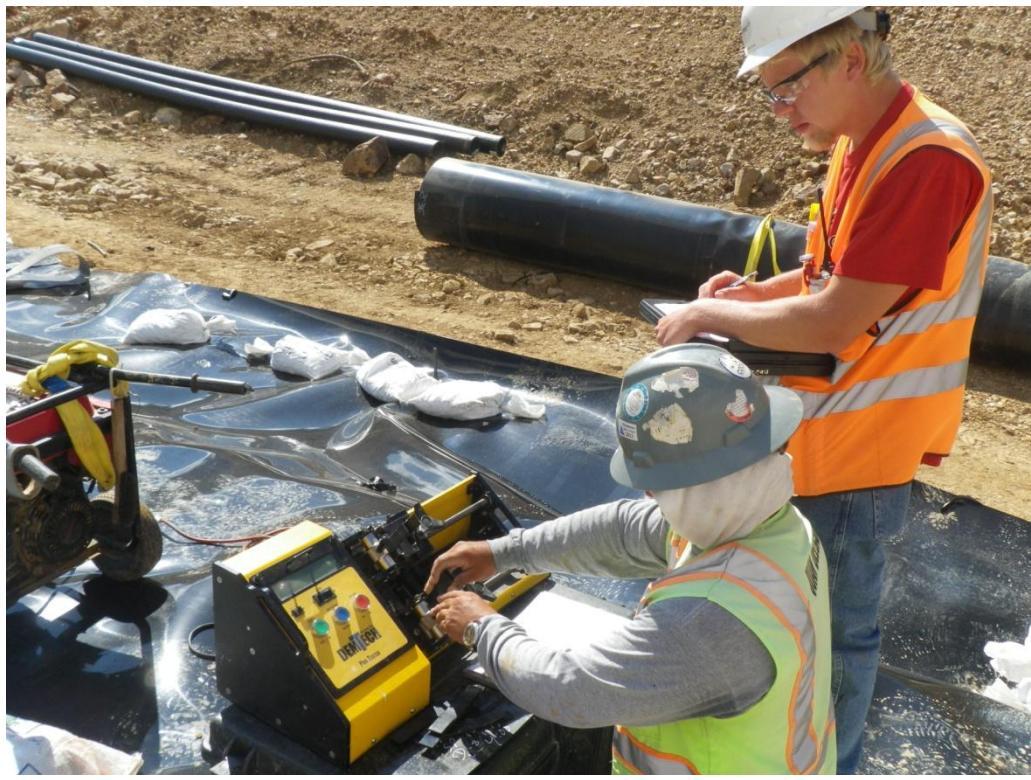
Photo 1: Destructive Testing for Geomembrane

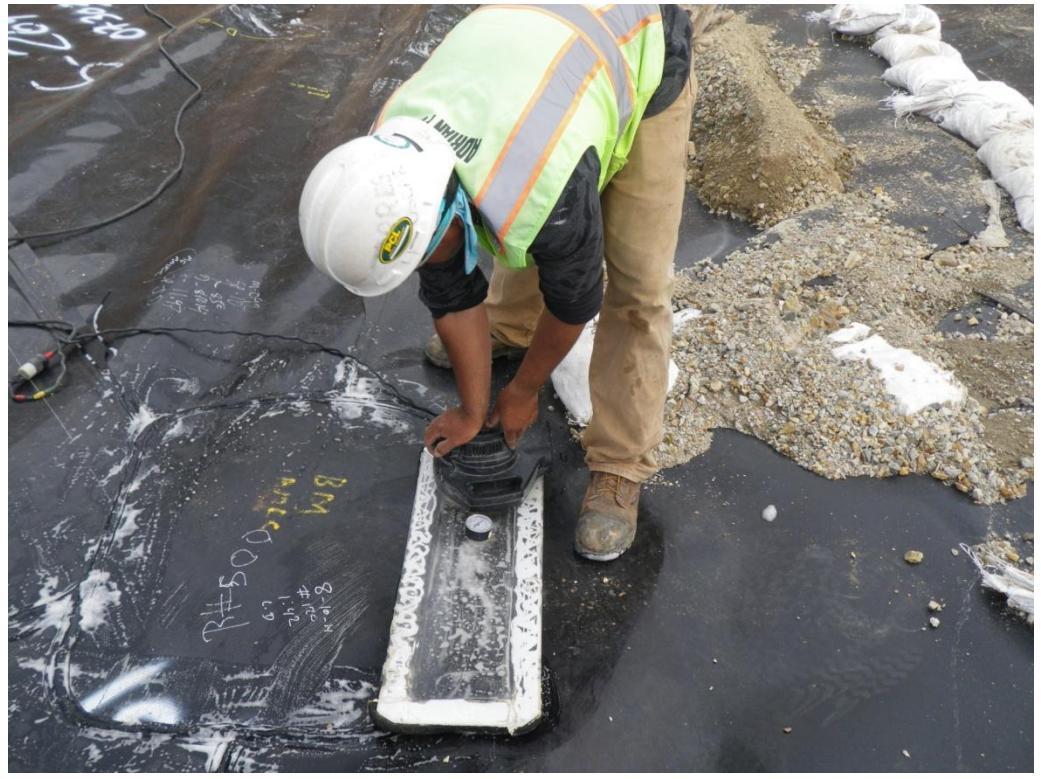
Photo 2: Vacuum Testing

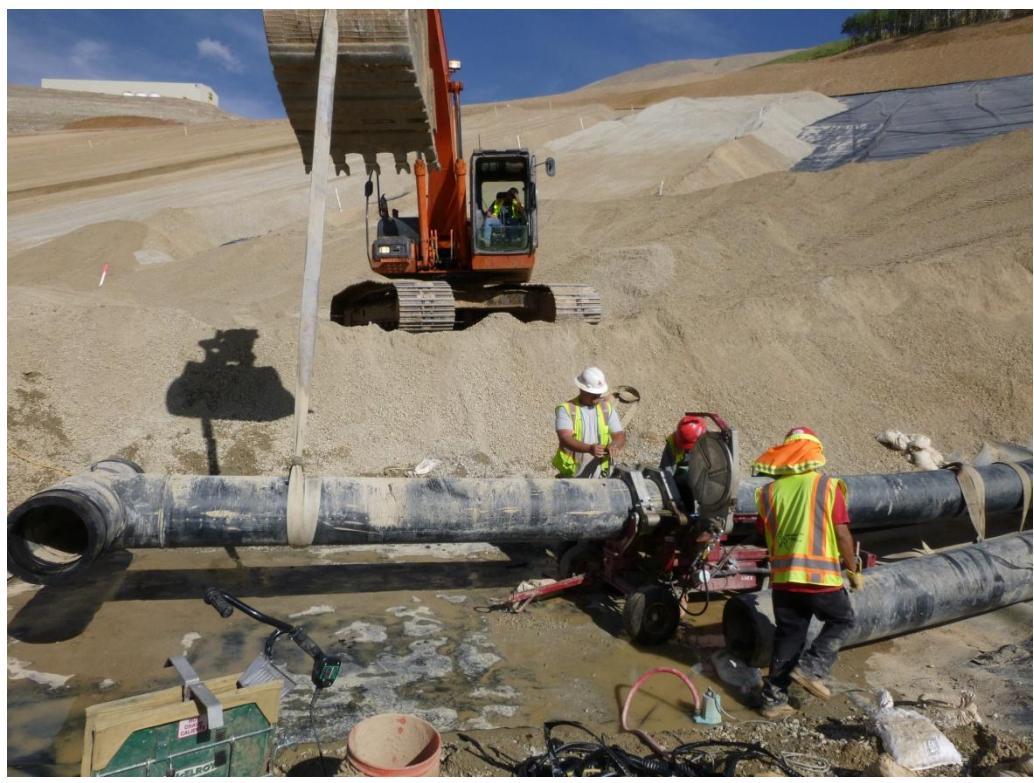
Photo 3: Fusing the LVSCS Manifold to the Riser Piping

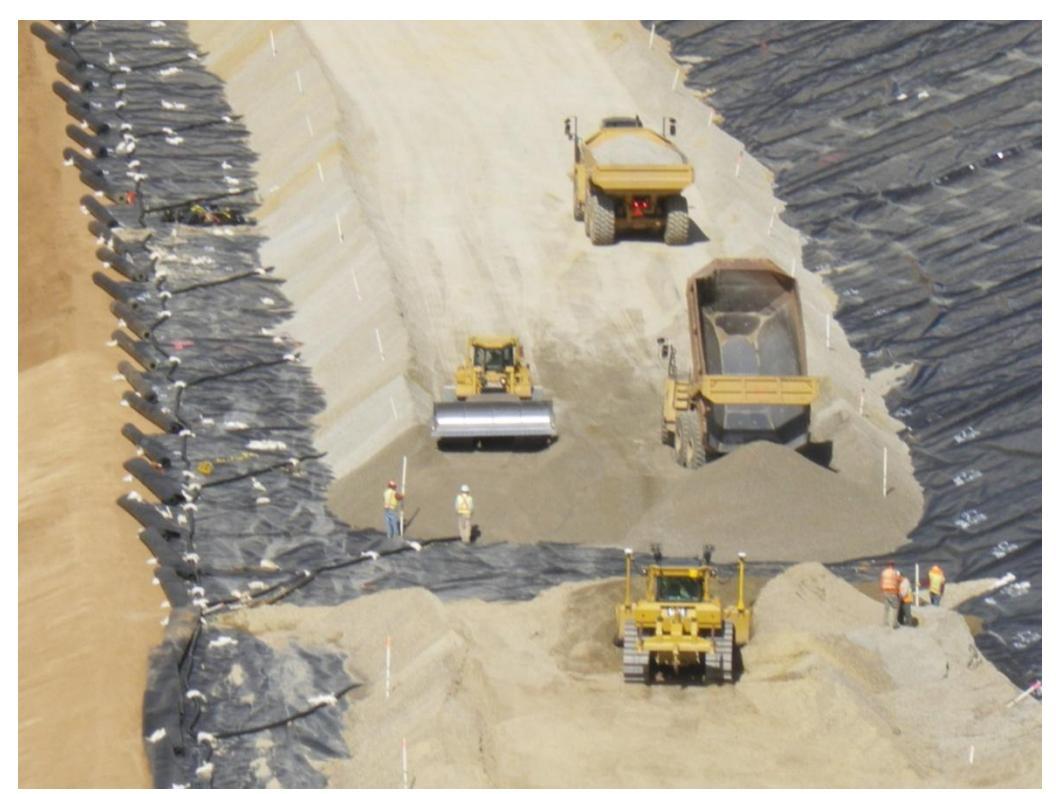
Photo 4: Placing Low Volume Fill at the PSSA

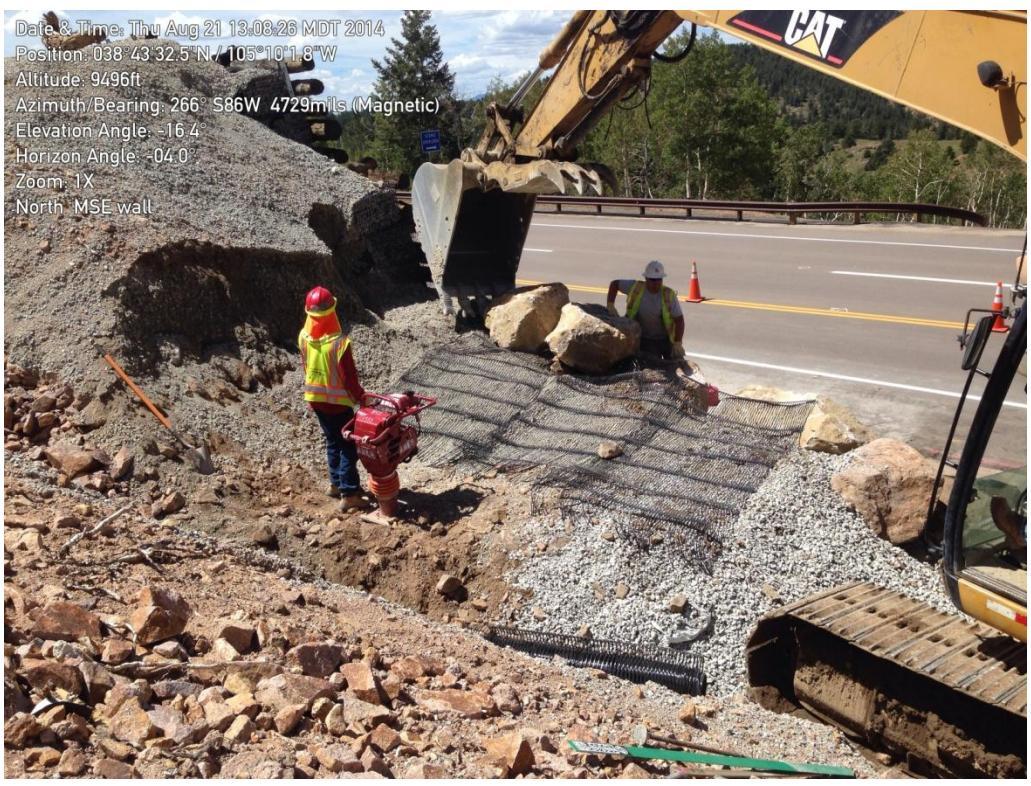
Photo 1: North MSE Wall Construction

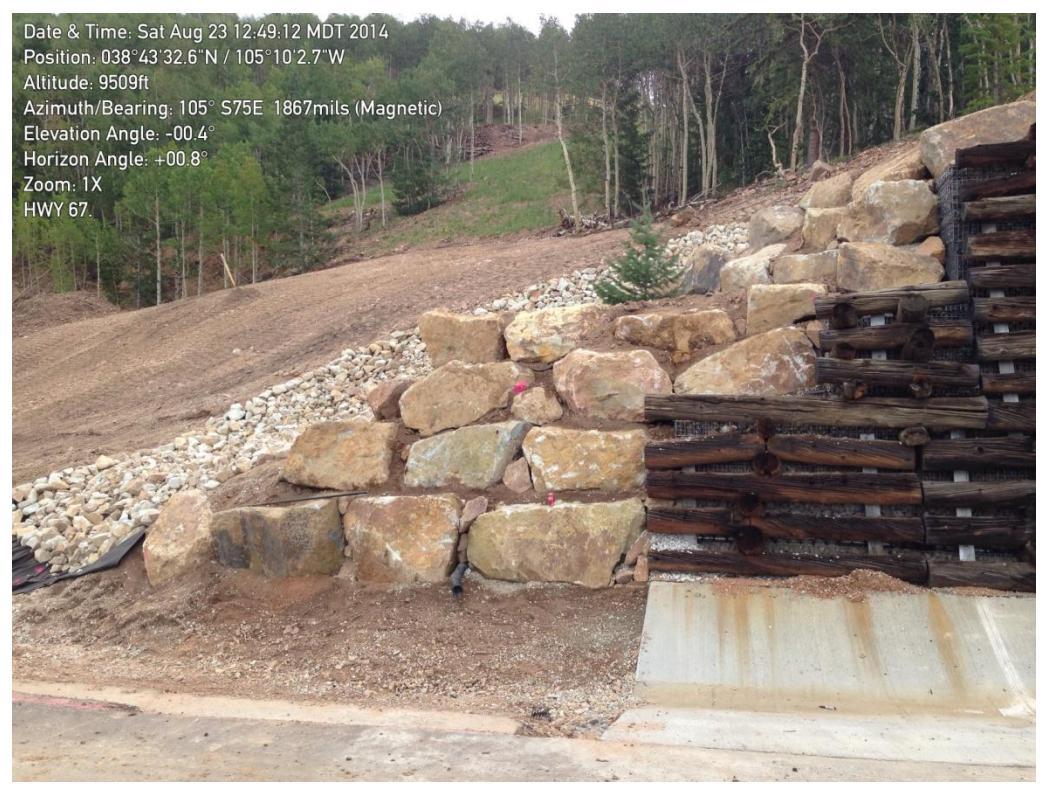
Photo 2: North MSE Wall Construction.

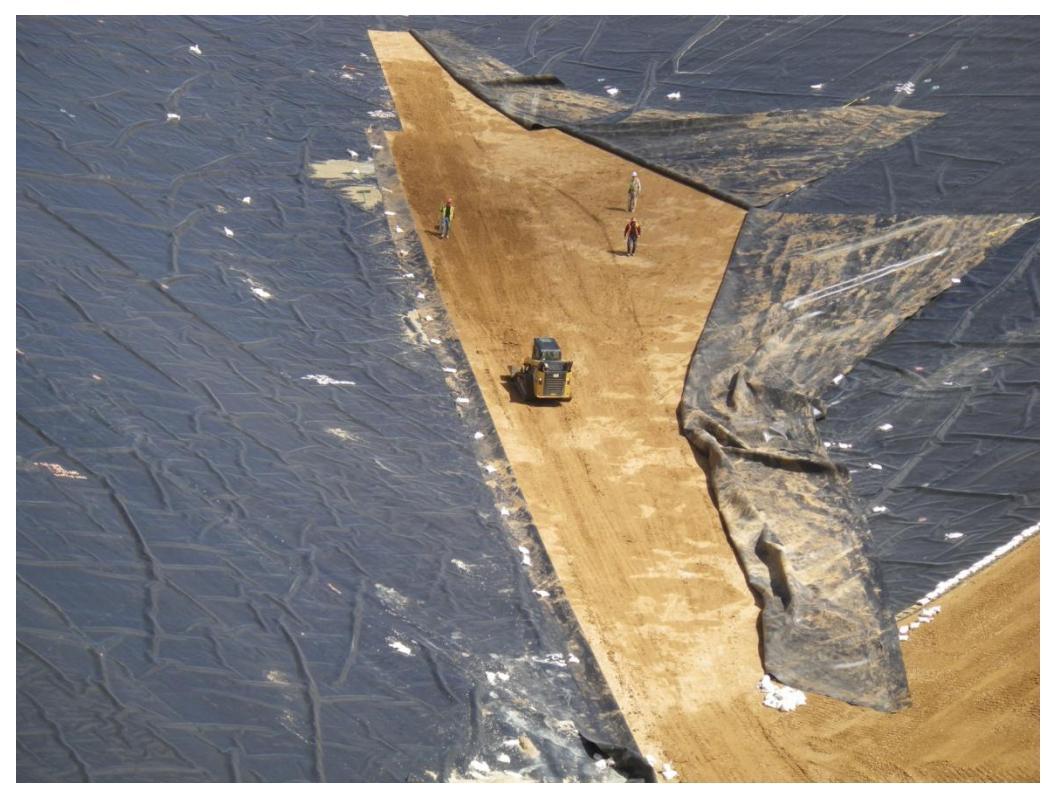
Photo 3: Pulling Back Liner in the Northwest PSSA Corner for SLF Reconditioning

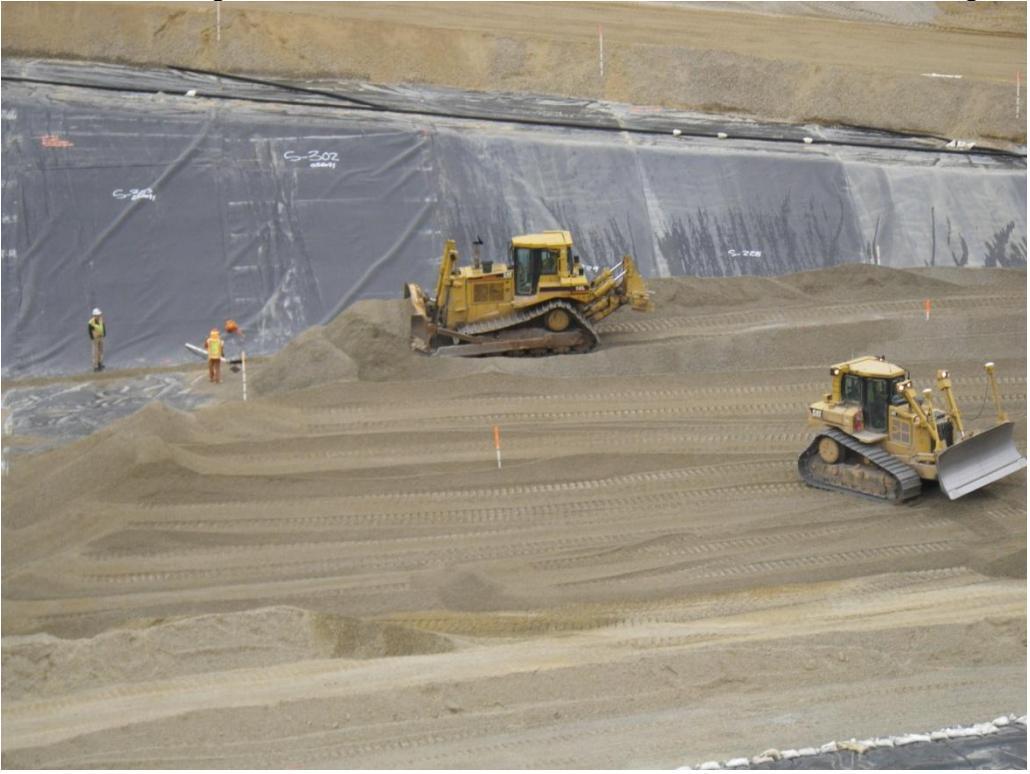
Photo 4: Low Volume Fill Placement at the PSSA floor

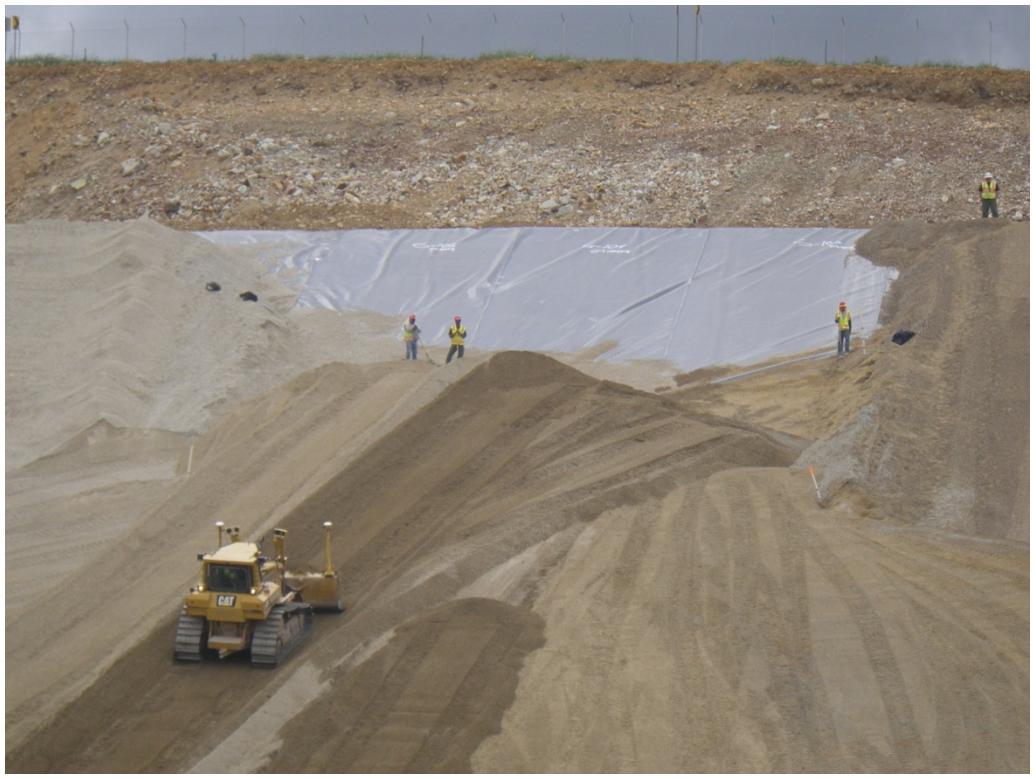
Photo 1: Low Volume Fill Placement

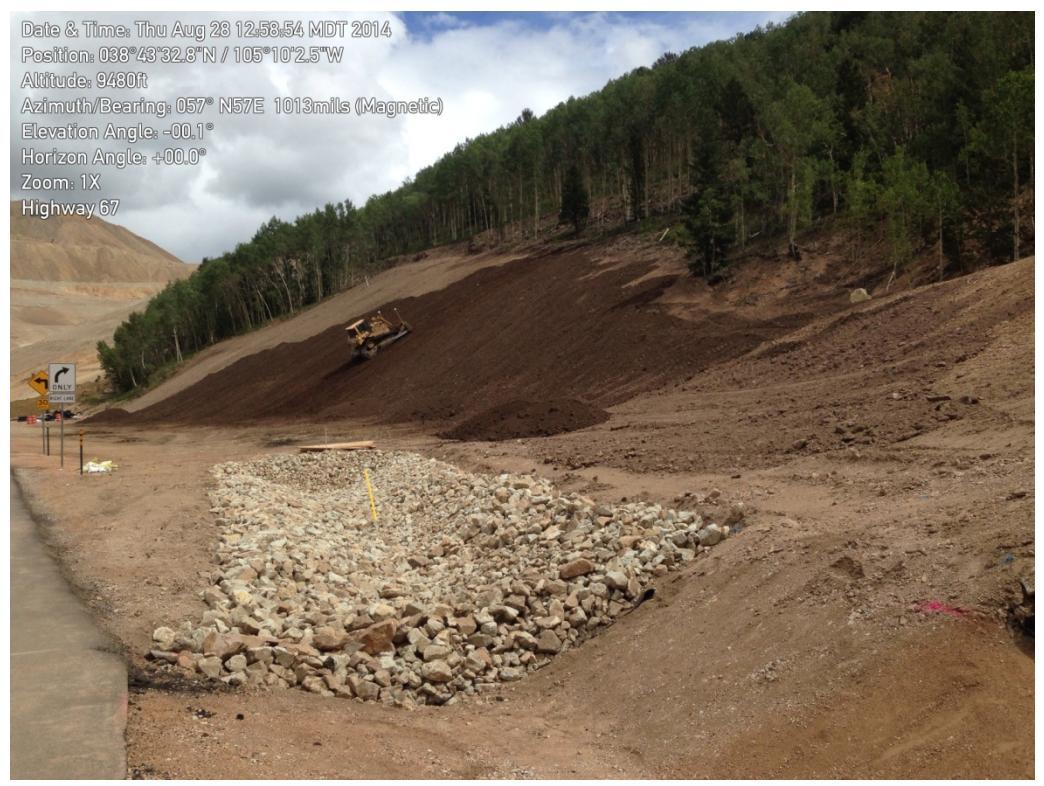
Photo 2: Topsoil Placement adjacent to Hwy 67 between the MSE Wall and the PSSA

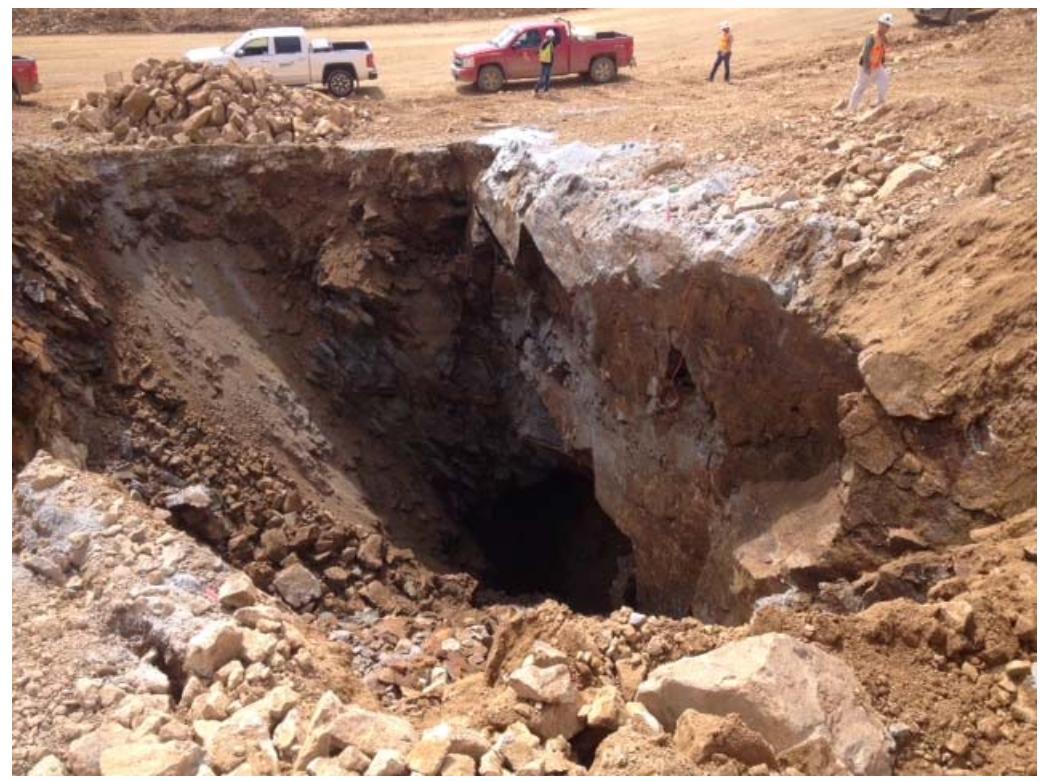
Photo 3: Underground Working #6639 After Blasting
