CRIPPLE CREEK & VICTOR GOLD MINING Co. ANGLOGOLD ASHANTI (COLORADO) SQUAW GULCH (VLF) & HWY 67 RE-ALIGNMENT MONITORING WEEKLY REPORT

Owner:	Cripple Creek & Victor Gold Mining Co.	Project Number:	74201125N0
Project:	Squaw Gulch Valley Leach Fill (VLF)	Week Ending:	July 19, 2014
Location:	Cripple Creek & Victor Gold Mine, CO		
Contractor:	Ames Construction, Inc.

Reporting Period: 07.12.2014 through 07.19.2014

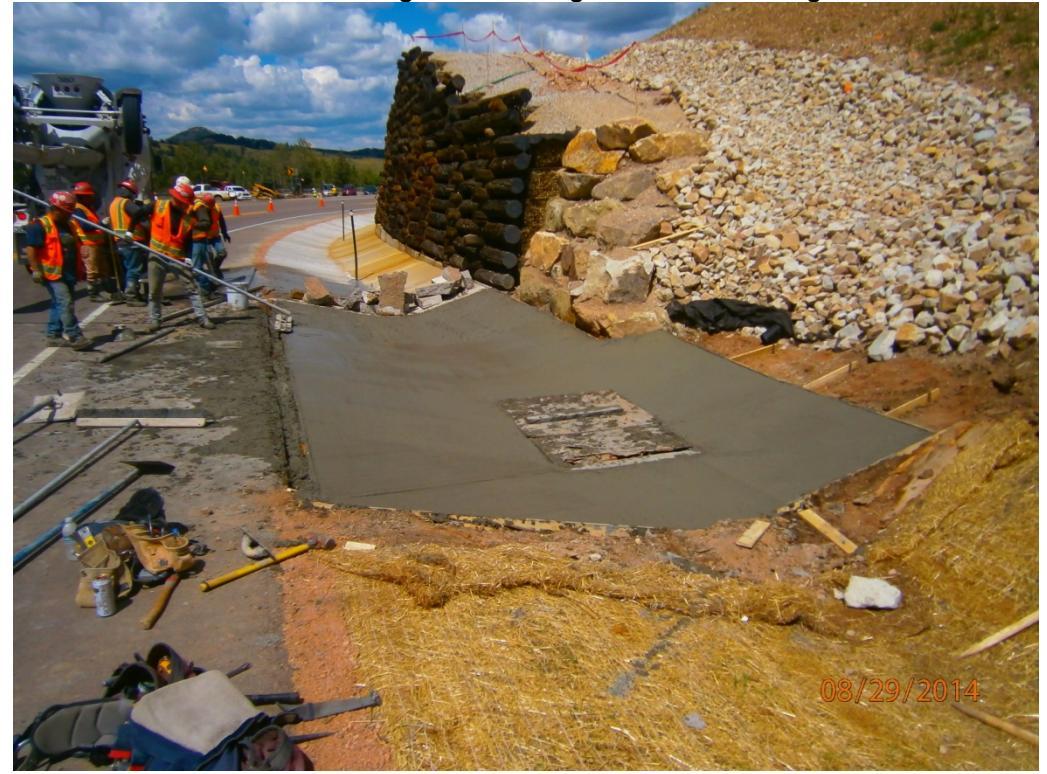
Photo 4: Concrete Pour at the Victor Side MSE Wall Ditch

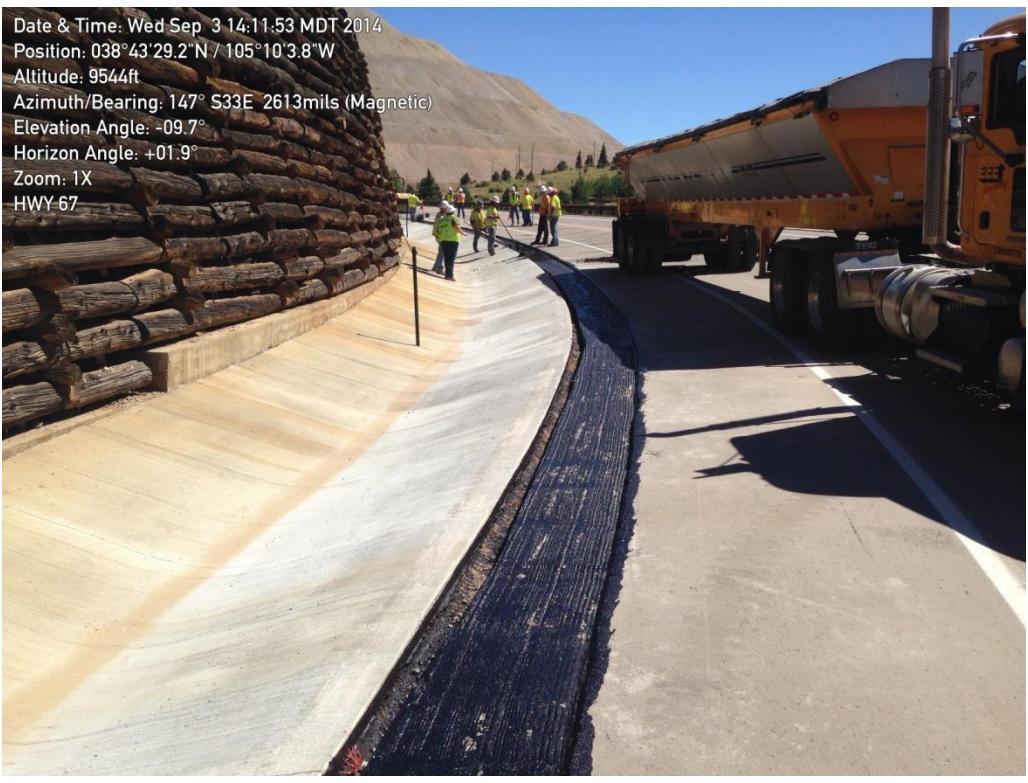
Photo 1: Asphalt Patching at HWY 67

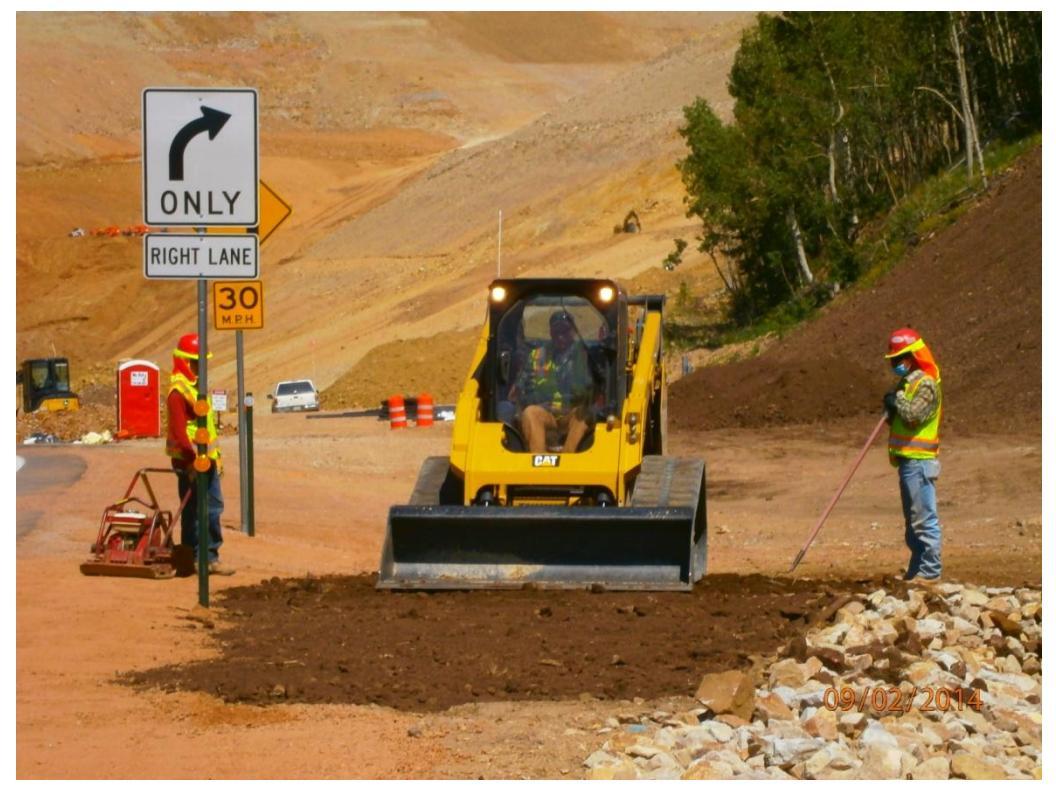
Photo 2: Topsoil Placement adjacent to Hwy 67 between the MSE Wall and the PSSA

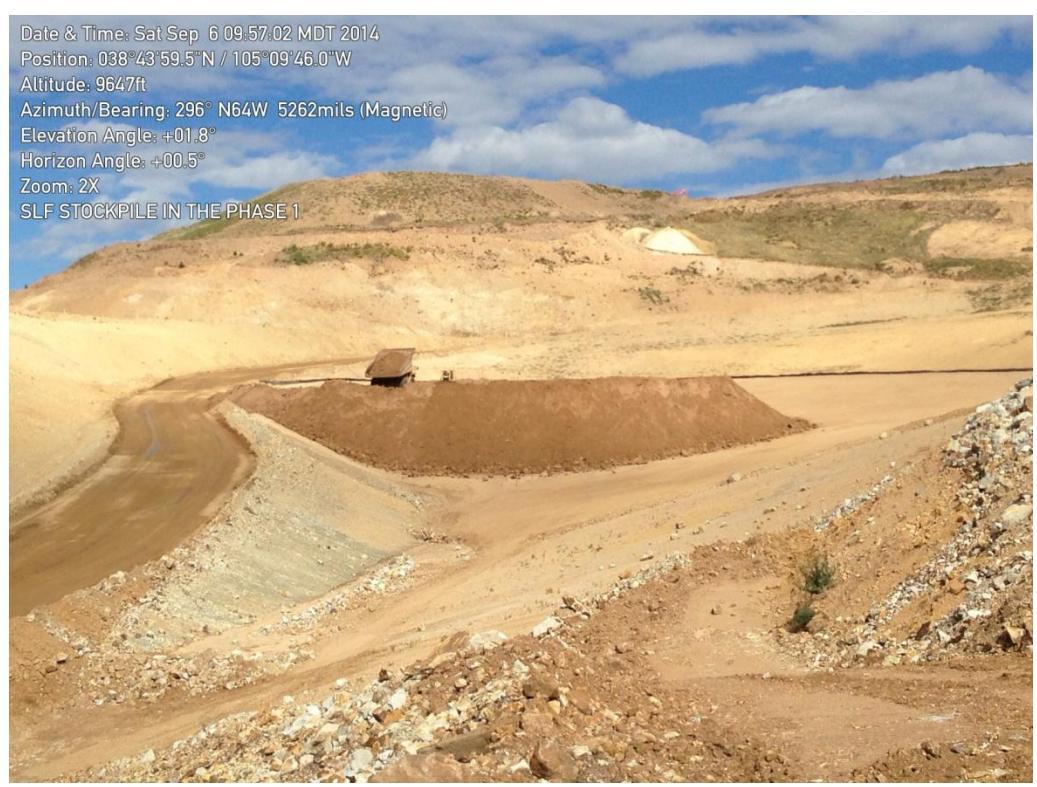
Photo 3: Stockpiling SLF below Stations F0+00 to F10+00

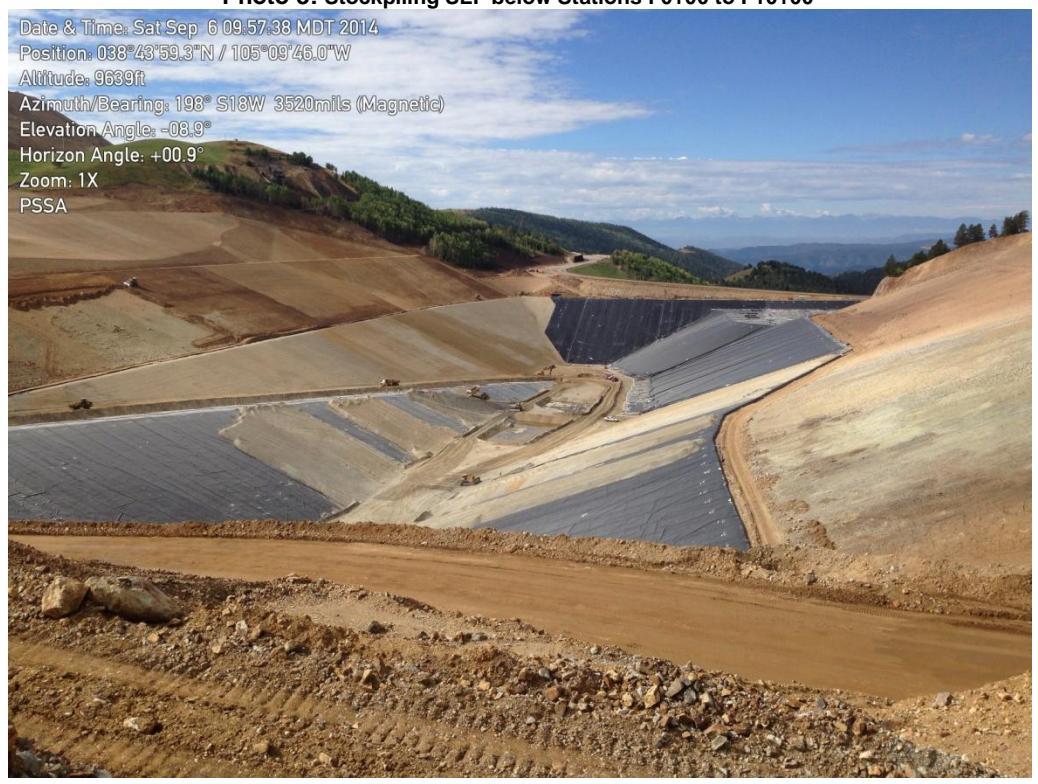
Photo 4: PSSA Overview

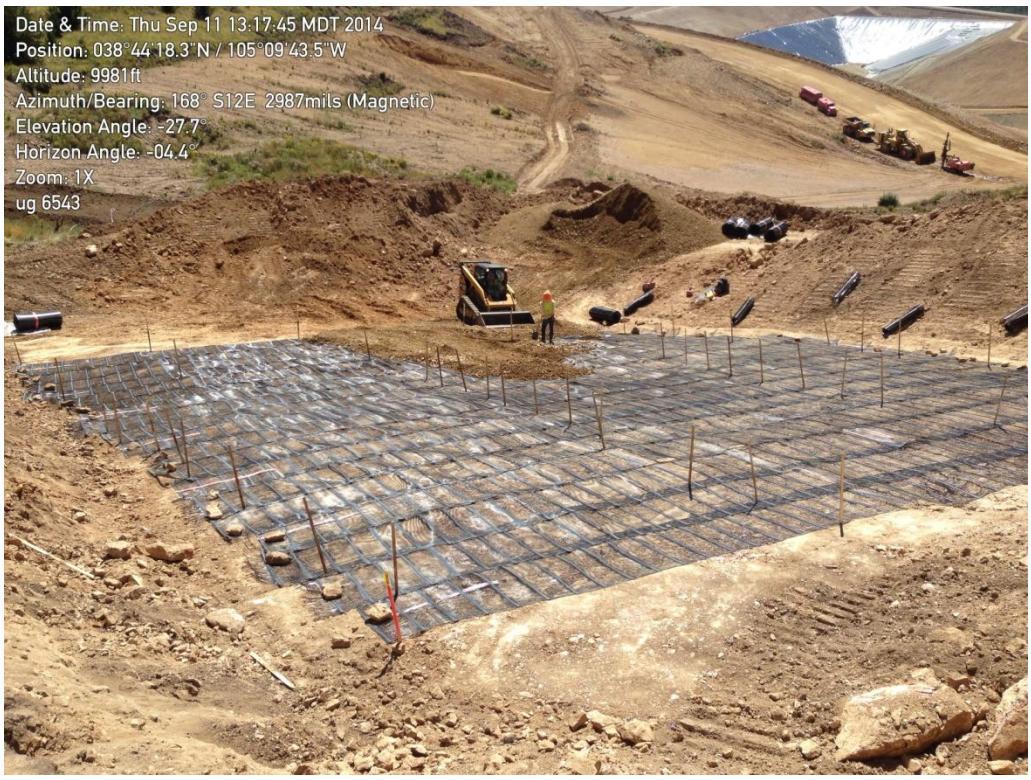
Photo 1: Geogrid and Select Structural Fill Placement at UG 6543

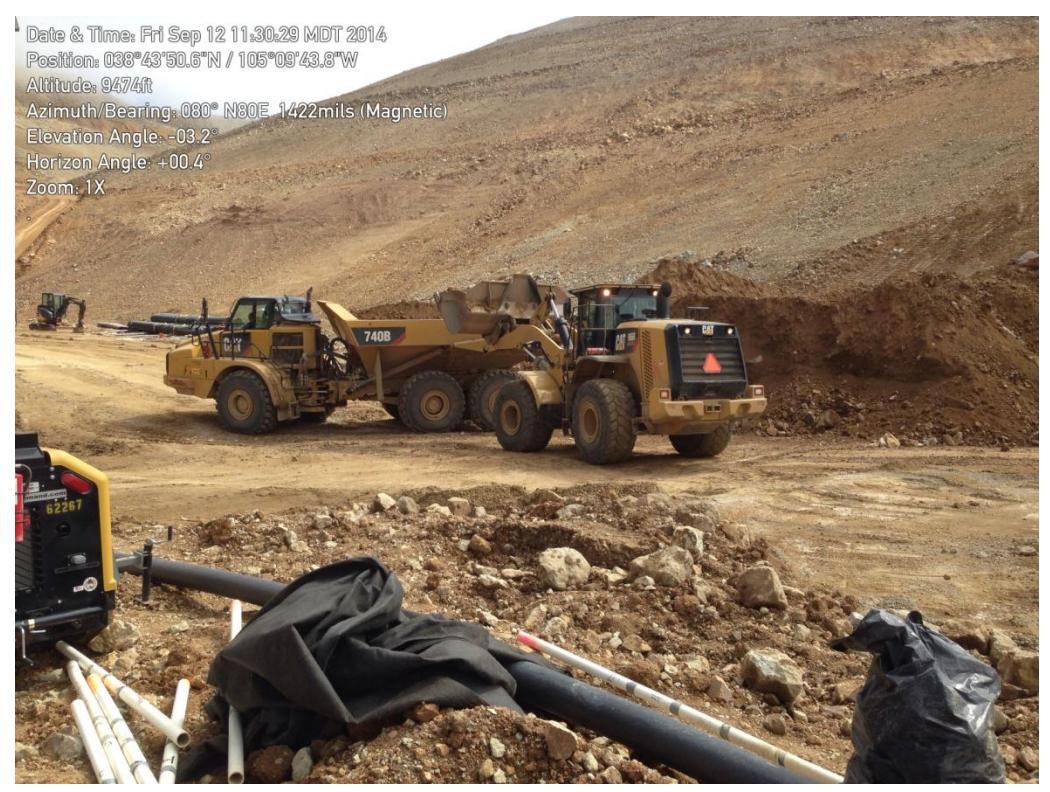
Photo 2: Loading Stockpiled Cut in the ADR Haul Road for use as Structural Fill

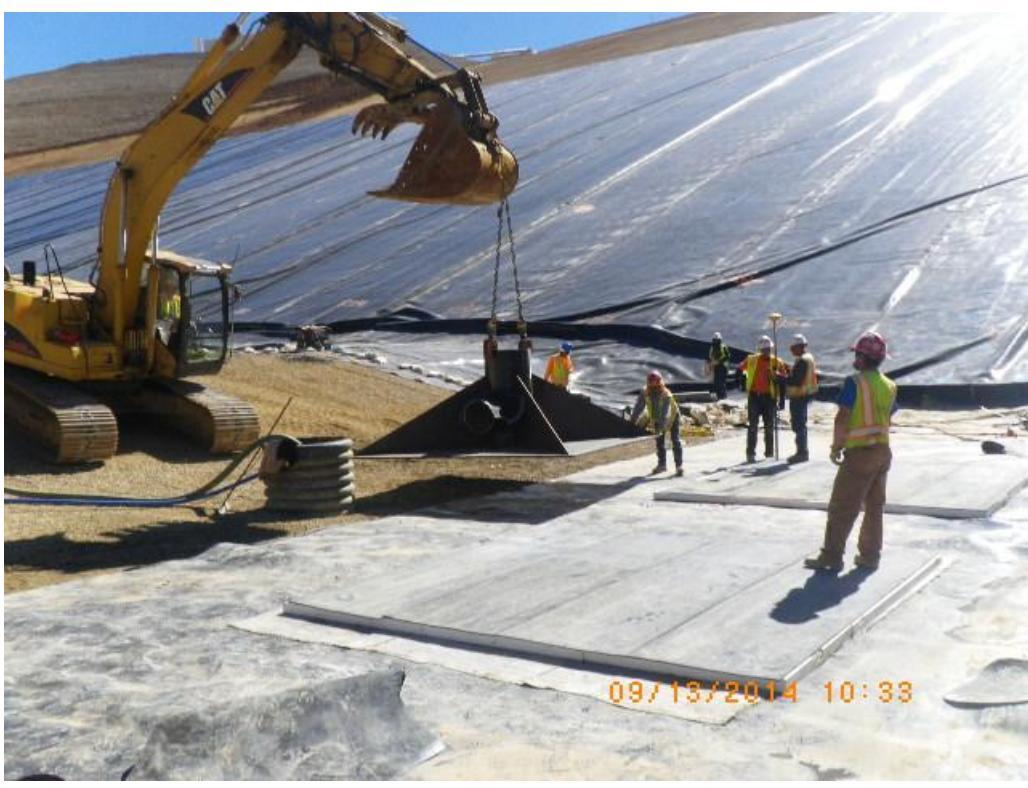
Photo 3: HVSCS Header Installation

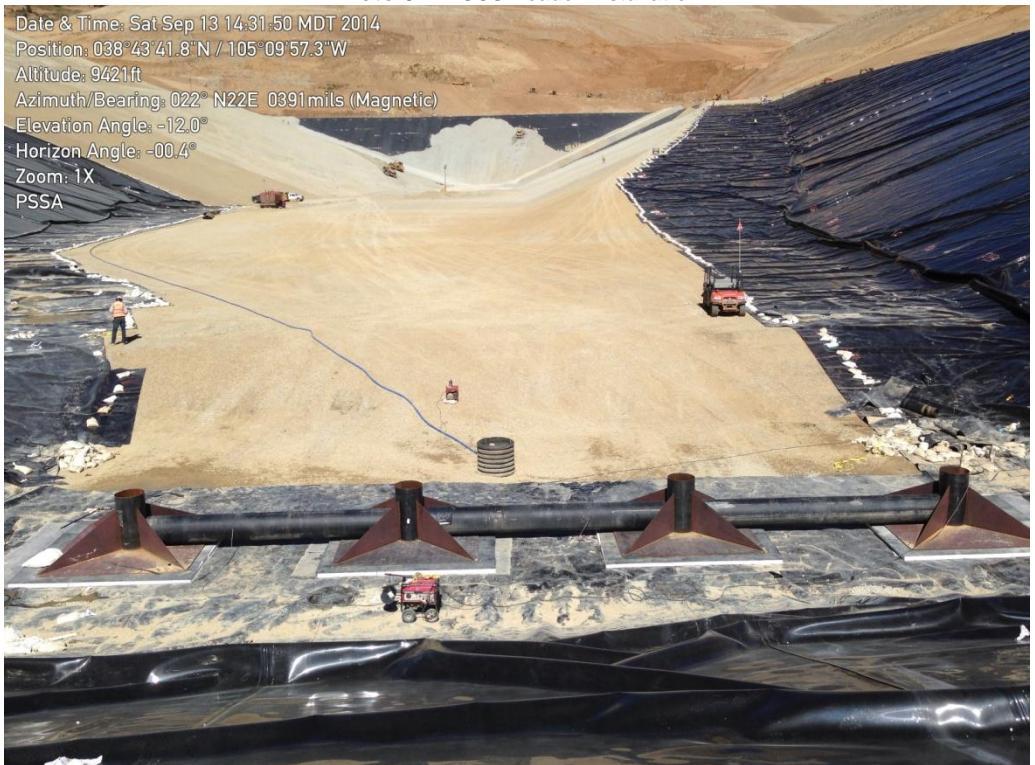
Photo 4: Completed HVSCS Header Installation
