# Appendix Q

# **Closure Drain Installation Summary**

Project No.: 74201125N

# Subject: Squaw Gulch VLF Closure Drain Installation Summary Revised with Detailed Logging Data and Horizontal Component Installation Details (REV 2)

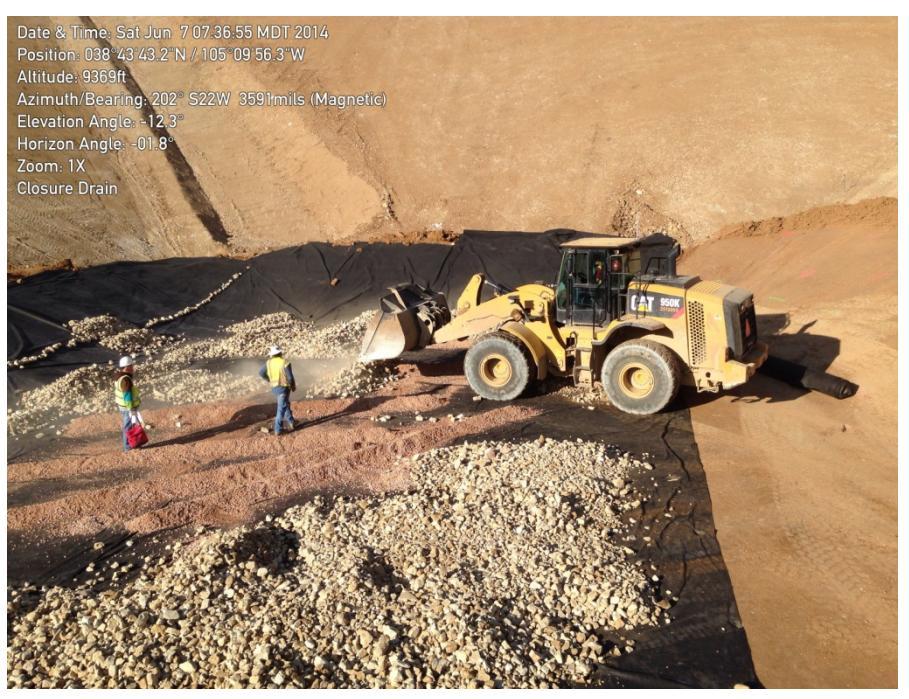
Photo 3 Placement of Non-woven Geotextile and PVC Drains

Non-woven geomembrane fabric was placed on the soil liner fill, and the horizontal components of the drains were constructed.

The drains horizontal components were built using 2-inch schedule 80 PVC 0.020 slotted screens, which were coupled with the downhole drain components using a 45° elbow coupler. The horizontal drains were covered with leak detection fill. A sample of the material (LDF1-R

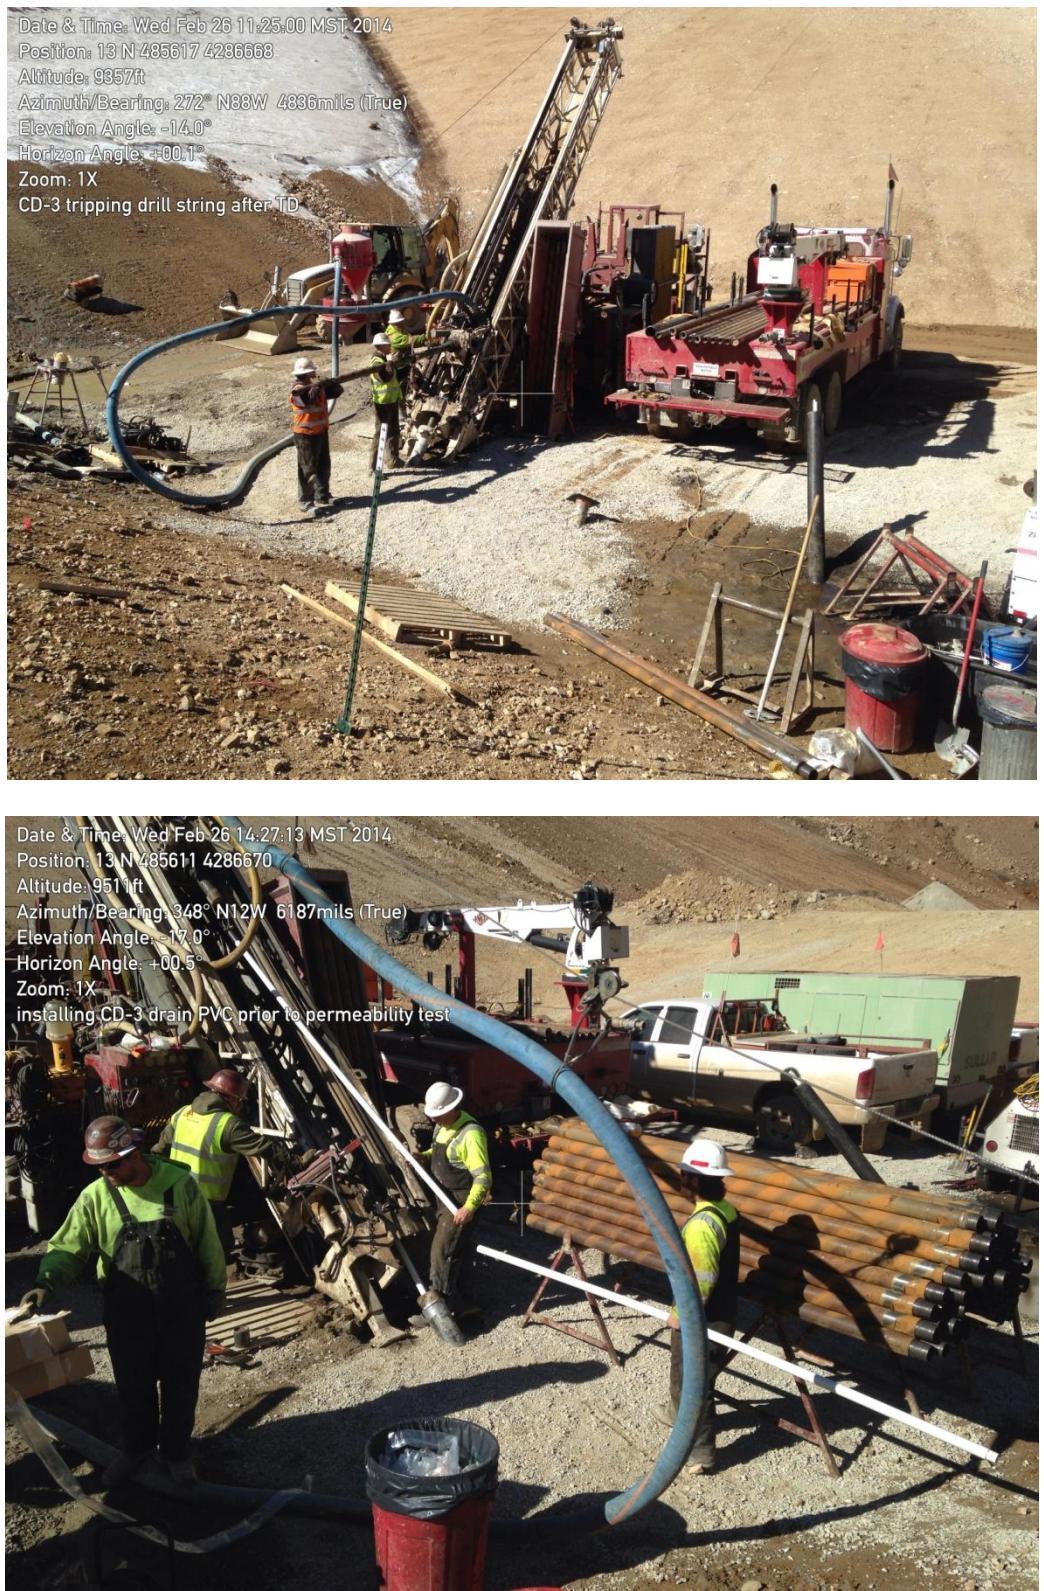
- 1100-1345 AK tripped RC rods from the hole.
- 1345-1415 AK shut down for Ames blasting in the VLF.
- 1415-1500 The drain PVC was installed with a 2-inch end cap, 30lf of 0.030 slotted screen, and 350lf of schedule 80 riser pipe before becoming hung up on a fracture in the quartz monzonite.

Photo 2. This is the first attempt to install the drain

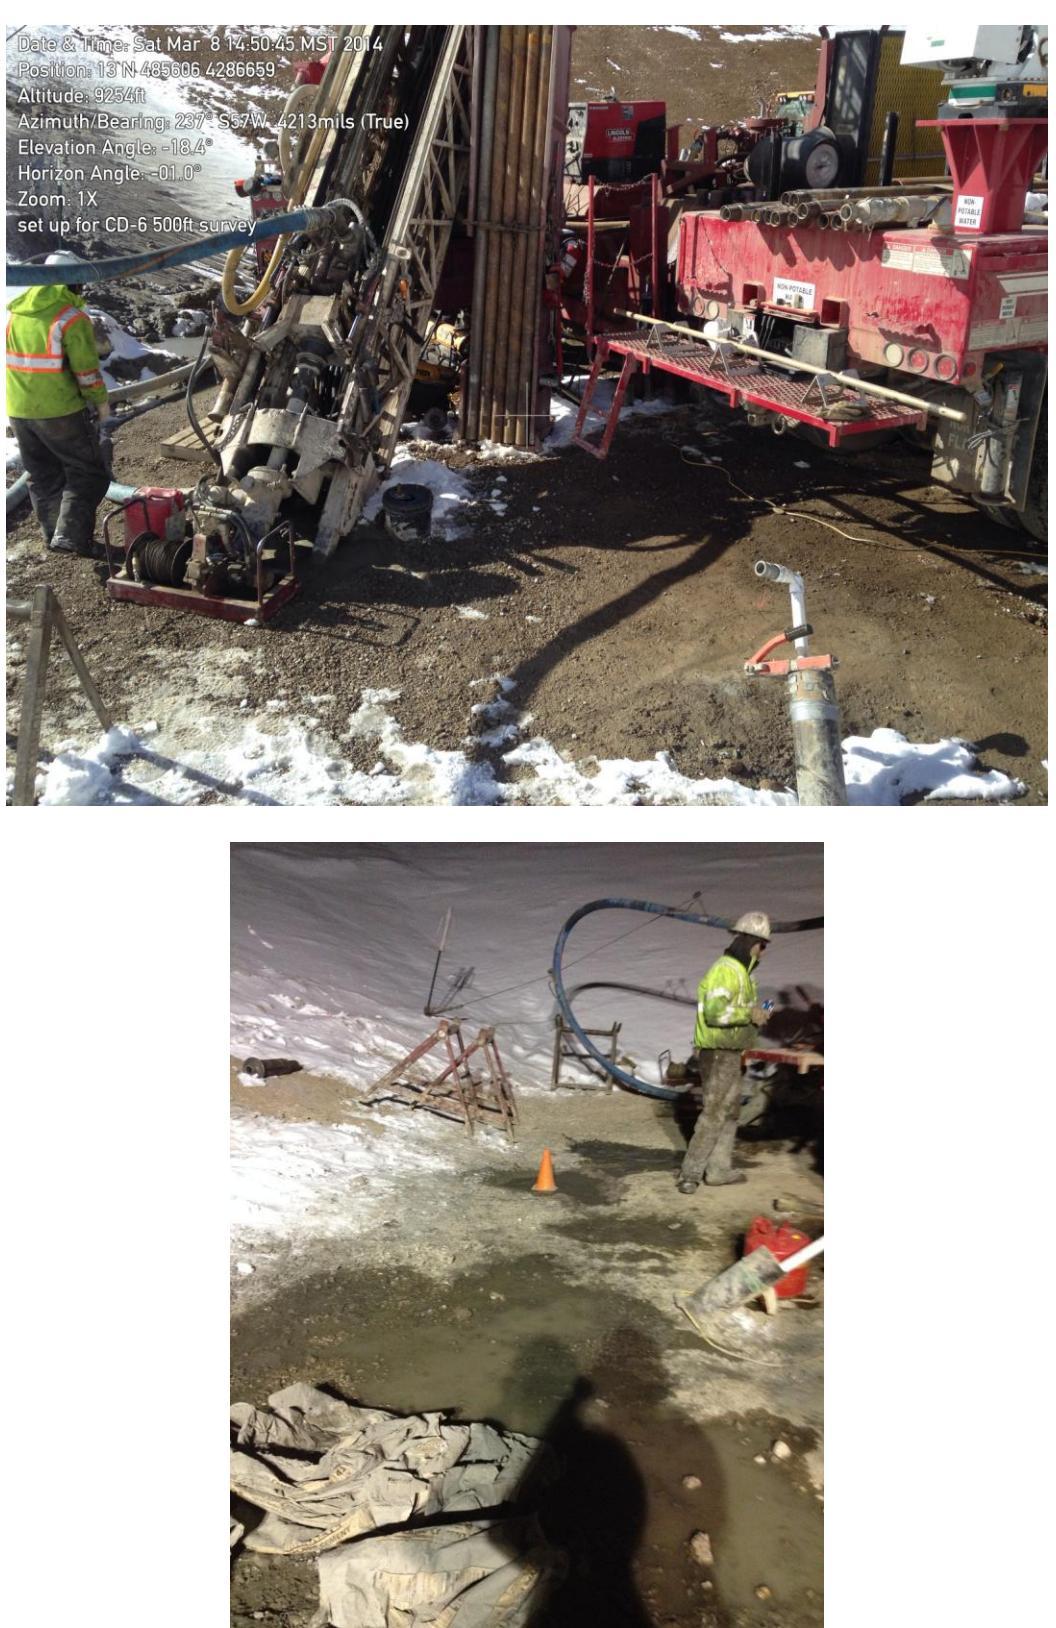
Photo 3. CD-5 was grouted to the surface and the casing was cut approximately 0.5ft below grade per Ames.
