MINE NAME:	MINE/PROSPECTING ID#:	MINERAL: COUNTY:	
Hatchery Pit	M-2014-043	Gravel, sand and bor Adams	
		for construction	
INSPECTION TYPE:	INSPECTOR(S):	INSP. DATE: INSP. TIME:	
Monitoring	Tyler V. O'Donnell	October 6, 2014 09:00	
OPERATOR:	<b>OPERATOR REPRESENTATIVE:</b>	TYPE OF OPERATION:	
Albert Frei & Sons Inc.	Ben Frei	112c - Construction Regular Operation	
<b>REASON FOR INSPECTION:</b>	BOND CALCULATION TYPE:	BOND AMOUNT:	
Normal I&E Program	Complete Bond	To be Determined	
DATE OF COMPLAINT:	POST INSP. CONTACTS:	JOINT INSP. AGENCY:

#### PERMIT #: M-2014-043 INSPECTOR'S INITIALS: TOD INSPECTION DATE: October 6, 2014

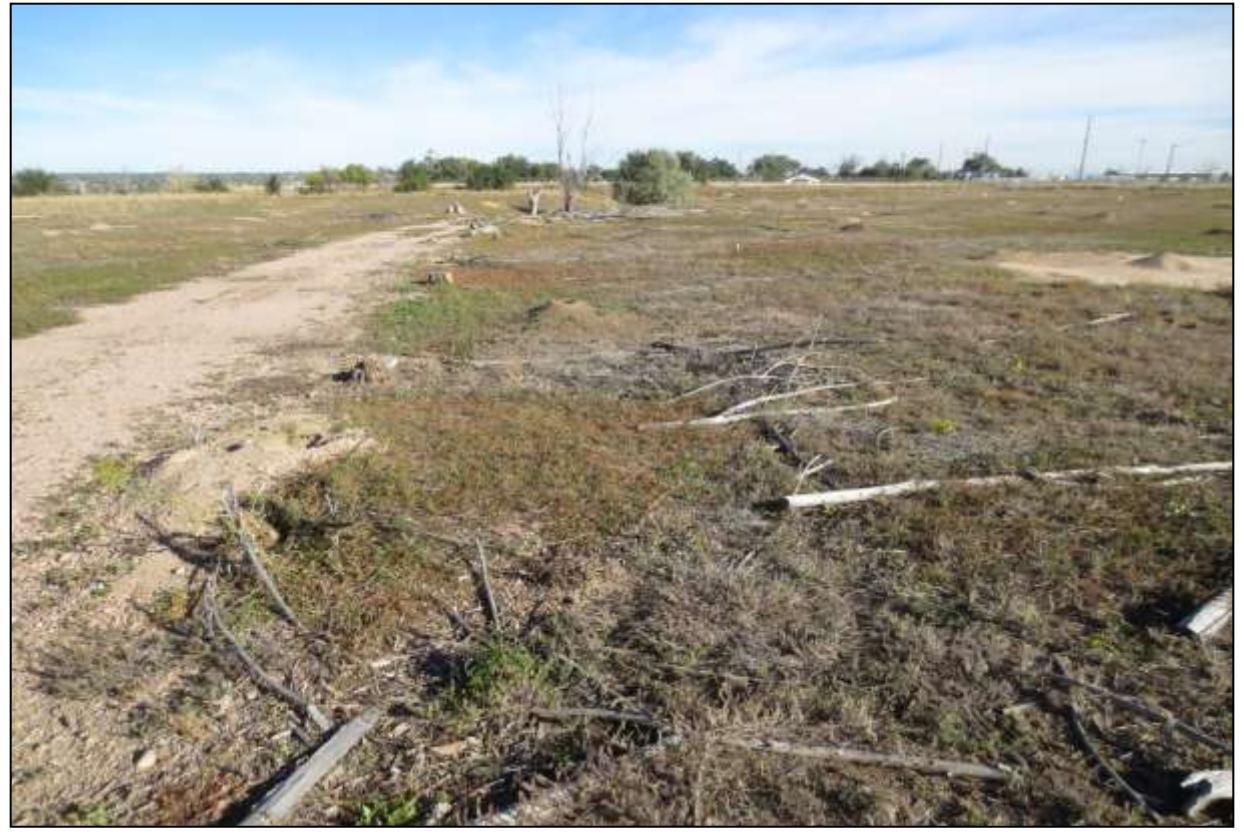
Photo 1: Old sod farm area on top of the terrace deposit.

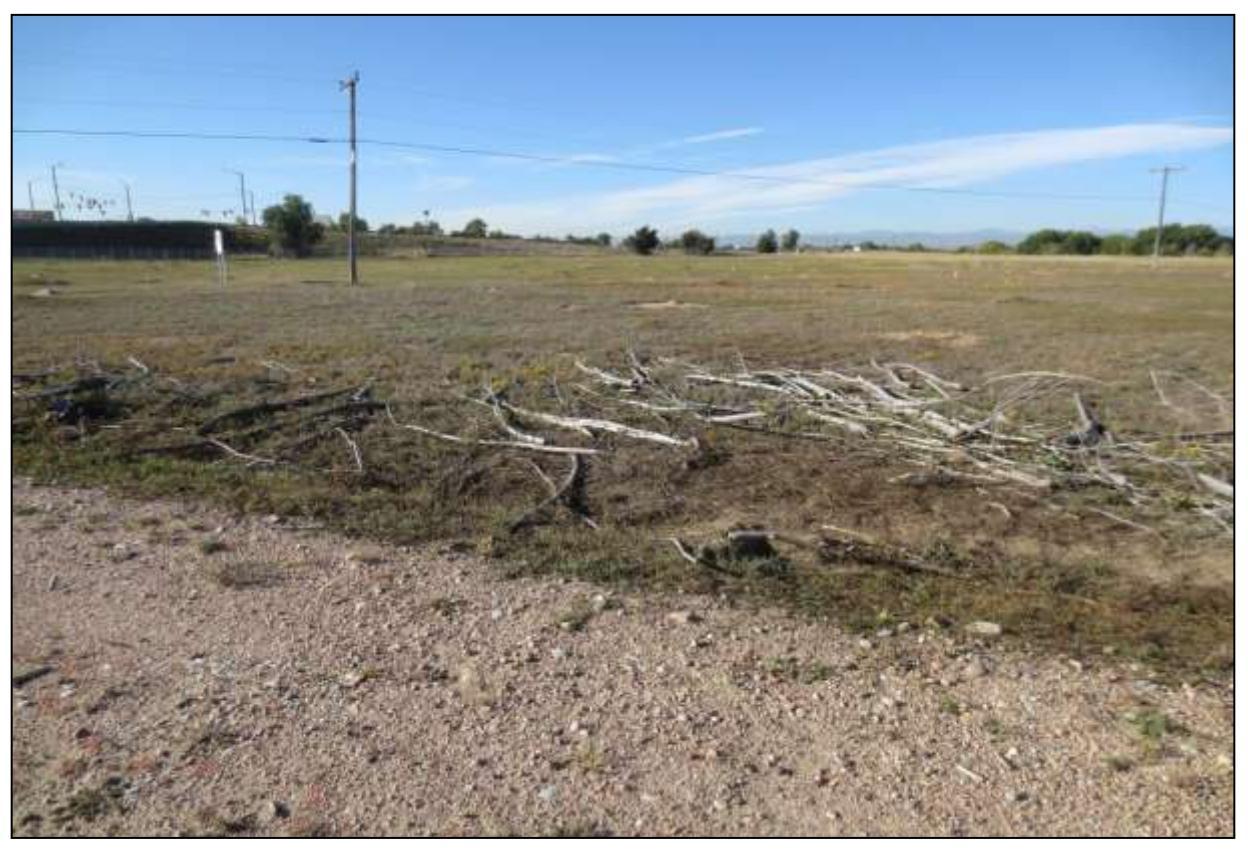
Photo 2: Old sod farm area on top of the terrace deposit.

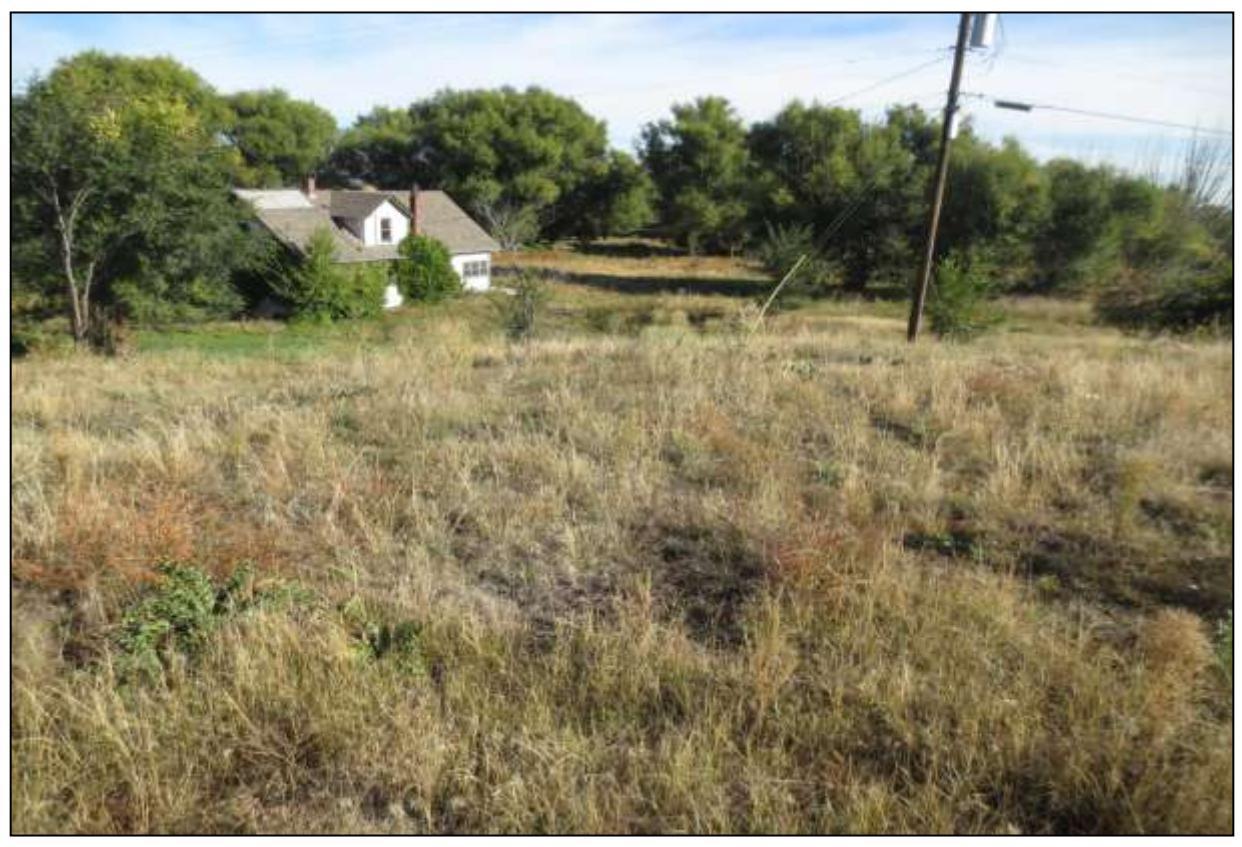
Photo 3: Lower alluvial deposit. Old homestead in the background.

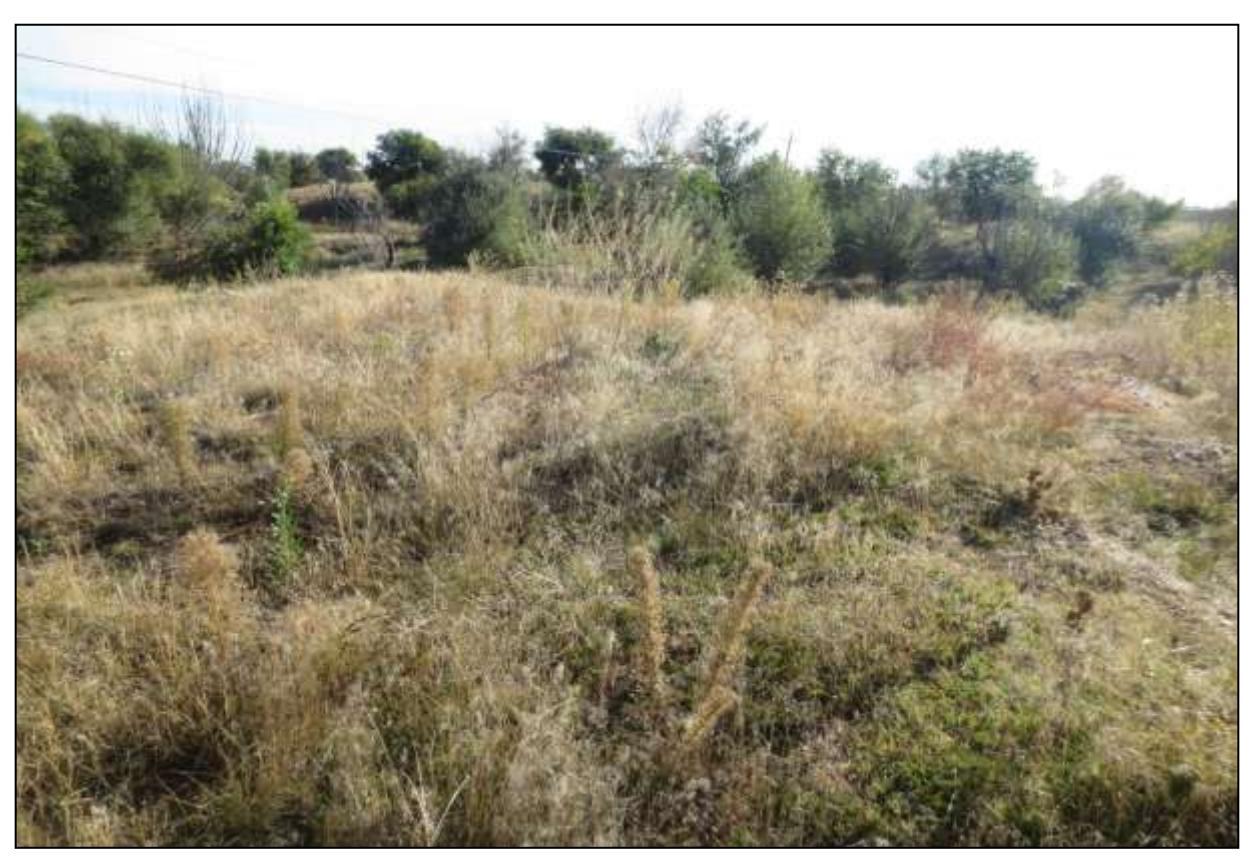
Photo 4: Lower alluvial deposit.

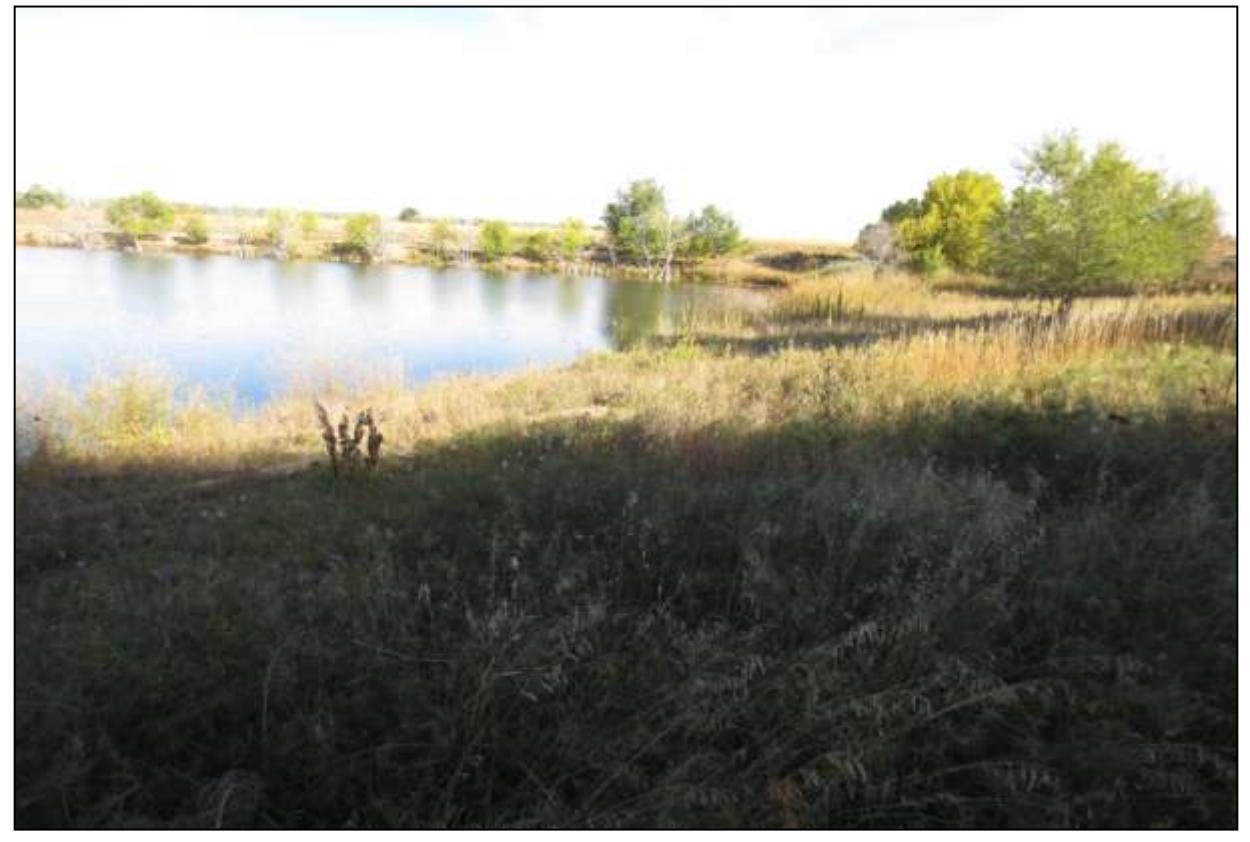
Photo 5: Lower alluvial deposit. Historic mining disturbance in the background.

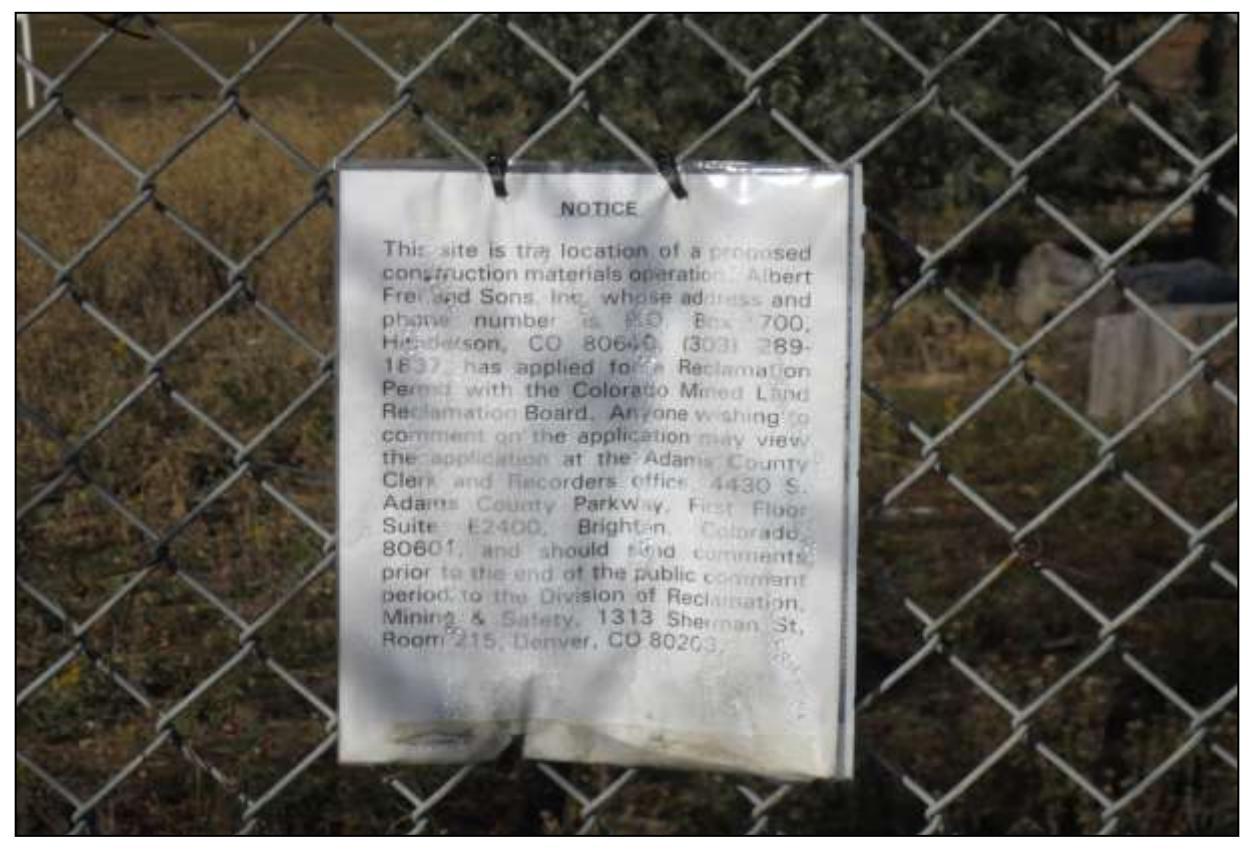
Photo 6: Public notice required by Rule 1.6.2(b) posted at the entrance of the site.
