**Re: Hatchery Pit, DRMS File No. M-2014-043,
112 Construction Materials Reclamation Permit Application,
Fourth Adequacy Review**

Re: Third review of Slope Stability Analysis, Albert Frei & Sons Inc., Hatchery Pit, File No. M-2014-043

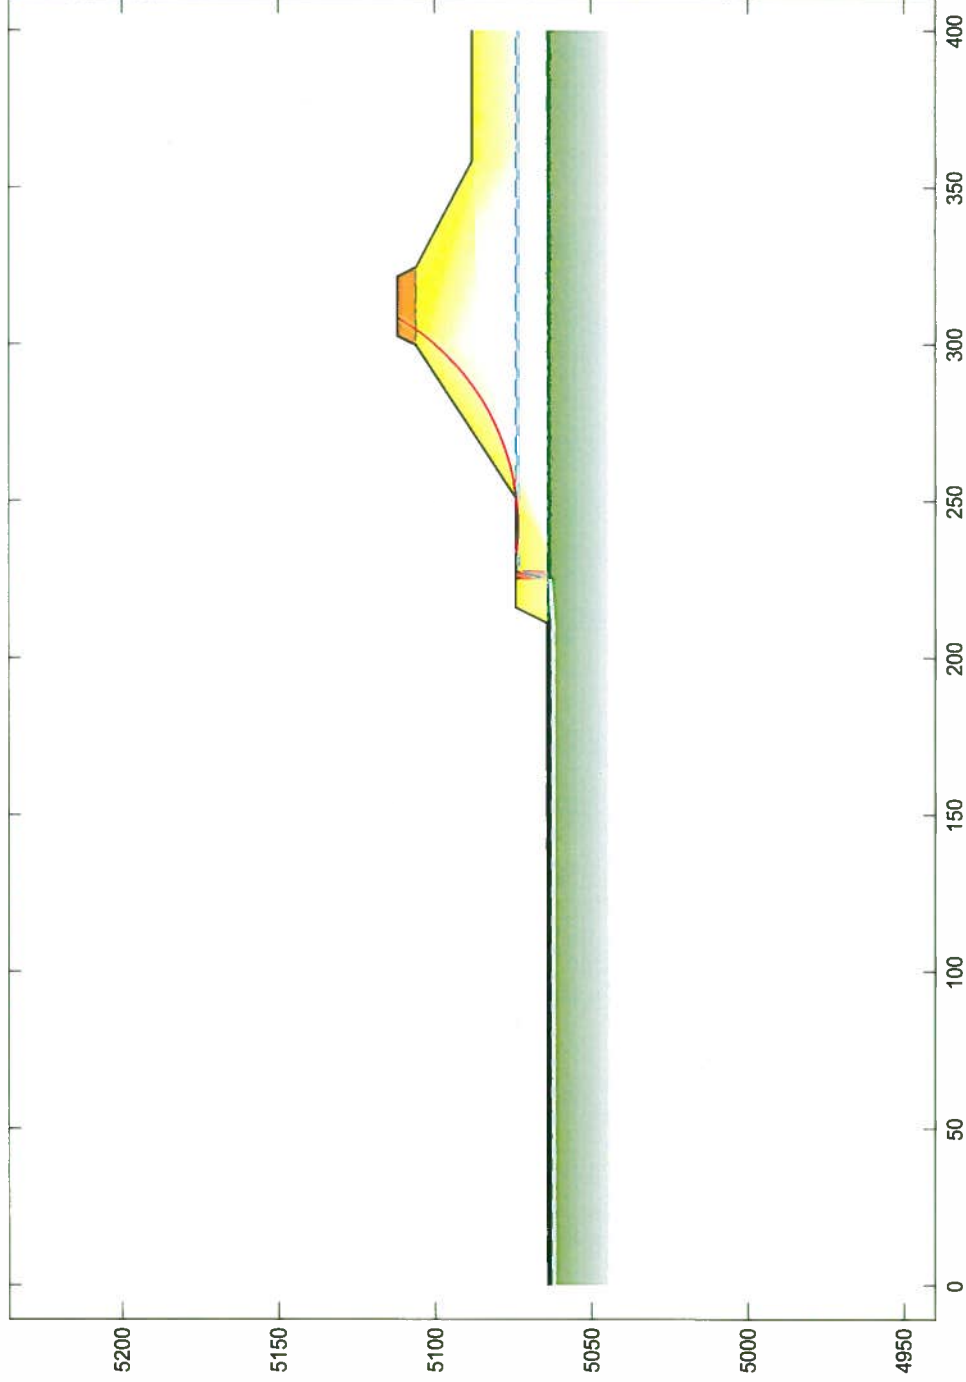
Project Albert Frei & Sons, Inc. - Hatchery Pit - M2014043
South Side

2. The Applicant's cross section was duplicated for verification. The safety factor produced by Galena is significantly lower (1.19) than the safety factor produced by the Applicant's model (1.3). Therefore, this slope configuration is unacceptable for the South Section cross-section. A copy of the Galena model is attached. The Division will require the Applicant to obtain structure agreements for all property, including easement holders, and structure owners within two hundred feet of the affected land for this cross-section. Alternatively, the Applicant may revise the model perimeters to increase the factor of safety to 1.3 or greater.

3. The Deere & Ault stability analysis model reversed the cross-section positions of overburden and sand & gravel and labeled the slurry wall as "Sand & Gravel". Please review the analysis model and revise the model as needed.

1.19

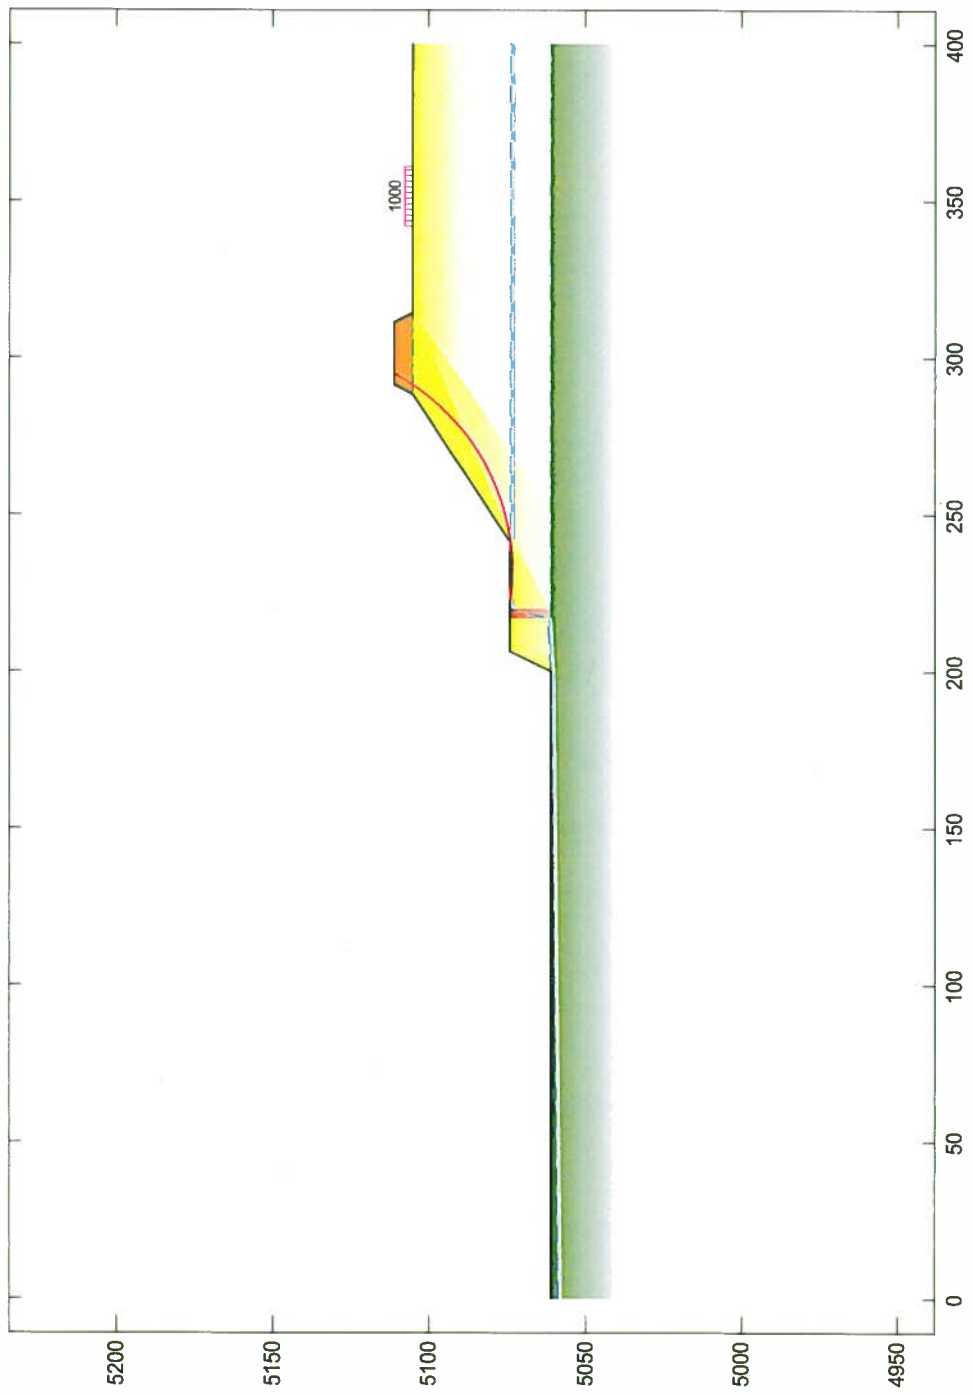
Project Albert Frei & Sons, Inc. - Hatchery Pit - M2014043
East Side

4. The Applicant's cross section was duplicated for verification. The safety factor produced by Galena is significantly lower (1.19) than the safety factor produced by the Applicant's model (1.3). Therefore, this slope configuration is unacceptable for the East Section cross-section. A copy of the Galena model is attached. The Division will require the Applicant to obtain structure agreements for all property, including easement holders, and structure owners within two hundred feet of the affected land for this cross-section. Alternatively, the Applicant may revise the model perimeters to increase the factor of safety to 1.3 or greater.
5. The Deere & Ault stability analysis model reversed the cross-section positions of overburden and sand & gravel. Please review the analysis model and revise the model as needed.

Results
Factor of Safety: 1.19

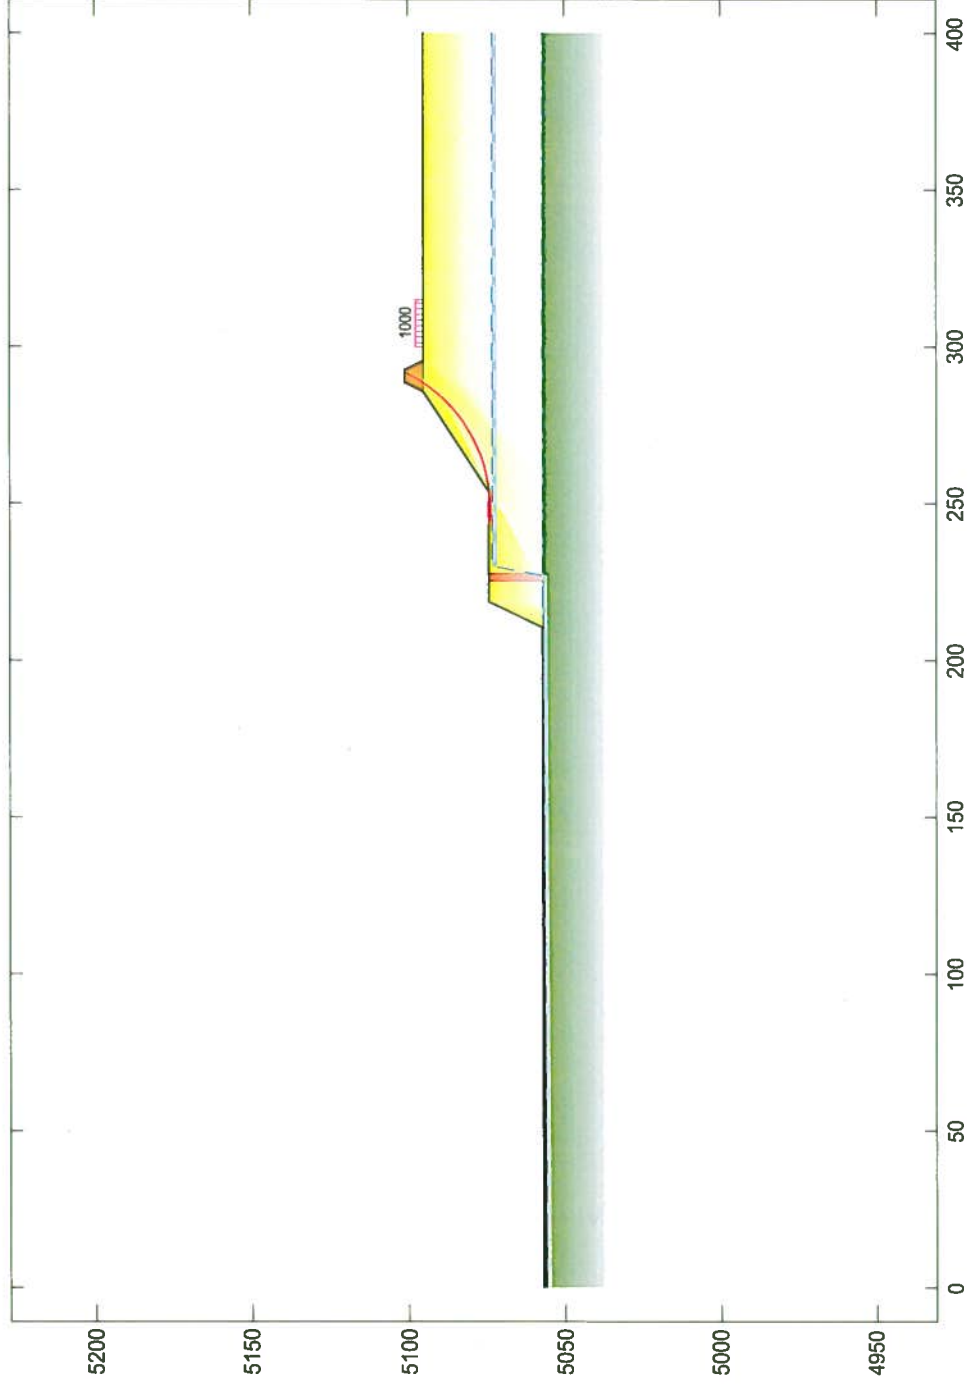
North Side

6. The Applicant's cross section was duplicated for verification. The safety factor produced by Galena is significantly lower (1.18) than the safety factor produced by the Applicant's model (1.3). Therefore, this slope configuration is unacceptable for the North Section cross-section. A copy of the Galena model is attached. The Division will require the Applicant to obtain structure agreements for all property, including easement holders, and structure owners within two hundred feet of the affected land for this cross-section. Alternatively, the Applicant may revise the model perimeters to increase the factor of safety to 1.3 or greater.
7. The Deere & Ault stability analysis model reversed the cross-section positions of overburden and sand & gravel and labeled the slurry wall as "Sand & Gravel". Please review the analysis model and revise the model as needed.

Results
Factor of Safety: 1.18

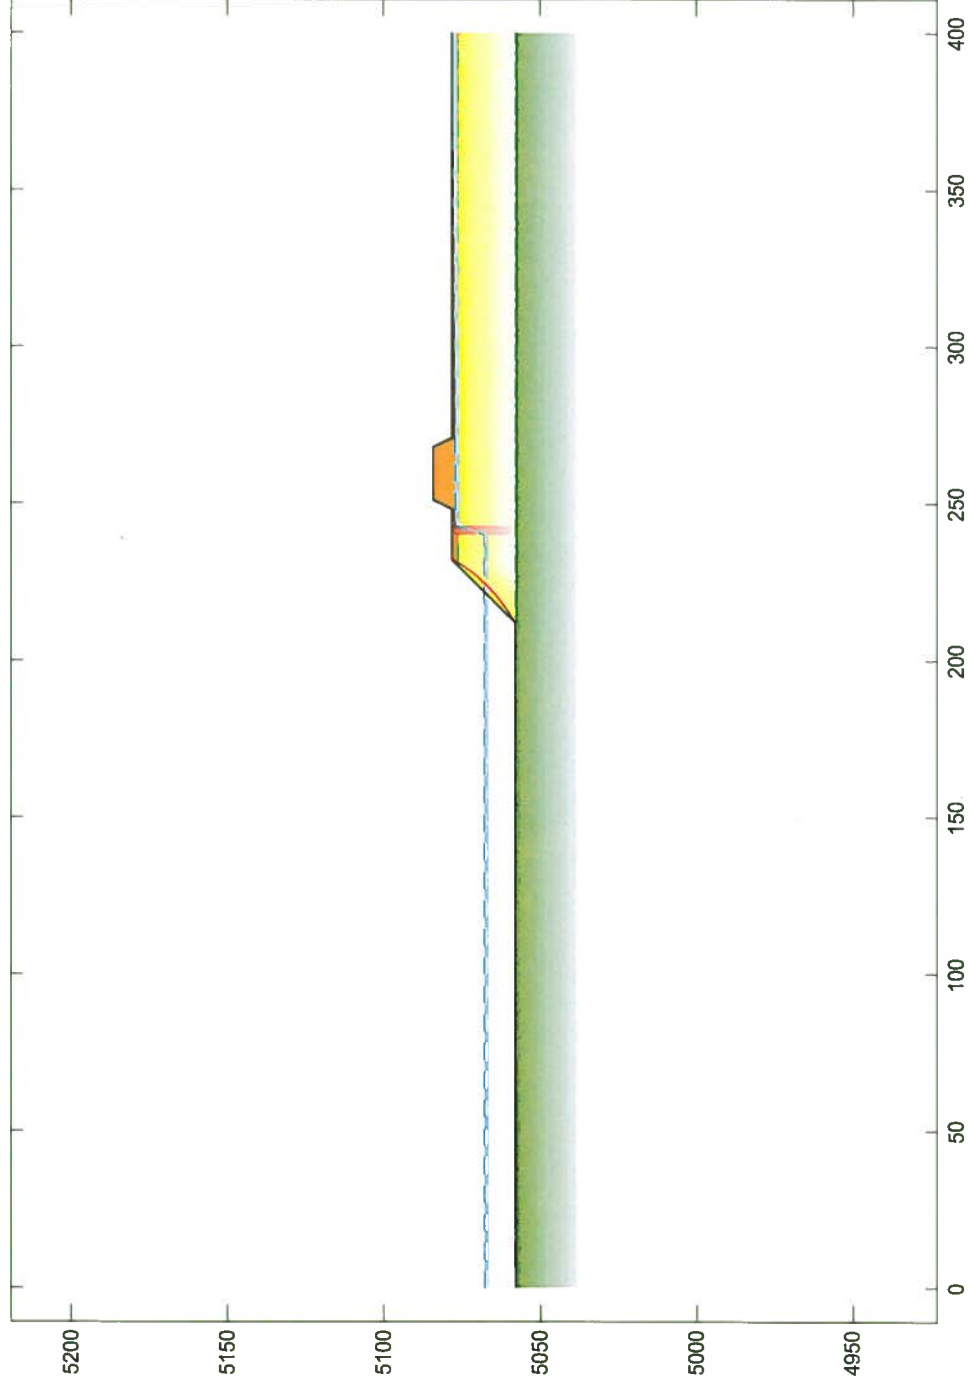
Project: Albert Frei & Sons, Inc. - Hatchery Pit - M2014043
Phase 1

8. The Applicant's cross section was duplicated for verification. The safety factor produced by Galena is significantly lower (0.74) than the safety factor produced by the Applicant's model (1.3). Therefore, this slope configuration is unacceptable for the Phase 1 Section cross-section. A copy of the Galena model is attached. The Division will require the Applicant to obtain structure agreements for all property, including easement holders, and structure owners within two hundred feet of the affected land for this cross-section. Alternatively, the Applicant may revise the model perimeters to increase the factor of safety to 1.3 or greater.

9. The Deere & Ault stability analysis model reversed the cross-section positions of overburden and sand & gravel. Please review the analysis model and revise the model as needed.

Factor of Safety: 0.74

Negative normal stresses exist on the base of one or more slices - examine slice data and consult the GALENA Help utility
