The Division of Reclamation, Mining and Safety has conducted an inspection of the mining operation noted below. This report documents observations concerning compliance with the terms of the permit and applicable rules and regulations of the Mined Land Reclamation Board.

MINE NAME:	MINE/PROSPECTING ID#:	MINERAL:	COUNTY:
Coyote Ridge	M-2000-052	Sand and gravel	Fremont
INSPECTION TYPE:	INSPECTOR(S):	INSP. DATE:	INSP. TIME:
Monitoring	Timothy A. Cazier	February 19, 2015	13:05
OPERATOR:	<b>OPERATOR REPRESENTATIVE:</b>	TYPE OF OPERATION:	
Rocky Mountain Materials & Asphalt, Inc.	Tom Smith	112c - Construction Regular Operation

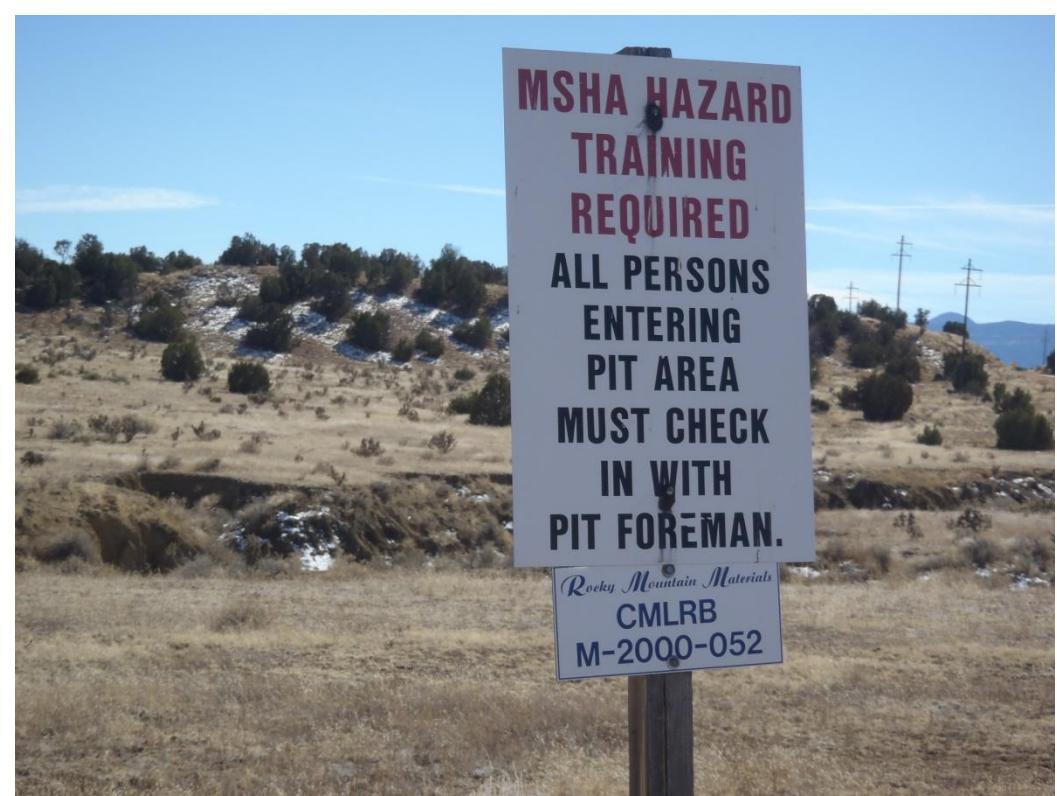
<u>Markers & Boundary</u> – A permit sign was displayed at the site entrance (see **Photo 1**). This is a ridge top operation and mining activity is restricted by topography. The Operator has marked the permit boundary with T-posts (see **Photo 2**).

Photo 1. Permit identification sign.

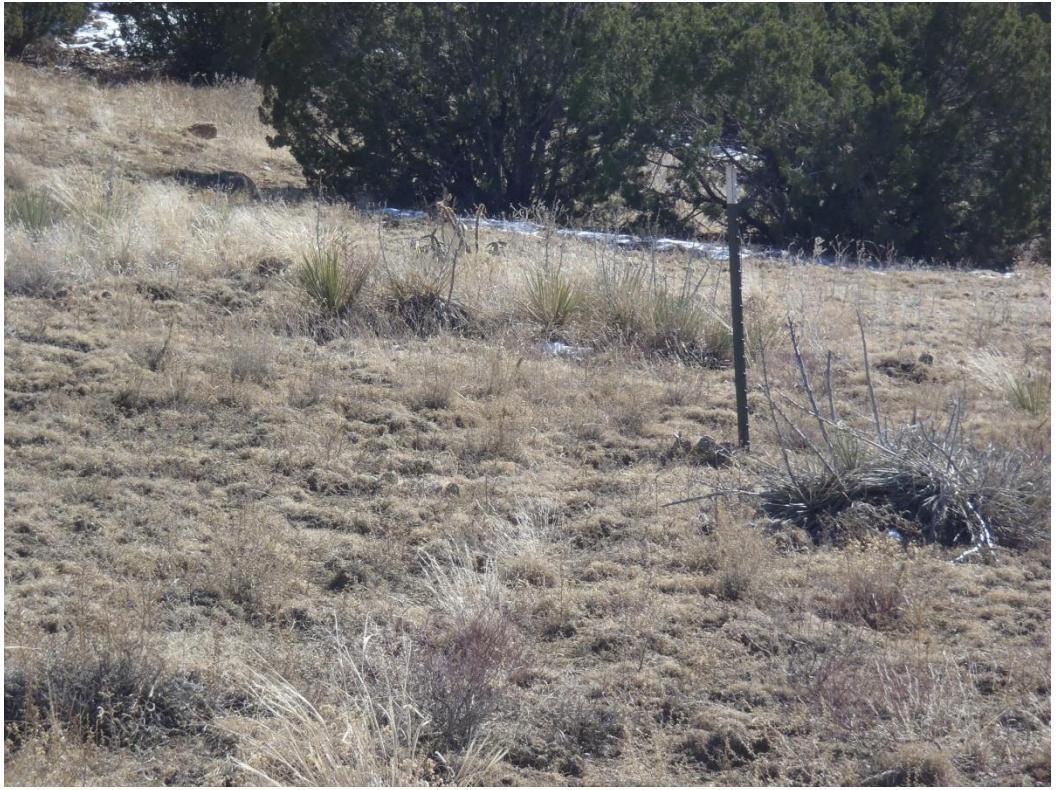
Photo 2. Typical permit boundary T-post (looking south).

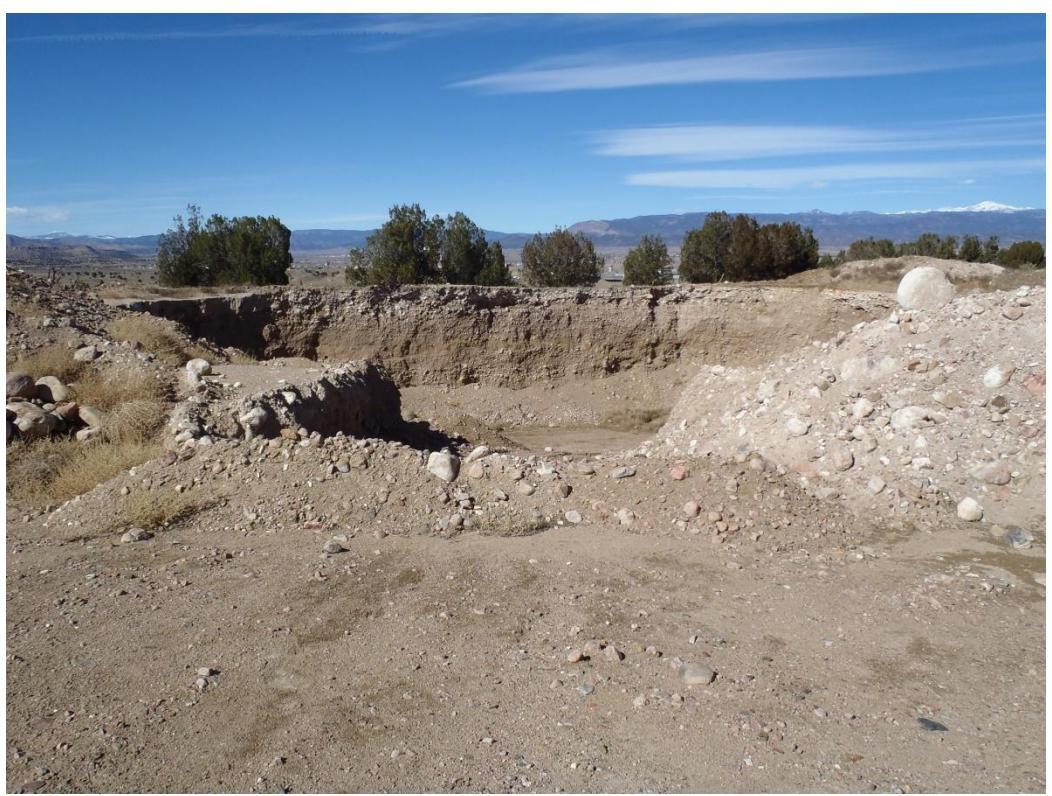
**PROBLEM/POSSIBLE VIOLATION:** Problem: The approved mine plan requires pit highwalls be excavated at 1H:1V. The operator must: A) flatten the highwalls to 1:1 or, B) submit a Technical Revision (TR) to revise the mine plan accordingly. A TR must include rationale as to why the highwalls should be allowed to be steeper and modifications to Exhibits E (Reclamation Plan) and L (Reclamation Cost Estimate) for the additional earth work required to backfill or flatten the highwalls.

- a) The total permitted area is 193.280 acres, with a <u>maximum allowed disturbed area</u> (at one time) of <u>45 acres</u>.
  - b) A review of the approved reclamation plan (Exhibit E, Section II, enclosed for your reference) states "<u>Mine slopes will generally be excavated to a 1:1 slope</u>." During the inspection, it was observed that the highwalls in the Area 3 pit were nearly vertical. The Operator must adjust the mining practice to excavate at a 1H:1V slope or submit a Technical Revision to modify the mine plan. The nearly vertical highwalls are cited as a problem on page 1 of this report.

Photo 3. Area 3 pit/highwall – note near vertical highwall (looking north).

**CORRECTIVE ACTIONS:** The operator shall submit: A) photographic evidence of flattening the highwalls, or B) a Technical Revision, with the required \$216 revision fee, to revise the mine and reclamation plans and the reclamation cost estimate by the corrective action date.

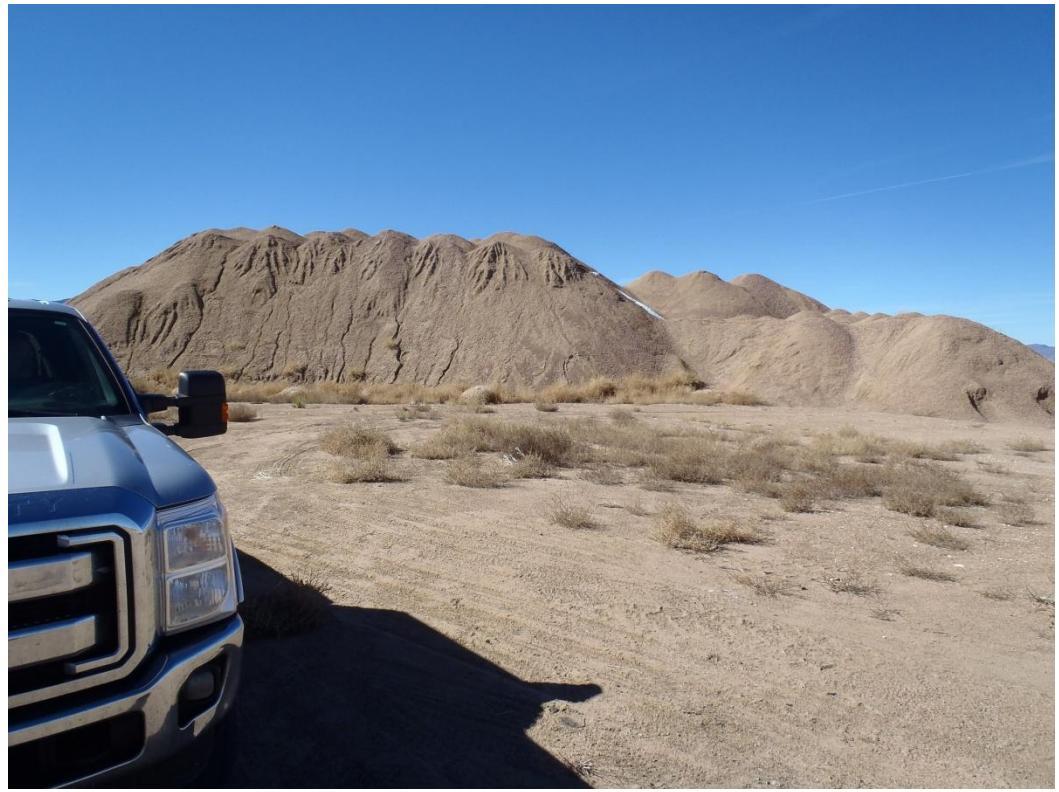
Photo 4. Material stockpiles in Area 3 (looking NW).

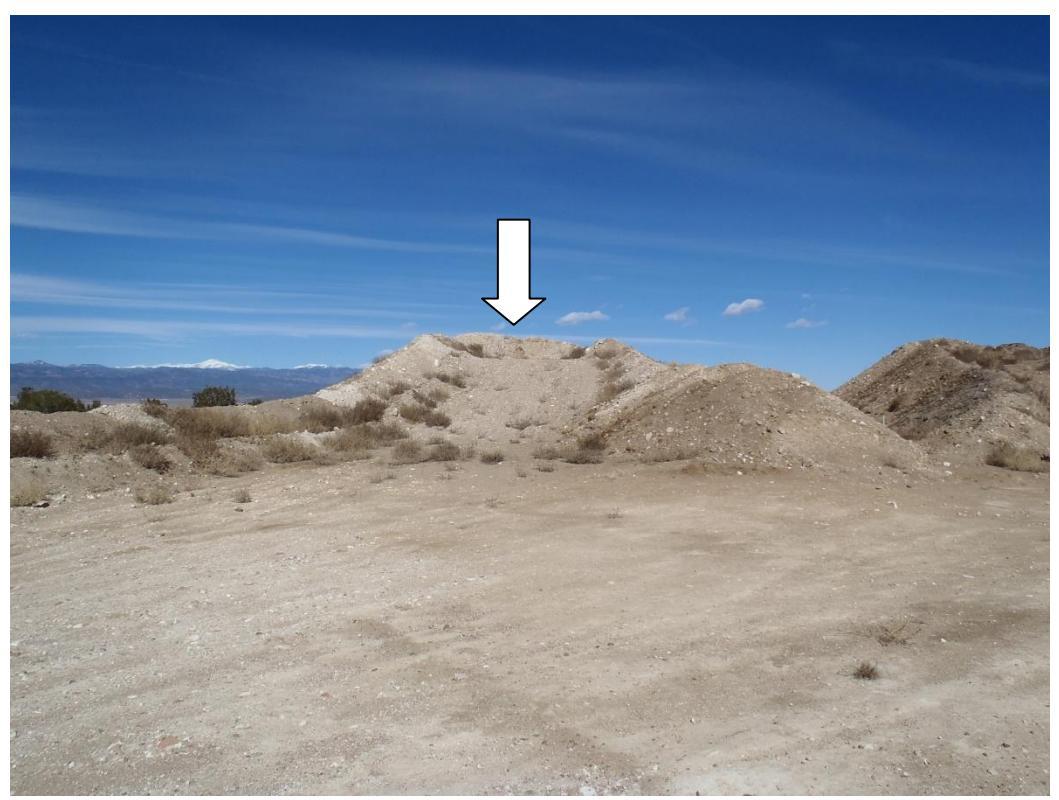
<u>Reclamation</u> – No reclamation had been initiated. This inspector noted the highwalls were shallower and flatter in the previously mined Phase 1 area than in the recently active Phase 3 area. Mr. Smith stated that if any highwalls remain after mining is complete (Note the plan is to remove the ridge top), the slopes will be 3H:1V or flatter. The observed overburden and topsoil stockpiles appeared stable.

Photo 5. Area 3 overburden stockpile (looking NNE).

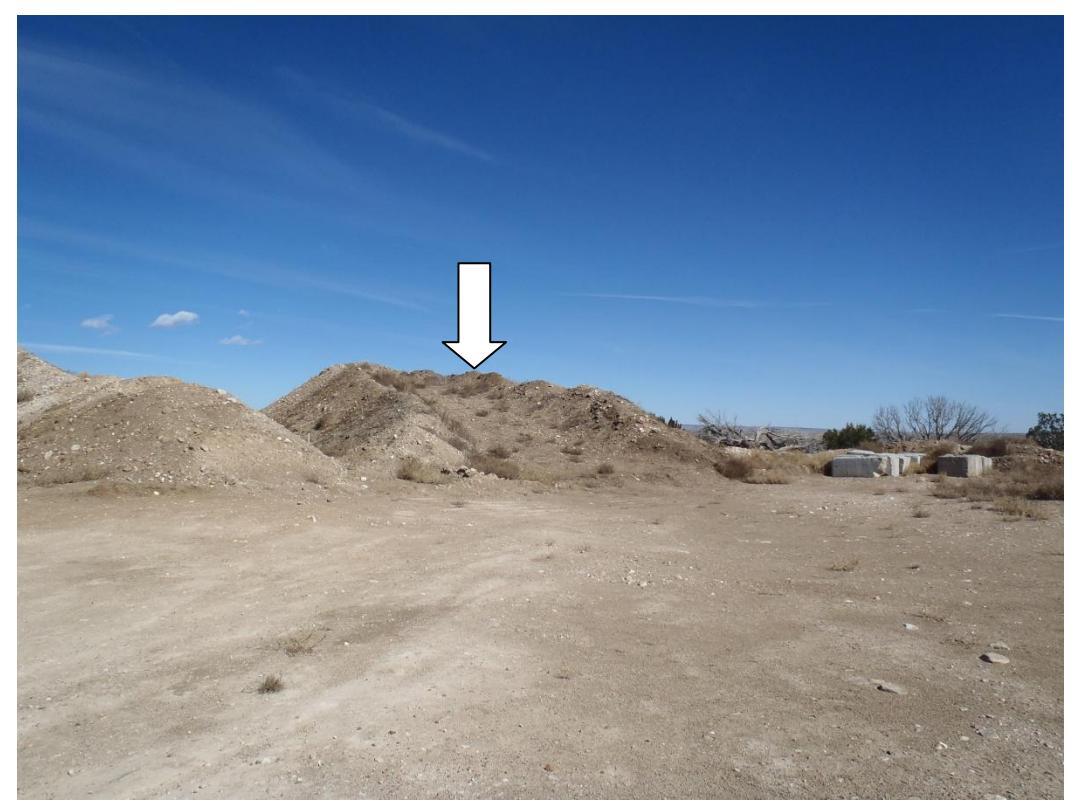
Photo 6. Area 3 topsoil stockpile (looking NE).
