MINE NAME:	MINE/PROSPECTING ID#:	MINERAL:	COUNTY:
Cresson Project	M-1980-244	Gold	Teller
INSPECTION TYPE:	INSPECTOR(S):	INSP. DATE:	INSP. TIME:
Monitoring	Timothy A. Cazier & Elliott Russell	April 21, 2015	10:15
OPERATOR:	OPERATOR REPRESENTATIVE:	TYPE OF OPERATION:	
Cripple Creek & Victor Gold Mining Company	Chris Hanks	112d-3 - Designated Mining Operation

INSPECTION TOPIC: Off-site Damage

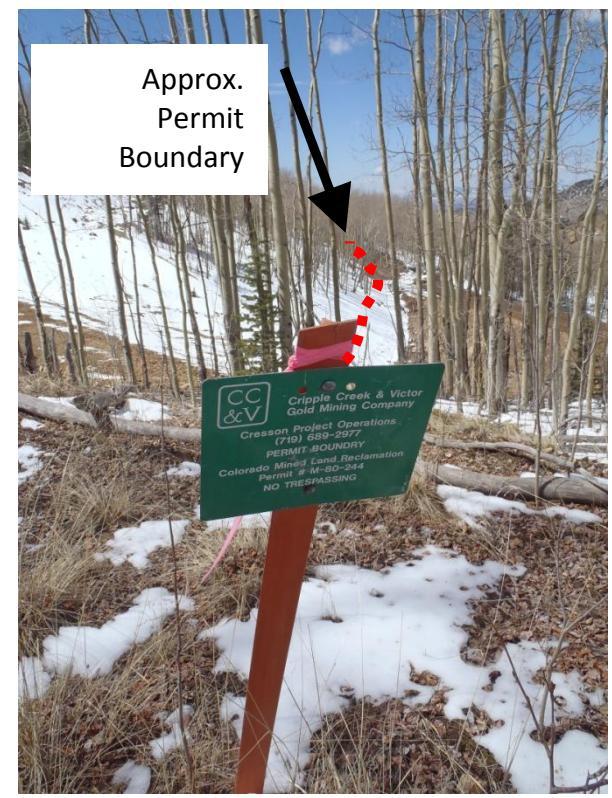
EMP-009A is near the Chicago Tunnel in Poverty Gulch on the northwest boundary of the Cresson Project permit boundary. With Mr. Hank's assistance, the Division located permanent boundary markers (**see Photo 1**) and surveyed AM-10 permit boundary marker stakes (**see Photo 2**). The Division used a hand-help Trimble Juno 3B GPS receiver to record the location of five of these boundary indicators in the vicinity of EMP-009A as well as the EMP-009A berm centerline, left and right abutment survey stakes (**see Photo 3**), and the perimeter of the EMP-009A construction disturbance (**see Photo 4**). Based on field observations, a significant portion of EMP-009A was constructed outside the permit boundary.

Photo 1. Required permit boundary sign (east of right abutment – looking SW).

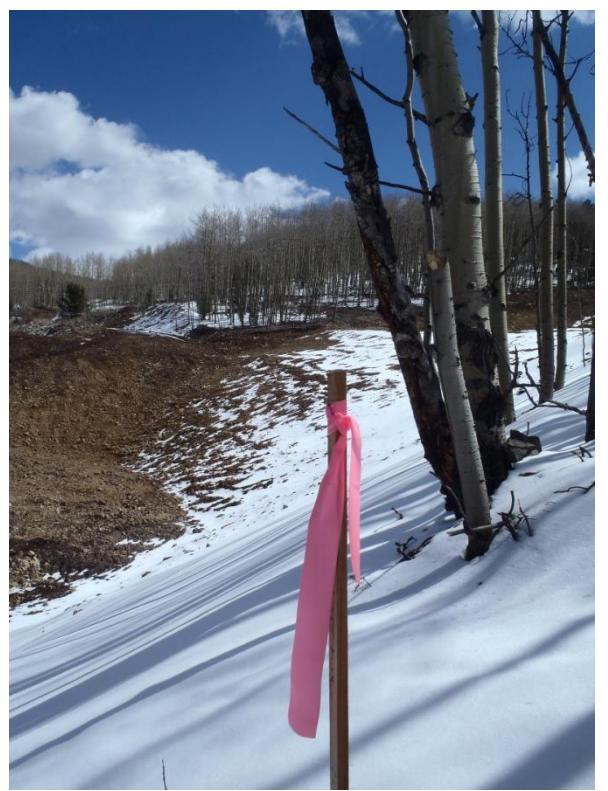
Photo 2. Permit boundary survey stake looking NE towards EMP-009A (note: area to left of stake is out of bounds).

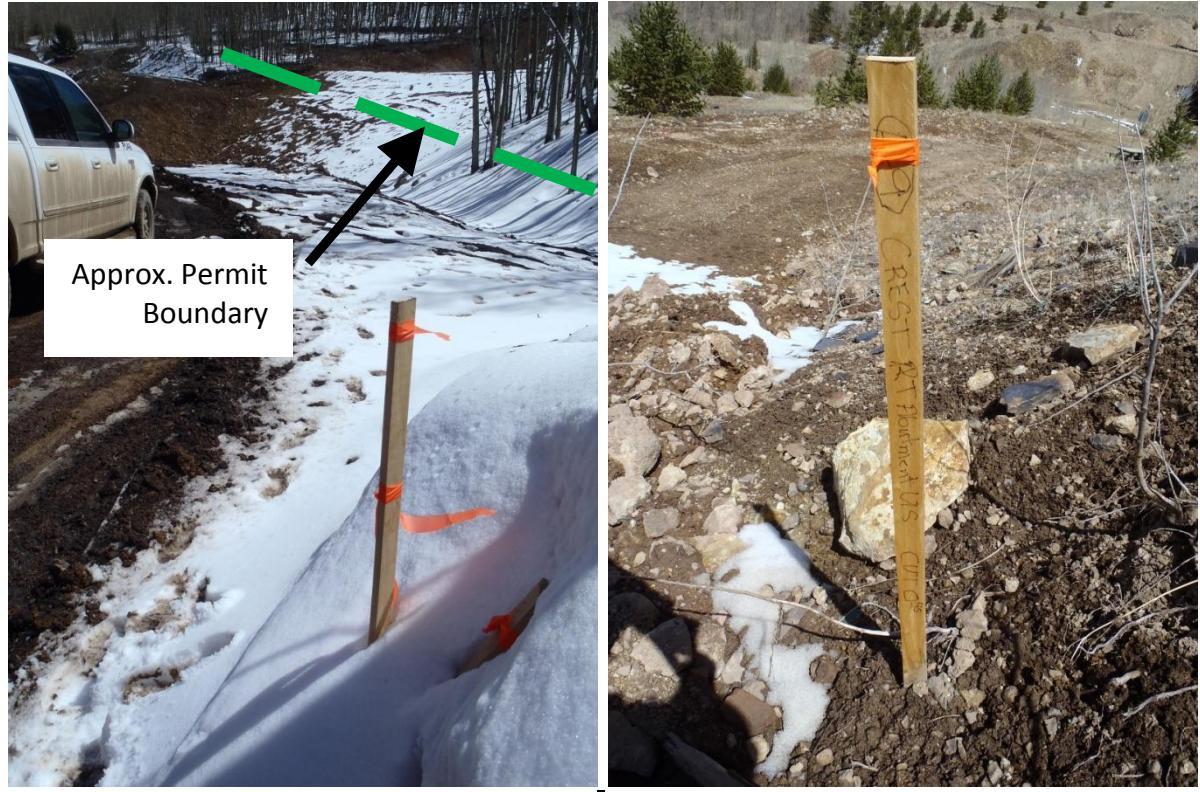
Photo 3. EMP-009A Left (left) & Right (right) abutment survey stakes.

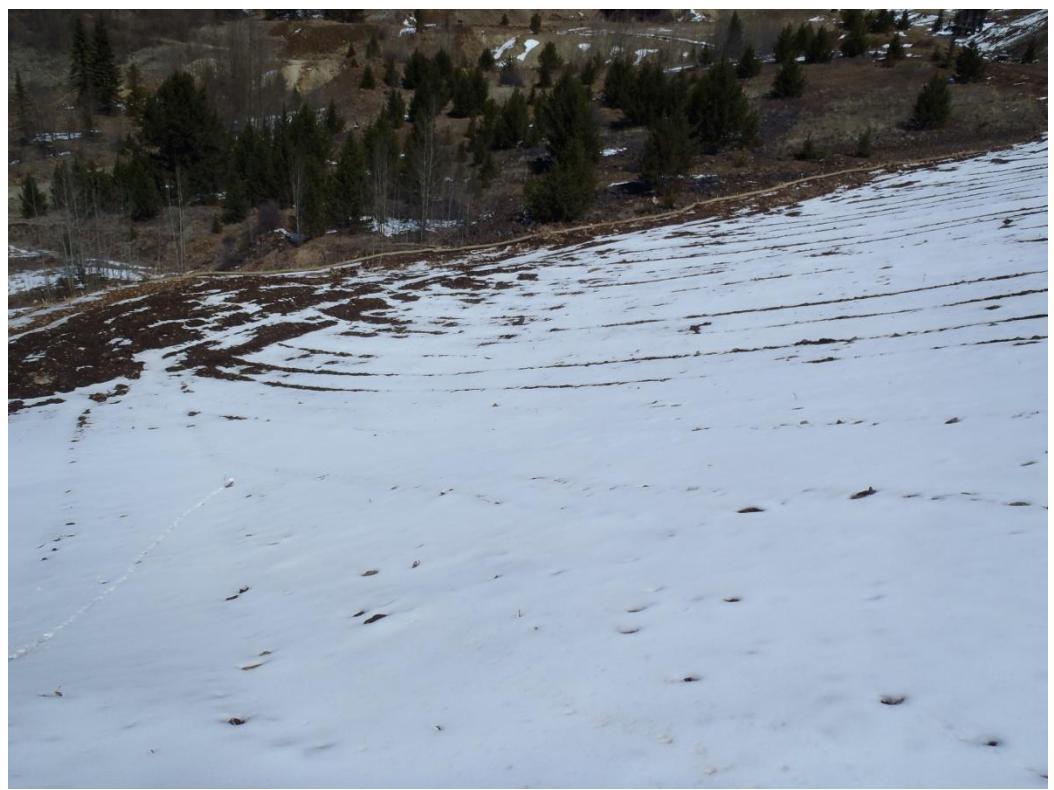
Photo 4. Toe of EMP-009A berm (looking north).

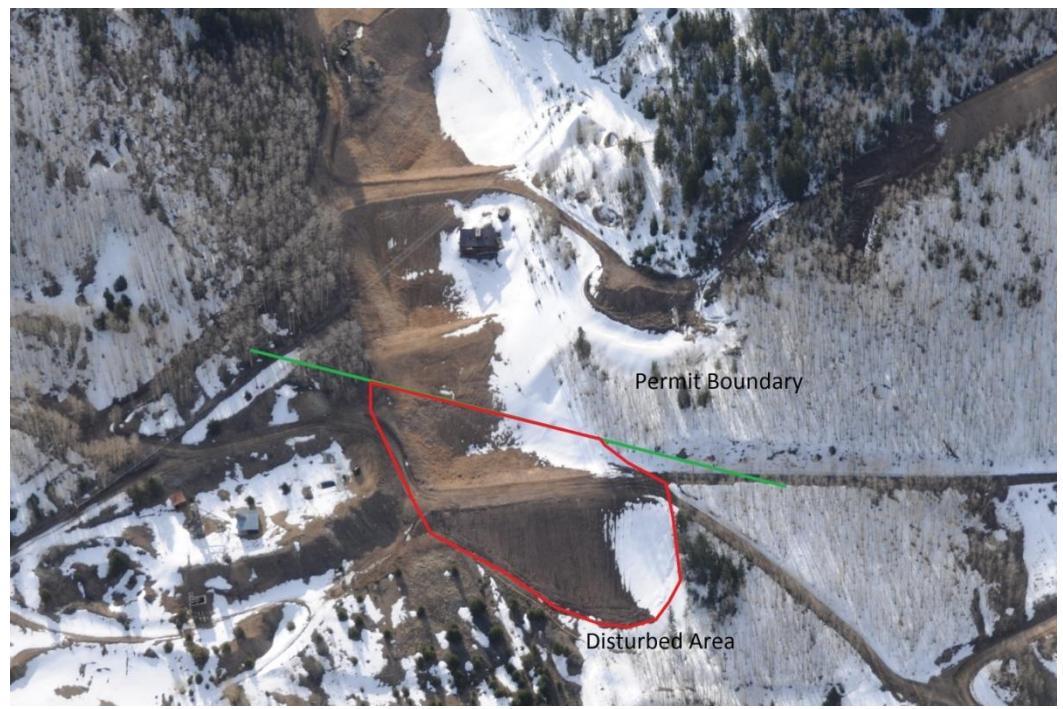
PROBLEM/POSSIBLE VIOLATION: Possible Violation: Land has been affected outside of the approved permit boundary. This is a possible violation at this time pursuant to C.R.S. 34-32-116(7)(h) for failure to protect areas outside of the affected land from slides or damages occurring during the mining operation.

Photo 5. March 30, 2015 aerial view of constructed EMP-009A (looking SE).

CORRECTIVE ACTIONS: This possible violation will require a hearing before the Mined Land Reclamation Board. The schedule and other details for the MLRB hearing will be provided under a separate document to be sent via certified mail to the operator.
