REQUEST FOR TECHNICAL REVISION (TR) COVER SHEET

File No.: M- 1976-056 Site Name: Riverside Pit

RE: Riverside Pit - M-1976-056
Technical Revision - Flood damage

RECLAMATION PLAN MAP - TECHNICAL REVISION MAP 5-15A

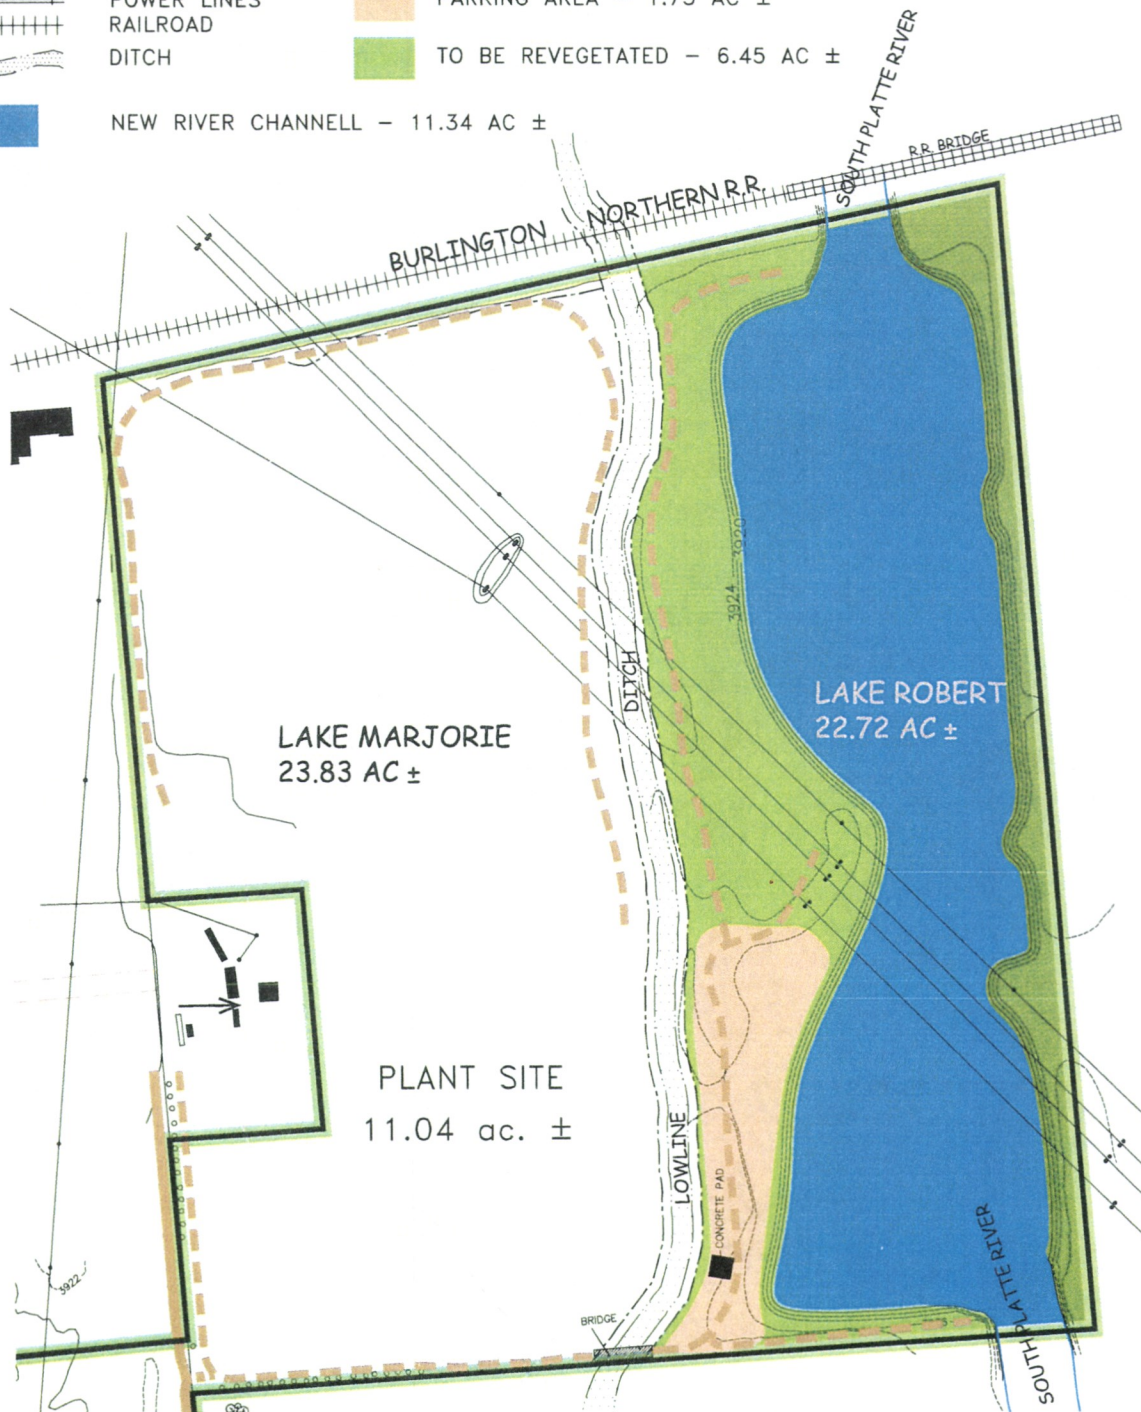
The current conditions of the Lake Robert Area can be broken into 2 areas separated by the new river channel. The eastern side, for which there is no access without crossing the river, and the western side still accessible via the original access road. Review of the attached **Reclamation Plan Map - Technical Revision Exhibit 5-15A** shows the areas as discussed below.

AREA DAMAGED BY SEPTEMBER 2013 FLOOD - 2.50 AC. ±

TO BE REVEGETATED - 6.45 AC ±

NEW RIVER CHANNELL - 11.34 AC ±

The west area contains 6.45 acres \pm that will be reclaimed as approved in the current Reclamation Plan. Vegetation will be restored on the areas damaged by flooding, property access roads, 0.68 acres \pm , will be kept to provides access around the west side of the river channel and to the power poles on the west. We also intend to leave a graveled parking area, 1.75 acres \pm , the access bridge over the Lowline Ditch and the access road to the parking area.

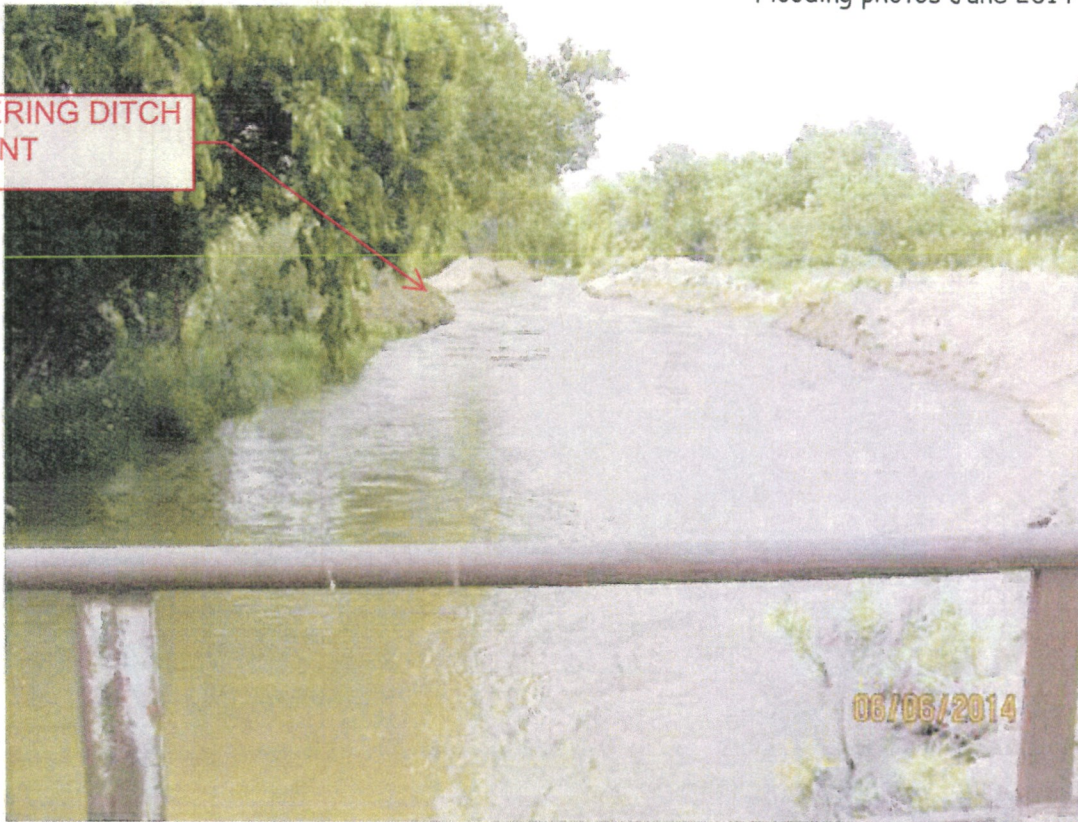
PHOTO #1 DATE: FRIDAY JUNE 6, 2014

LOWLINE DITCH LOOKING SOUTH FROM BRIDGE
ACROSS DITCH FLOW IS TOWARDS CAMERA

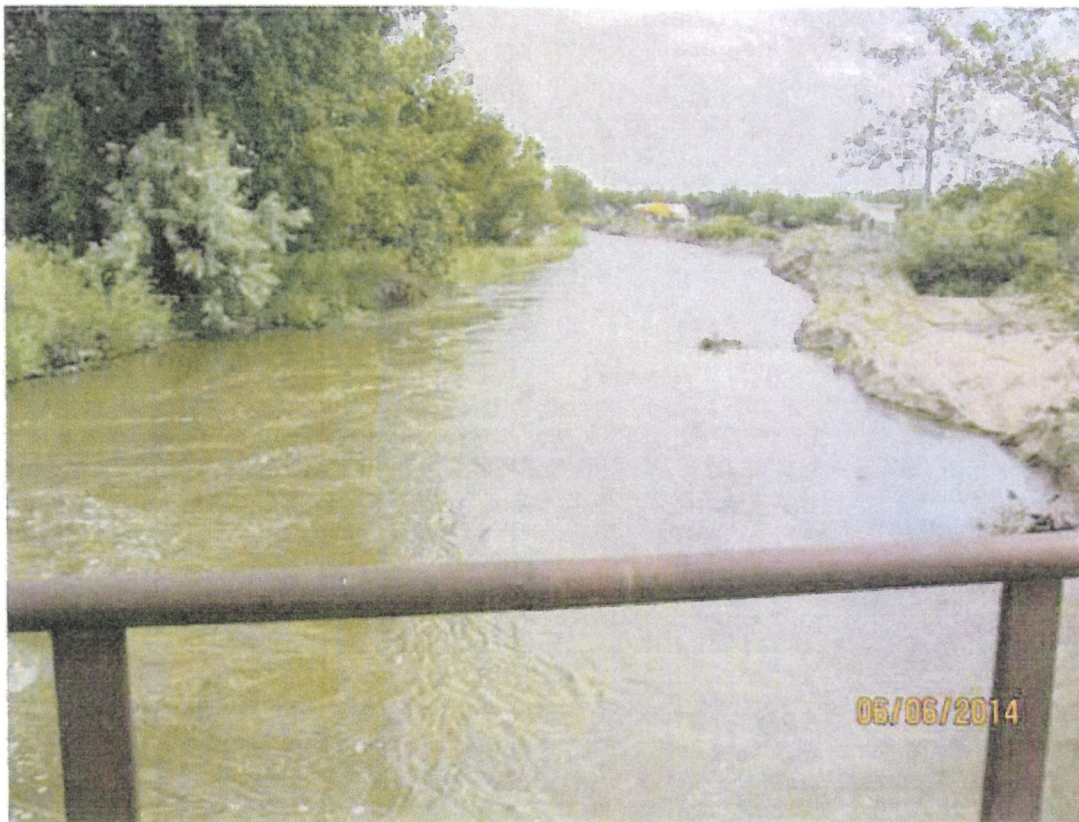
PHOTO #2 DATE: FRIDAY JUNE 6, 2014

LOWLINE DITCH LOOKING NORTH FROM BRIDGE
ACROSS DITCH. FLOW IS AWAY FROM CAMERA

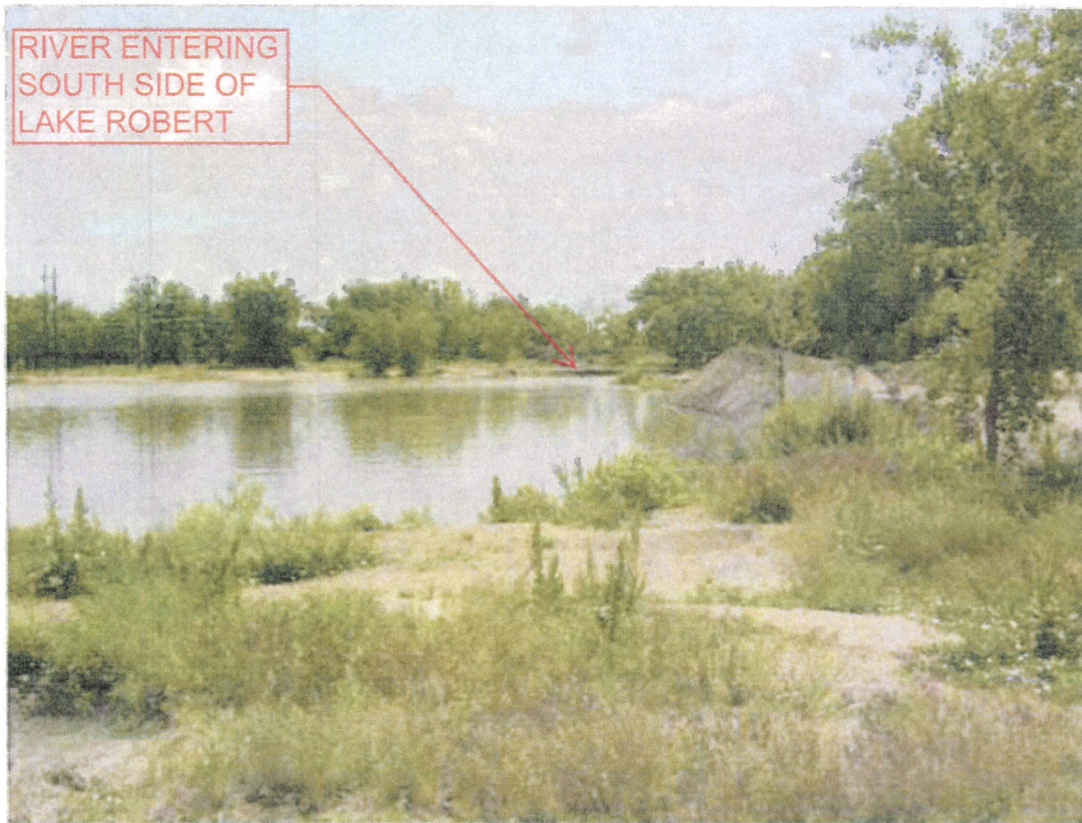
PHOTO #3 DATE: FRIDAY JUNE 6, 2014

RIVER ENTERING
SOUTH SIDE OF
LAKE ROBERT

LAKE ROBERT LOOKING AT 9/13 BREACH POINT
ALONG SOUTH LAKE BANK

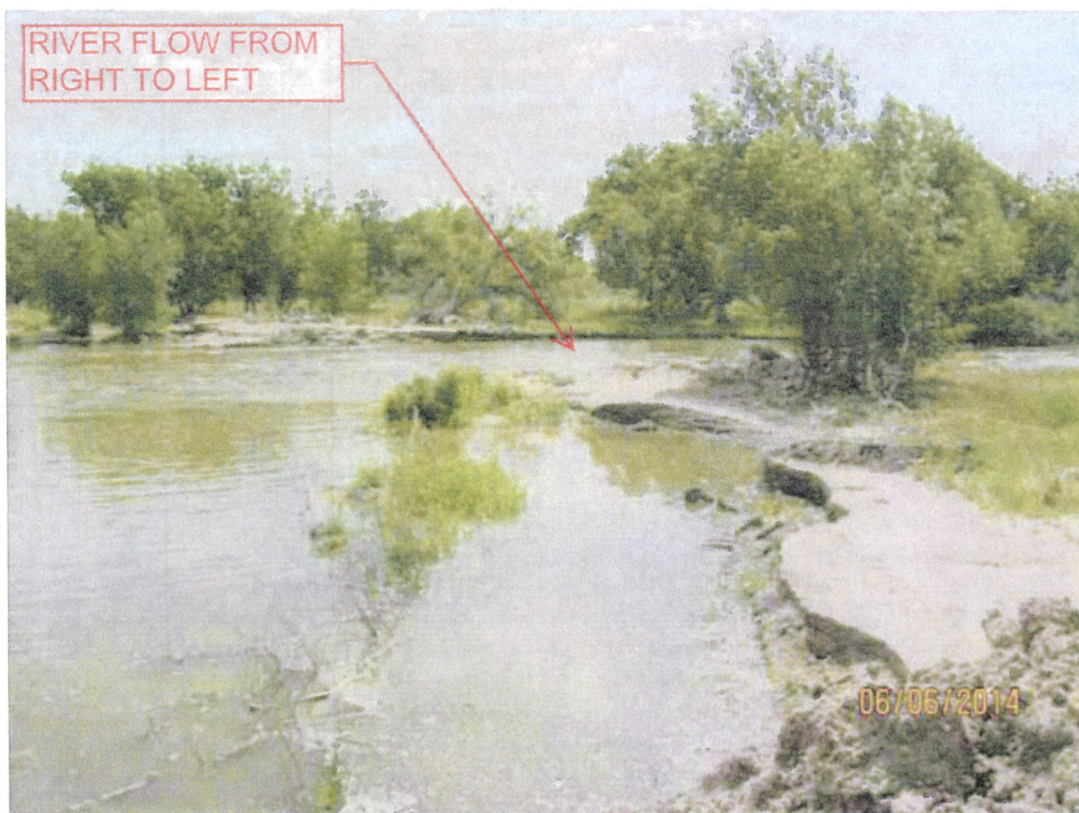
PHOTO #4 DATE: FRIDAY JUNE 6, 2014

RIVER FLOW FROM
RIGHT TO LEFT

LAKE ROBERT LOOKING AT POINT WHERE RIVER
BREACHED SOUTH BANK IN 9/2013

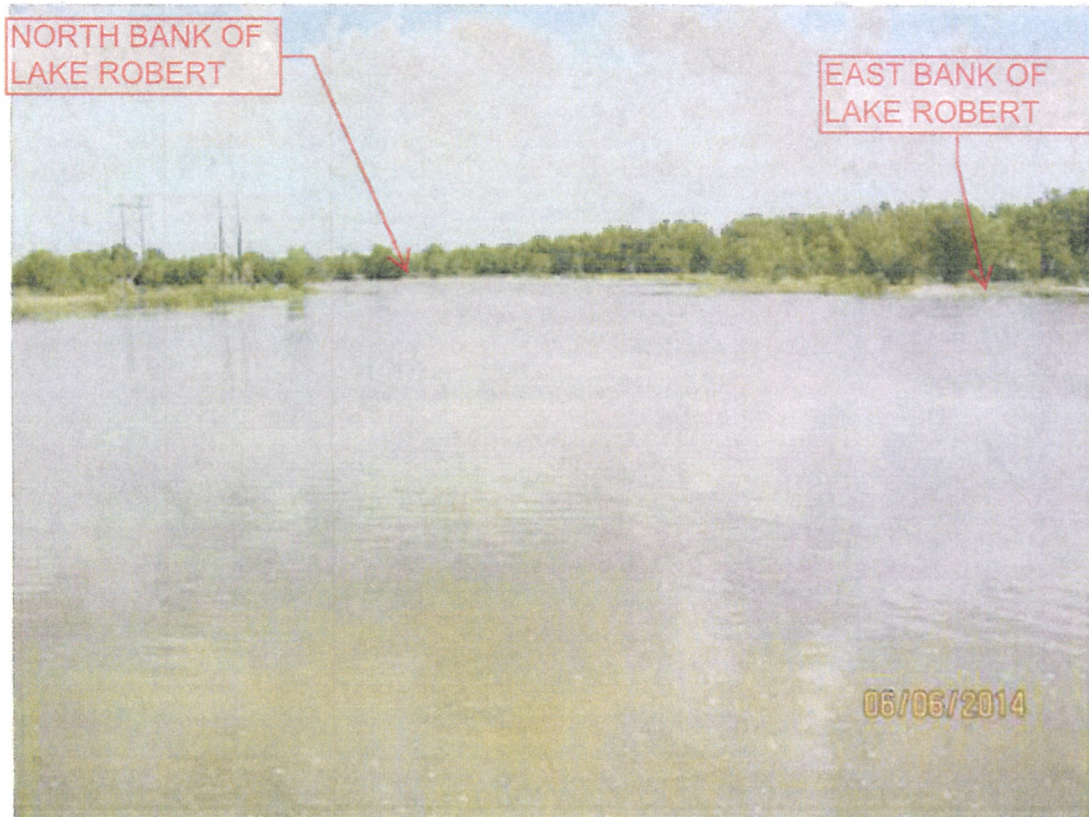
PHOTO #5 DATE: FRIDAY JUNE 6, 2014

LAKE ROBERT LOOKING NORTH FROM
SOUTHWEST CORNER OF LAKE

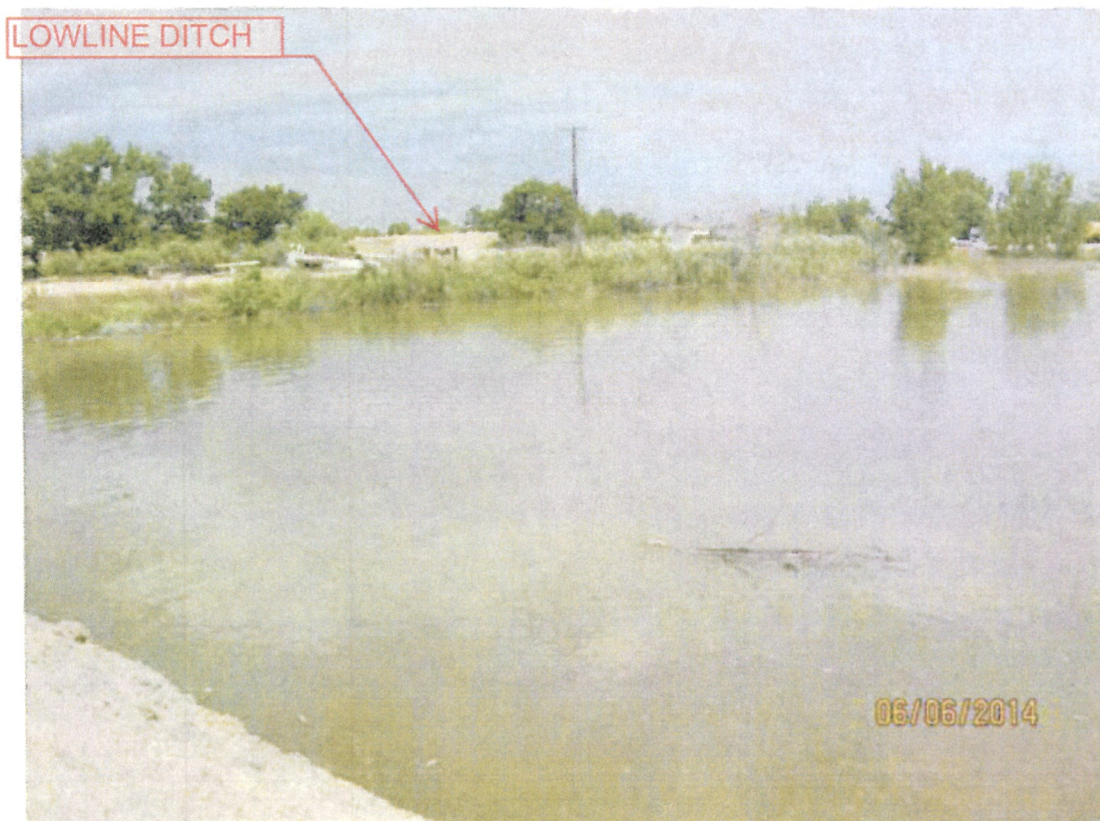
PHOTO #6 DATE: FRIDAY JUNE 6, 2014

LAKE ROBERT LOOKING AT WEST SHORE OF LAKE
FROM SOUTH BANK

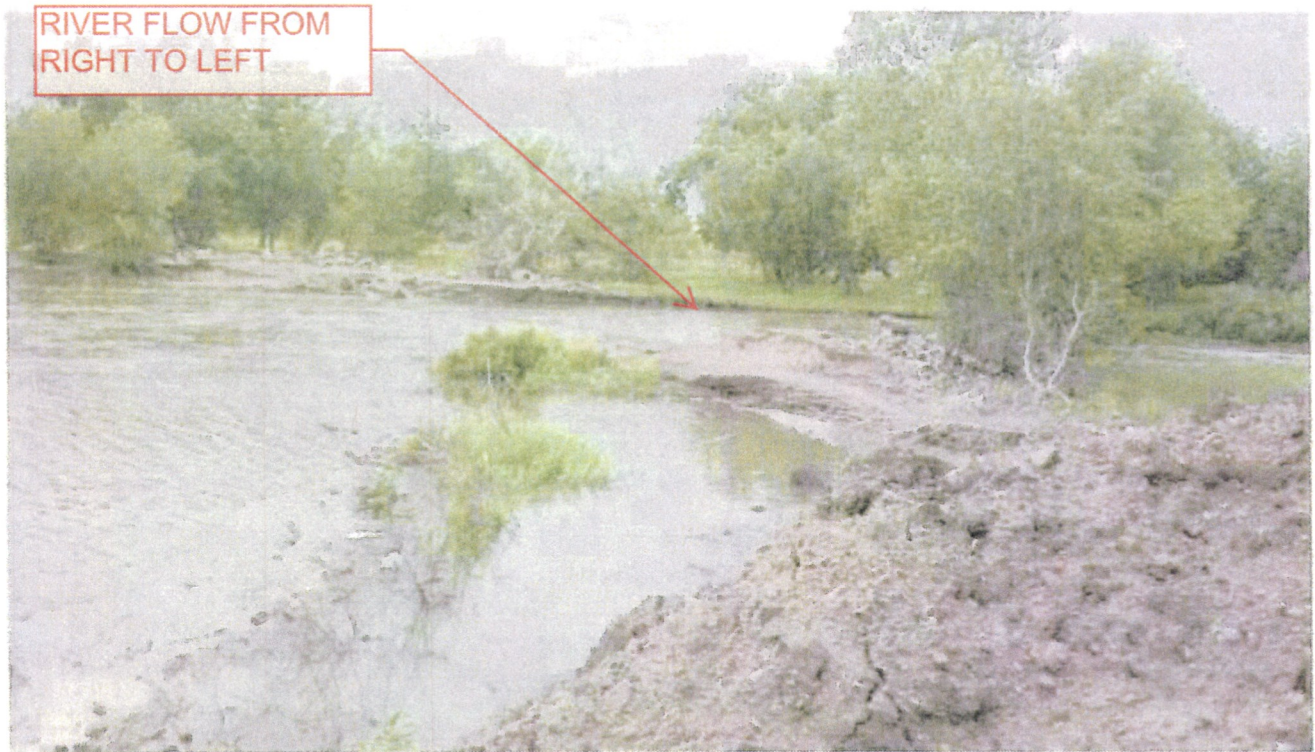
PHOTO #7 DATE: MONDAY JUNE 9, 2014 @ 640am

LAKE ROBERT LOOKING AT 9/13 BREACH POINT
ALONG SOUTH LAKE BANK

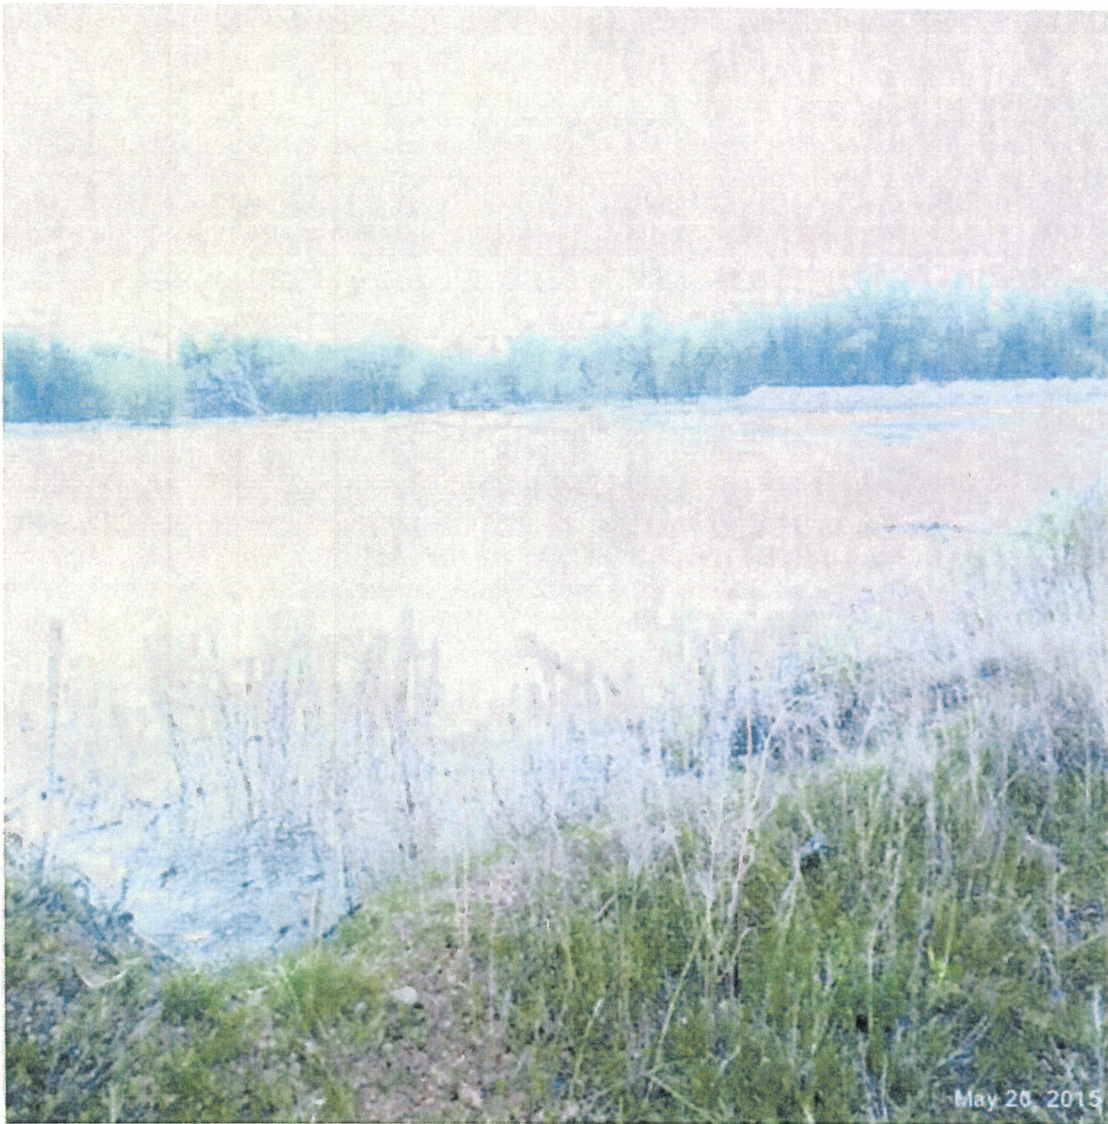
PHOTO DATE: FRIDAY MAY 20, 2015

LOOKING SOUTHEAST FROM NEAR POWER POLES. PILEAS
ARE ALONG SOUTH PERMIT LINE OF LAKE ROBERT.
