MINE NAME:	MINE/PROSPECTING ID#:	MINERAL:	COUNTY:
Powderwash Pit No. 66	M-2005-006	Sand and gravel	Moffat
INSPECTION TYPE:	INSPECTOR(S):	INSP. DATE:	INSP. TIME:
Monitoring	Amy C. Yeldell	August 4, 2015	11:30
OPERATOR:	OPERATOR REPRESENTATIVE:	TYPE OF OPERATION:	
Moffat County	Billy Mack	112c - Construction Regular Operation

INSPECTION TOPIC: Sediment Control

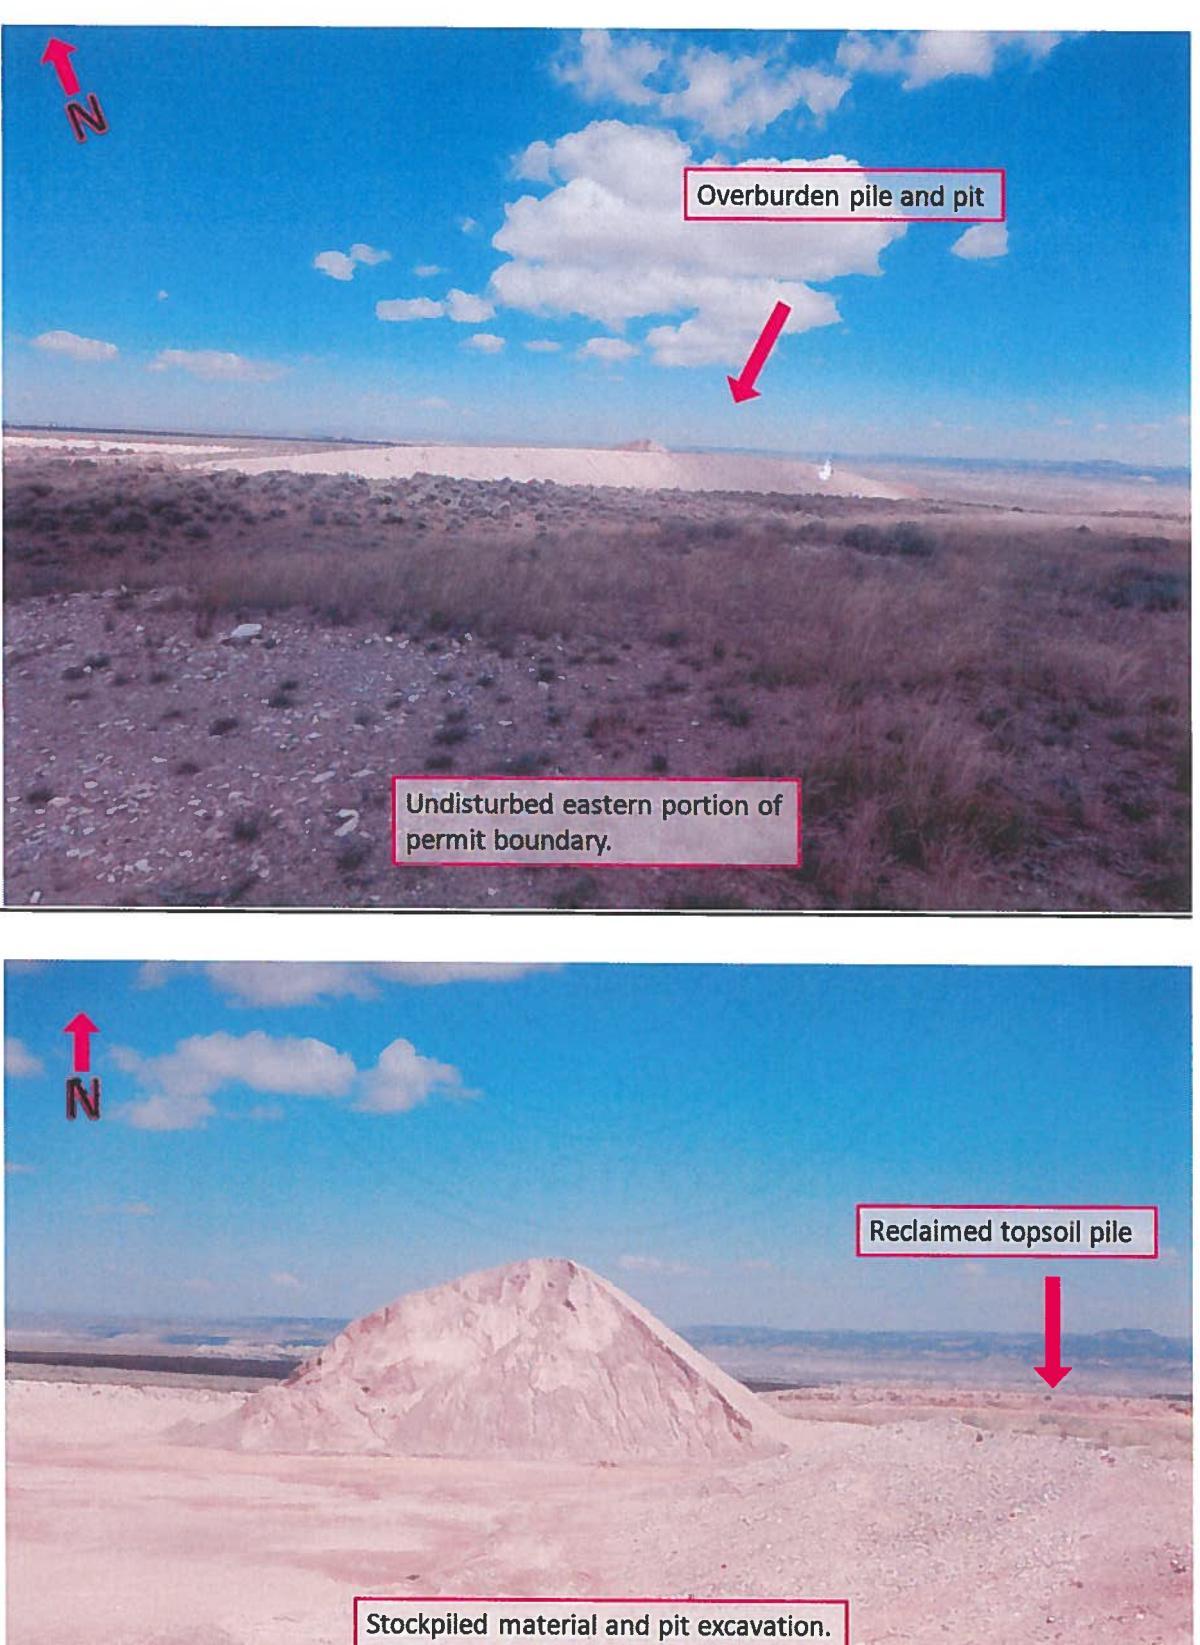
Riling present on stockpiled material but no threat of offsite damages
