The Division of Reclamation, Mining and Safety has conducted an inspection of the mining operation noted below. This report documents observations concerning compliance with the terms of the permit and applicable rules and regulations of the Mined Land Reclamation Board.

MINE NAME:	MINE/PROSPECTING ID#:	MINERAL:	COUNTY:
Bridalveil	M-2001-054	Gravel	Ouray
INSPECTION TYPE:	INSPECTOR(S):	INSP. DATE:	INSP. TIME:
Multi Person Inspection	Lucas J. West	September 9, 2015	10:00
OPERATOR:	OPERATOR REPRESENTATIVE:	TYPE OF OPERATION:	
Bridal Veil Construction, LLC	Lynn Olin, Brian Briggs	110c - Construction Limited Impact

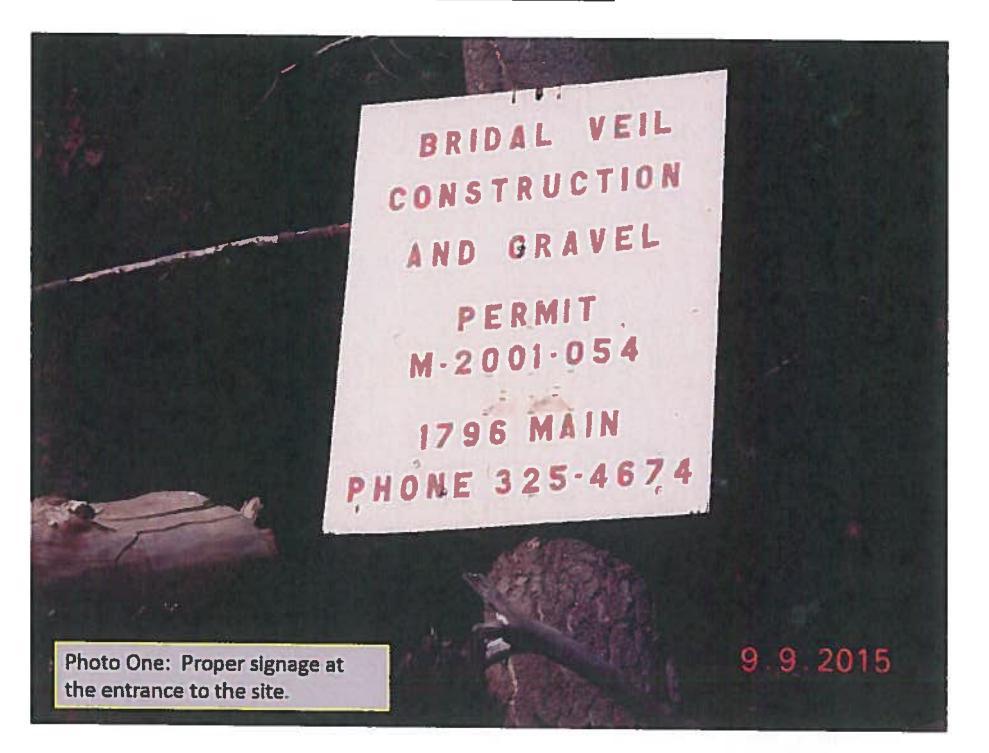
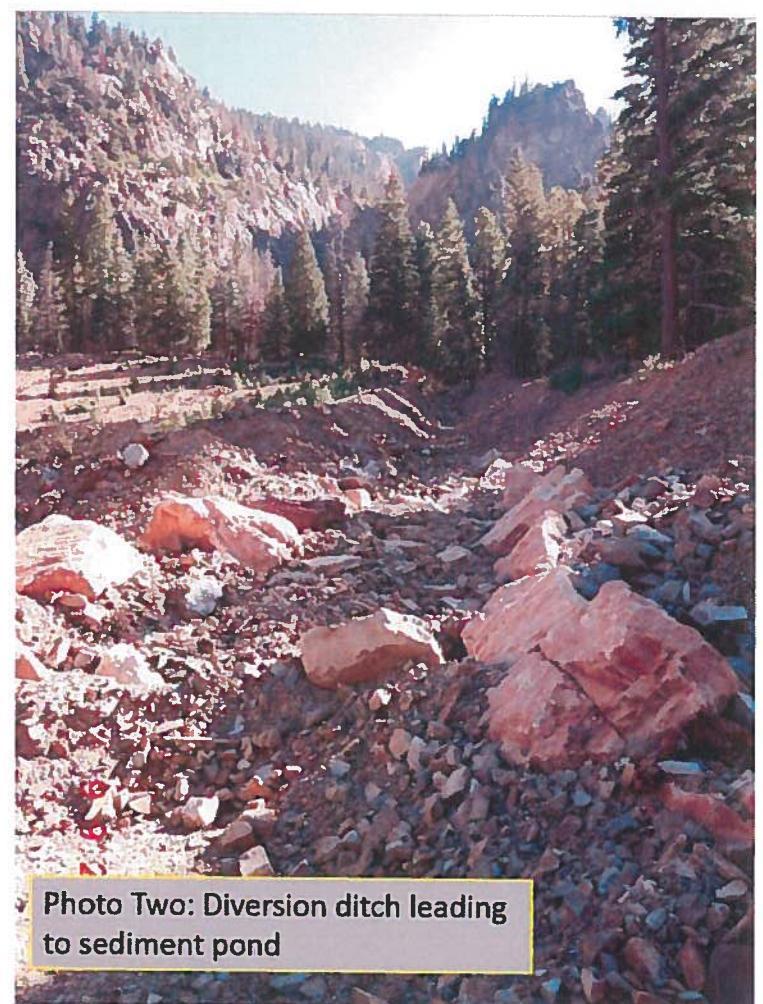
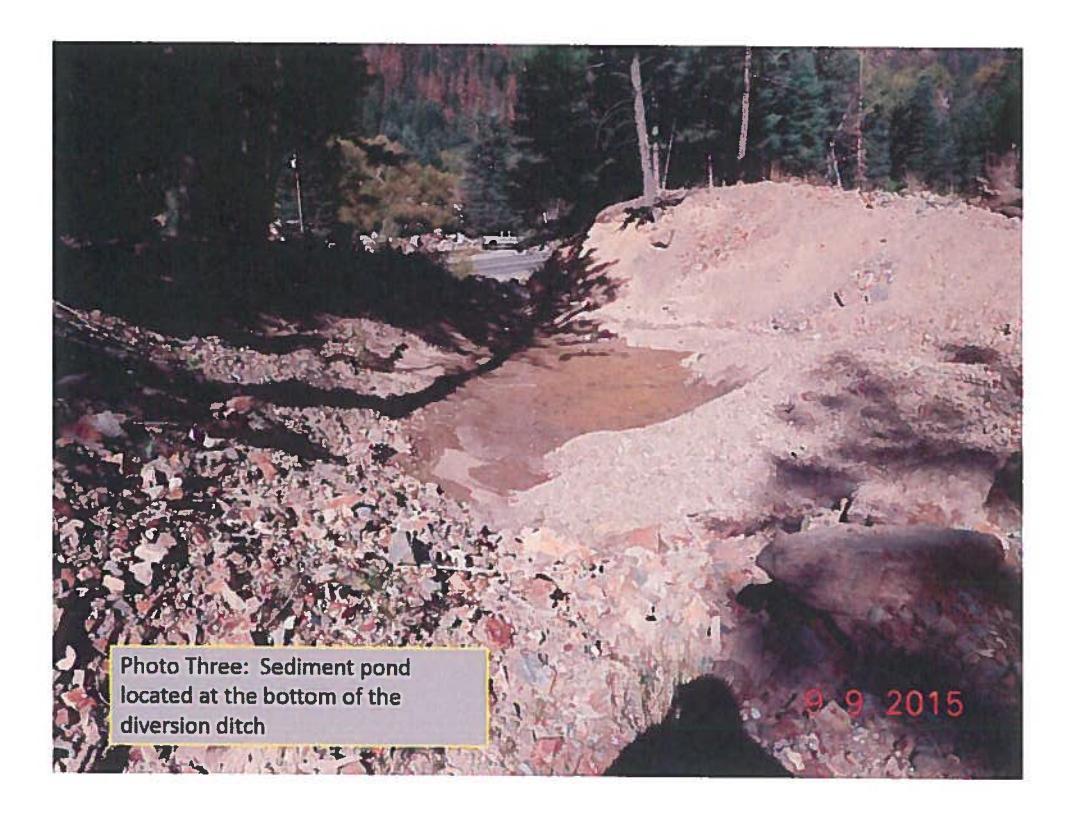
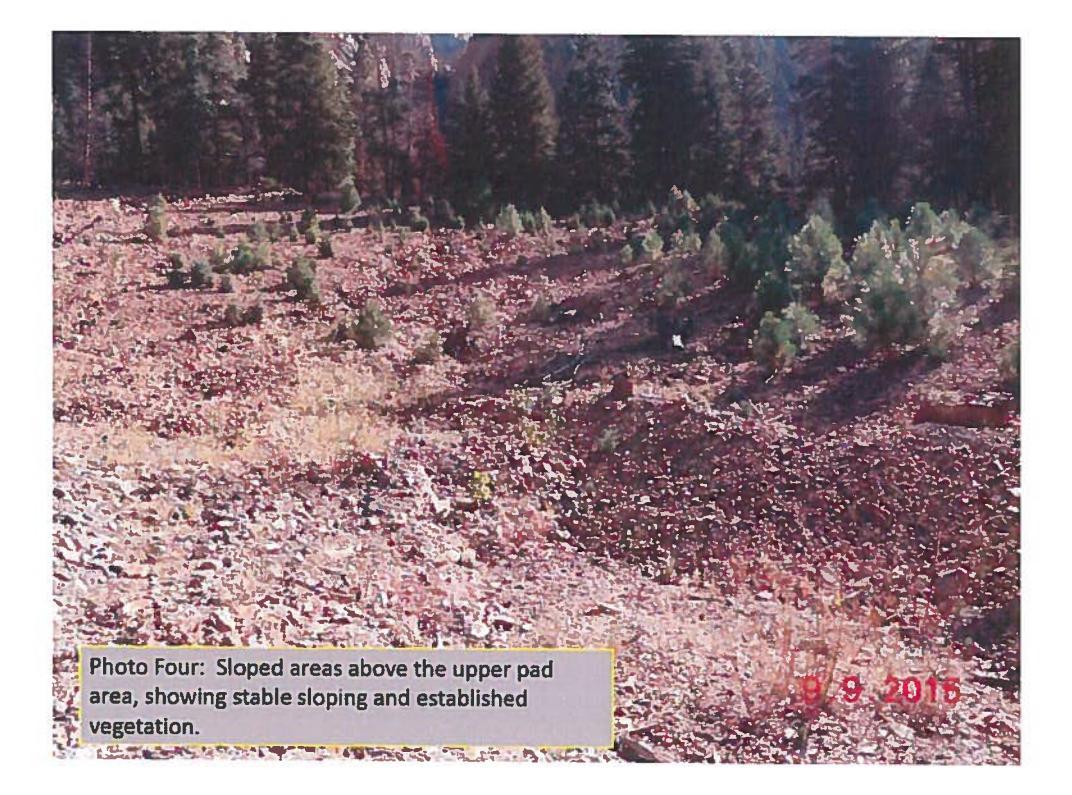
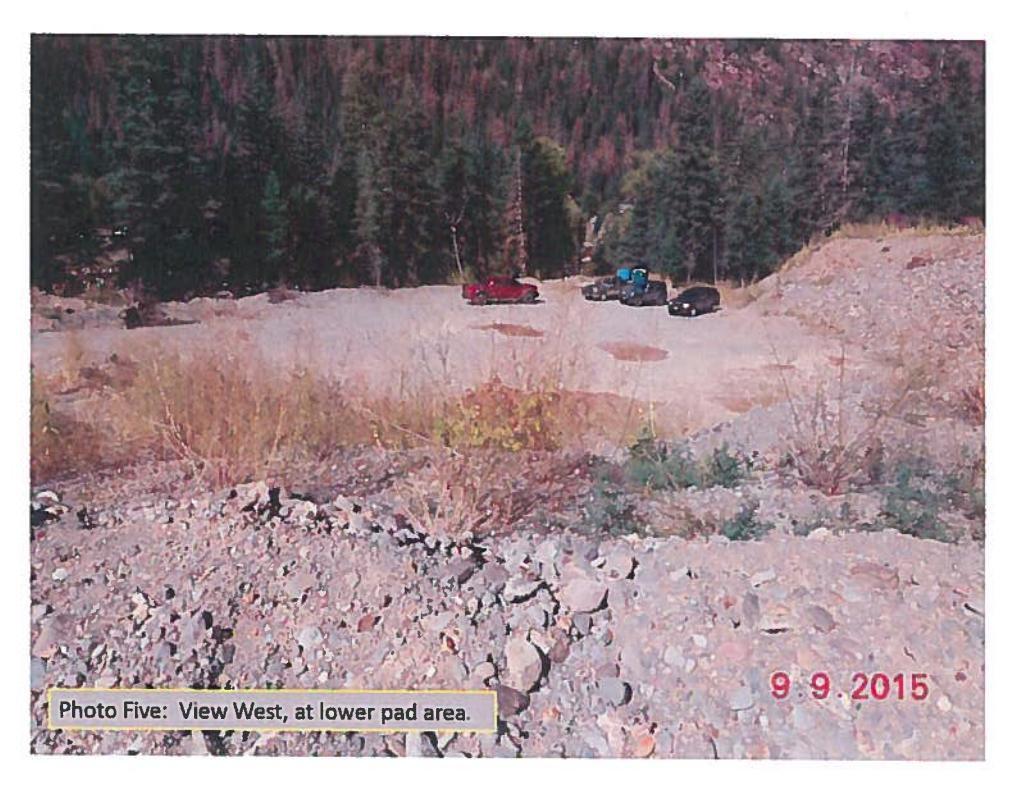
PHOTOGRAPHS

The site was not active at the time of the inspection, no material has been excavated or hauled from the site in approximately 6-8 years. The site was in final reclamation and all of the earthwork has been completed in accordance with the approved reclamation plan which consists of 3H: 1V slopes leading down to an upper and lower bench area. All sloped areas area stable, no erosional features were observed. Vegetative cover has been established on the sloped areas and consists of tree and shrub seedlings, both planted and volunteer. The vegetation appears adequate and self-sustaining. No noxious weeds were observed onsite. As seen in Photo One, proper signage was observed at the entrance to the site. Located along the southern edge of the disturbance area is a diversion ditch leading to a sediment pond as seen in Photos Two and Three. The channel and sediment pond appear to be stable and function as designed. Since the last inspection with the Operator dated August 5, 2014 the operator installed a new diversion ditch across the upper bench leading into the channel. This section was also stable and showed no signs of erosion. No problems or possible violations were observed at this time.
