MINE NAME:	MINE/PROSPECTING ID#:	MINERAL:	COUNTY:
Sundance Sand and Gravel Resource	M-2006-073	Sand and gravel	El Paso
INSPECTION TYPE:	INSPECTOR(S):	INSP. DATE:	INSP. TIME:
Surety-Related Inspection	Timothy A. Cazier	September 14, 2015	10:15
OPERATOR:	<b>OPERATOR REPRESENTATIVE:</b>	TYPE OF OPERATION:	
Martin Marietta Materials, Inc.	Mike Drabing	112c - Construction Regular Operation

<b>REASON FOR INSPECTION:</b>	BOND CALCULATION TYPE:	BOND AMOUNT:
Surety Related	Complete Bond	\$1,000.00
DATE OF COMPLAINT:	POST INSP. CONTACTS:	JOINT INSP. AGENCY:
NA	None	None
WEATHER:	INSPECTOR'S SIGNATURE:	SIGNATURE DATE:
Clear	Ofen for	September 22, 2015
	10

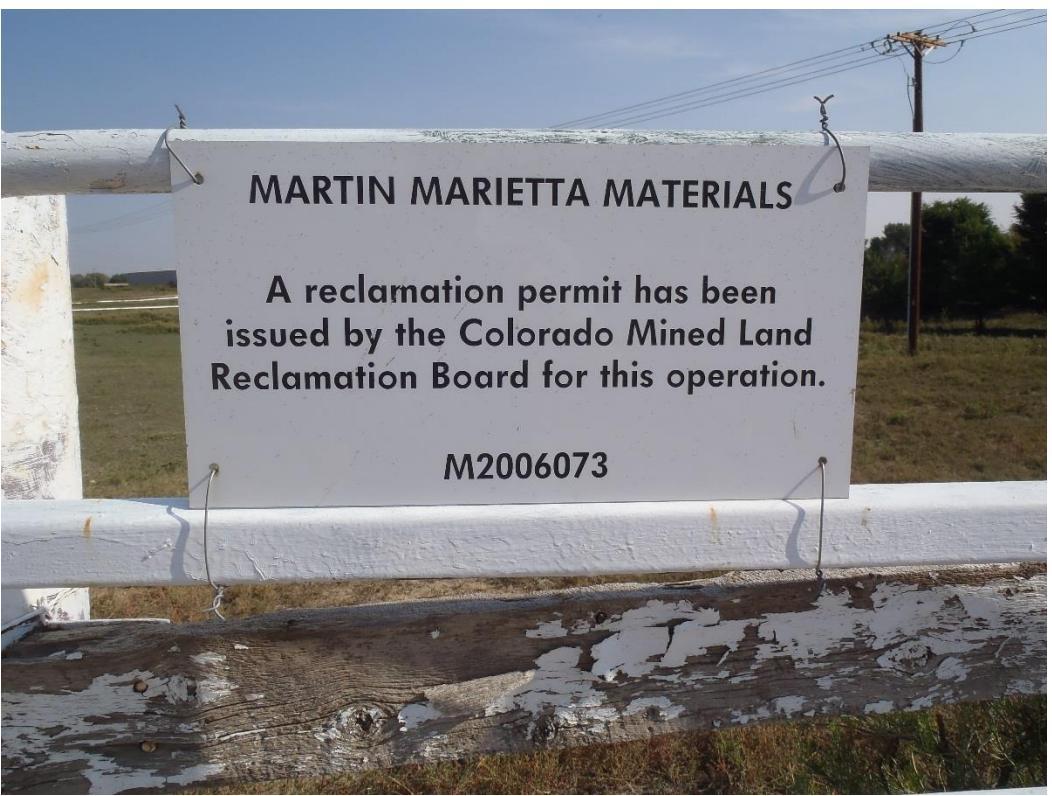
The permit sign was displayed as required (see **Photo 1**), but the name of the Operator will need to be changed upon approval of the SO application. The permit boundaries were marked by fences (see **Photo 2**).

Photo 1. Permit sign at entrance gate (looking east).

- 1) No mining disturbance was observed at the site.
- 2) The permit sign will need to be updated to reflect the new Operator's name.
- 3) The Division deems the token \$1,000 bond to be adequate as the site has not yet been disturbed. However, the Operator must re-post a full bond approved by the Division prior to initiating mining activity.

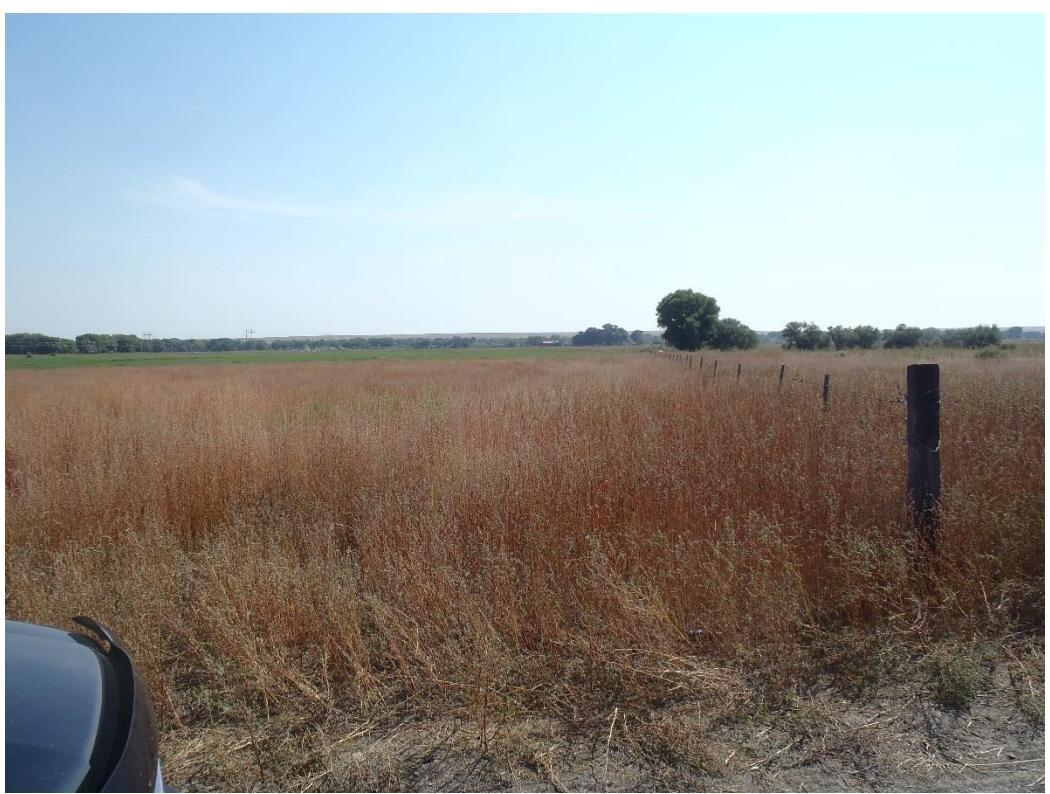
Photo 2. South boundary fence (looking east).
