The Division of Reclamation, Mining and Safety has conducted an inspection of the mining operation noted below. This report documents observations concerning compliance with the terms of the permit and applicable rules and regulations of the Mined Land Reclamation Board.

MINE NAME:	MINE/PROSPECTING ID#:	MINERAL:	COUNTY:
Blue Star #1	M-2014-030	Gemstones	Chaffee
INSPECTION TYPE:	INSPECTOR(S):	INSP. DATE:	INSP. TIME:
Monitoring	Dustin Czapla, Michael Cunningham	September 3, 2015	15:00
OPERATOR:	OPERATOR REPRESENTATIVE:	TYPE OF OPERATION:	
Blue Star Exploration, LLC		110(2) - Hard Rock Limited Impact

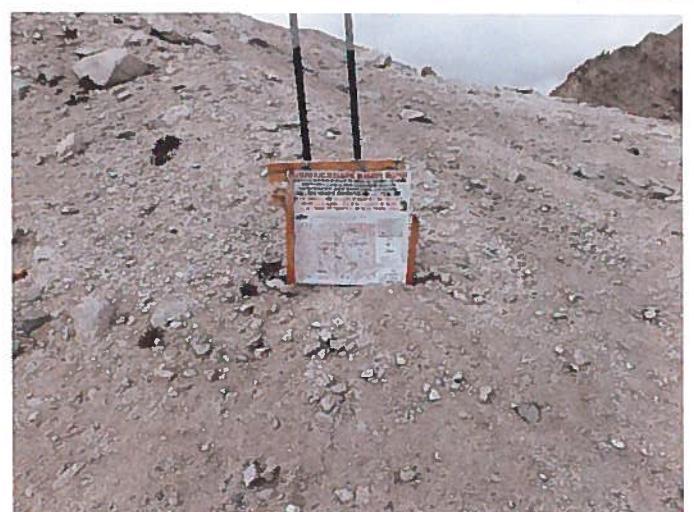
Figure 1: Inadequate mine ID sign

- Pursuant to Rule 3.1.12 (1), place a sign at the entrance to the site <u>that includes the name of the</u> operator, a statement that a reclamation permit has been issued by the Colorado Mined Land <u>Reclamation Board</u>, and the permit number.
- 2. Mark the permit area boundary. <u>Markers shall be clearly visible and adequate to delineate the permit</u> <u>boundary</u>.

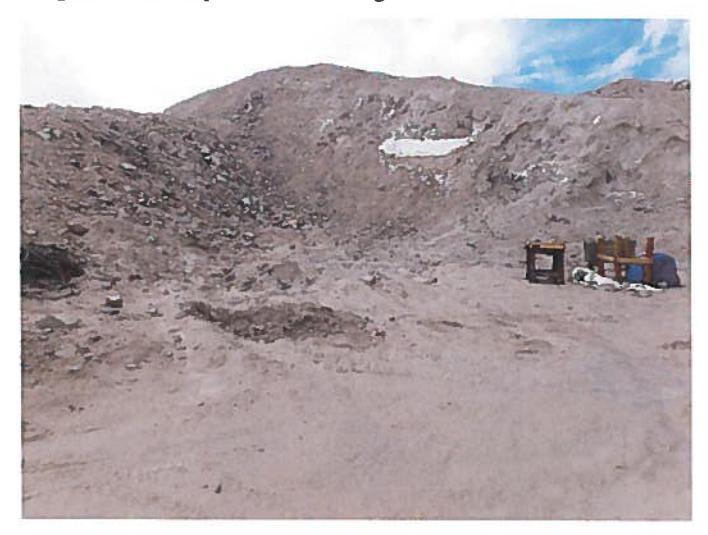
Figure 3: Dig/screening area

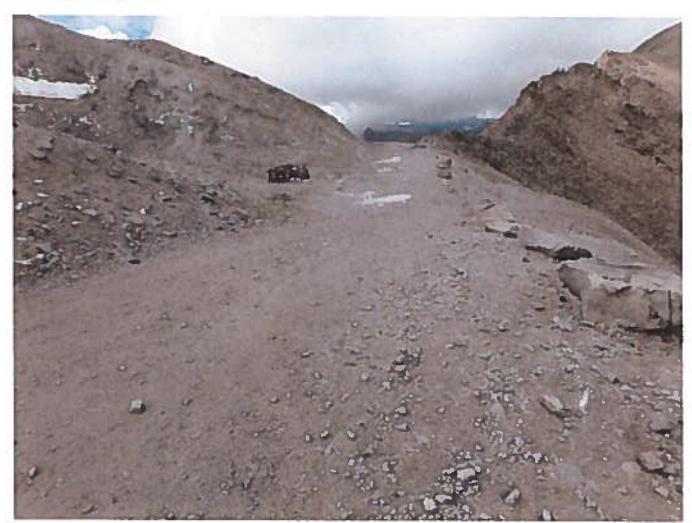
Figure 2: Dig/screening area

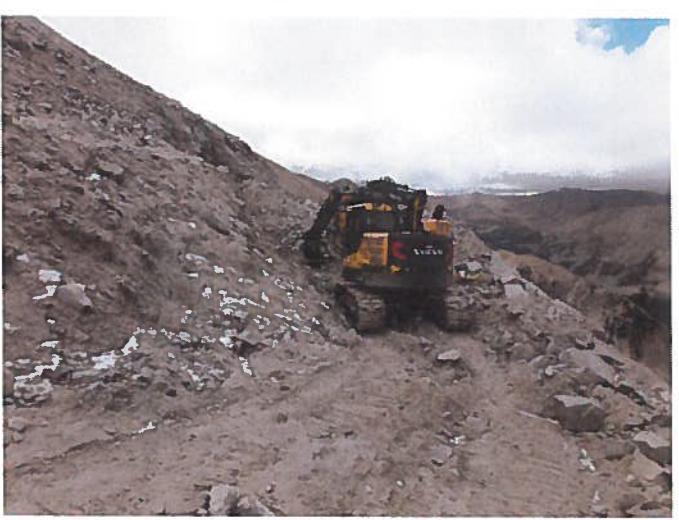
Figure 4: Current dig area
