MINE NAME:	MINE/PROSPECTING ID#:	MINERAL:	COUNTY:
Yocam Pit	M-1999-060	Gravel	Las Animas
INSPECTION TYPE:	INSPECTOR(S):	INSP. DATE:	INSP. TIME:
Pre-Operation Inspection	Amy Eschberger	September 29, 2015	16:00
OPERATOR:	OPERATOR REPRESENTATIVE:	TYPE OF OPERATION:	
Las Animas County	Clell Goode	110c - Construction Limited Impact

This was a pre-operation inspection of the Yocam Pit (Permit No. M-1999-060) conducted by Amy Eschberger and Wally Erickson of the Division of Reclamation, Mining and Safety (Division). On 08/25/2015, the Division received a Conversion application (Revision No. CN-01) to convert the 110c permit to a 112c permit. This application is currently under review, with a decision date of 11/30/2015. Mr. Clell Goode represented the operator, Las Animas County during the inspection. The site is located approximately 28 miles northeast of Kim, Colorado. The main access to the site is from the north, off of Co Rd 70. The affected land is owned by Gary Yocam Ranch, LLC. The approved post-mining land use for the site is pastureland.

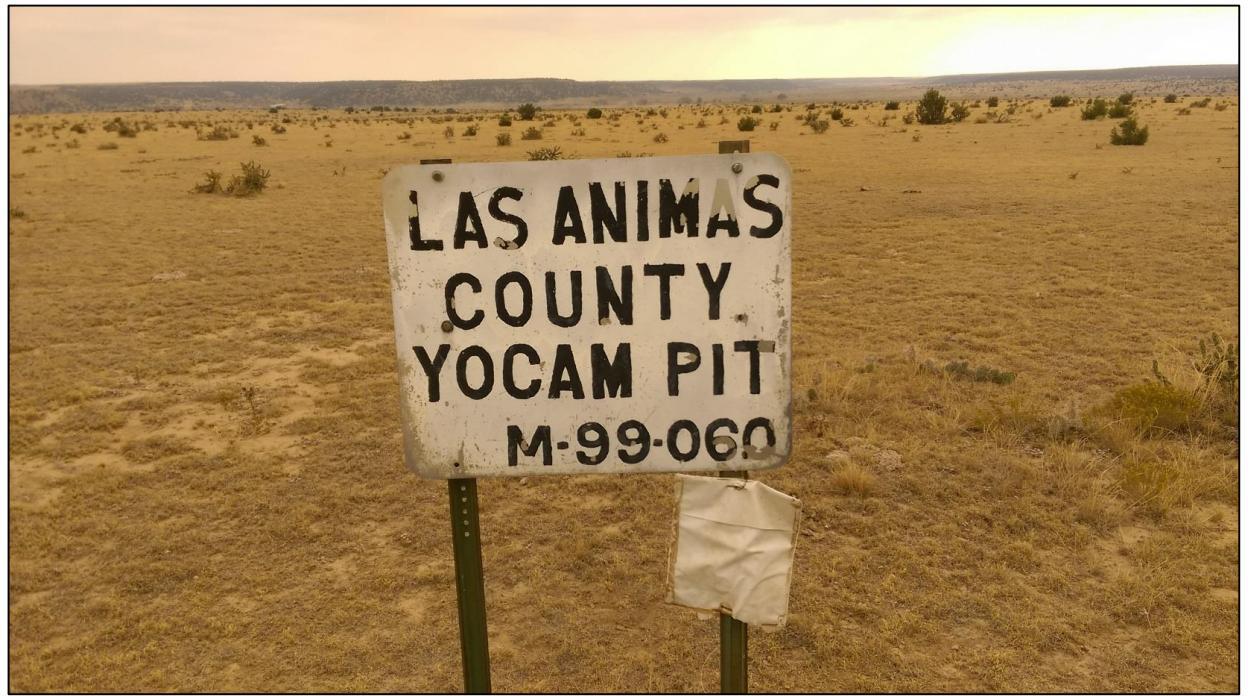
At the time of the inspection, the weather was partly cloudy, cool, and breezy. No standing water was observed on site. A permit sign was posted at the main site entrance off of Co Rd 70 (**Photo 1**). This sign includes the permit number and operator name as required. To be fully compliant with Rule 3.1.12(1), the sign should also include a statement that the permit was issued by the Colorado Mined Land Reclamation Board. This could be abbreviated on the sign to read as "issued by CO MLRB". The corners of the current 110c permit boundary were marked with metal posts (**Photo 2**). The proposed 112c permit boundary was delineated by metal posts with orange cones on top (**Photos 3 and 4**). The mine was not active during the inspection, and no equipment was stored on site. According to the operator, the county extracts, processes, and/or hauls off material every year, which is in compliance with its intermittent status.

Photo 1. View of permit sign posted at main site entrance off of Co Rd 70. To be fully compliant with Rule 3.1.12(1), the sign should also include a statement that the permit was issued by the CO MLRB, which could be written on the sign as "issued by CO MLRB".

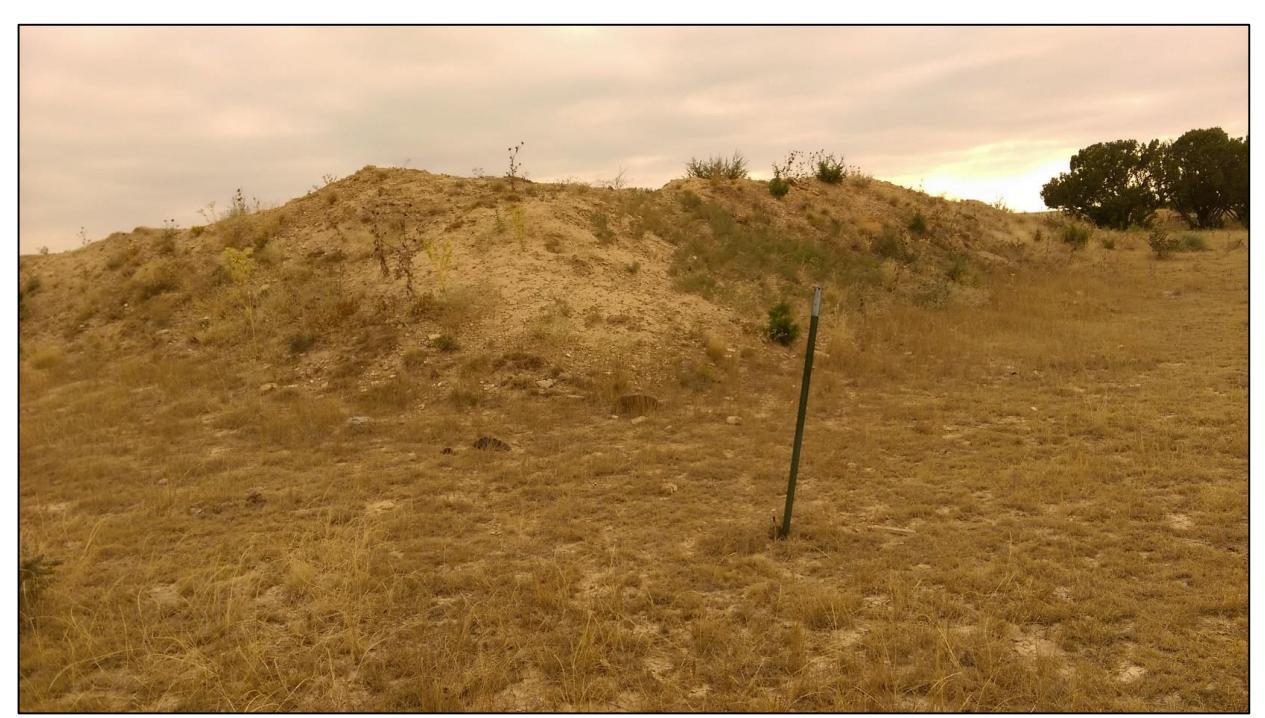
Photo 2. View of metal post marking northeast corner of 110c permit boundary. Portion of small earthen berm lining northwestern permit boundary visible behind marker.

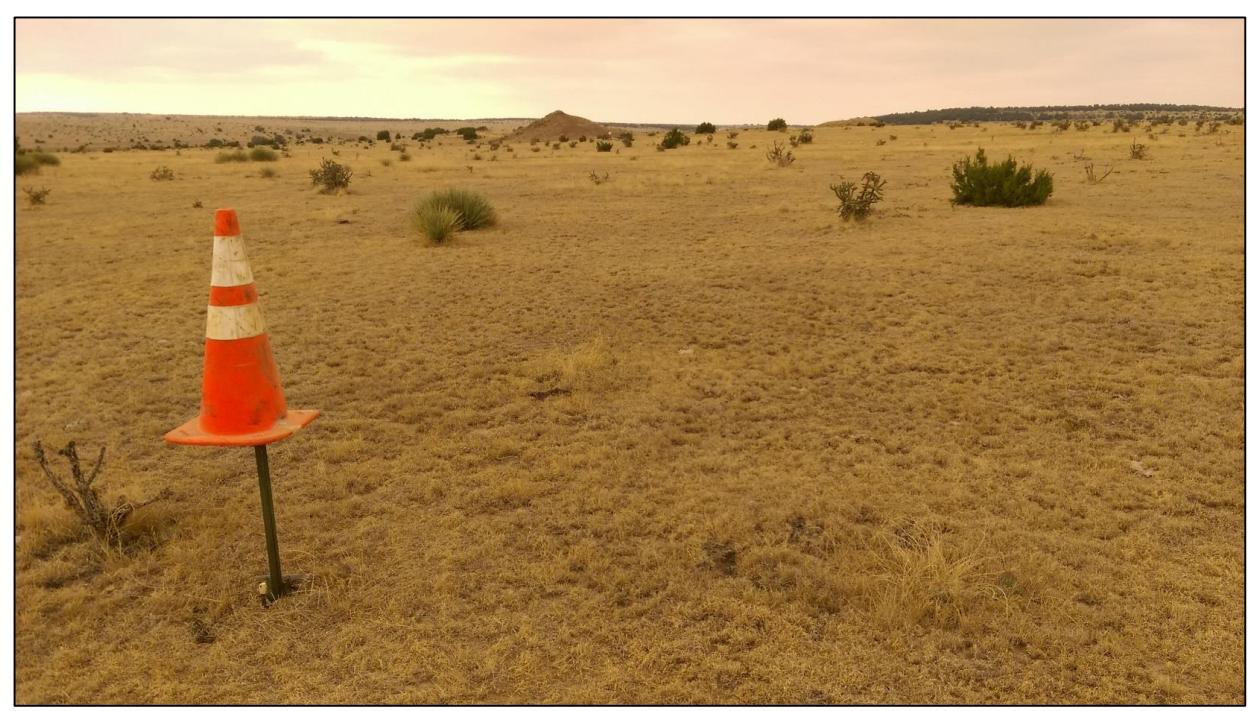
Photo 3. View of metal post (with orange cone on top) marking southwestern corner of permit boundary shared for both 110c permit and proposed 112c permit. Looking northwest across undisturbed portion of 110c permit area.

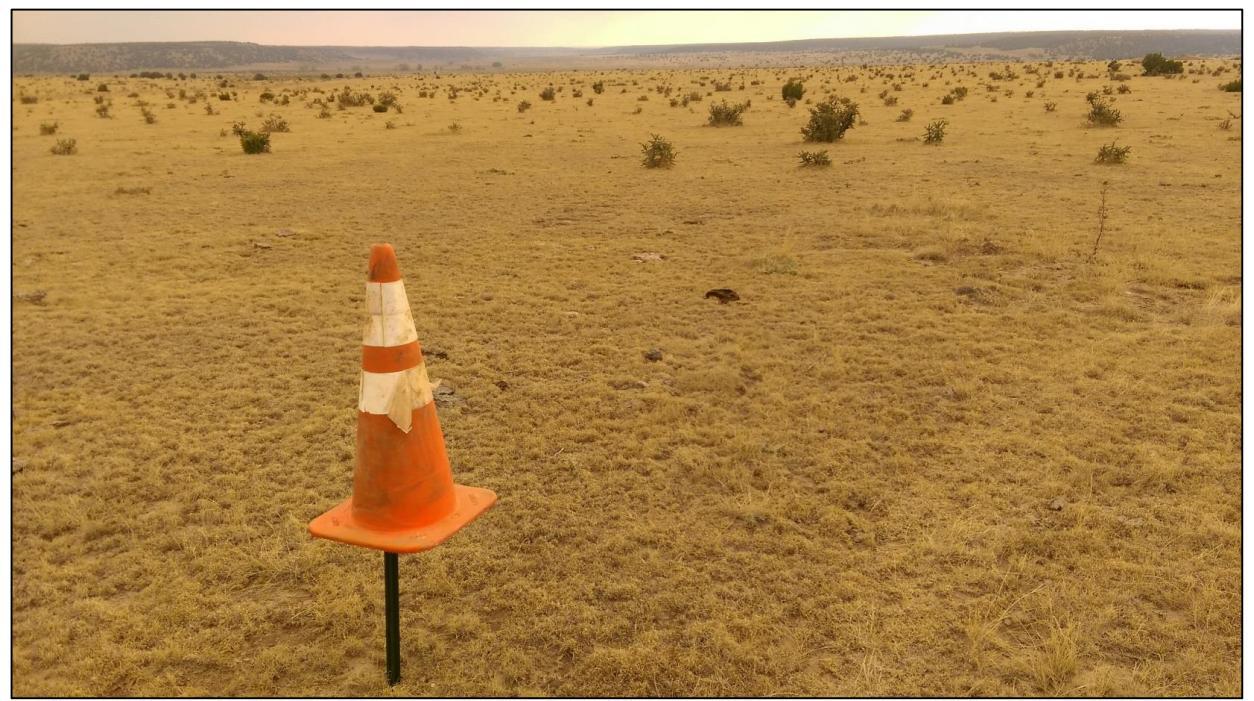
Photo 4. View of metal post (with orange cone on top) marking northeastern corner of proposed 112c permit boundary. Looking south along proposed eastern permit boundary (112c permit area at right).

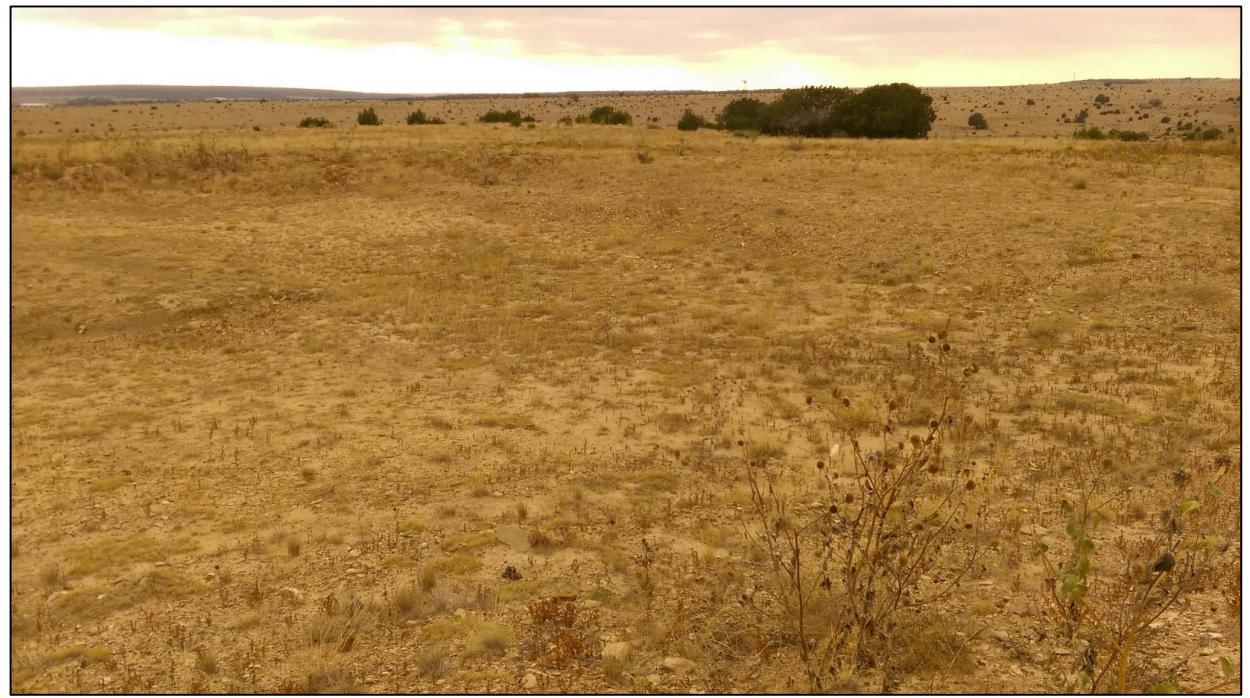
Photo 5. View looking northwest across northwestern portion of 110c disturbed area from northeastern edge of disturbance. Note slopes graded 3H:1V or flatter, and site stable with volunteer vegetative cover.

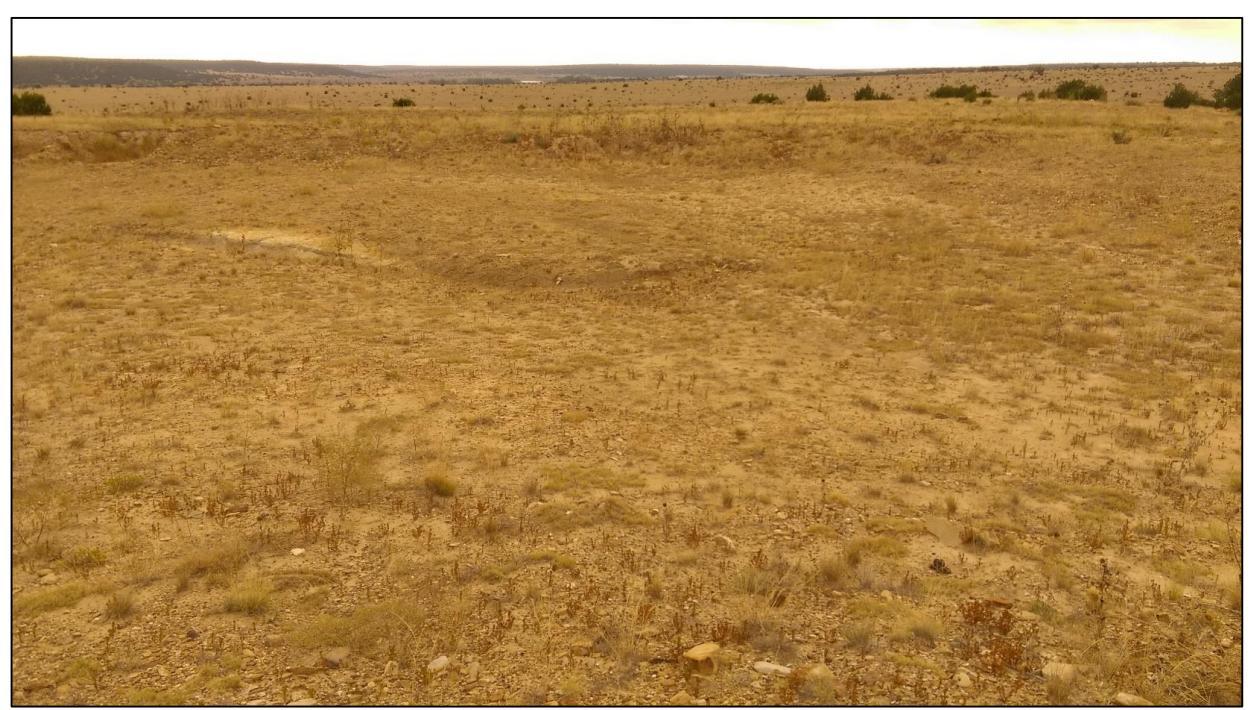
Photo 6. View looking southwest across central portion of 110c disturbed area from northeastern edge of disturbance. Note slopes graded 3H:1V or flatter, and site stable with volunteer vegetative cover.

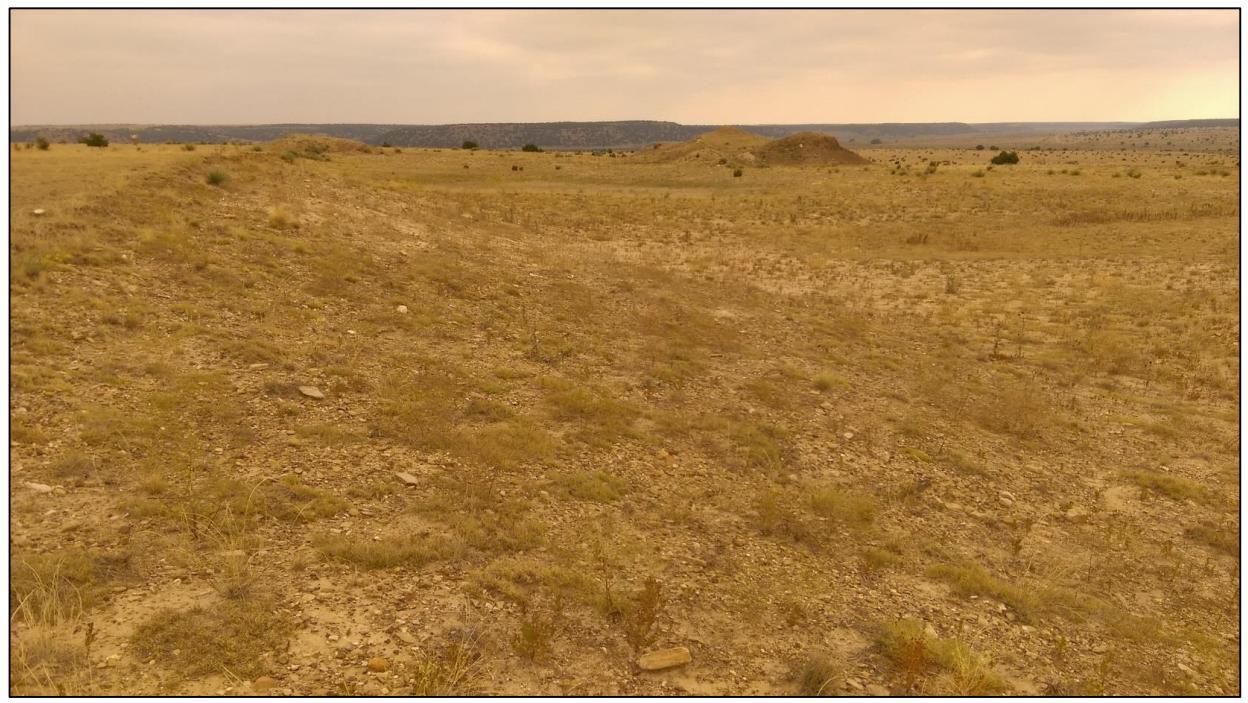
Photo 7. View looking southeast across central portion of 110c disturbed area from northeastern edge of disturbance. Note slopes graded 3H:1V or flatter, and site stable with volunteer vegetative cover. Topsoil stockpiles visible in distance.

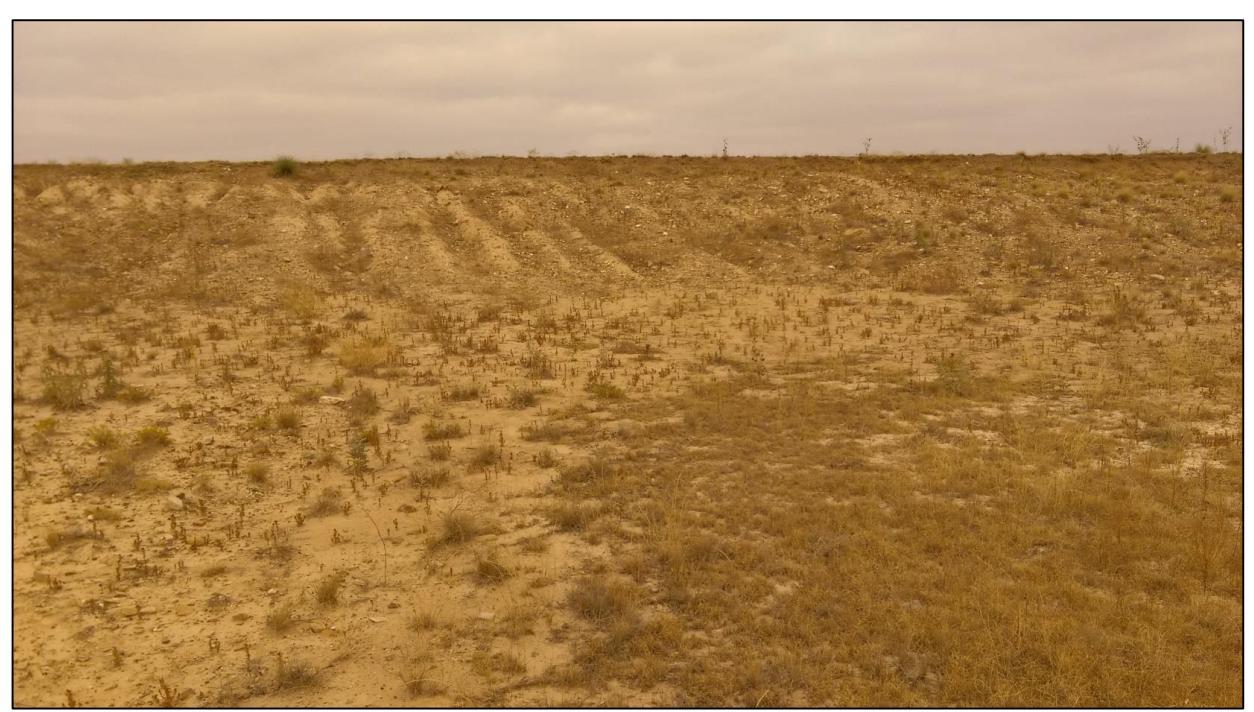
Photo 8. View looking at central portion of northeastern mined wall. Note slopes graded 3H:1V or flatter, and site stable with volunteer vegetative cover.

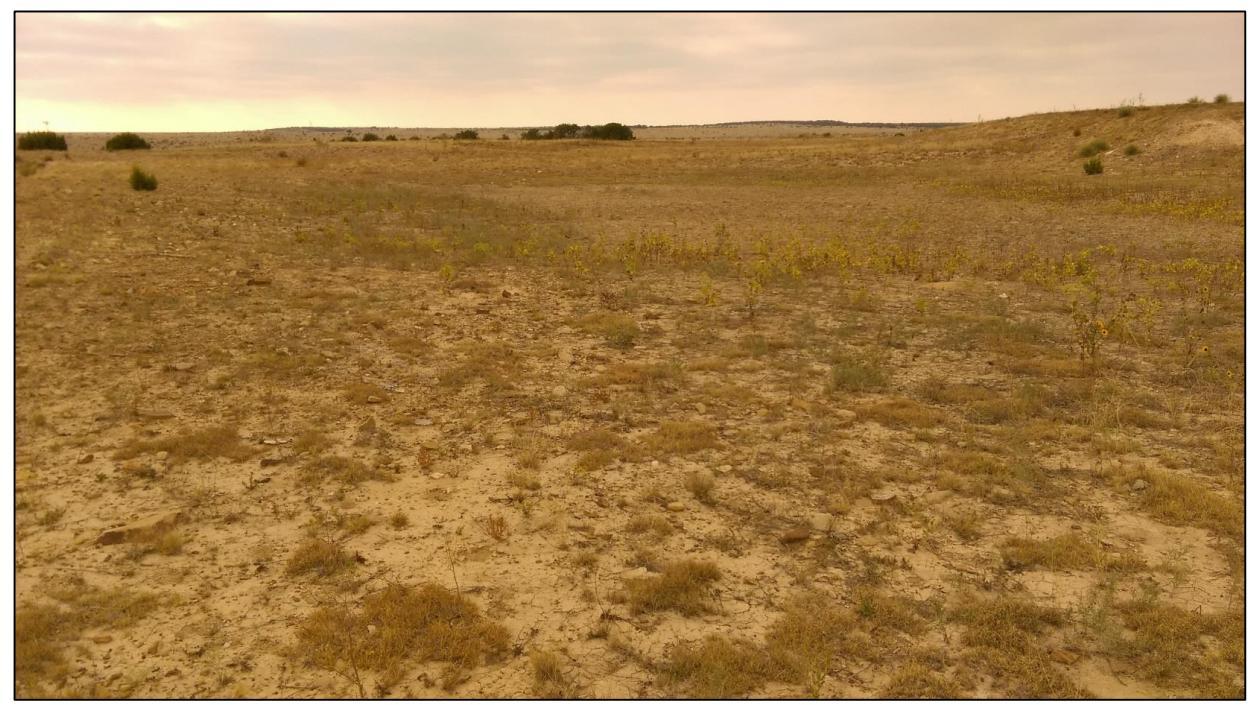
Photo 9. View looking northwest across southeastern portion of 110c disturbed area from southwestern edge of disturbance. Note slopes graded 3H:1V or flatter, and site stable with volunteer vegetative cover.

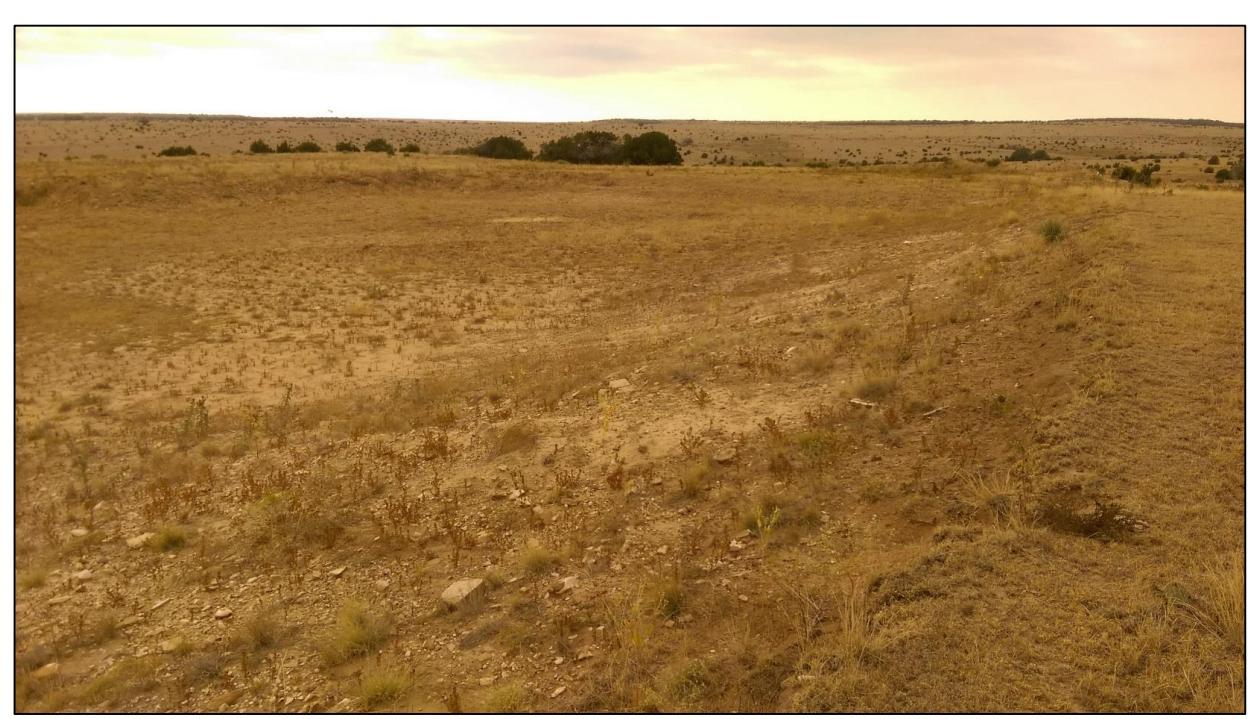
Photo 10. View looking west across southeastern portion of 110c disturbed area from southeastern edge of disturbance. Note slopes graded 3H:1V or flatter, and site stable with volunteer vegetative cover.

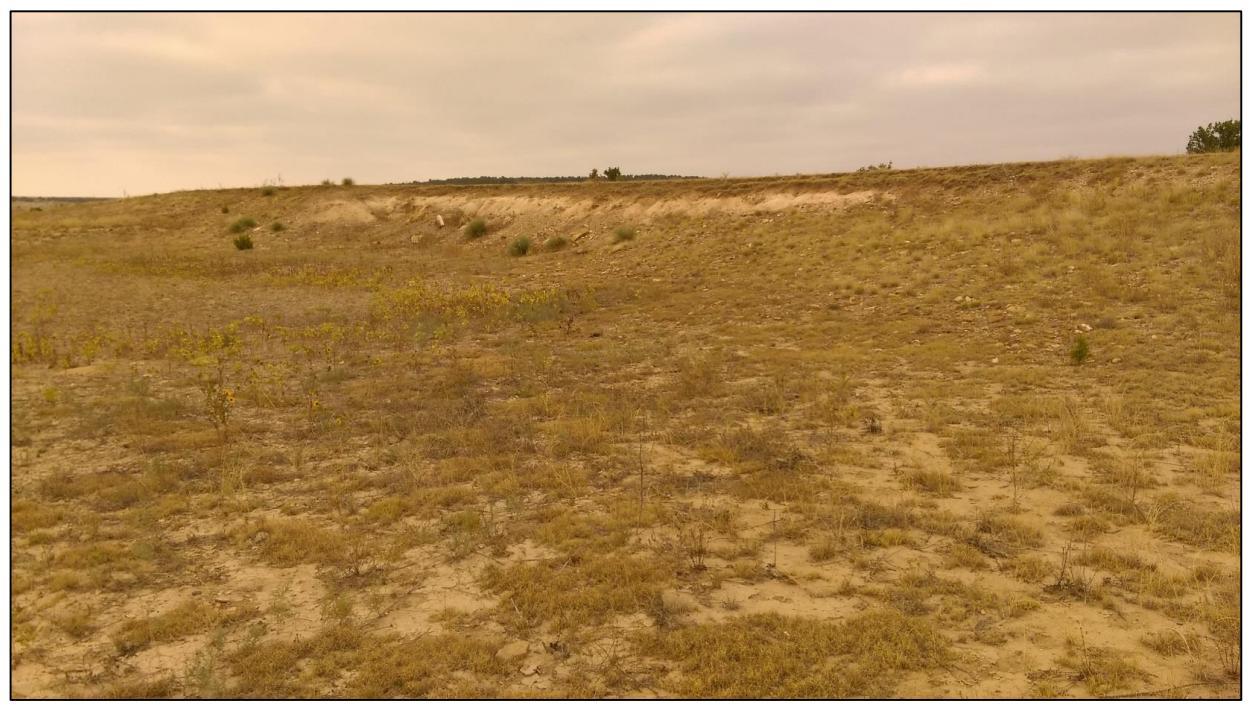
mined wall had slope gradients of 1H:1V to 2H:1V (**Photo 11**). Salvaged topsoil was stockpiled at the southern edges of the pit, and appeared to be stable with vegetative growth (**Photos 12 and 13**). No mined material was stockpiled on site. Overall, the site appeared to be stable with native grasses, forbs, yucca, and some annual weeds volunteering across disturbed areas. The Division did not observe any additional structures that were unaccounted for in the CN-01 application. Co Rd 70 is located approximately 200-220 feet from the proposed northern permit boundary, and Co Rd 217.2 is located approximately 200-210 feet from the proposed eastern permit boundary. Both of these structures are owned and maintained by the operator. Vegetation of undisturbed land in the proposed expanded permit area consists primarily of buffalograss, blue grama, and sand dropseed, with some yucca, cholla cactus, prickly pear cactus, and a few scattered junipers (**Photos 14-16**).

Photo 11. View looking northeast from southern edge of disturbance, showing small portion of northeastern mined wall with slope gradients of 1H:1V to 2H:1V.

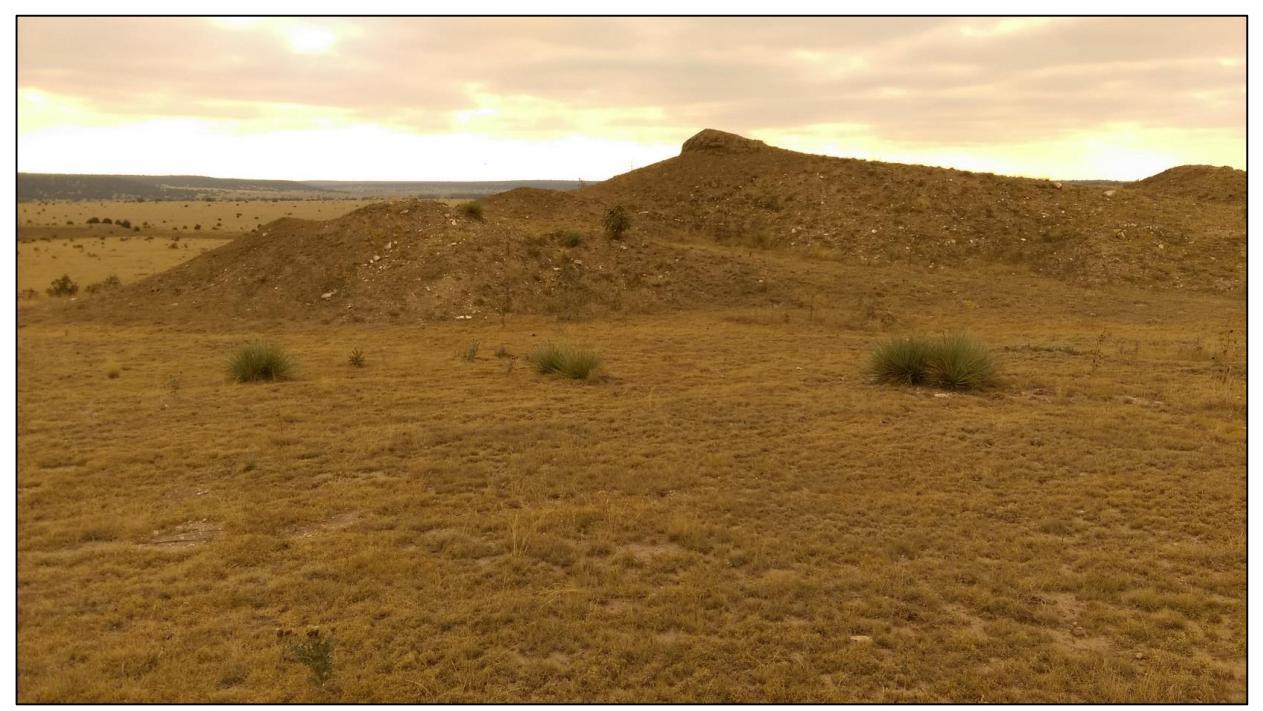
Photo 12. View of large topsoil stockpile stored at southwestern corner of disturbance that is stable with vegetative cover.

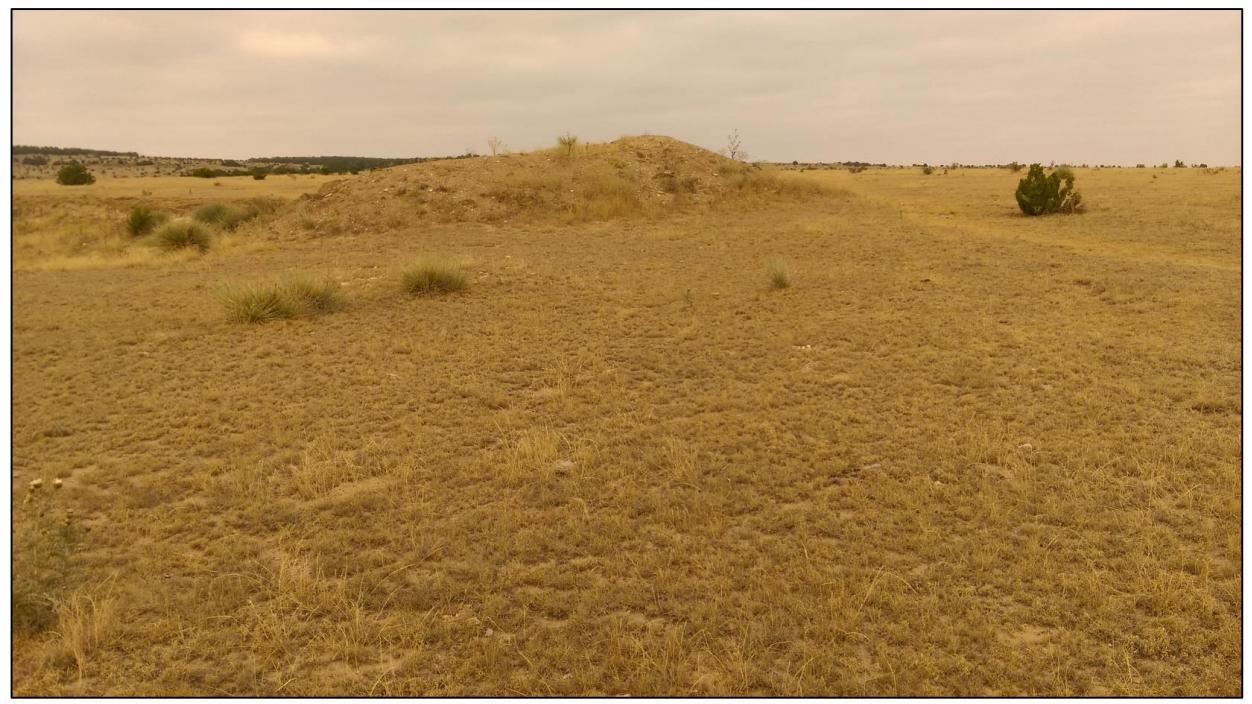
Photo 13. View of smaller topsoil stockpile stored at southeastern corner of disturbance that is stable with vegetative cover.

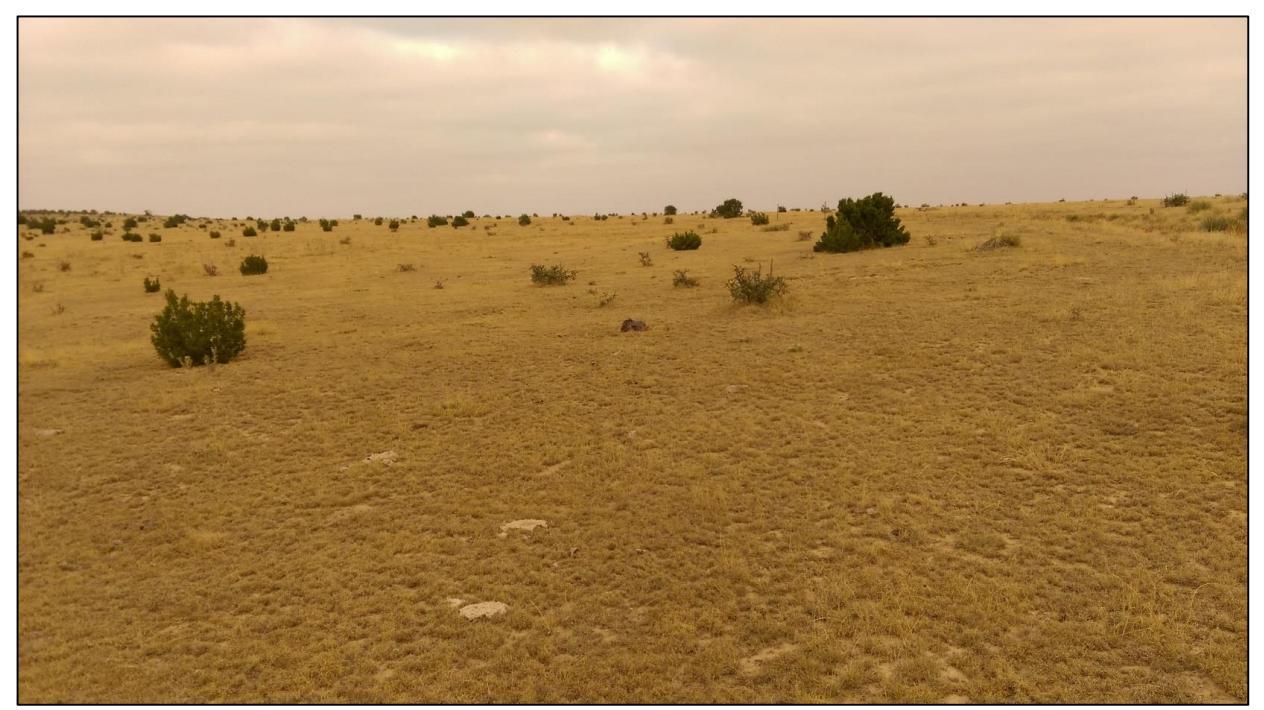
Photo 14. View looking east/northeast from western corner of proposed 112c permit area, showing undisturbed land to be affected by operation (located north of haul road).

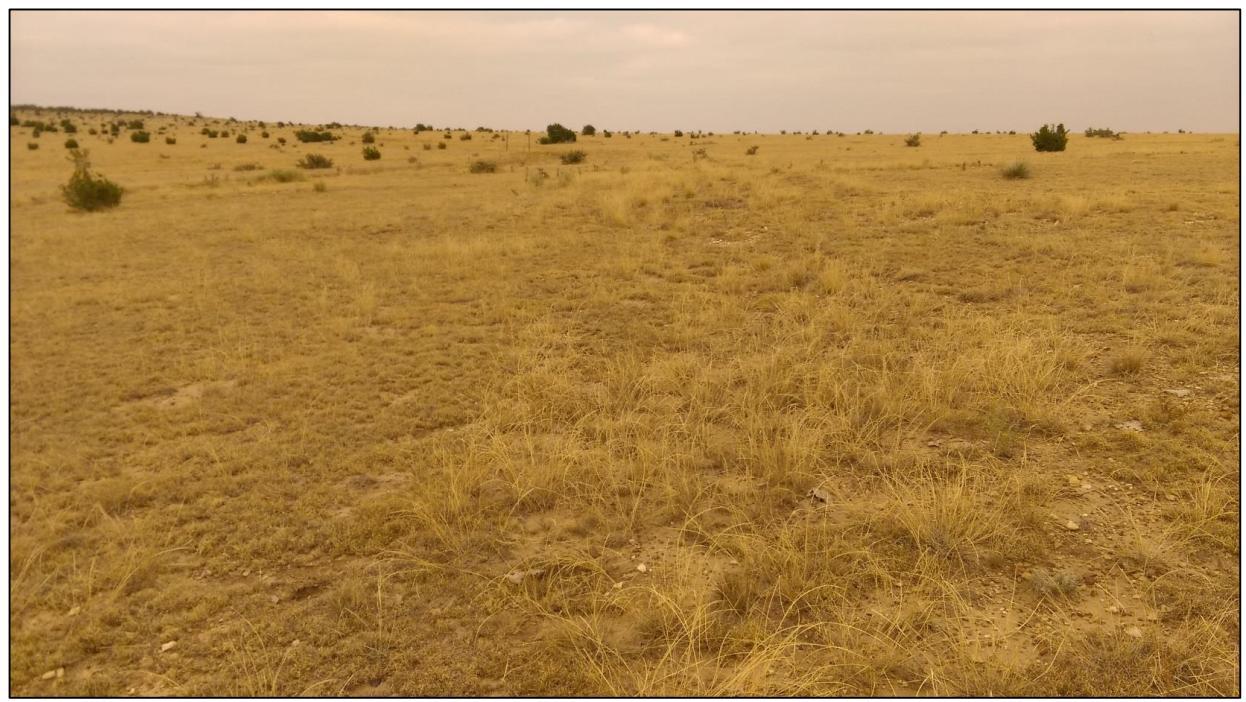
Photo 15. View looking northeast from northeastern edge of 110c permit area, showing undisturbed land to be affected by operation (located east of current pit).

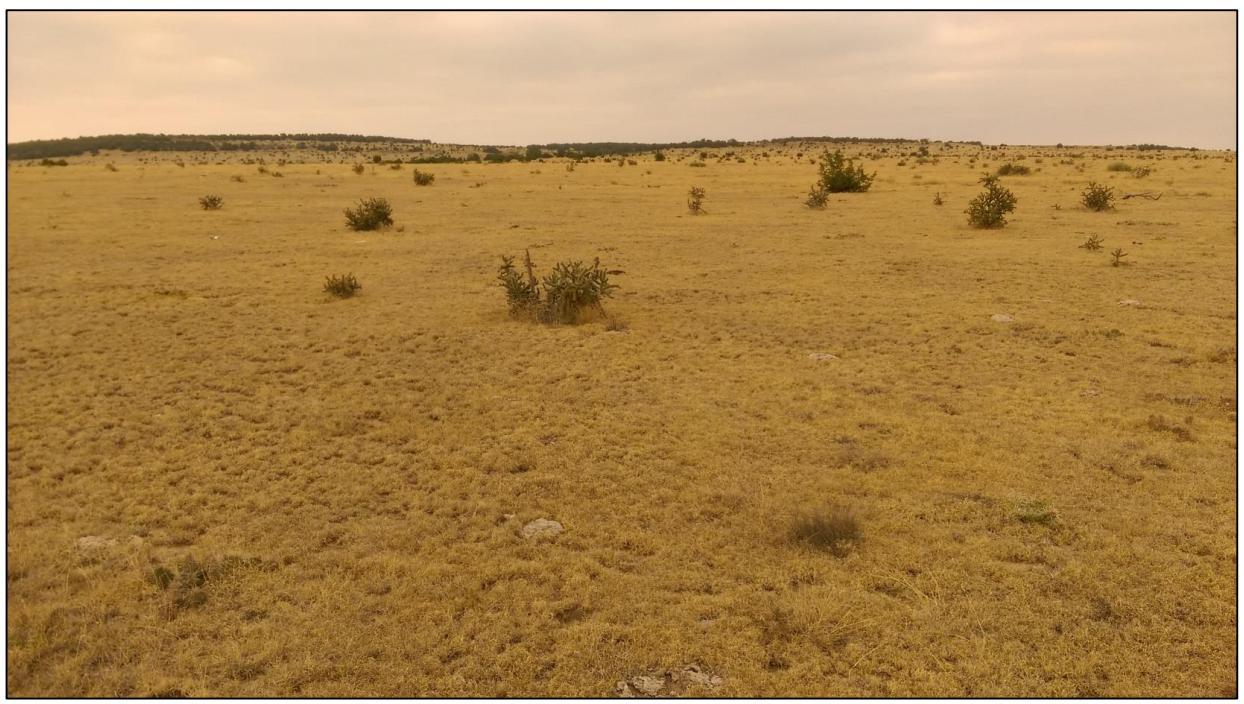
Photo 16. View looking north from proposed 112c southern permit boundary, showing undisturbed land to be affected by operation.
