The Division of Reclamation, Mining and Safety has conducted an inspection of the mining operation noted below. This report documents observations concerning compliance with the terms of the permit and applicable rules and regulations of the Mined Land Reclamation Board.

MINE NAME:	MINE/PROSPECTING ID#:	MINERAL:	COUNTY:
Colona Gravel Pit	M-1994-005	Sand and gravel	Montrose
INSPECTION TYPE:	INSPECTOR(S):	INSP. DATE:	INSP. TIME:
Monitoring	Dustin M. Czapla	November 3, 2015	12:30
OPERATOR:	OPERATOR REPRESENTATIVE:	TYPE OF OPERATION:	
Oldcastle SW Group, Inc. dba United	Jason Burkey	112c - Construction Regular Operation	
Companies of Mesa County

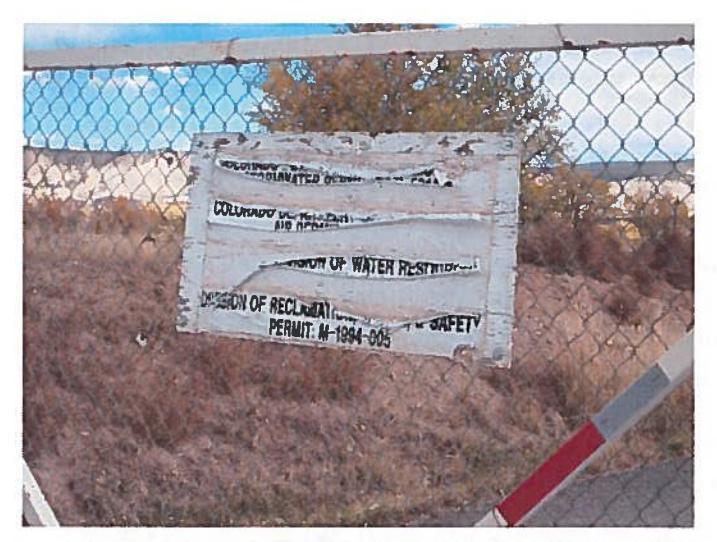
PROBLEM/POSSIBLE VIOLATION: Problem: The mine identification sign posted at the entrance of the mine site is deteriorated and the required information is no longer displayed. This is a problem for failure to maintain an adequate mine identification sign as required by Section 3.1.12(1) of the rule.

Adequate mine identification signage was not noted at the entrance to the site. The mine sign posted on the entrance gate has deteriorated to a point where the required information is no longer visible. This has been noted as a problem.

Figure 1: Inadequate sign at mine entrance

CORRECTIVE ACTIONS: The operator shall, at the entrance of the mine site, post a sign which shall be clearly visible from the access road with the following: the name of the operator, a statement that a reclamation permit for the operation has been issued by the Colorado Mined Land Reclamation Board; and the permit number. The operator shall submit photo documentation that a proper sign has been posted by the corrective action date.

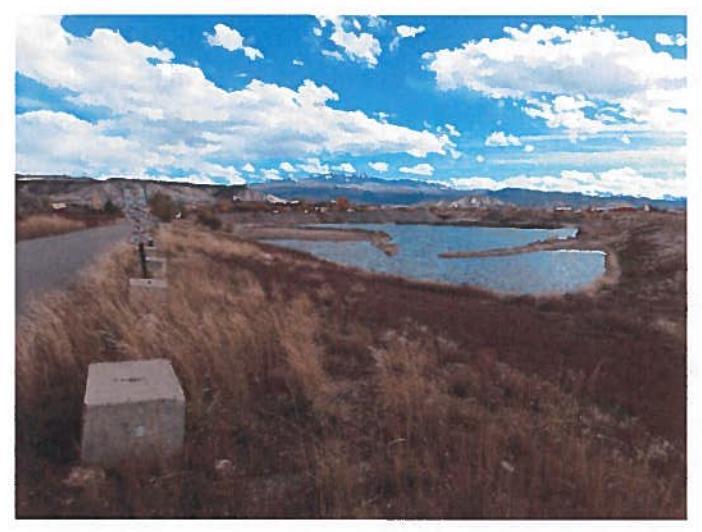
The mining area consists of a north and south pit. Approximately eight acres in the north pit have been mined below the water table. Slopes beneath the water table appeared to be approximately 2H:1V. The north and west slope in the north pit above the water table are approximately 3H:1V with vegetation becoming well established. The slope on the east side of the pit above the water table is approximately 1H:1V and does not have topsoil or vegetation. Stockpiles are still located in the north and south pits. The south pit floor is above the water table. Slopes around the south pit have been graded to approximately 2H:1V, with vegetation becoming established.

Figure 3: North slope of the north pit viewed from the west

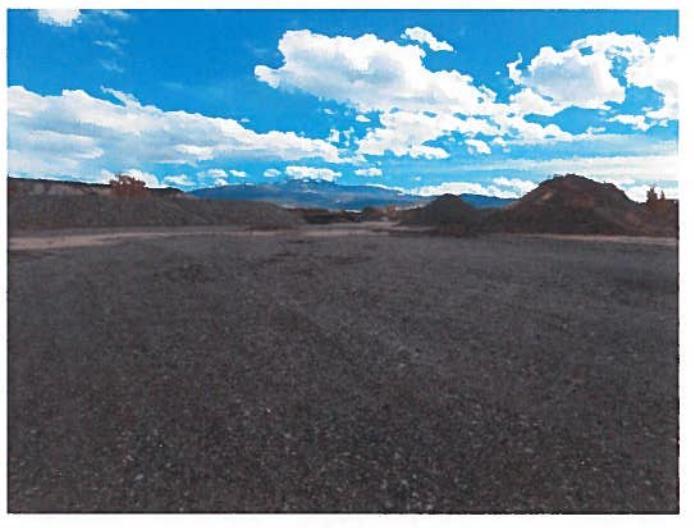
Figure 5: South part of the north pit area

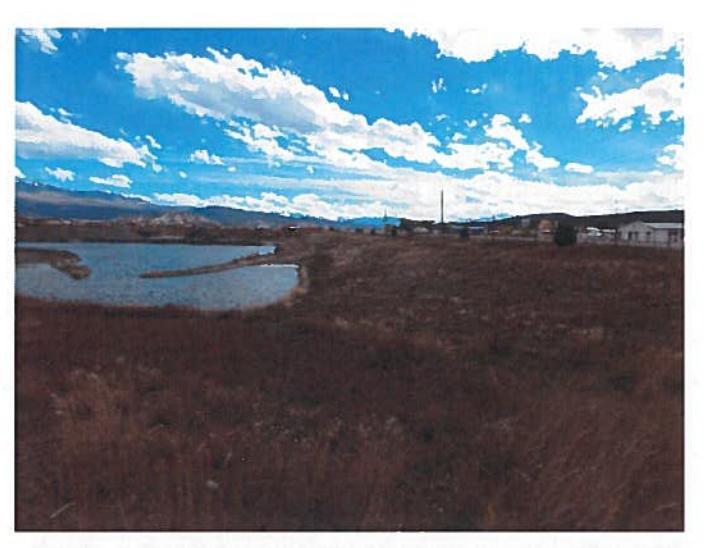
Figure 2: West slope of the north pit viewed from the north

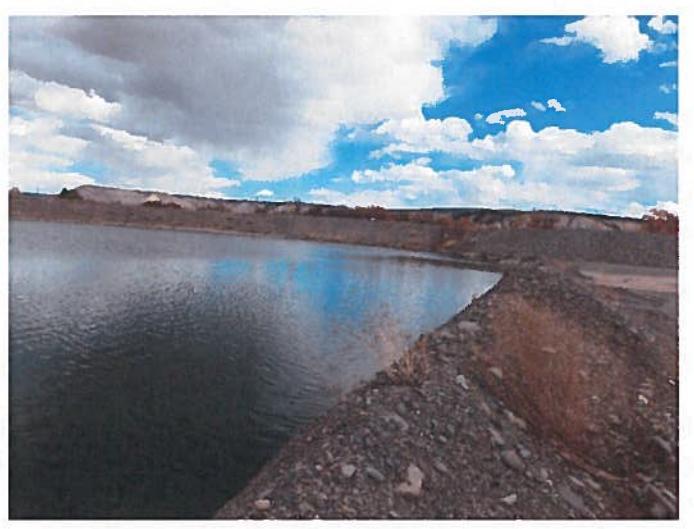
Figure 4: Looking toward the east slope of the north pit from the south side of the lake

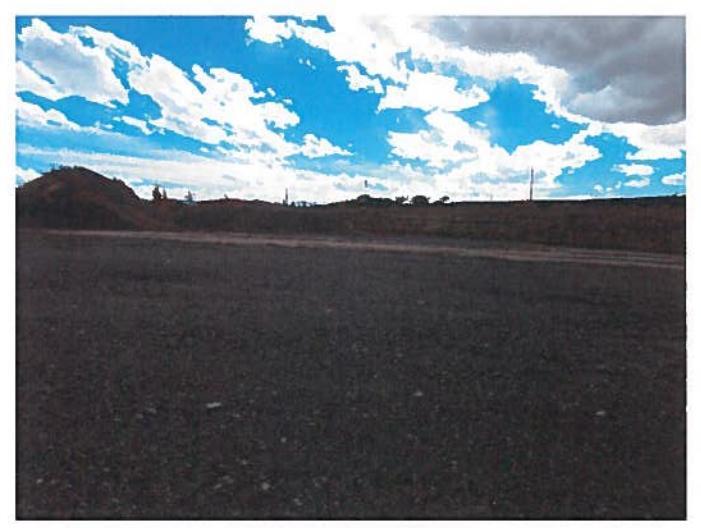
Figure 6: South part of the north pit area

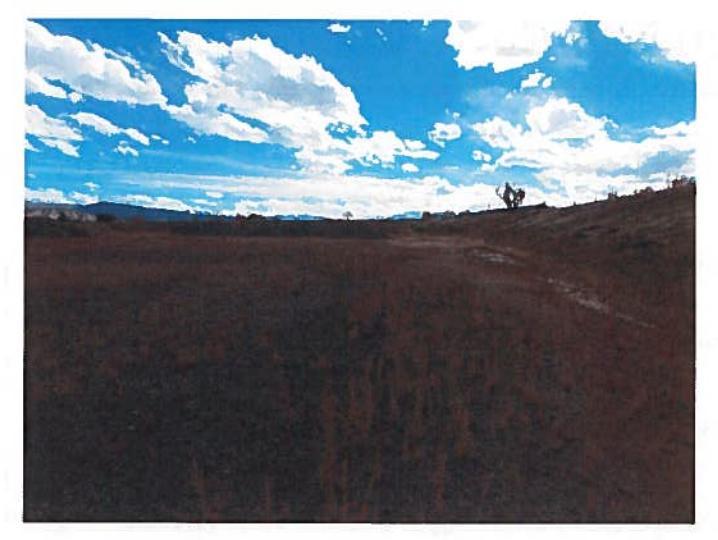
Figure 7: South pit area

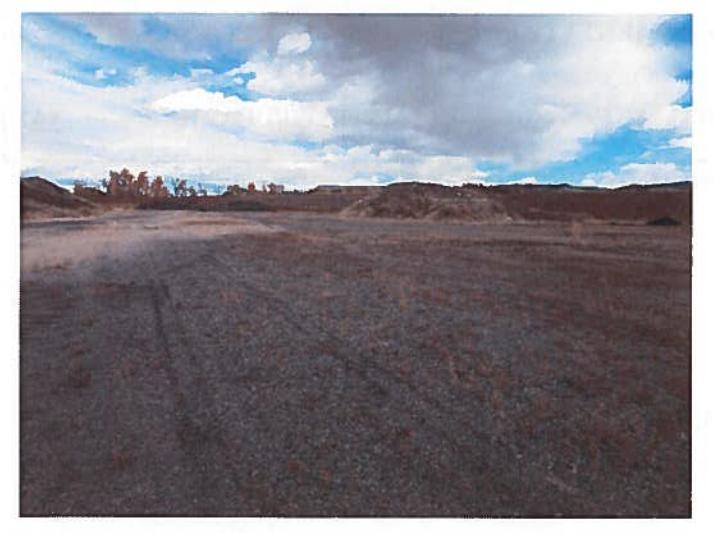
Figure 9: South pit area

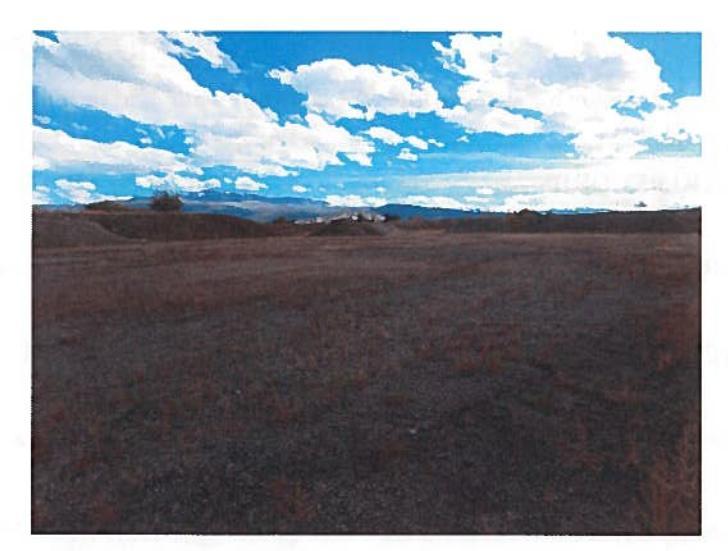
Figure 8: South pit area

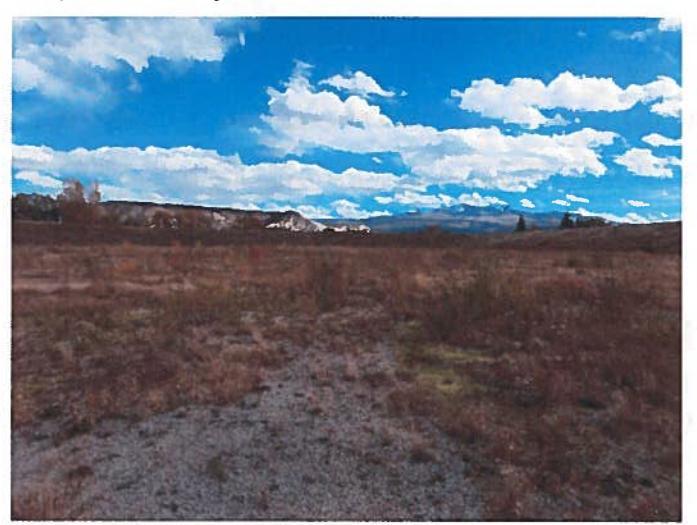
PROBLEM/POSSIBLE VIOLATION: Problem: Tamarisk (salt cedar) trees are present within the south pit area and are becoming established. This is a problem for failure to employ weed control methods for a state listed noxious weed species within the permitted area, and to reduce the spread of weeds to nearby areas as required by Section 3.1.10 (6) of the rule.

An infestation of tamarisk is developing in the south part of the pit. This has been noted as a problem.

Figure 10: Tamarisk infestation developing in southernmost part of the south pit.

CORRECTIVE ACTIONS: The operator shall either implement the existing weed control plan, or develop a weed control and management plan in accordance with Section 3.1.10 (6) of the Rule. This plan should be developed in consultation with the county extension agency, or weed control district office and should include specific control measures to be applied, a schedule for when control measures will be applied and a post-treatment monitoring plan. This weed control plan shall be submitted to the Division as

a Technical Revision to the approved plan with the appropriate Technical Revision fee of \$216.00 by the corrective action date.
