The Division of Reclamation, Mining and Safety has conducted an inspection of the mining operation noted below. This report documents observations concerning compliance with the terms of the permit and applicable rules and regulations of the Mined Land Reclamation Board.

MINE NAME:	MINE/PROSPECTING ID#:	MINERAL:	COUNTY:
Thomeczek Pit	M-1995-007	Sand and gravel	Bent
INSPECTION TYPE:	INSPECTOR(S):	INSP. DATE:	INSP. TIME:
Monitoring	Amy Eschberger	September 30, 2015	08:45
OPERATOR:	<b>OPERATOR REPRESENTATIVE:</b>	<b>TYPE OF OPERAT</b>	TION:
Bent County Ready Mix	Judy Thomeczek	110c - Construction Limited Impact

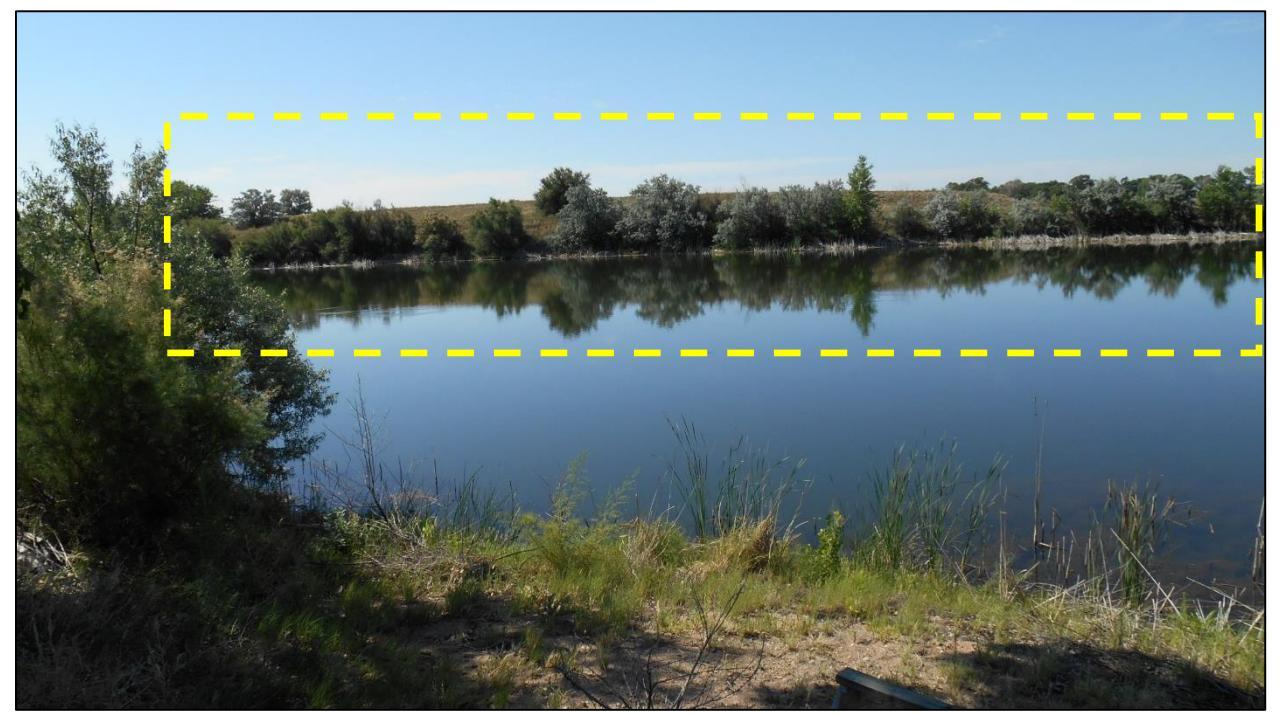
**Photo 1.** View looking south from northern pond bank (during 7/3/2014 inspection), showing numerous Tamarisk and Russian Olive trees that were present at that time along the southern shoreline (indicated).

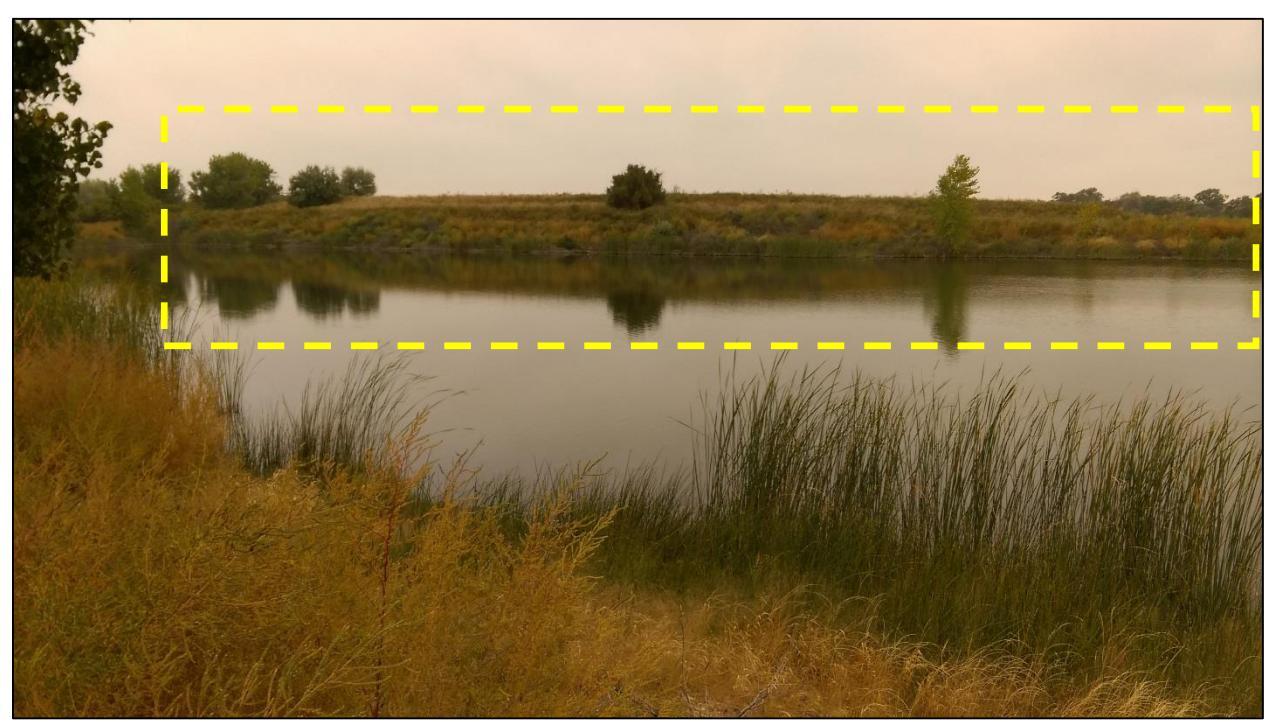
The purpose of this inspection was to reassess site conditions, particularly the presence of noxious weeds (as the Division received documentation in May indicating some had been removed). The Division walked around the perimeter of the pond with Mrs. Bucholz and Mrs. Thomeczek. At the time of the inspection, the vegetation around the pond consisted primarily of Russian thistle, marestail weed, Tamarisk trees, cottonwood trees, a few willows, a few small patches of wild sunflowers, and some cattails along the shallow edges of the pond. The primary grass species on site appeared to be sand dropseed. Since the 07/03/2014 inspection, Mrs. Bucholz and her husband had cut down several of the Tamarisk and Russian Olive trees that were present along the northern and southern pond banks (compare **Photos 1 and 2**), and treated the stumps with herbicide (**Photos 3-5**). Mrs. Bucholz and her husband did this work in order to help Mr. Thomeczek meet the Corrective Action deadline for April. During this inspection, a few new Tamarisk trees were observed growing back into some of these areas (**Photo 6**).

**Photo 2.** View looking south from northern pond bank (during recent inspection), showing most of the Tamarisk and Russian Olive trees were removed from the southern shoreline by the adjacent landowner (indicated). Compare with **Photo 1**.

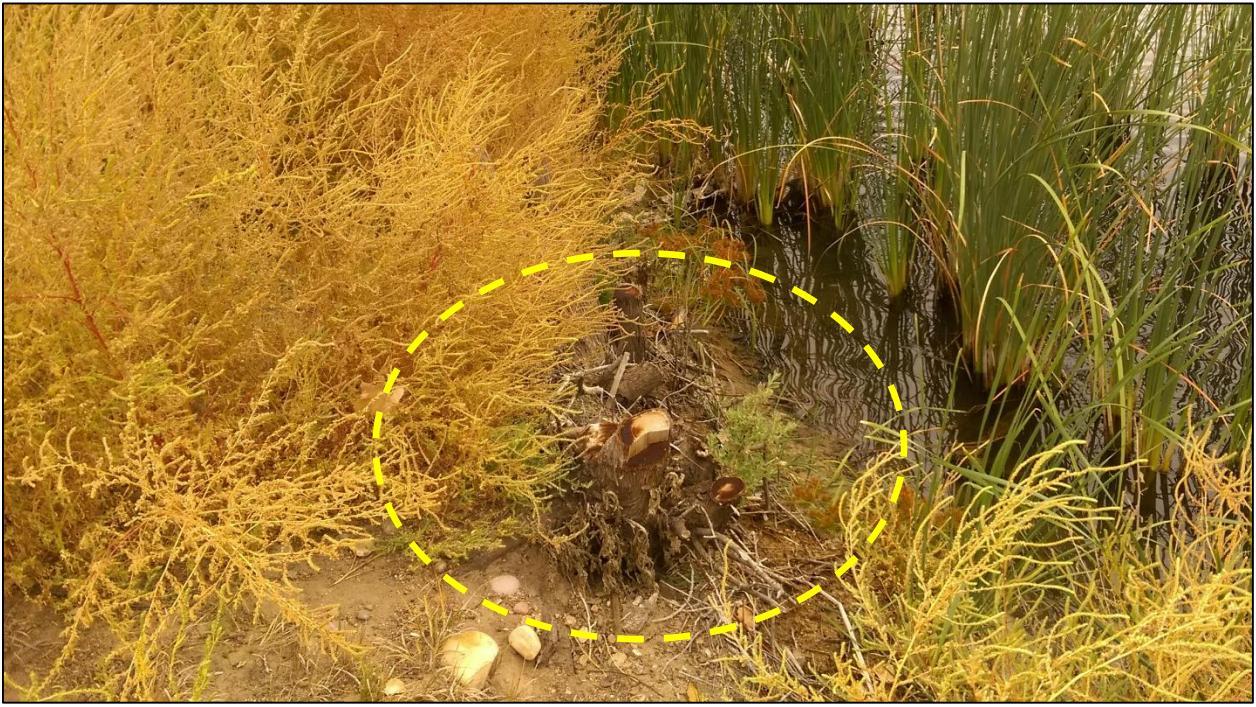
**Photo 3.** View of stump (indicated) that remains on northern pond bank where Tamarisk tree was cut and treated by adjacent landowner.

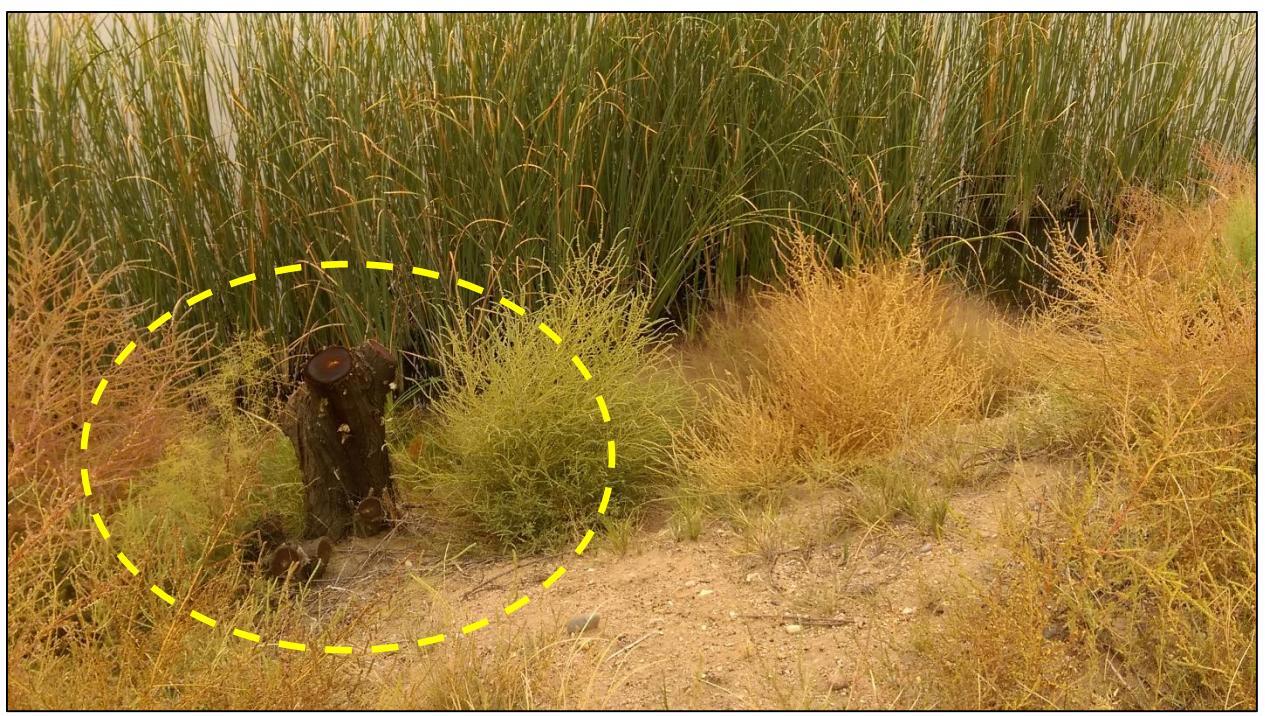
**Photo 4.** View of another stump (indicated) that remains on northern pond bank where Russian Olive tree was cut and treated by adjacent landowner.

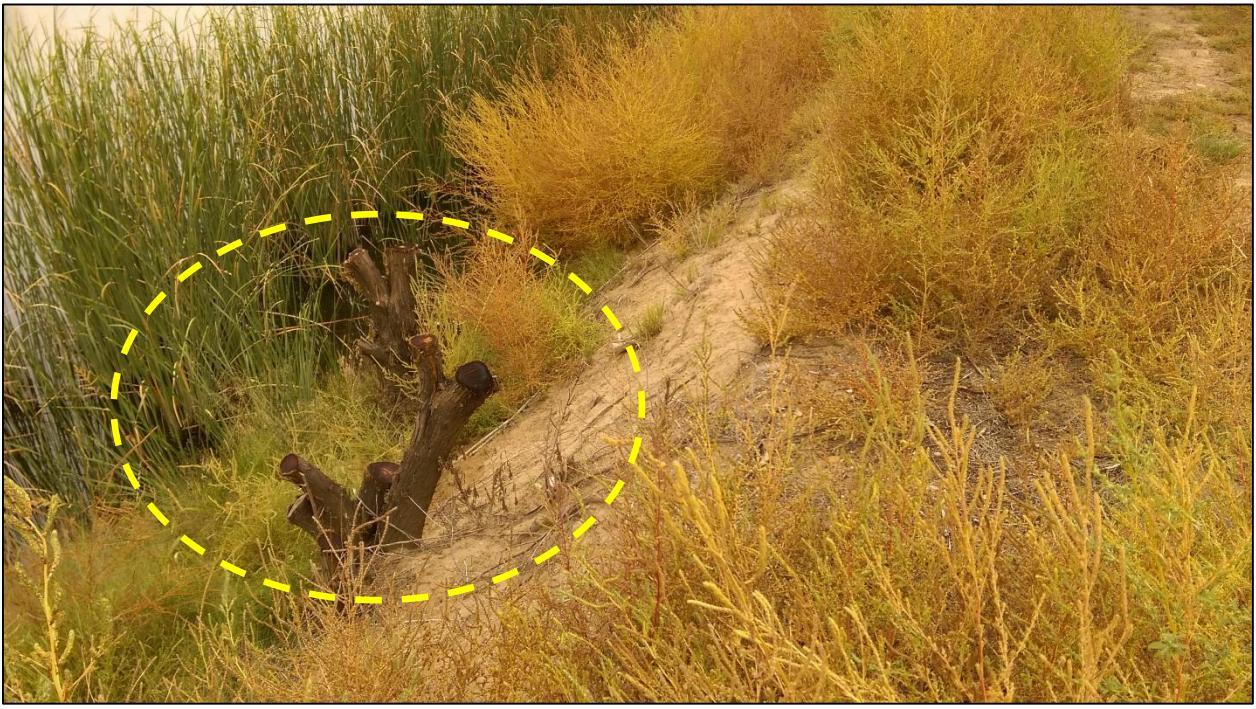
**Photo 5.** View of two stumps (indicated) that remain on northern pond bank where Russian Olive trees were cut and treated by adjacent landowner.

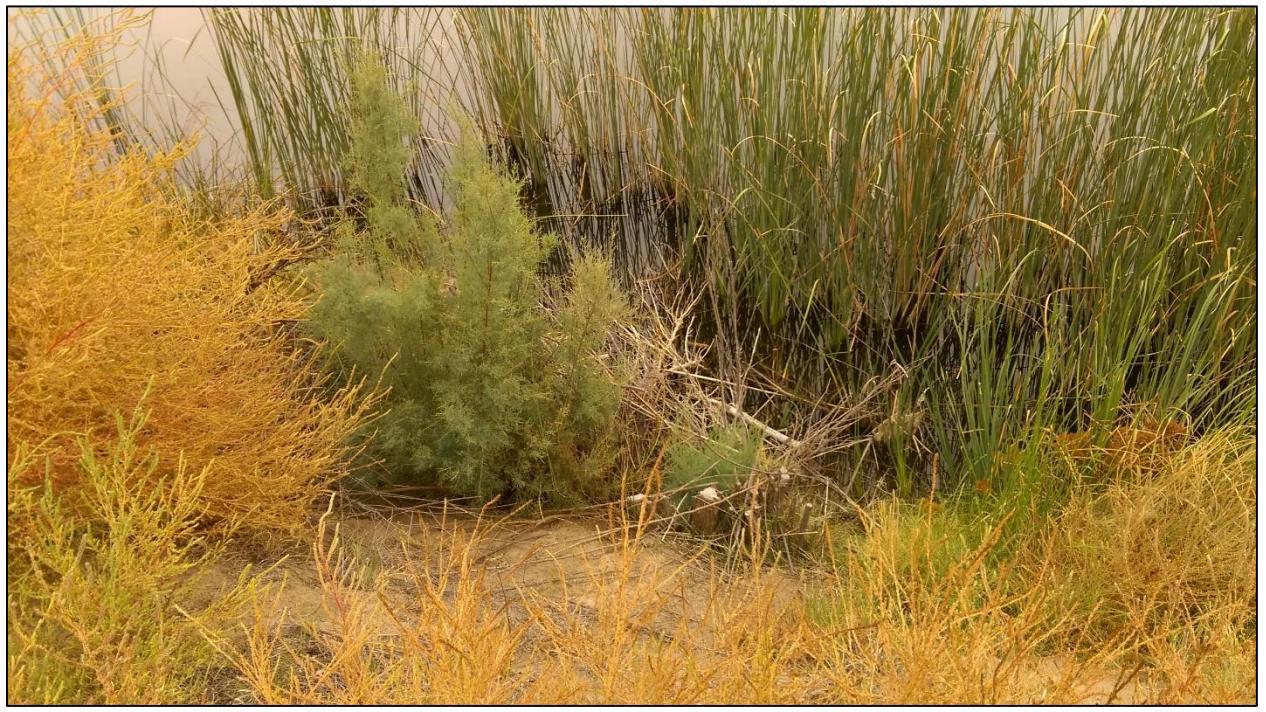
**Photo 6.** View of new Tamarisk tree now growing near stump where Tamarisk tree was removed earlier in the year by adjacent landowner.

**CORRECTIVE ACTIONS:** Implement the approved weed control plan and promptly notify the Division so that a follow-up inspection can be conducted to verify compliance. If a weed control plan is not already in place, the Operator shall develop a weed control and management plan in accordance with Rule 3.1.10(6). This plan should be developed in consultation with the county extension agency, or weed control district office and should include specific control measures to be applied, a schedule for when control measures will be applied and a post-treatment monitoring plan. This weed control plan shall be submitted to the Division as a Technical Revision to the approved plan with the appropriate Technical Revision fee of \$216.00 by the corrective action date. **CORRECTIVE ACTION DUE DATE:** 10/31/15 (original deadline)

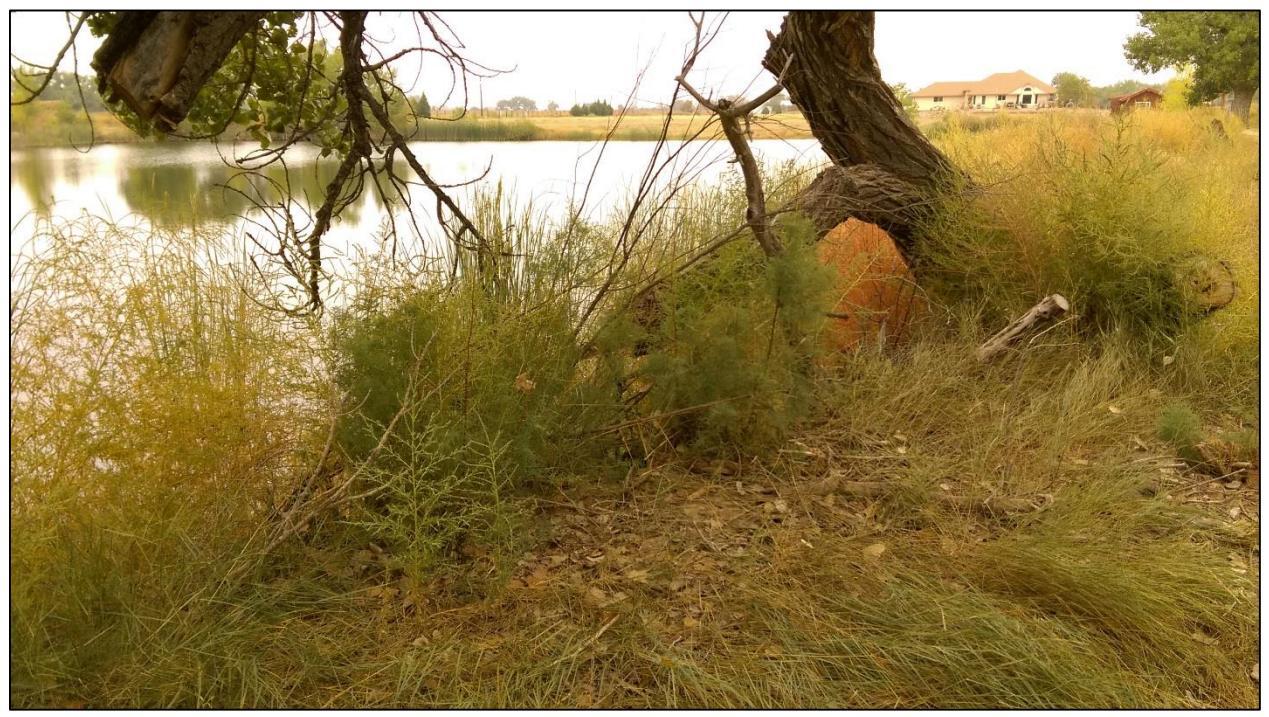
**PROBLEM/POSSIBLE VIOLATION:** Problem: Tamarisk (salt cedar) and Russian Olive trees are present within or have volunteered into the permit area and are becoming established. This is a problem for failure to employ weed control methods for a state listed noxious weed species within the permitted area, and to reduce the spread of weeds to nearby areas as required by Rule 3.1.10(6).

Several Tamarisk trees still exist mainly along the northeastern and eastern pond banks (**Photos 7-10**). Some of these trees are up to 10 feet in height or more, indicating they have been present for some time. A large (older growth) Tamarisk tree is growing on the northern side of the large overburden stockpile located at the southern edge of the permit area (**Photo 11**). It is clearly evident that there has been no weed control and management at this site in many years, except for efforts made by the adjacent landowner in removing Tamarisk and Russian Olive trees along the northern and southern pond banks. <u>Until the permit is released, it is the operator's responsibility to employ weed control methods for all state-listed noxious weed species in the permit area. In addition, weed control should be employed for all other weed species invading the disturbed area which would seriously threaten the growth of desired vegetation.</u>

Photo 7. View of small Tamarisk trees growing along northeastern pond bank.

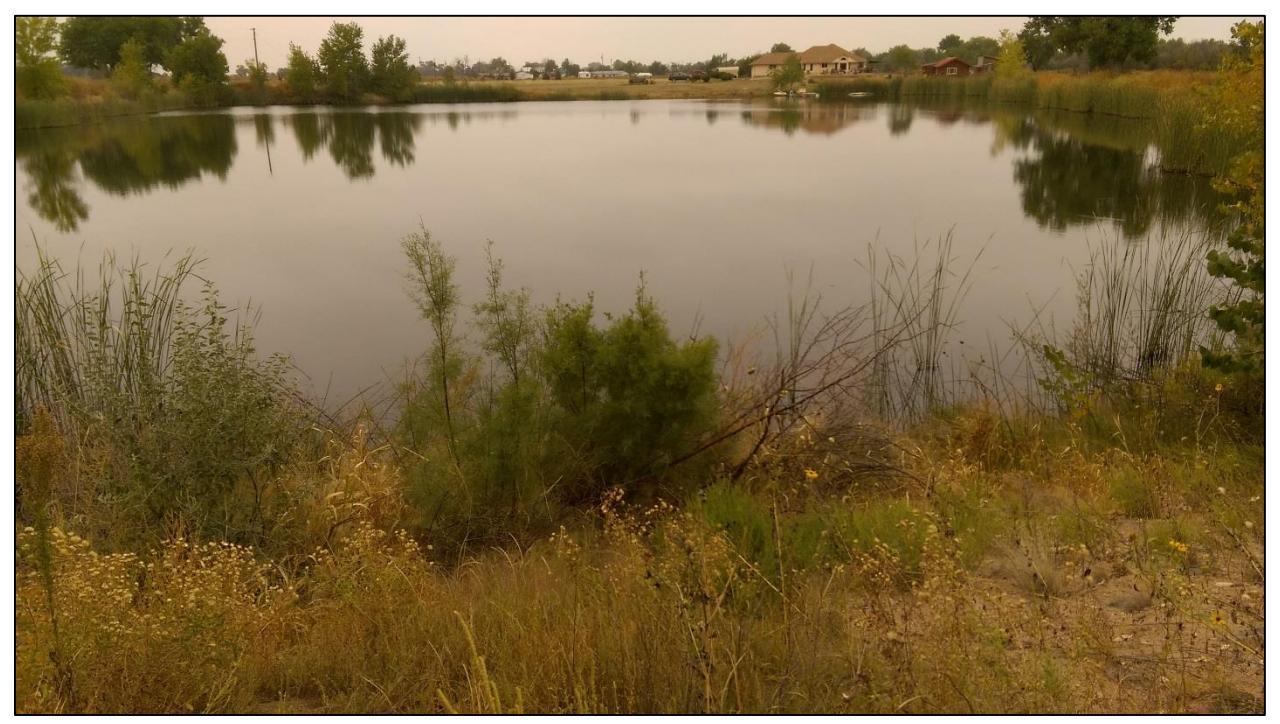
**Photo 8.** View of small Tamarisk tree growing along eastern pond bank.

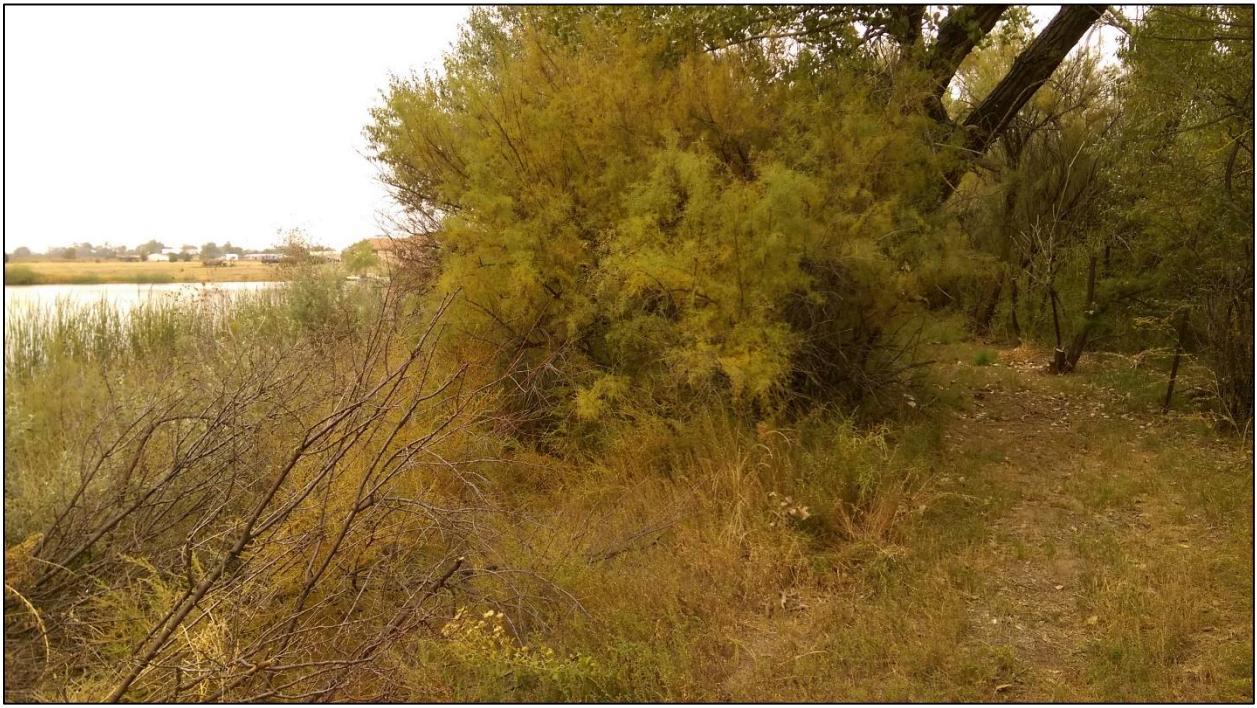
Photo 9. View of taller Tamarisk trees growing along northeastern pond bank.

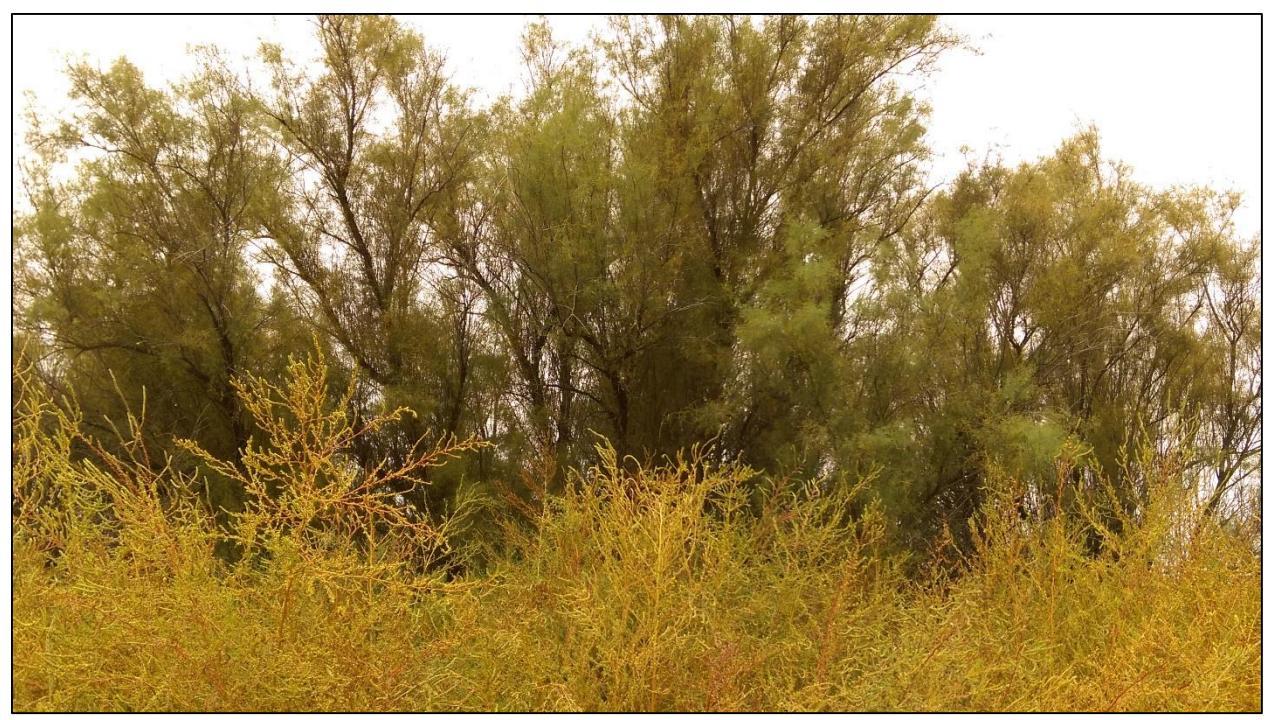
**Photo 10.** View of taller Tamarisk trees growing along eastern pond bank.

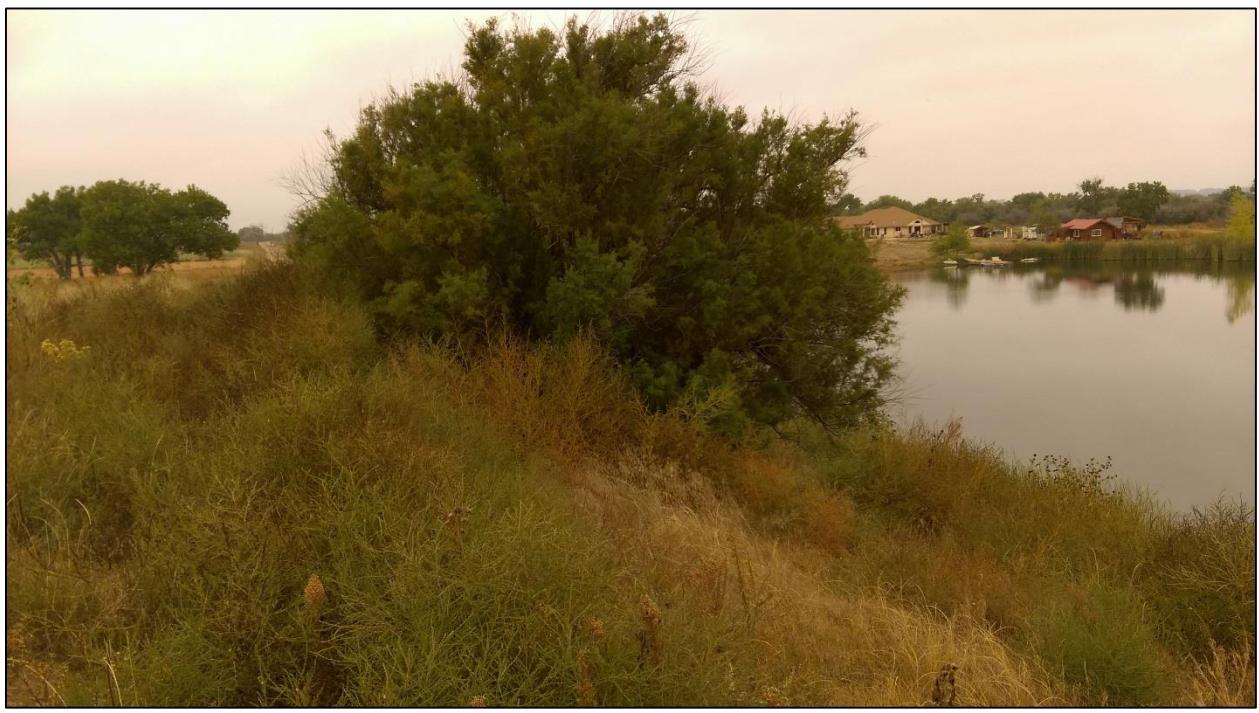
**Photo 11.** View of large Tamarisk tree growing on northern side of overburden stockpile present at southern edge of permit area.

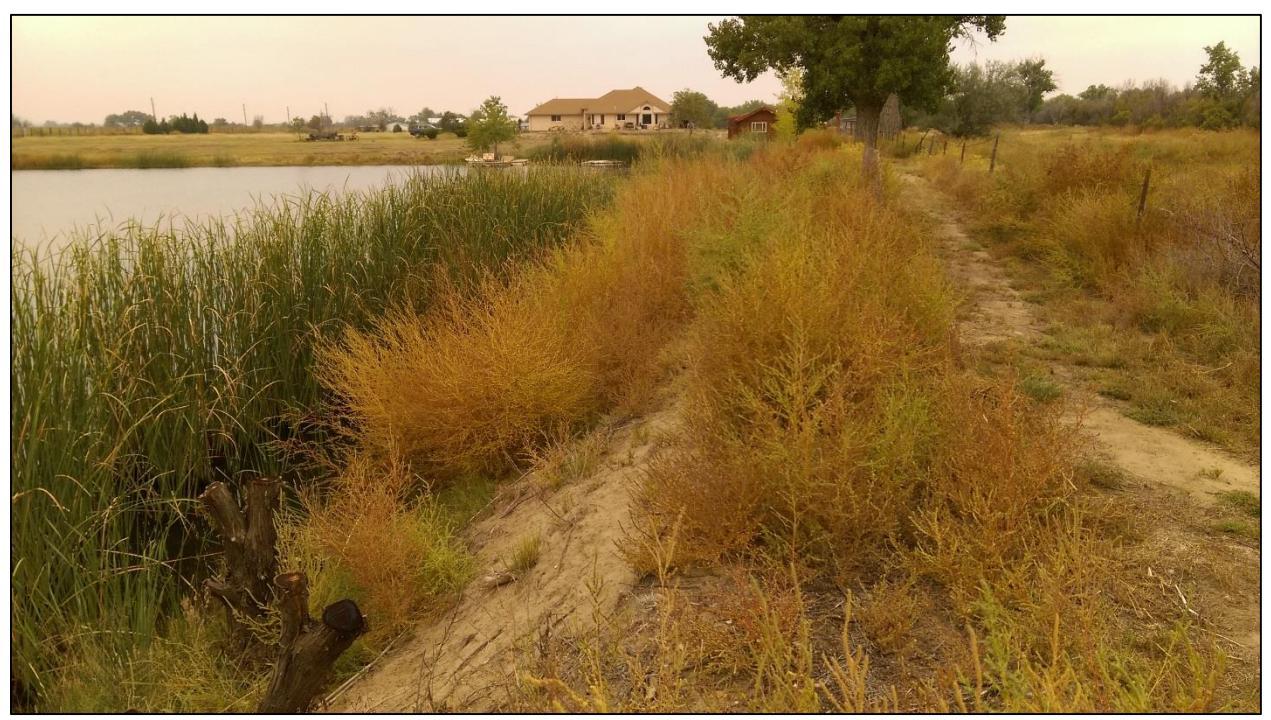
At the time of the inspection, the pond shoreline had dense weed growth along the banks, making it difficult to see the slopes in many of the photos taken during the inspection. However, the Division confirmed that the pond banks remain steeper than the approved 3H:1V slope gradient. The pond slopes range from 1.5H:1V to 2.5H:1V, rising approximately 3-5 feet above waterline (**Photos 12-14**).Only the northwestern portion of the pond bank (owned by the adjacent landowner) has been graded to the required slope gradient (**Photo 15**). This portion of the pond bank was graded by the Bucholz family to approximately 4H:1V. For final reclamation, the entire shoreline of the pond must be graded to a slope gradient of 3H:1V or flatter.

**Photo 12.** View looking west across portion of northern pond bank, showing slope gradient of approximately 1.5H:1V. Note dense weed growth along pond bank (primarily Russian thistle).

**CORRECTIVE ACTIONS:** The Operator must complete all final reclamation earthwork and seeding by the corrective action due date. After completing these tasks, the Operator shall promptly notify the Division so that a follow-up inspection can be conducted to verify compliance.

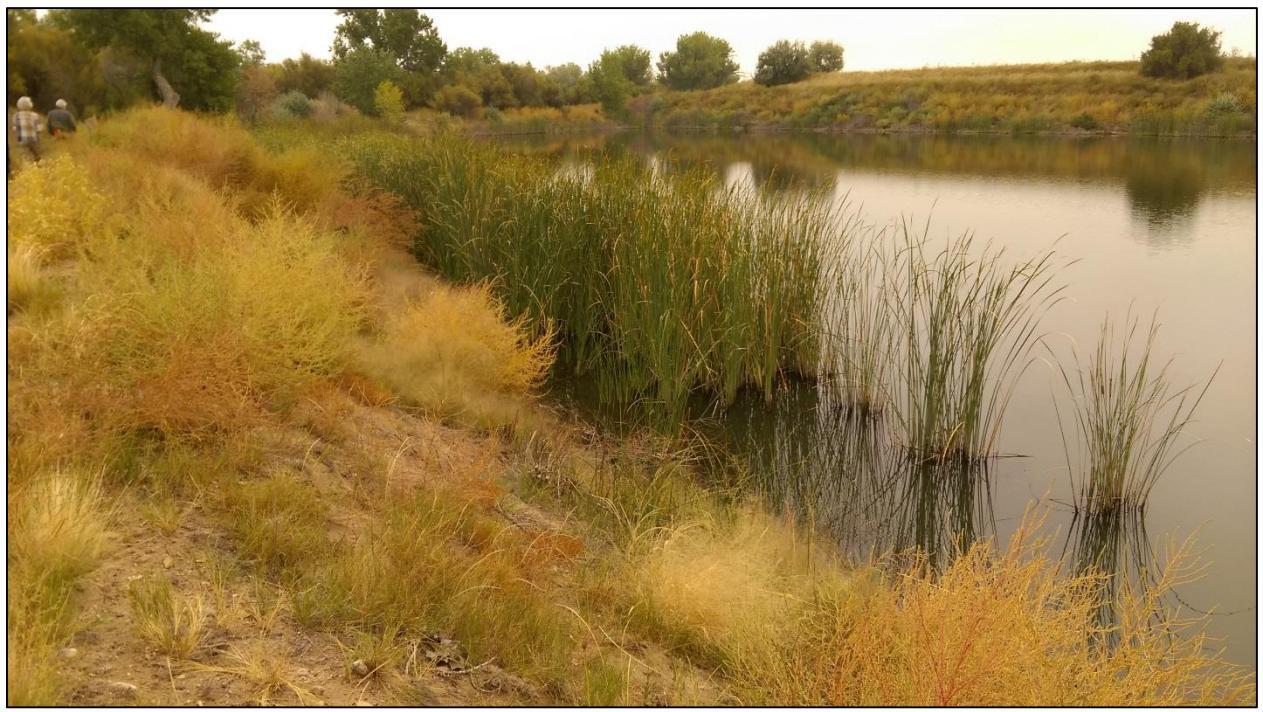
**Photo 13.** View looking east across portion of northern pond bank, showing slope gradients of approximately 1.5H:1V to 2H:1V. Note dense weed growth along pond bank (primarily Russian thistle).

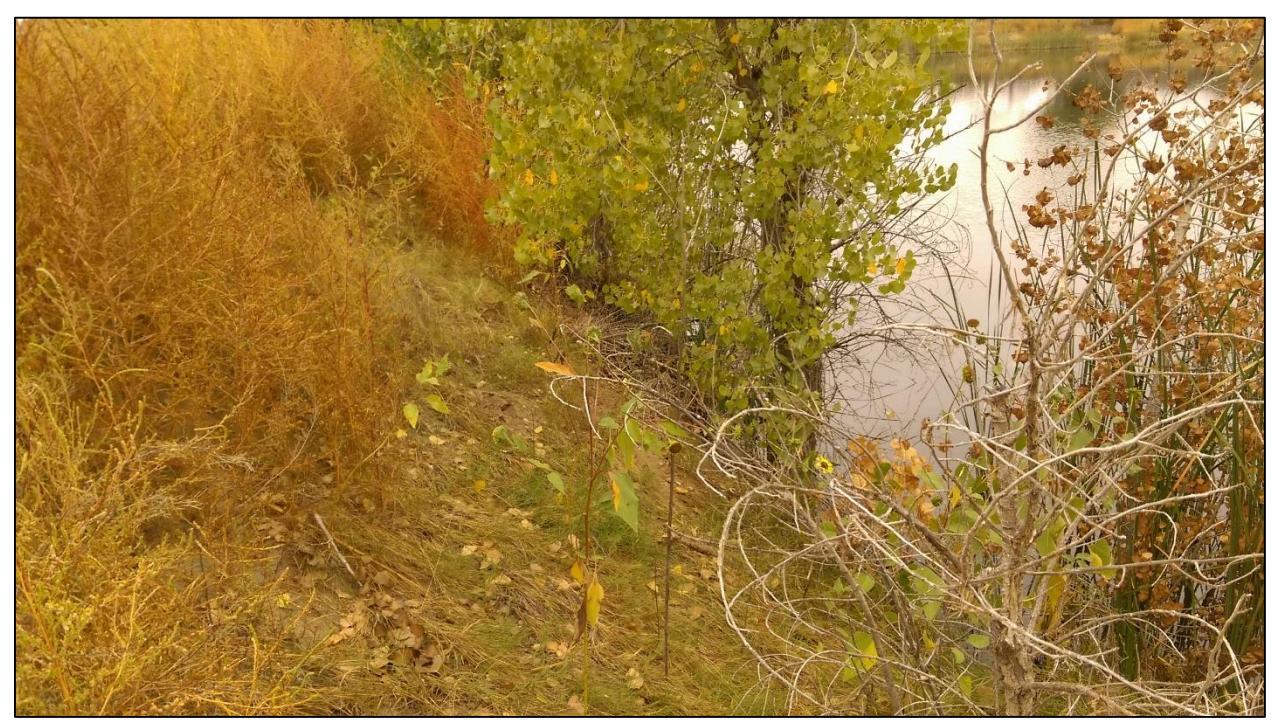
**Photo 14.** Close-up view of portion of southwestern pond bank, showing slope gradient of approximately 2H:1V to 2.5H:1V.

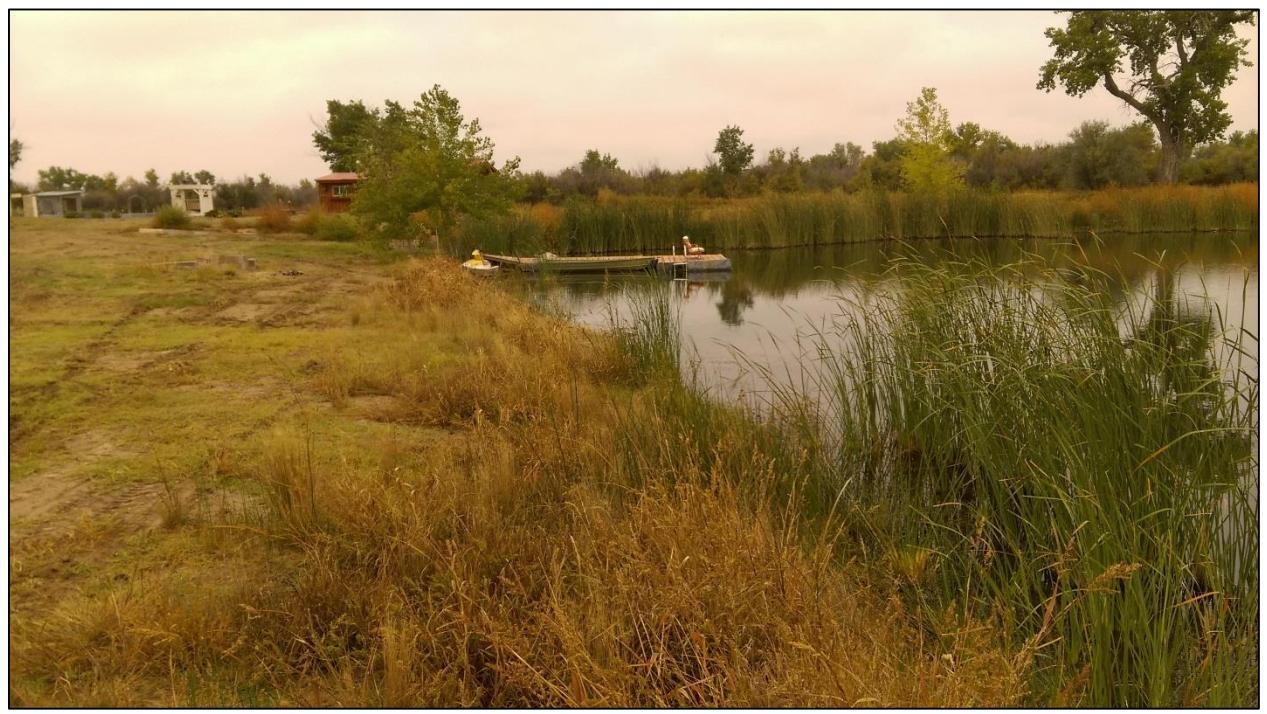
**Photo 15.** View looking north at northwestern portion of pond shoreline that adjacent landowner graded to approximately 4H:1V.

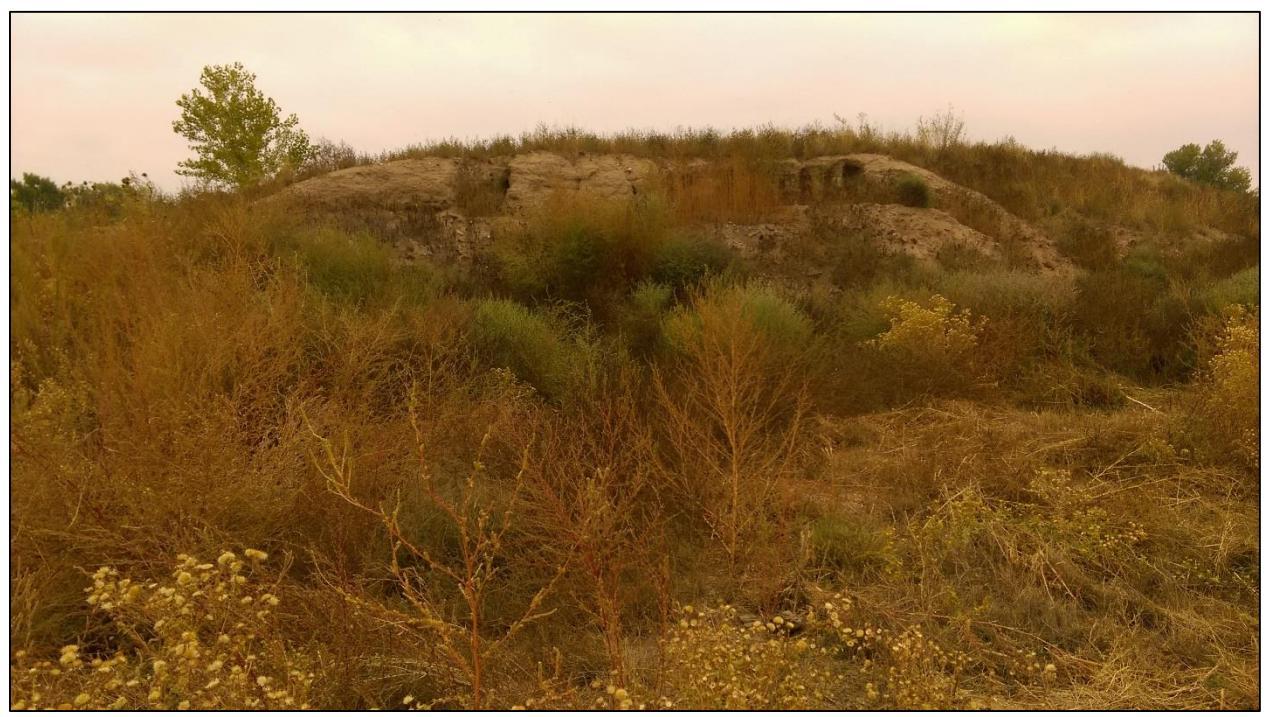
The large overburden stockpile was still present along the southern edge of the permit area (**Photos 16-18**). The Division previously estimated this stockpile to contain approximately 13,500 cubic yards of material. As discussed with the operator and his consultants, the majority of this stockpile must be removed and the area graded to 3H:1V or flatter for final reclamation. It is up to the operator to decide whether to use the stockpiled material to grade the pond banks, to push the material into the pond, or to haul it off site. After completing the grading work in the stockpile area and along the pond banks, these areas will then need to be seeded with the approved seed mixture.

**Photo 16.** View of western end of large overburden stockpile located at southern edge of permit area. This side of the stockpile has slope gradients of approximately near vertical to 1H:1V.

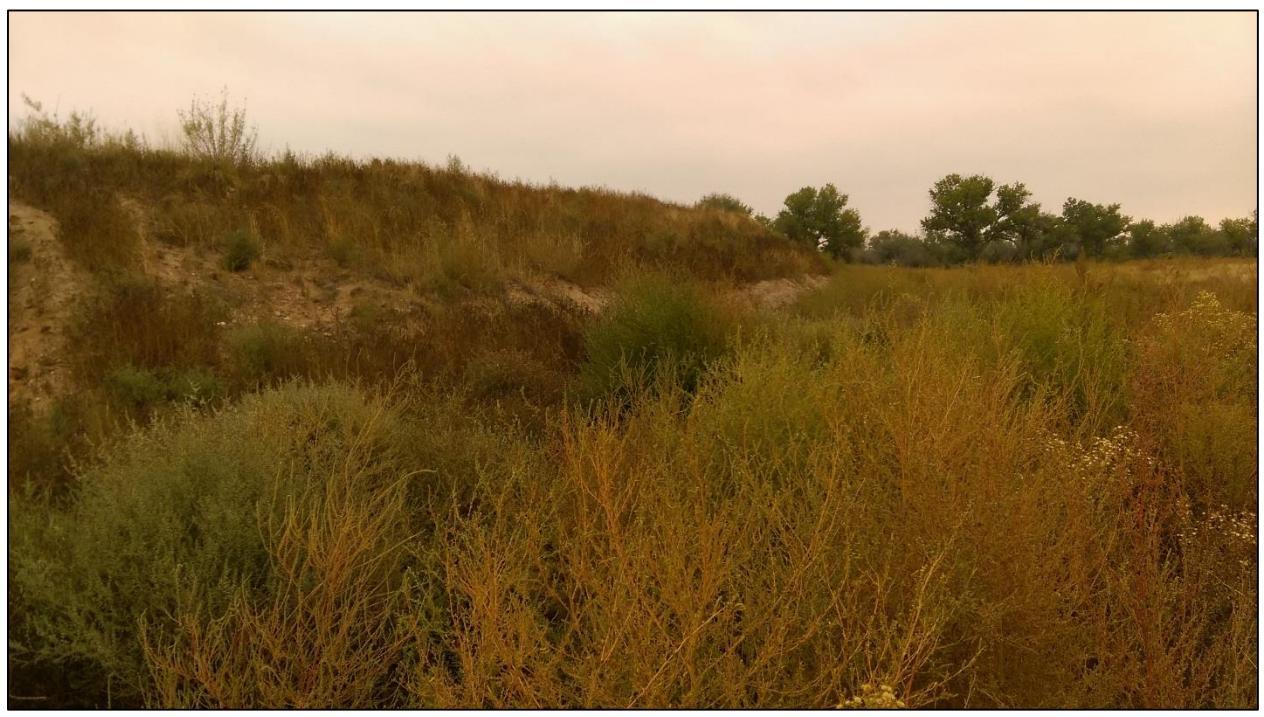
**Photo 17.** View of southern side of large overburden stockpile located at southern edge of permit area. This side of the stockpile has slope gradients of approximately 1H:1V to 2H:1V.

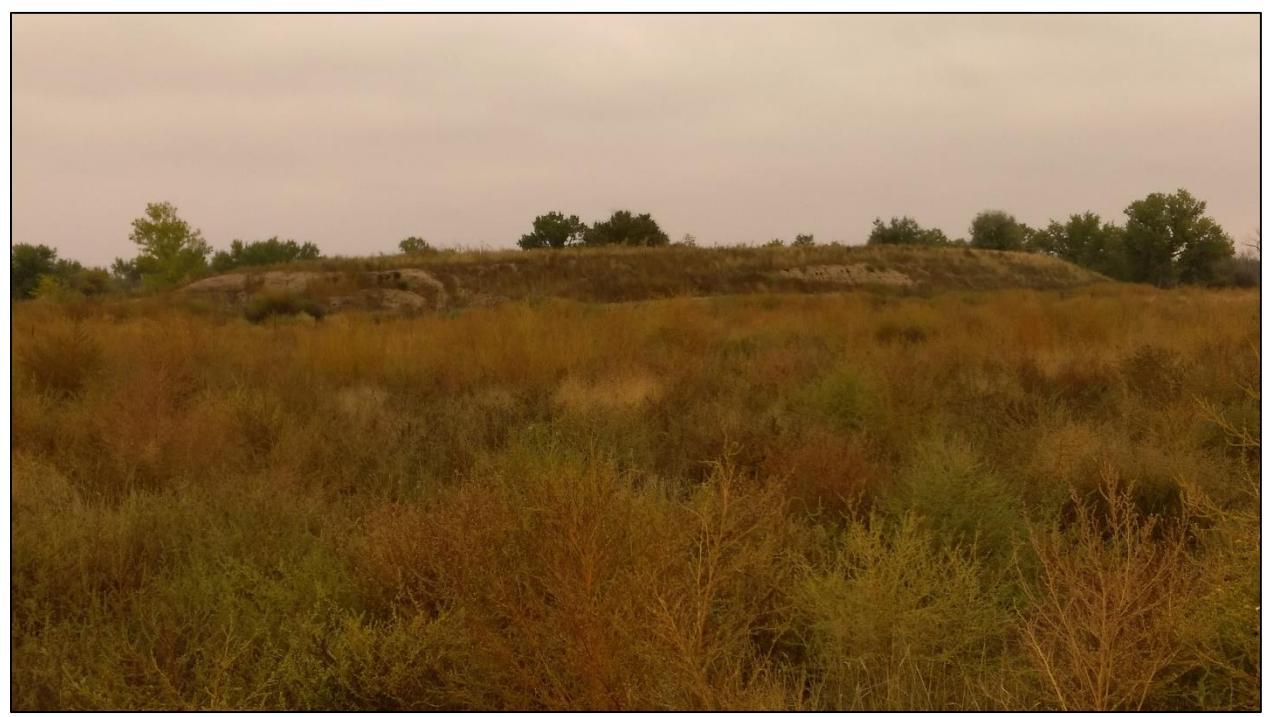
**Photo 18.** View looking north from south of permit area, showing south side of large overburden stockpile that extends along the southern permit boundary.
