Department of Natural Resources

December 15, 2015

Re: Cripple Creek & Victor Mining, Co., Cresson Project, M-1980-244; Review of Responses to Comments for Quality Assurance Monitoring & Test Results Final Report for Squaw Gulch VLF Phase 1 (9,450 to 9,550 Bench)

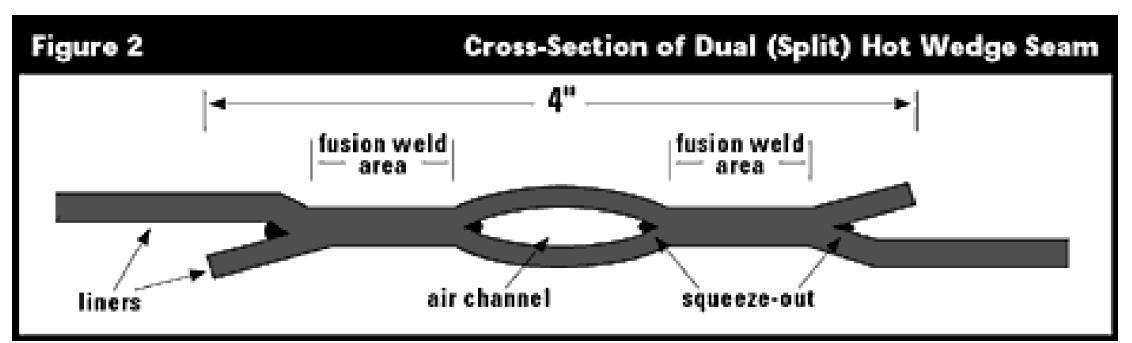
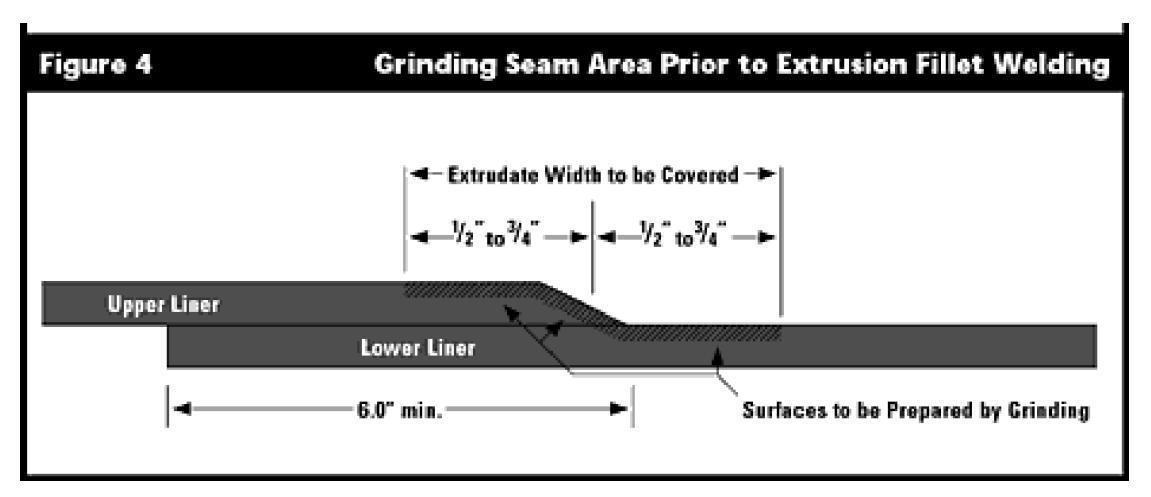
- 1. <u>Sect 2.1.1, Collapsed Workings</u>: The response is adequate.
- 2. <u>Sect 6.3.2, Seaming Observations</u>: The response is partially adequate The Division accepts installation recommendations from Agru for a minimum overlap of 75 mm (3"), but we are confused as to how 3 inches on the top layer and 3 inches on the bottom layer add up to 6 inches. The standard overlap diagrams shown below (Figure 2 for a hot wedge seam and Figure 4 for an extrusion weld seam) would suggest an eight-inch overlap (Figure 2) and a 12-inch overlap (Figure 4) if we understand the statement in the response. Please confirm

this is what is meant or provide a sketch explaining how two three-inch overlaps results in a six-inch overlap.
