The Division of Reclamation, Mining and Safety has conducted an inspection of the mining operation noted below. This report documents observations concerning compliance with the terms of the permit and applicable rules and regulations of the Mined Land Reclamation Board.

MINE NAME:	MINE/PROSPECTING ID#:	MINERAL:	COUNTY:
Providence Mine	M-2012-052	Silver and gold	Teller
INSPECTION TYPE:	INSPECTOR(S):	INSP. DATE:	INSP. TIME:
Monitoring	Timothy A. Cazier	January 20, 2016	13:35
OPERATOR:	OPERATOR REPRESENTATIVE:	TYPE OF OPERATION:	
Cripple Creek & Victor Gold Mining Compar	Chris Hanks	110d - Designated Limited Impact

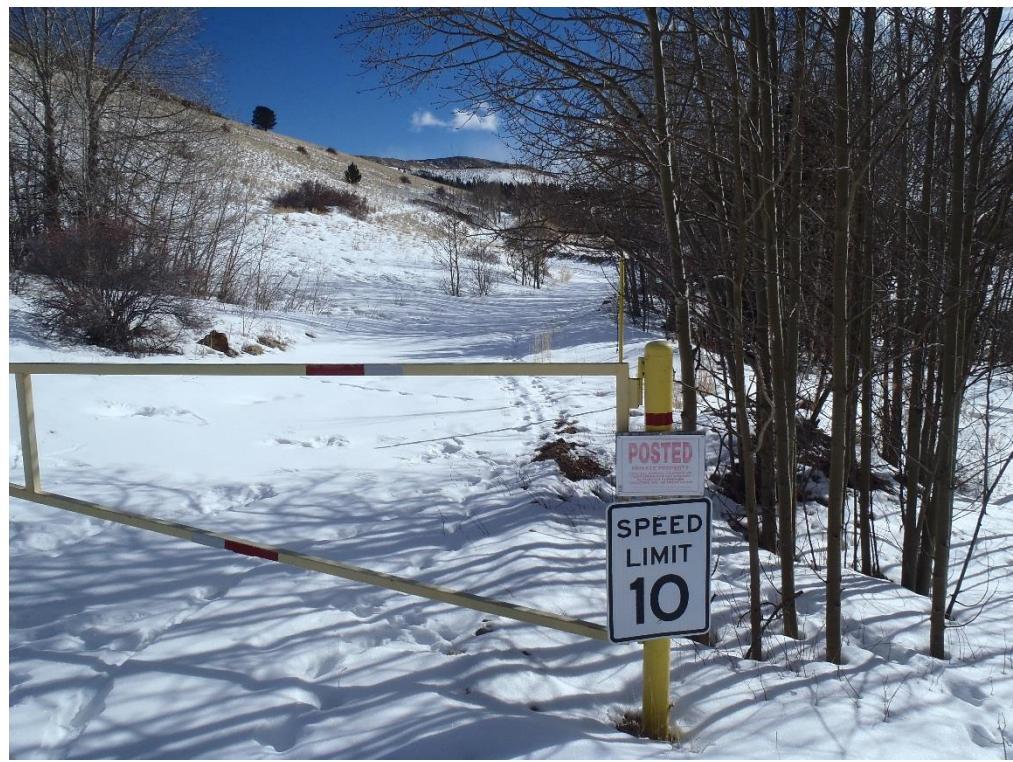
PROBLEM/POSSIBLE VIOLATION: Problem: The mine identification sign was not posted at the entrance of the mine site. This is a problem for failure to post a mine identification sign as required by Section 3.1.12(1) of the rule.

Inspection – A permit identification sign was not posted at the site entrance (Photo 1). <u>The missing permit sign</u> is cited as a problem on page 1 of this report. No permit boundary markers were observed either. This is partly due to the site being permitted previously as a Notice of Intent to prospect (NOI file No. P-2005-005), which does not require permit signs nor boundary markers. <u>The lack of permit boundary markers is cited as a</u> <u>problem on page 1 of this report</u>. The surface disturbance is limited to a small area near the mine entrance (adit) (Photo 2). Small temporary buildings, and equipment were observed in this area (Photo 3). Mr. Hanks indicated most of the temporary buildings and equipment belong to the former Operator (Shannon Murphy). CC&V is working with Mr. Murphy to get this removed. However, CC&V wishes to keep the ventilation fan, ductwork and the temporary office building (as it has electrical hookups). Mr. Hanks stated they will work with the County to get proper permits once Mr. Murphy has removed his temporary buildings. Mr. Hanks pointed out the explosive magazines had been removed (Photos 4 and 5).

Photo 1. Missing permit sign at entrance gate.

CORRECTIVE ACTIONS: The operator shall, at the entrance of the mine site, post a sign which shall be clearly visible from the access road with the following: the name of the operator, a statement that a reclamation permit for the operation has been issued by the Colorado Mined Land Reclamation Board; and the permit number. The operator shall submit photo documentation that a proper sign has been posted by the corrective action date.

CORRECTIVE ACTION DUE DATE: 4/07/16

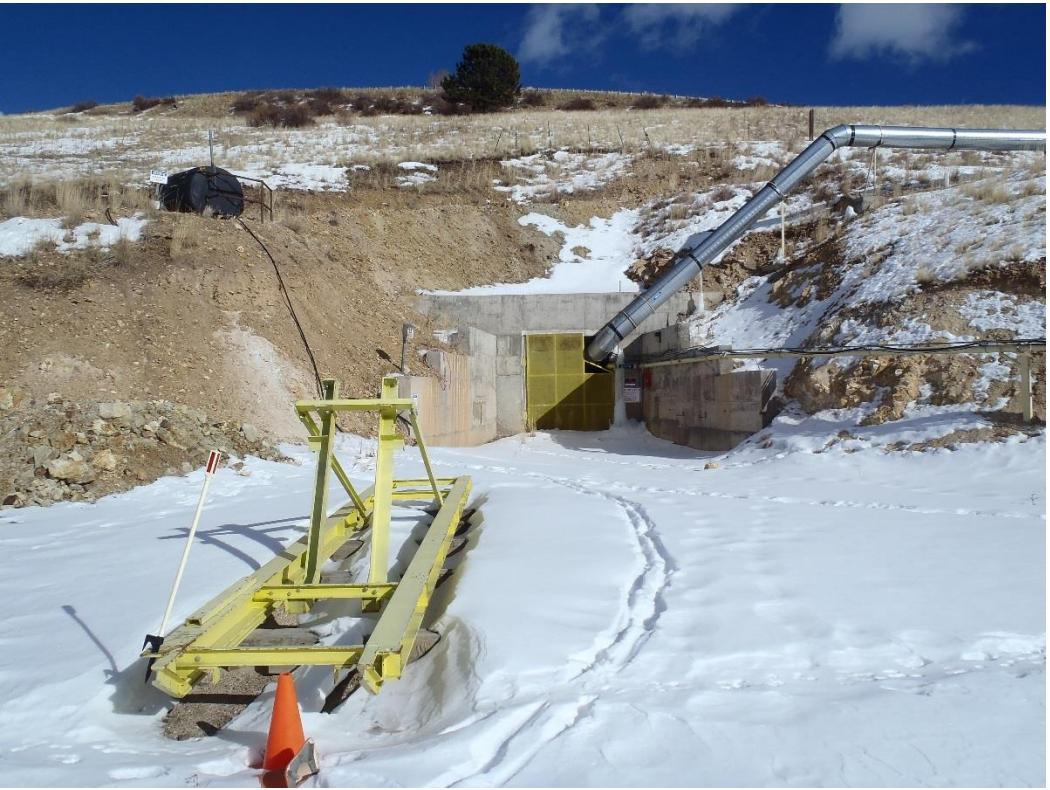
Photo 2. Mine entrance (adit) and ventilation duct work.

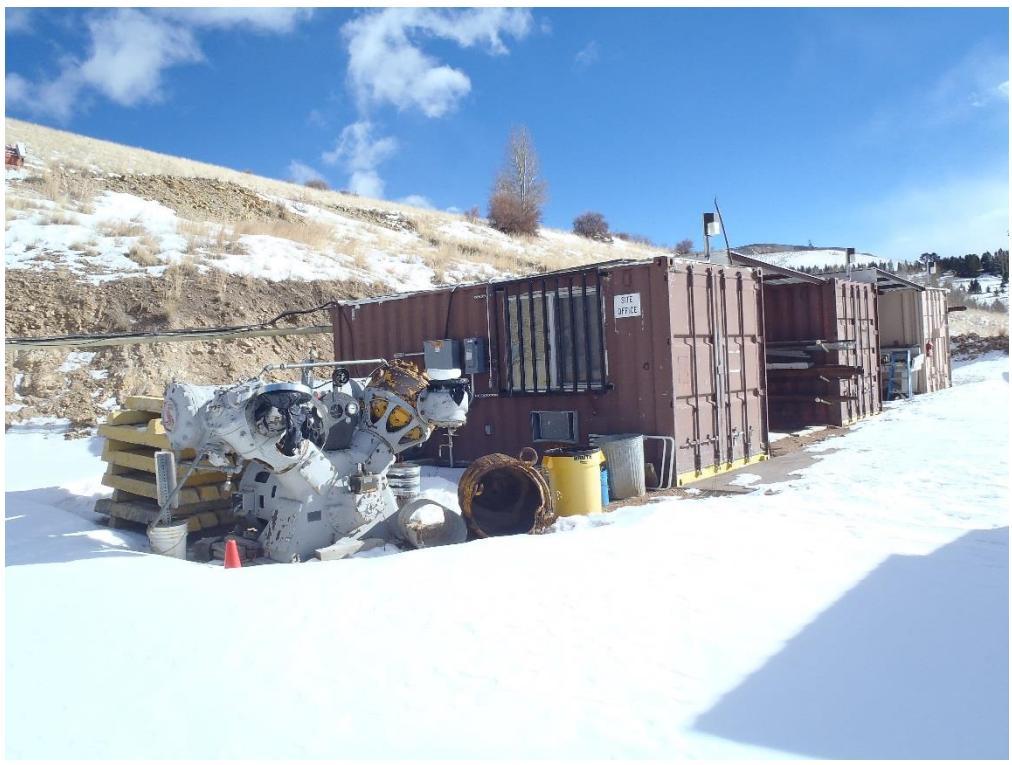
Photo 3. Small temporary buildings and equipment near adit (looking south).

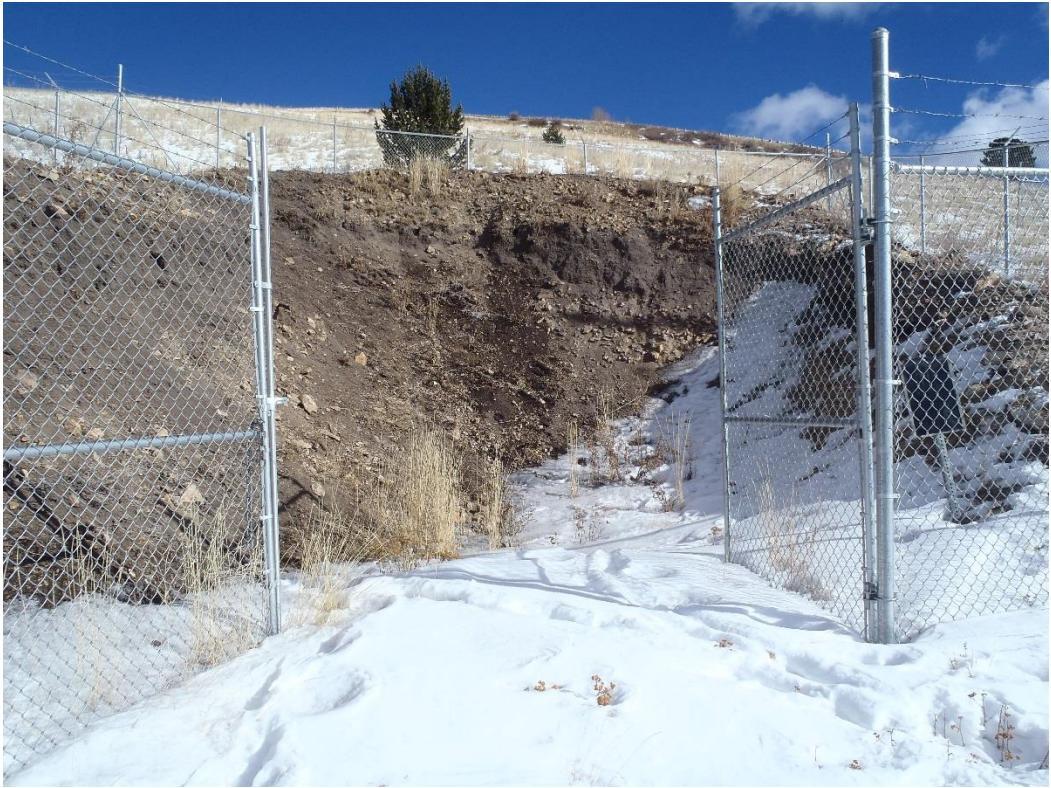
Photo 4. Explosives magazine (1 of 2) removed – previously inside fenced area.

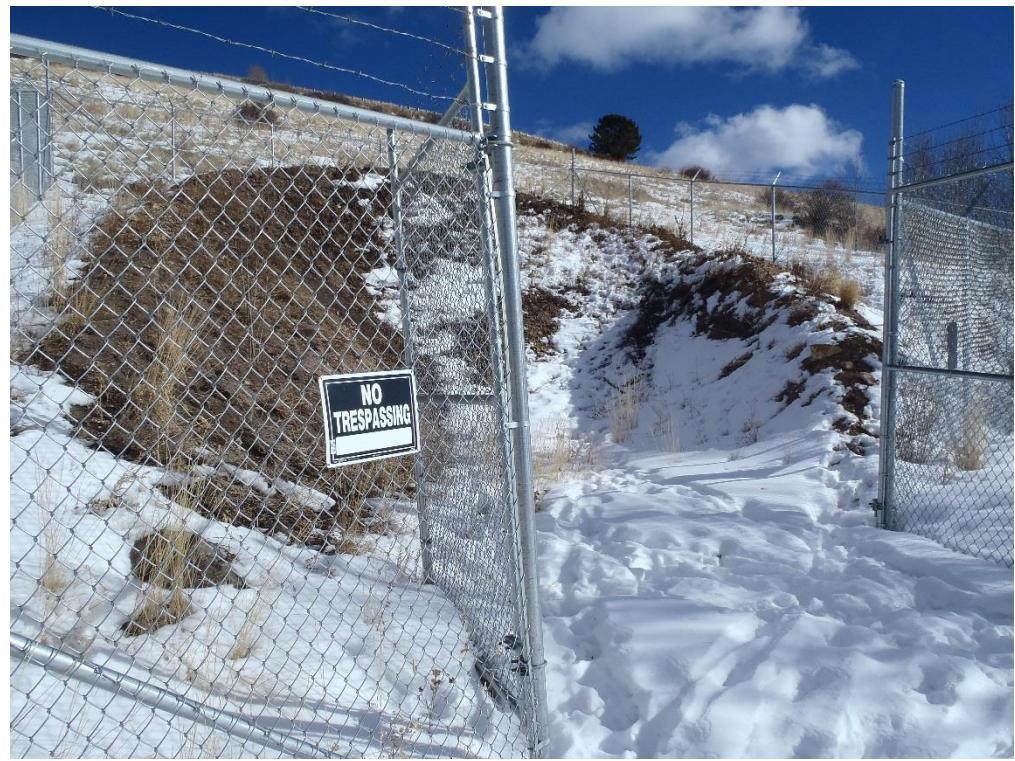
Photo 5. Explosives magazine (2 of 2) removed – previously inside fenced area.

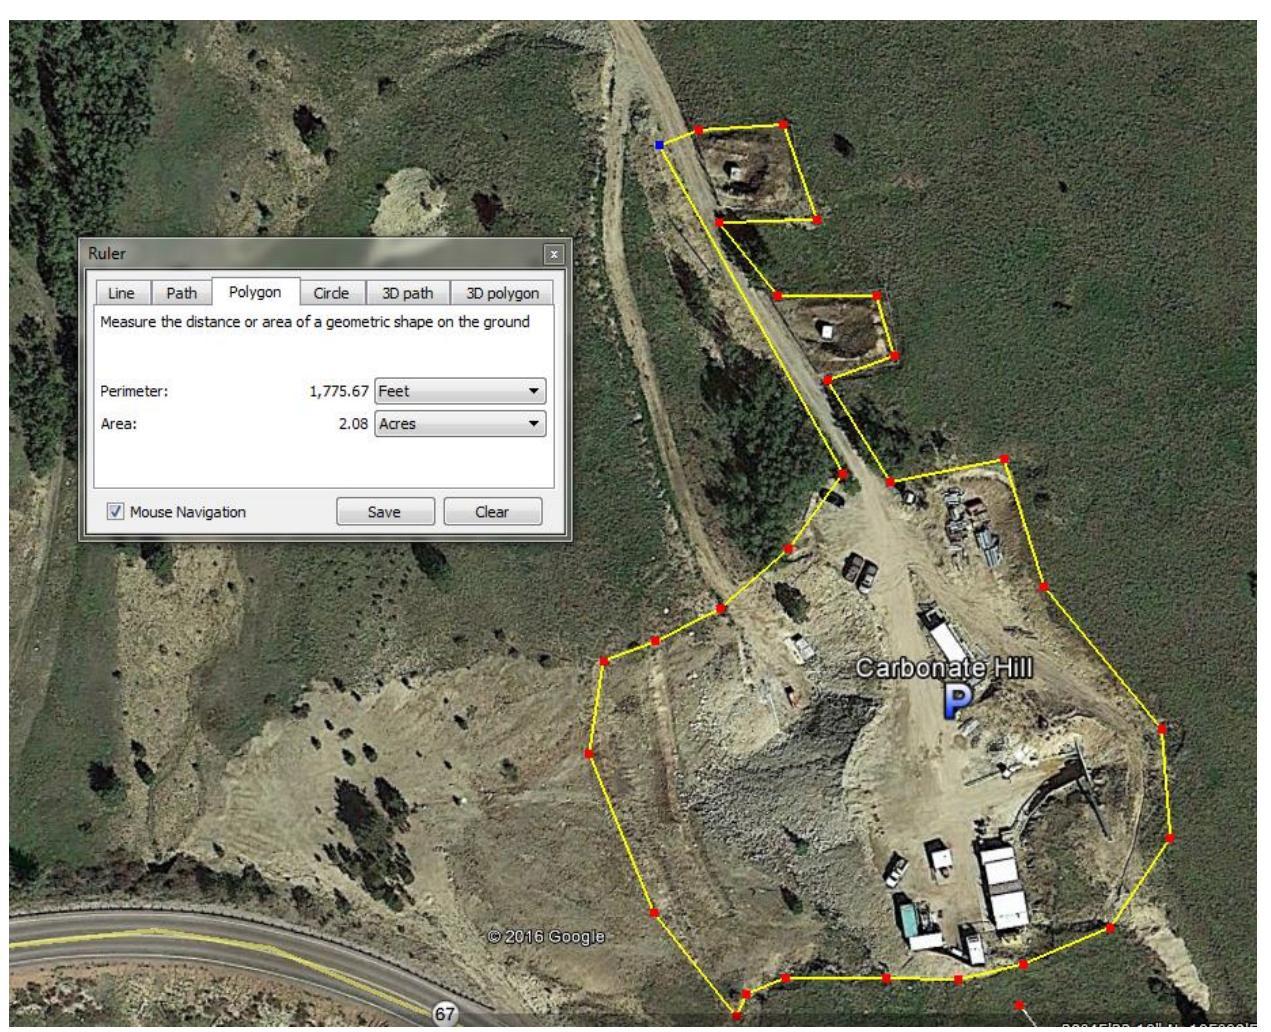
- Other Records
 - a) The total permitted area is 9.93 acres, the 2015 annual report indicated ~2 acres of disturbance which is consistent with Google Earth disturbed area estimates (see **Figure 1**).

Figure 1. Google Earth Disturbed Area Estimate (9/24/2013 Image). Note: Carbonate Hill was the site name under NOI File No. P-2005-005.
