**COLORADO DIVISION OF RECLAMATION, MINING AND SAFETY**  
**MINERALS PROGRAM INSPECTION REPORT**  
**PHONE: (303) 866-3567**

<b>MINE NAME:</b> BLM/West End Pit	<b>MINE/PROSPECTING ID#:</b> M-1992-017	<b>MINERAL:</b> Sand and gravel	<b>COUNTY:</b> Montrose
<b>INSPECTION TYPE:</b> Monitoring	<b>INSPECTOR(S):</b> Dustin M. Czapla	<b>INSP. DATE:</b> March 16, 2016	<b>INSP. TIME:</b> 11:00
<b>OPERATOR:</b> Public Works	<b>OPERATOR REPRESENTATIVE:</b> None	<b>TYPE OF OPERATION:</b> 112c - Construction Regular Operation

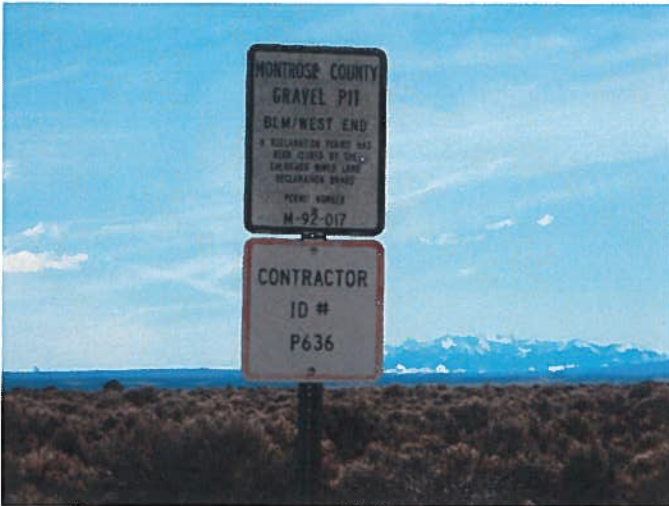
Adequate mine identification signage was noted at the entrance to the site.

Figure 1: Sign at entrance.

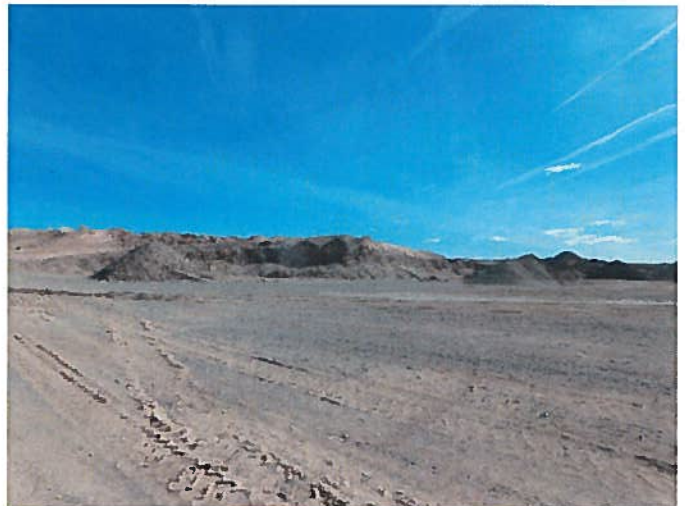
Figure 2: Stockpile area

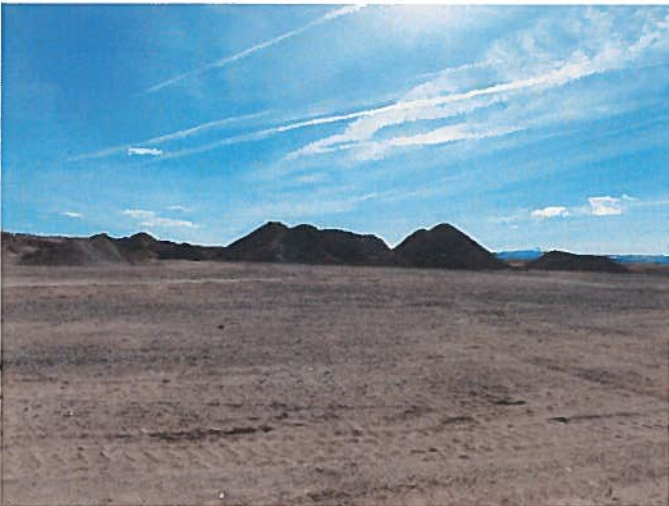
Figure 3: Stockpile area

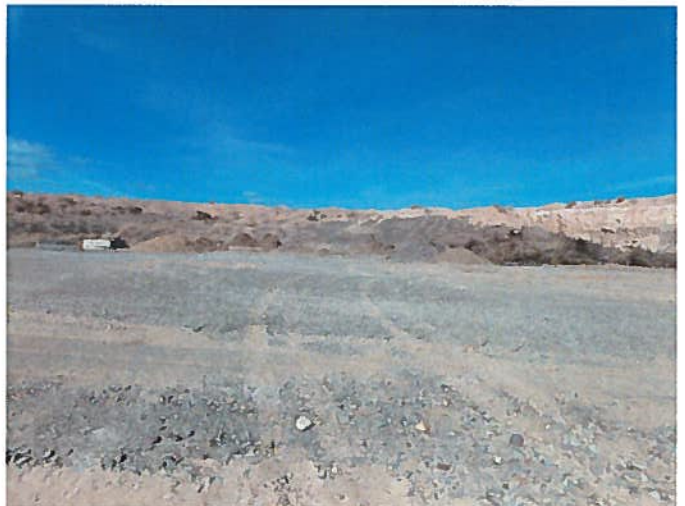
Figure 4: Woody debris and mulch stored on west side of stockpile area

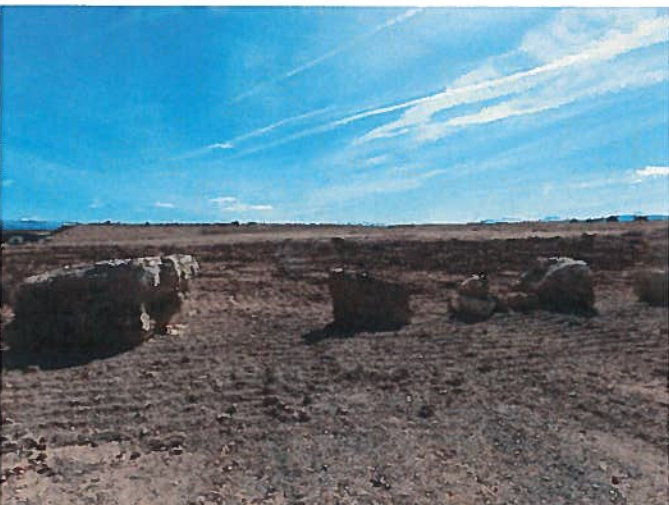
Figure 5: Looking east at the Phase 1a reclamation area

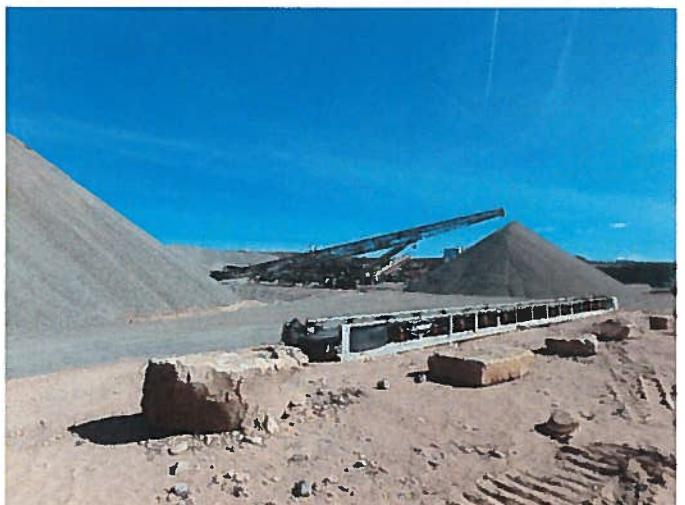
Figure 6: Process area
