MINERALS PROGRAM INSPECTION REPORT PHONE: (303) 866-3567

MINE NAME:		MINE/PROSPECTING ID#:	MINERAL:	COUNTY:
Pathfinder Pit		M-1994-113	Gravel	San Miguel
INSPECTION TYPE:		INSPECTOR(S):	INSP. DATE:	INSP. TIME:
Monitoring		Lucas J. West	November 2, 2016	10:30
OPERATOR:		OPERATOR REPRESENTATIVE:	TYPE OF OPERATION:	
Pathfinder Development, Inc		John Dourlet, Mike Horner	112c - Construction Regular Operation	
REASON FOR INSPECTION:		BOND CALCULATION TYPE:	BOND AMOUNT:	
Normal I&E Program		None	\$43,488.00	
DATE OF COMPLAINT:		POST INSP. CONTACTS:	JOINT INSP. AGENCY:	
NA		None	None	
WEATHER:	INSPECTOR'S SIGNATURE:		SIGNATURE DATE:	
Clear	and the second s		November 21, 2016

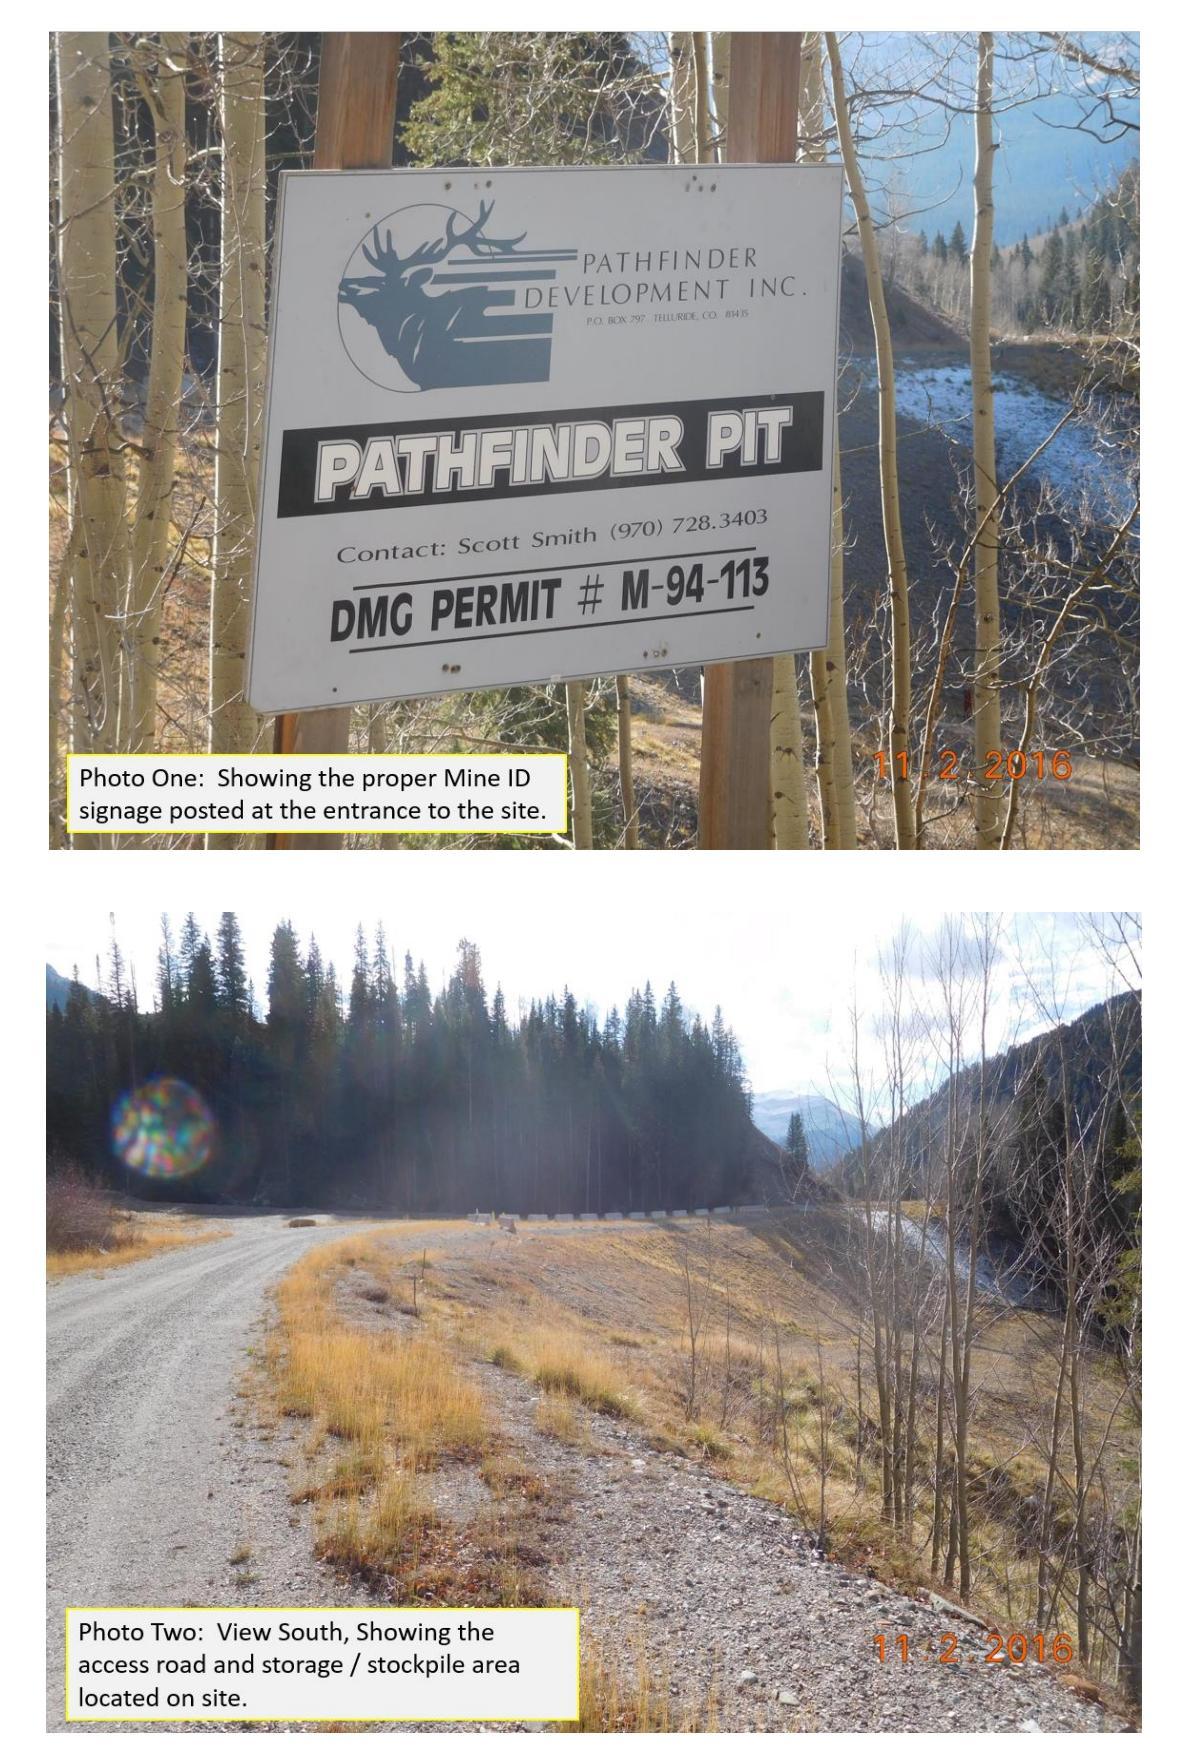
Proper mine identification signage is posted at the entrance to the site, as Seen in Photo One. At the completion of the Succession of Operator, the sign will need to be updated to reflect the new operator's information. The access road in the permitted area appears to be stable and in good condition. A storage and stockpile area is located in the northern section of the permitted area. The road and storage area can be seen in Photos Two and Three. Discussions with the operator and county representative indicate that the area was constructed in conjunction with the County Engineer and meets their specifications. There are three piezometers installed in the storage area to monitor the integrity of the construction.

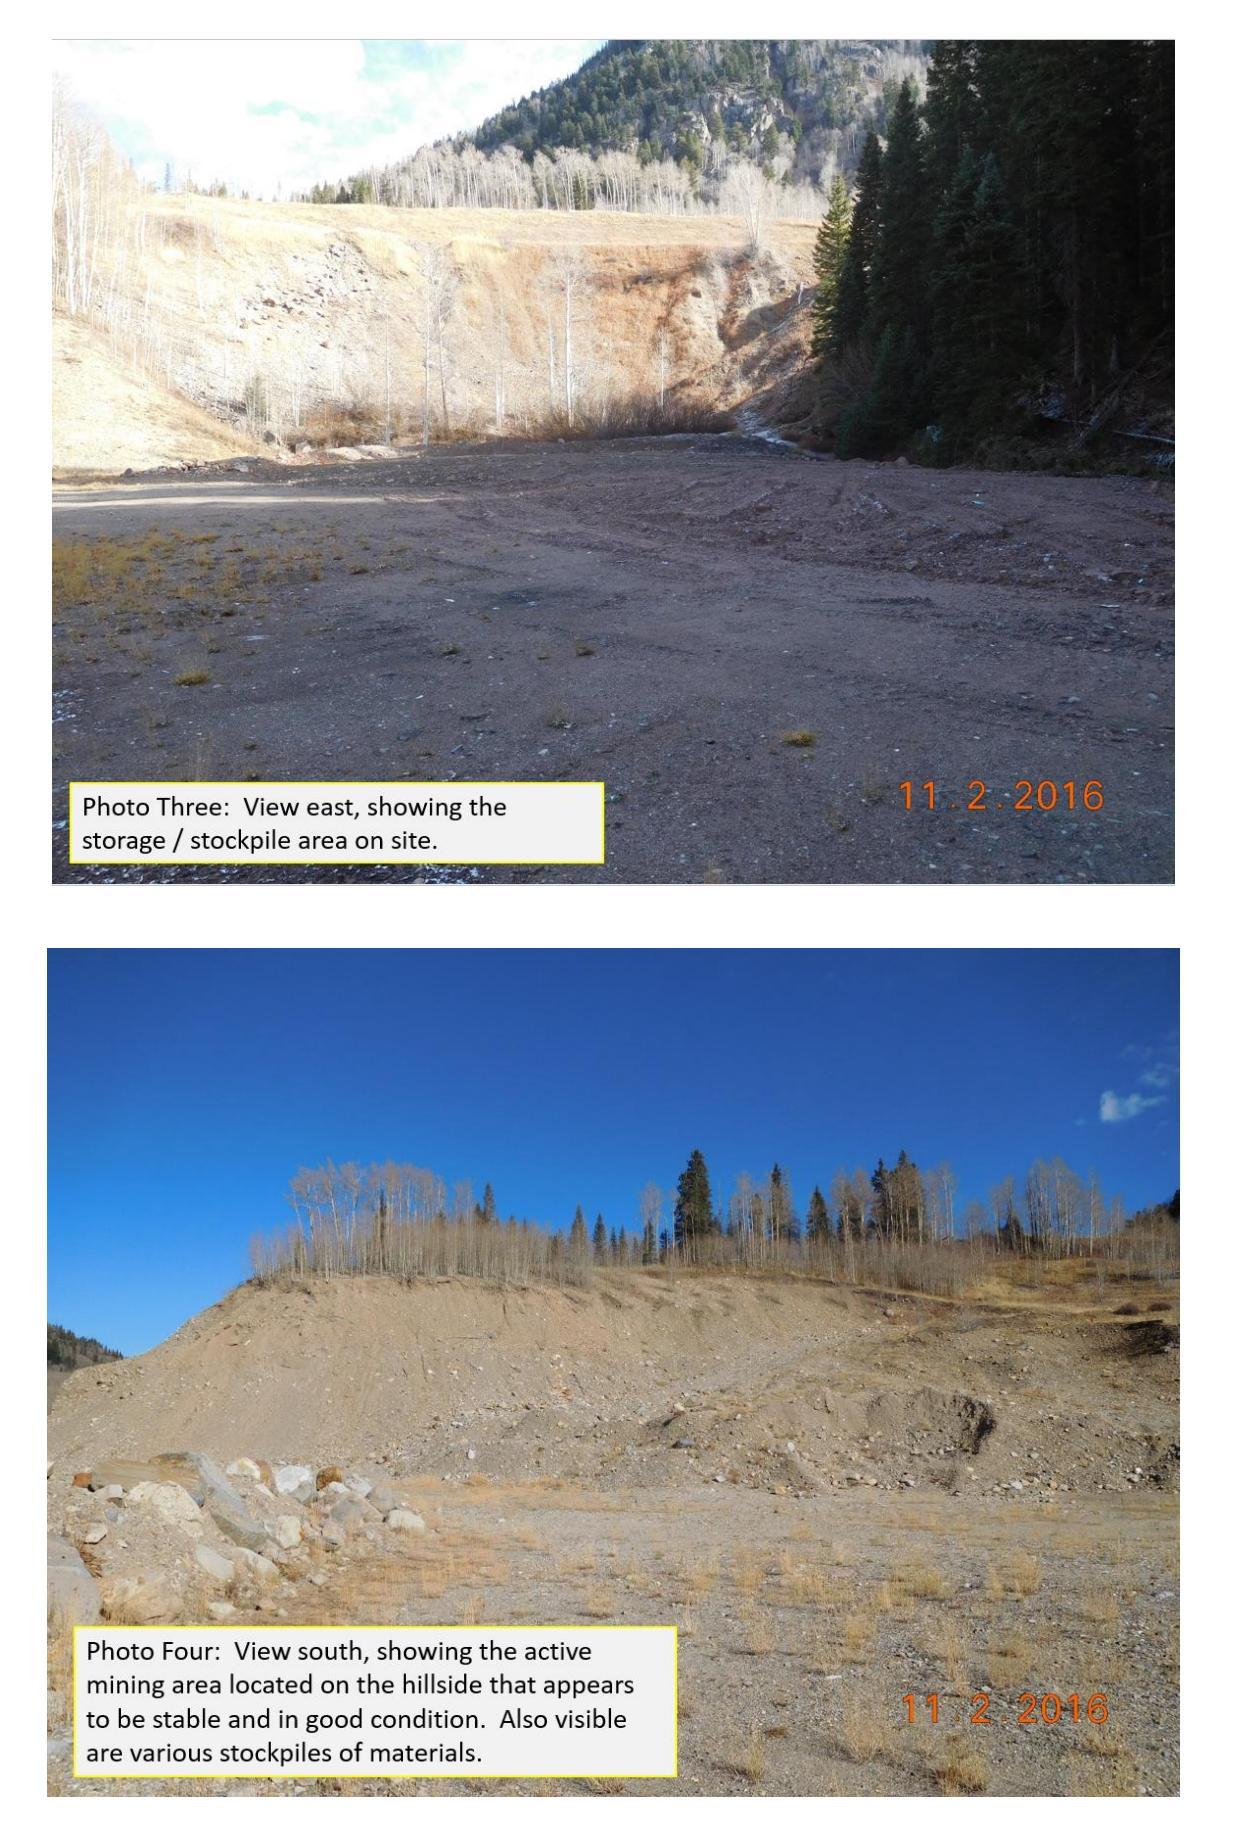
The main excavation and stockpile area is located in the southern section of the permitted area. The mining areas, which can be seen in Photo Four and Five, consist of a hillside which is being mined at a near reclamation grade, as well as a small pit area located adjacent to the hillside. Both mining areas appear to be stable and in good condition. No signs of significant erosion, settling, slumping or failure was noted during the inspection. Several stockpiles of various sized materials were noted on site, all materials stockpiled were in good condition. At the southern edge of the site the topsoil stockpile was observed. It is well vegetated, stable, in good condition and can be seen in Photo Six.
