MINERALS PROGRAM INSPECTION REPORT PHONE: (303) 866-3567

MINE NAME:	MINE/PROSPECTING ID#:	MINERAL:	COUNTY:
Clear Spring Ranch Pit	M-1992-074	Gravel	El Paso
INSPECTION TYPE:	INSPECTOR(S):	INSP. DATE:	INSP. TIME:
Monitoring	Timothy A. Cazier	May 26, 2016	11:35
OPERATOR:	OPERATOR REPRESENTATIVE:	TYPE OF OPERATION:	
City of Colorado Springs	Michelle Wills-Hill and Patti Zietlow	112c - Construction Regular Operation	
REASON FOR INSPECTION:	BOND CALCULATION TYPE:	BOND AMOUNT:	
Normal I&E Program	None	\$0.00	
DATE OF COMPLAINT:	POST INSP. CONTACTS:	JOINT INSP. AGENCY:	
NA	None	None	
WEATHER:	INSPECTOR'S SIGNATURE:	SIGNATURE DATE:	
Cloudy	Thing age	April 2, 2017

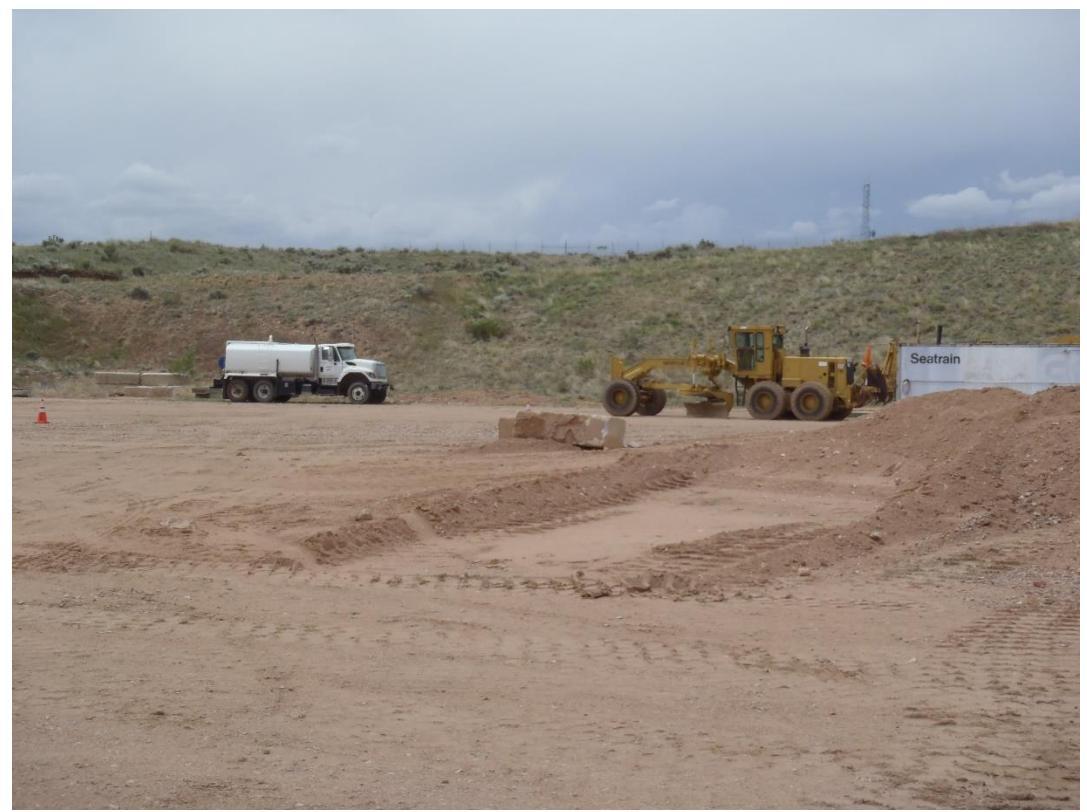
<u>Reclamation Plan Compliance</u>: Site representatives indicated the west portion of phase 1 of the pit had been backfilled, topsoiled and seeded (see **Photo 1**). Phase 2 was being backfilled.

<u>Revegetation</u>: Site representatives indicated the west portion of phase 1 of the pit had been revegetated. No noxious weeds were observed.

Photo 1. Reclaimed portion of Phase 1 (looking SW).

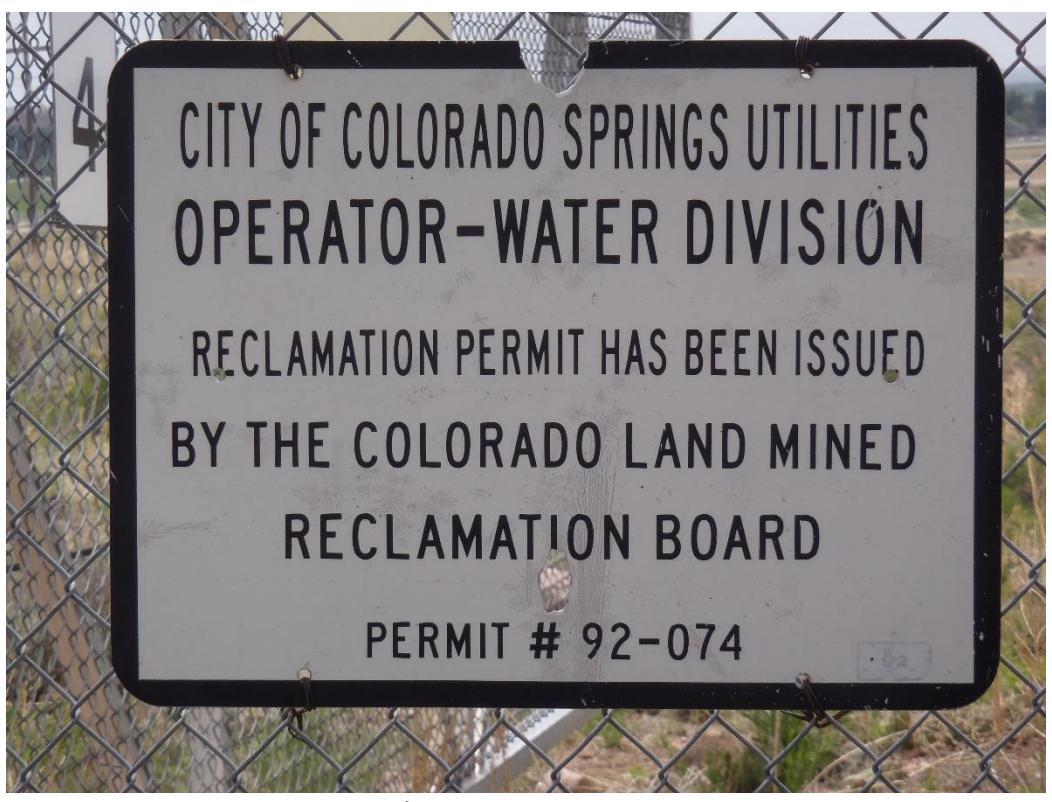
<u>Signs and Markers</u>: The permit sign was properly posted (see **Photo 2**) and boundary markers were observed to delineate the permit boundary (see **Photo 3**).

Photo 2. Permit sign.

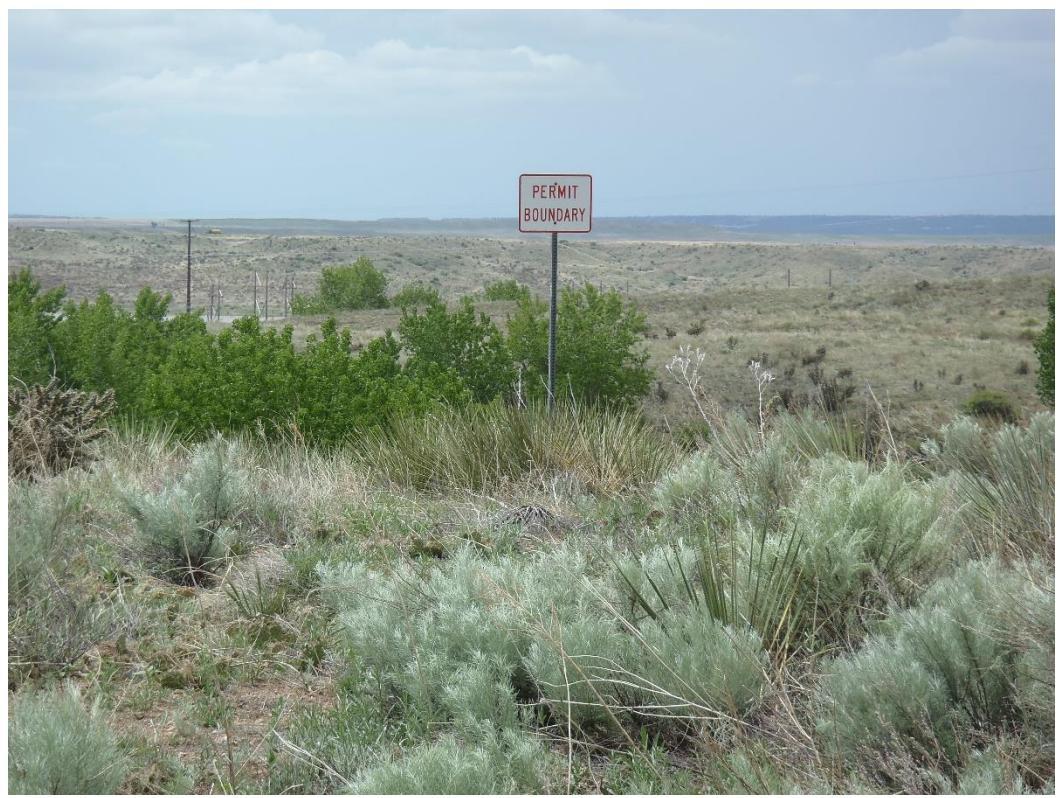
Photo 3. Typical permit boundary sign (south side).

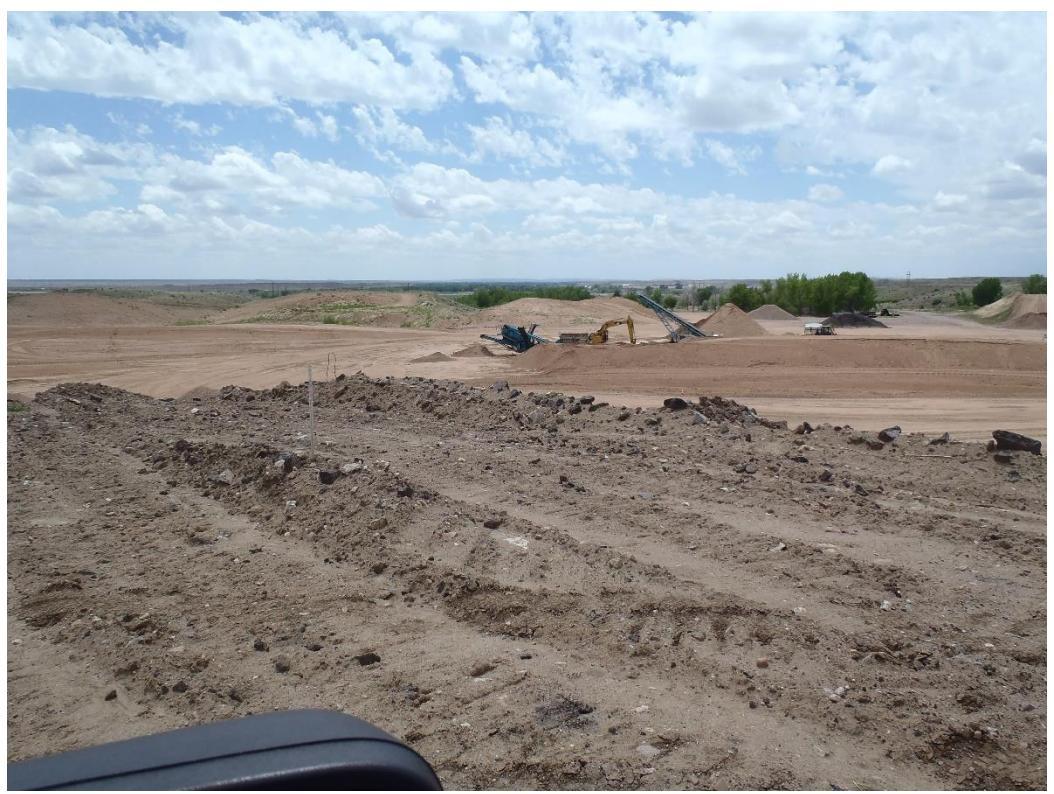
Support Facilities On-site: A screen, conveyor, loader, and backhoe were observed (see Photo 4).

Photo 4. Screen, conveyor, loader, and backhoe (looking south).

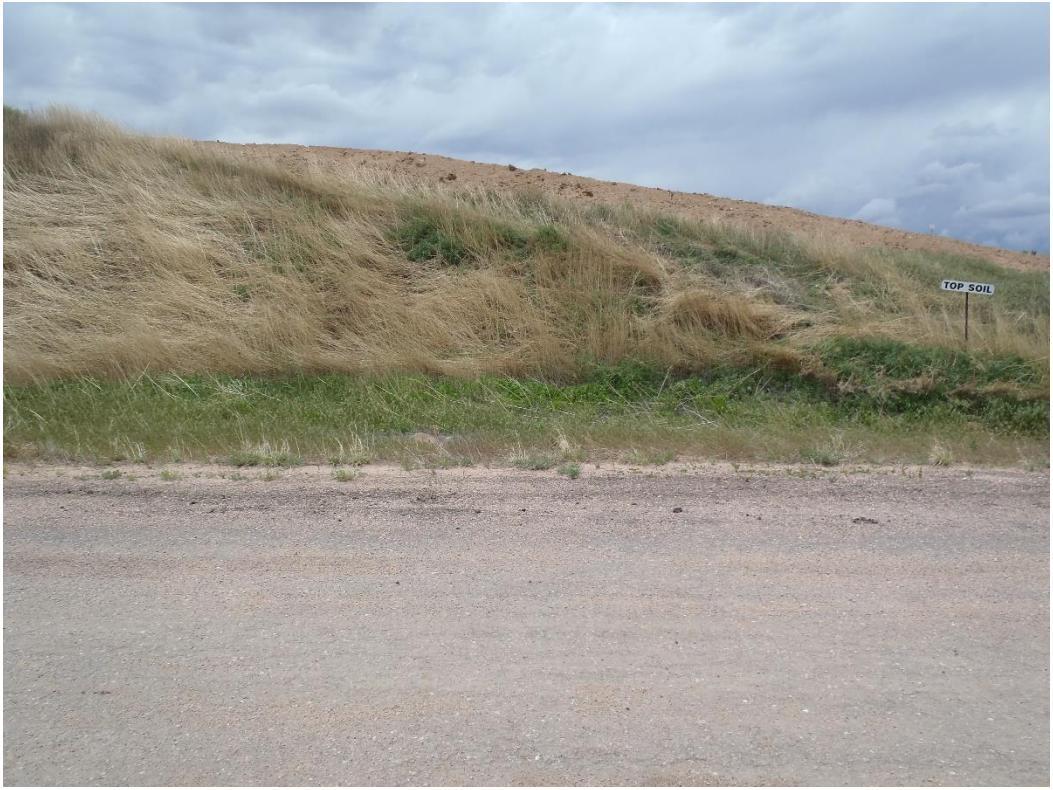
<u>Topsoil</u>: A topsoil stockpile is in the southwest corner of the pit and labeled as such (see **Photo 5**).

Photo 5. Topsoil stockpile with sign (SW corner).
