MINERALS PROGRAM INSPECTION REPORT PHONE: (303) 866-3567

MINE NAME:	MINE/PROSPECTING ID#:	MINERAL:	COUNTY:
Mitchell Mine No 1	M-1986-025	Sand and gravel	El Paso
INSPECTION TYPE:	INSPECTOR(S):	INSP. DATE:	INSP. TIME:
Monitoring	Timothy A. Cazier	March 14, 2017	12:10
OPERATOR:	OPERATOR REPRESENTATIVE:	TYPE OF OPERATION:	
R E Monks Construction Co.	Greigg Newlon & Leroy Garcia	110c - Construction Limited Impact	
K E Monks Construction Co.	Greigg Newioli & Leiby Garcia	110e - Collstituction Elinited Impact

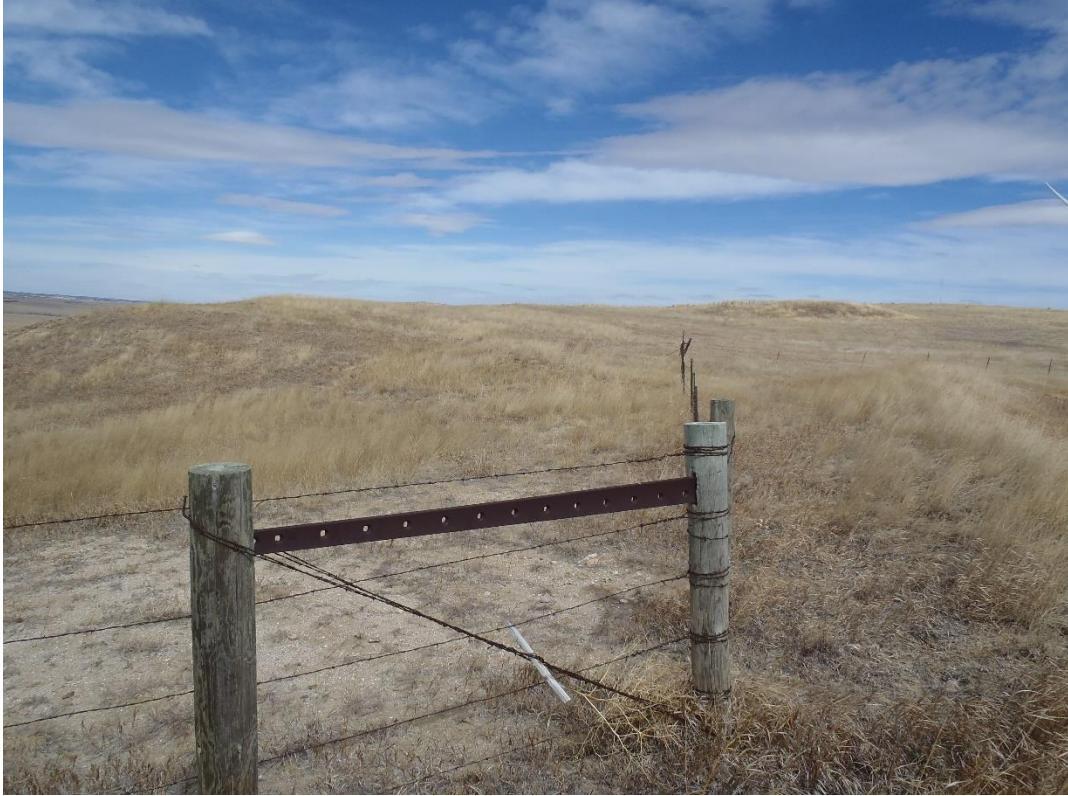
<u>Off-site Damage</u>: The operation appeared to be confined to the permit boundary, based on Google Earth review and area fences (see **Photo 1**).

Photo 1. Southeast fence corner (looking north).

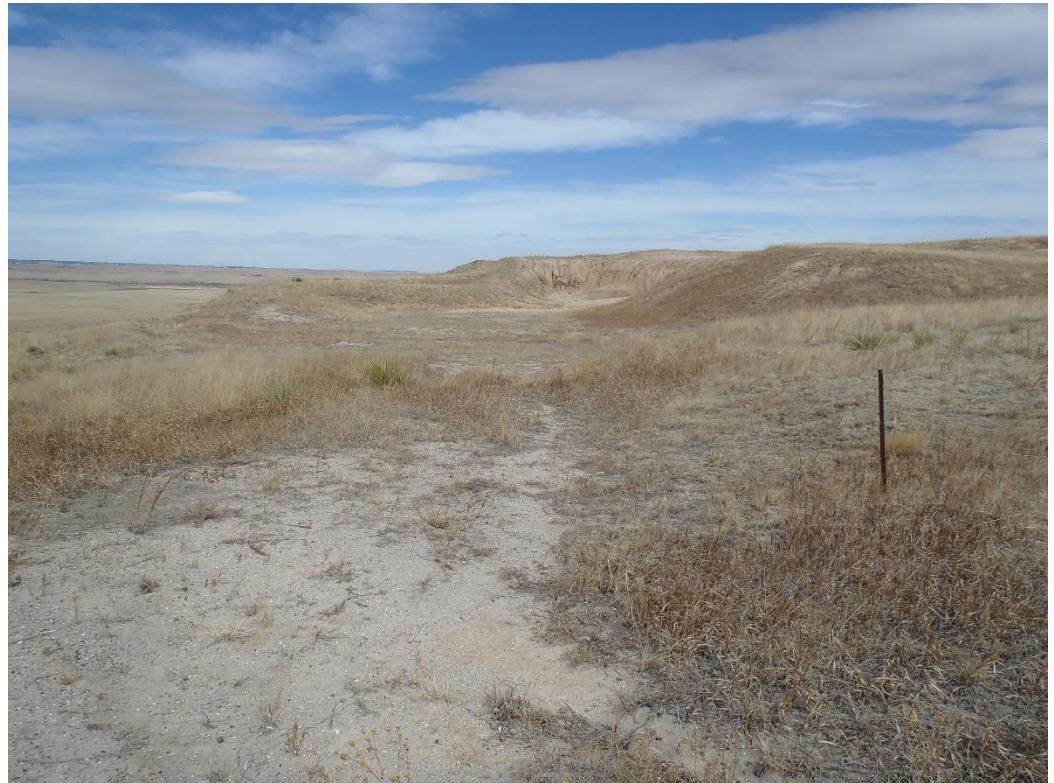
<u>Reclamation Success</u>: No reclamation has been initiated by R E Monks. However, due to the inactivity some self-reclamation was observed (85 see **Photo 2**).

Photo 2. Mitchell Mine No. 1 pit (looking north).

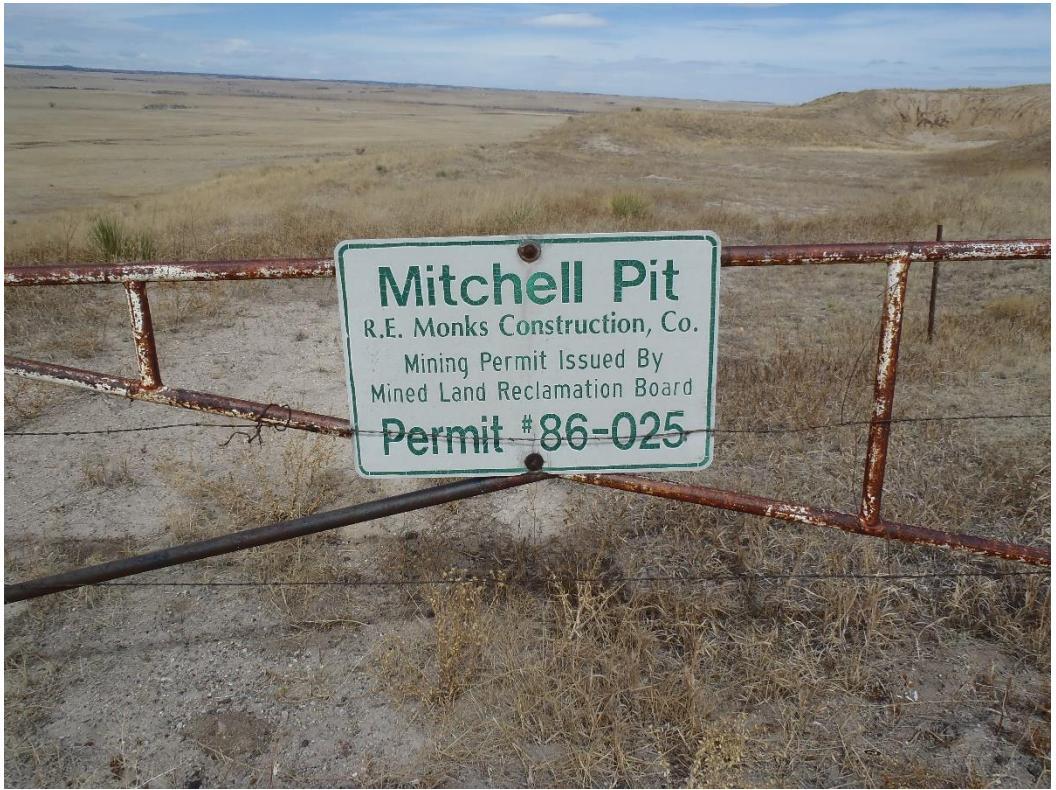
<u>Signs and Markers</u>: The permit sign was properly posted (see **Photo 3**) and boundary markers were observed to delineate the permit boundary.

Photo 3. Permit sign.
