# MINERALS PROGRAM INSPECTION REPORT PHONE: (303) 866-3567

MINE NAME:		MINE/PROSPECTING ID#:	MINERAL:	COUNTY:
The Broyles Pit		M-2004-028	Gravel	Las Animas
<b>INSPECTION TYPE:</b>		INSPECTOR(S):	INSP. DATE:	INSP. TIME:
Surety-Related Inspection		Michael A. Cunningham	April 11, 2017	15:00
OPERATOR:		<b>OPERATOR REPRESENTATIVE:</b>	TYPE OF OPERATION:	
Febbraro Construction Co.		Joseph Febbraro	112c - Construction Regular Operation	
<b>REASON FOR INSPECTION:</b>		BOND CALCULATION TYPE:	BOND AMOUNT:	
Normal I&E Program		Complete Bond	\$12,023.61	
DATE OF COMPLAINT:		POST INSP. CONTACTS:	JOINT INSP. AGENCY:	
NA		None	None	
WEATHER:	INSPECTOR'S SIGNATURE:		SIGNATURE DATE:	
Clear	U	il C.f	April 19, 2017

#### PERMIT #: M-2004-028 INSPECTOR'S INITIALS: MAC INSPECTION DATE: April 11, 2017

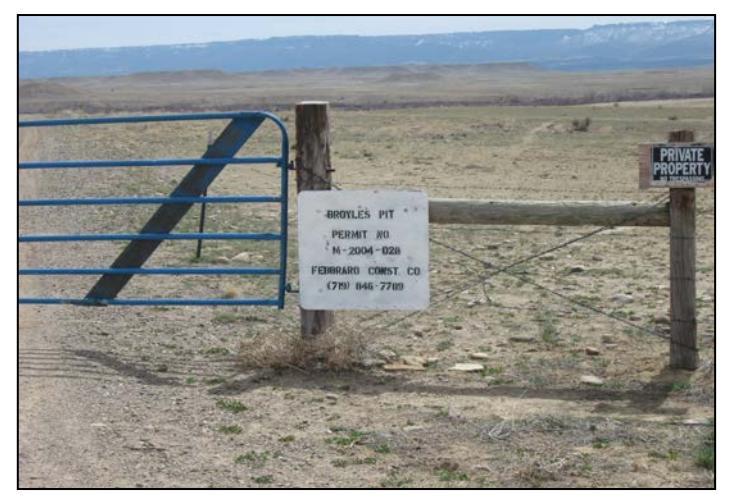
The Broyles Pit is currently in the first five-year term of temporary cessation, which will expire on March 8, 2018. The site was inactive at the time of the inspection and no equipment was present at the site. The permit sign was posted at the site entrance and the boundaries of the affected lands were delineated by monuments as required by Rule 3.1.12. Upon transfer of the Reclamation Permit, the successor Operator will need to revise/replace the permit sign so that the new Operator name is listed.

1. Permit sign at site entrance.

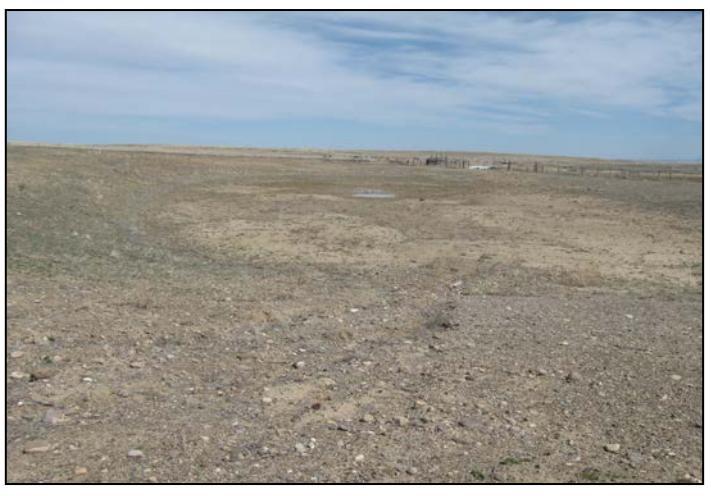
The Broyles Pit is divided into four permit areas: West Pit, East Pit, Stockpile Area, and haul road. The East Pit has been reclaimed and all pit slopes are at a grade of 3H:1V or flatter. The East Pit did not have any vegetative growth and this area will require reseeding if no further mining will occur. The Stockpile Area is located to the north of the East Pit and contains a single product stockpile. The West Pit is currently affected by the mining operation and contains a large product stockpile. The pit slopes have been graded to 3H:1V, with the exception of a vertical section approximately 40 ft. in length located at the west end of the pit and the south side of the haul road. Topsoil has been salvaged and stockpiled at the west end of the pit. The West and East Pits are connected by the haul road which is 800 ft. in length.

2. East pit.

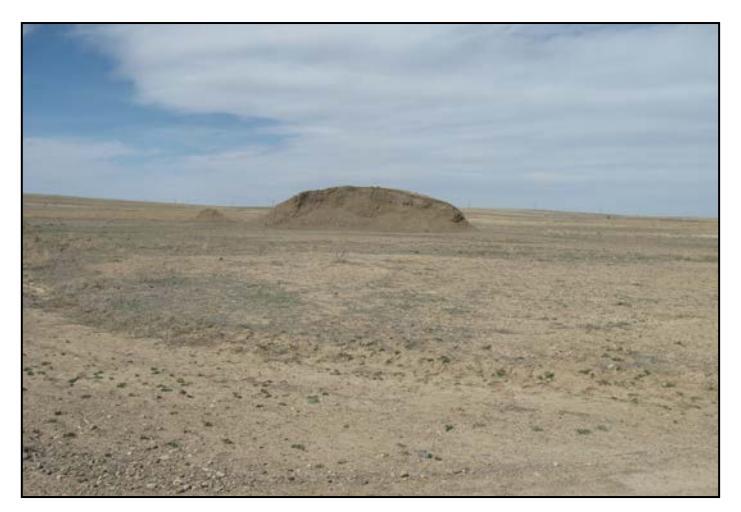
3. Storage area.

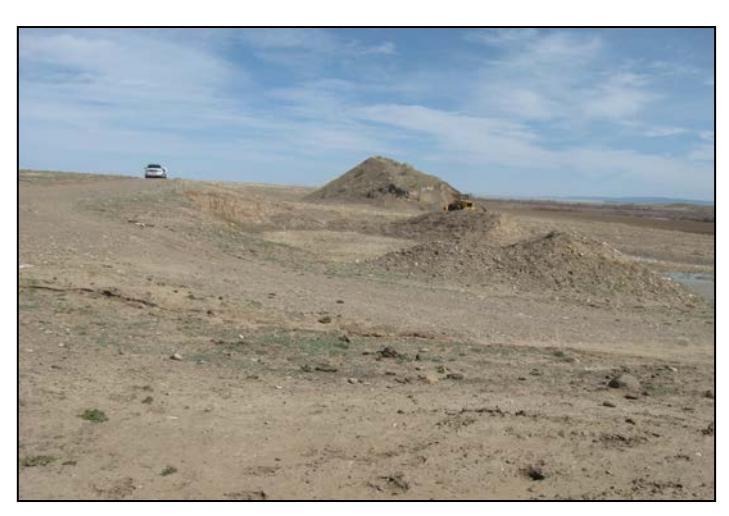
4. West Pit.
