**MINERALS PROGRAM INSPECTION REPORT**  
**PHONE: (303) 866-3567**

<b>MINE NAME:</b> Scott Blue II	<b>MINE/PROSPECTING ID#:</b> M-2007-031	<b>MINERAL:</b> Gold, Gemstone	<b>COUNTY:</b> Teller
<b>INSPECTION TYPE:</b> Monitoring	<b>INSPECTOR(S):</b> Elliott R. Russell	<b>INSP. DATE:</b> April 19, 2017	<b>INSP. TIME:</b> 10:30
<b>OPERATOR:</b> The Turquoise Connection, Inc.	<b>OPERATOR REPRESENTATIVE:</b> Foster Scott	<b>TYPE OF OPERATION:</b> 110(2) - Hard Rock Limited Impact

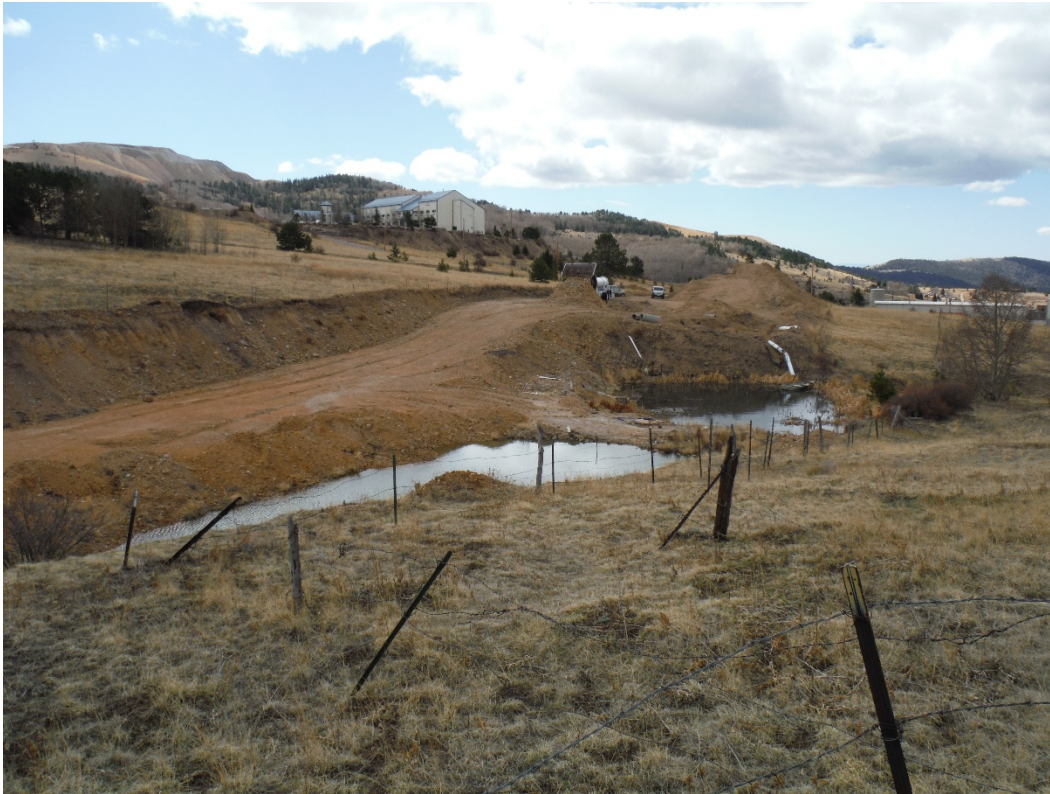
The Scott Blue II is a 110(2) Operation and is approved to affect 1.7 acres of land. The site is located immediately northeast of Cripple Creek in Teller County. Affected lands will be reclaimed to support rangeland post-mining land use. The operation is approved to process alluvial materials for gold and turquoise. The majority of the operation is located on the south side of the upper reaches of Cripple Creek, while a small portion of the operation is located in the ephemeral channel. The southern portion consists of the site entrance, processing area, a large processed-material stockpile, and a small topsoil stockpile. The northern portion (channel area) consists of the mining excavation and two settling ponds (see **Photo 1**).

**Photo 1.** Site overview; looking southeast.

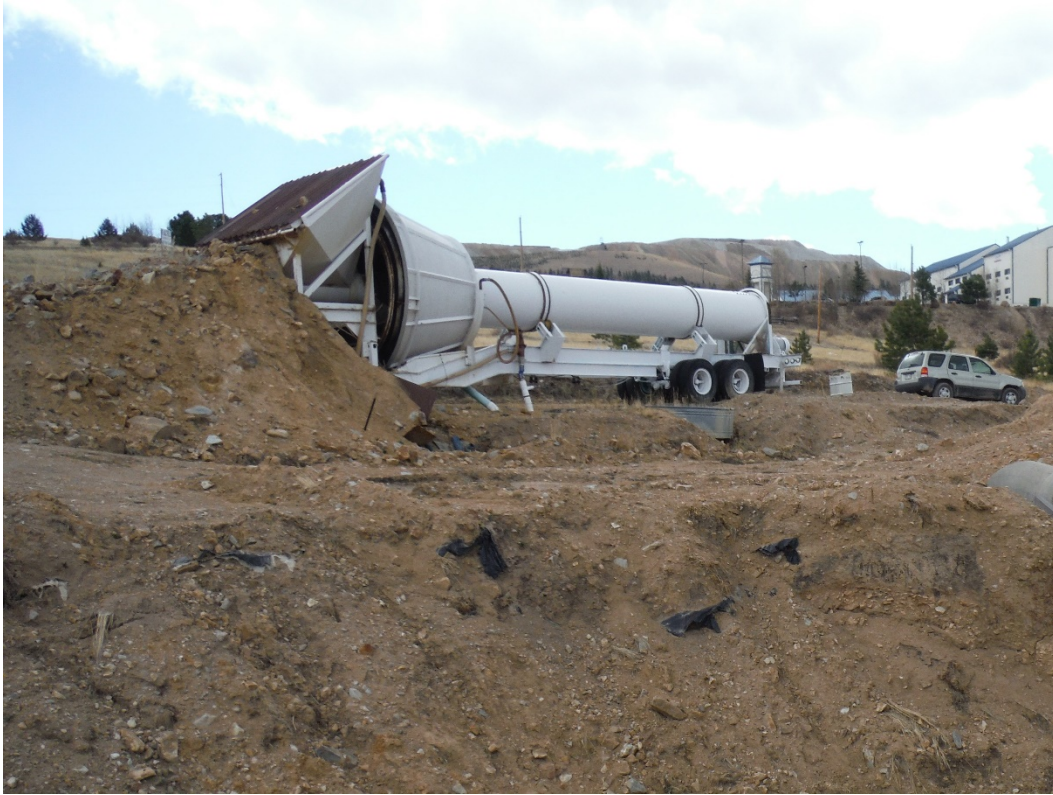
the time of the inspection and no equipment was on-site. Mr. Scott stated the placer operations have not been active for eight years; however, the 2016 Annual Reports indicates the date of last excavation, processing, or hauling activity was in April 2015. The Operator is reminded of permit activity obligations and the requirements of temporary cessation in accordance with C.R.S. 34-32-103(6)(a)(II) and Rule 1.13. The only equipment located on-site at the time of the inspection was a large trommel (see **Photo 2**).

**Photo 2.** Trommel used for processing the placer deposit; looking southeast.

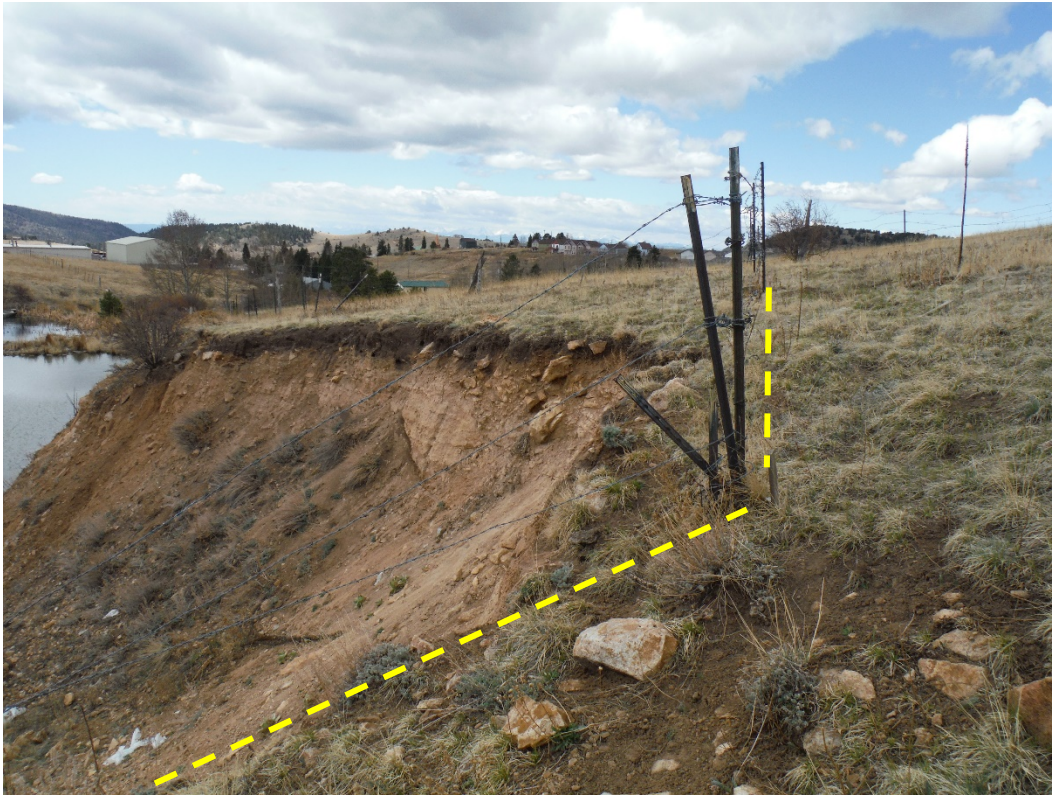
Backfilling and Grading: Mining slopes in the northern portion of the permit were approximately 1H:1V and steeper (see **Photo 3**). The steepest slopes are located in the northwest portion of the site (see **Photo 4**). A processed-material stockpile is located in the southwest portion of the site (see **Photo 5**); this appears to be an adequate amount of material to be used as backfill to achieve the approved final reclamation configuration at the site. However, Mr. Scott stated this material is potential ore and may be hauled off-site for further processing. Please note, this is in conflict with the approved permit as material was not proposed to be hauled off-site and the processed material would be used as backfill; a technical revision to the approved mining and reclamation plans is required address this proposal. In addition, potential milling operations would require a permit with the Division pursuant to C.R.S. 34-32-103(8).

**Photo 4.** Mining slopes in northwest corner of the site in close proximity of the permit boundary (yellow line); looking southwest.

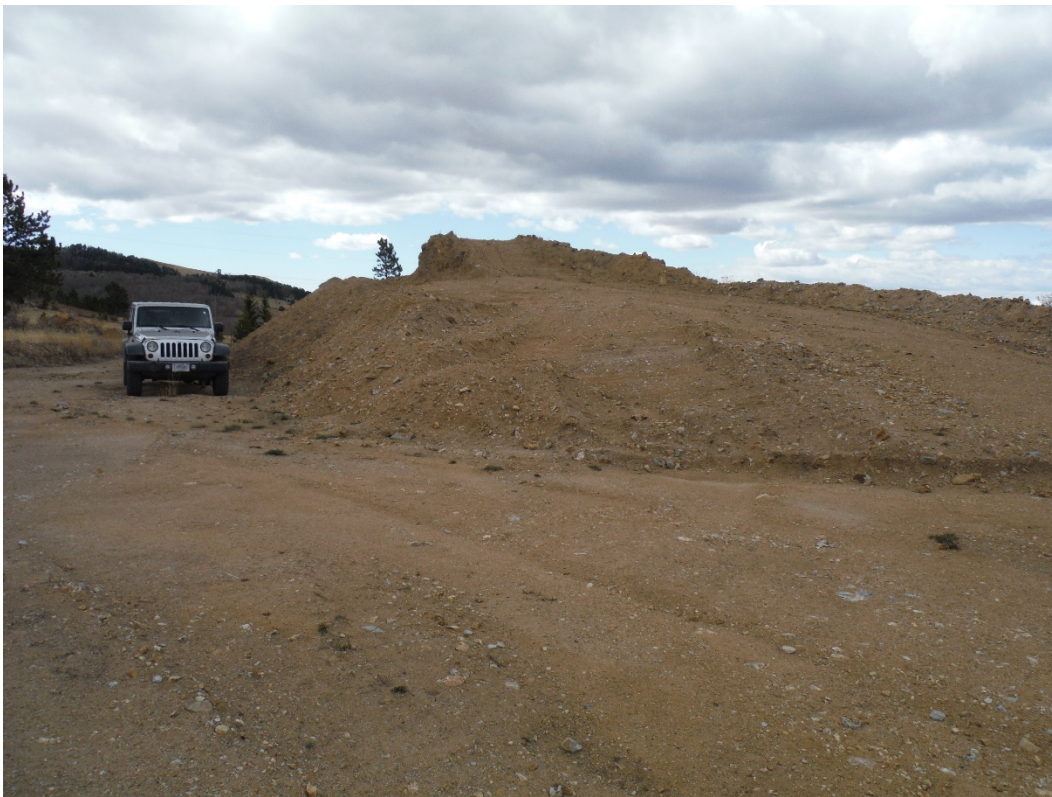
**Photo 5.** Processed-material stockpile located in the southern portion of the site; looking south.

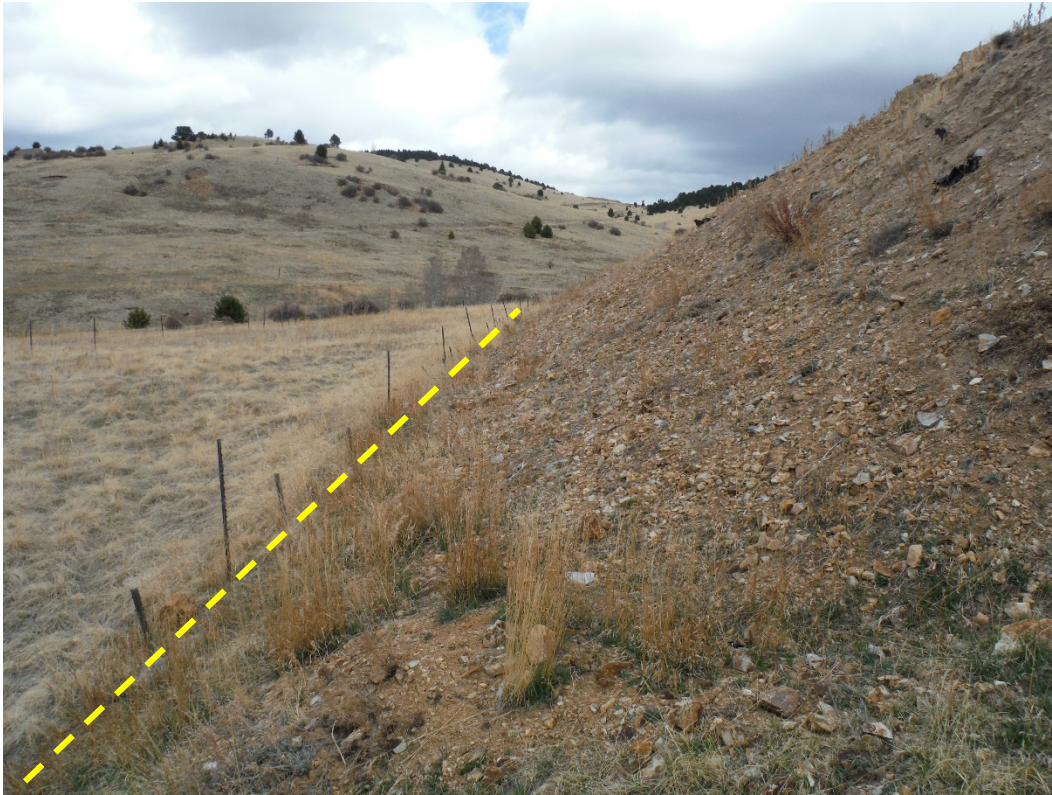
**COMPLIANCE PROBLEM #1:** Approved storm water control and sedimentation prevention methods have not been implemented or have not been maintained.

Gen. Compliance With Mine Plan: The Division observed evidence of an old and dilapidated silt fence along the western permit boundary at the toe of the processed-material stockpile (see **Photo 6**). This silt fencing will need to be replaced in accordance with the approved permit. This is cited as Compliance Problem #1 on page two of this report. Upon further review of the approved permit, in addition to silt fencing along the western permit boundary to protect off-site lands from sedimentation, a berm was to be installed along the eastern permit boundary to protect the site from off-site runoff and erosion. The Division did not observe a berm along the eastern boundary (see **Photo 7**). This is also cited as a part of Compliance Problem #1.

**Photo 6.** Toe of processed-material stockpile along western permit boundary (yellow line), evidence of degraded silt fence; looking north.

**CORRECTIVE ACTIONS:** The operator shall submit photo documentation showing the implementation of approved storm water control methods by the corrective action date.

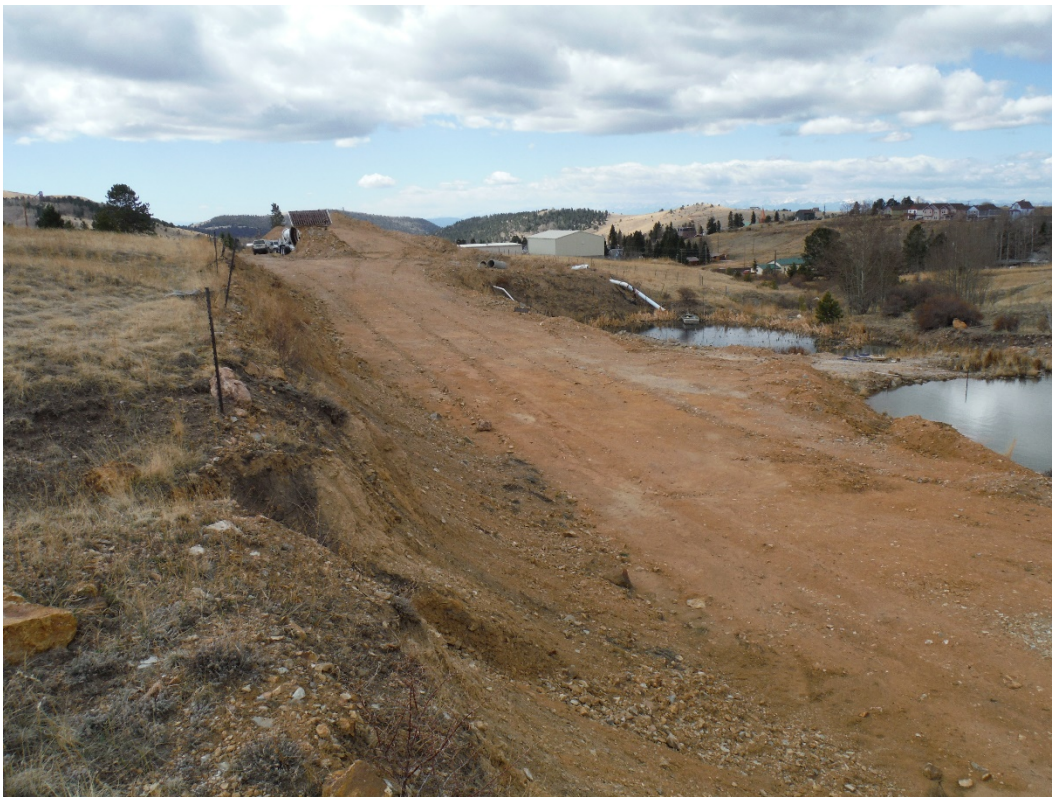
**Photo 7.** No drainage berm observed along eastern permit boundary (yellow line); looking south.

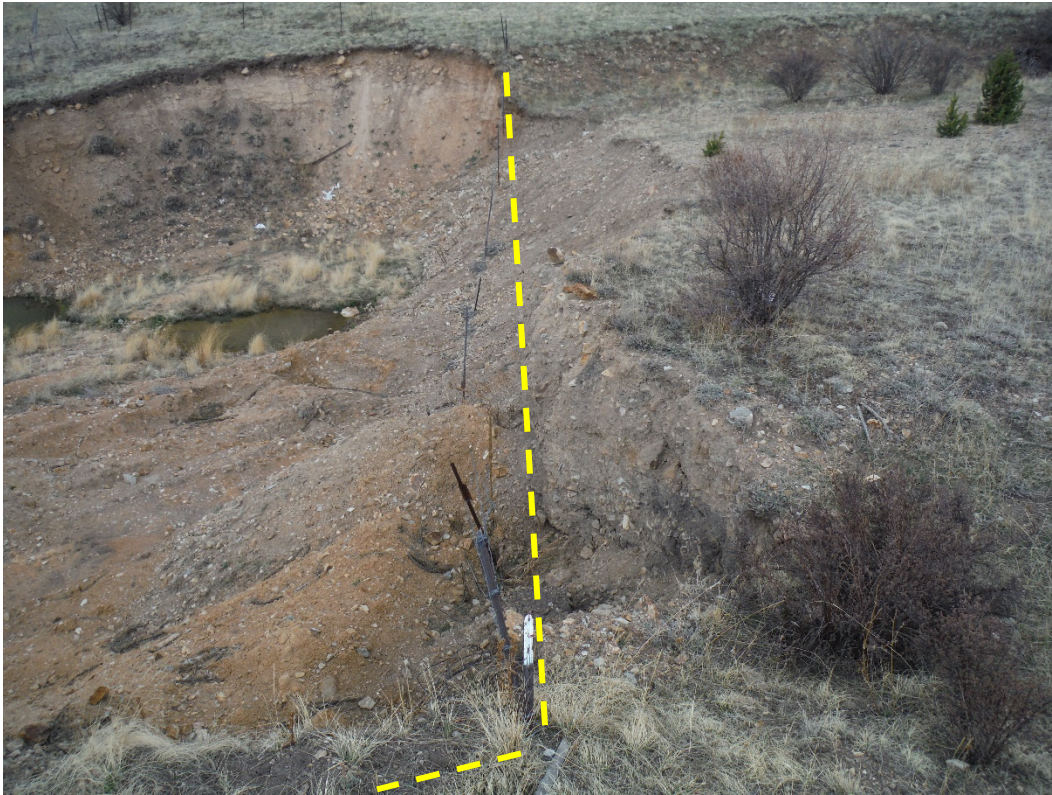
**POSSIBLE VIOLATIONS:** Land has been affected outside of the approved permit boundary by uncontrolled erosion. This is a possible violation of C.R.S. 34-32-116(7)(h) for failure to protect areas outside of the affected land from slides or damages occurring during the mining operation, and a possible violation of C.R.S. 34-32-116(7)(i) for failure to stabilize and protect all surface areas of the affected land to effectively control erosion..

Off-site Damage: During the inspection the Division observed a head cut erosional feature in the northwest portion of the site advancing upstream of the ephemeral channel. A fence, delineating the permit boundary, was damaged by this head cut which had affected lands approximately 10 feet upstream of the permit boundary (see **Photos 8 and 9**). The Division collected GPS data of the head cut and the two survey monuments on either side of the channel, which delineated the permit boundary corners, and determined that approximately 683 square feet of lands outside of the permit boundary have been affected. A second erosional feature has developed along the eastern permit boundary and advanced to off-site lands. Failure to implement the berm discussed above has allowed a small head cut to develop from upland storm water entering the operation's excavation (see **Photos 10 and 11**). The off-site disturbances and uncontrolled erosion is cited as Possible Violations on page two of this report.

**Photo 8.** Head cut erosional feature migrating upstream of the permit boundary (yellow line); looking northwest.

**CORRECTIVE ACTIONS:** These possible violations will require a hearing before the Mined Land Reclamation Board scheduled for the June 28-29, 2017 Board meeting. The schedule and other details for the MLRB hearing will be provided under a separate document to be sent via certified mail to the operator.

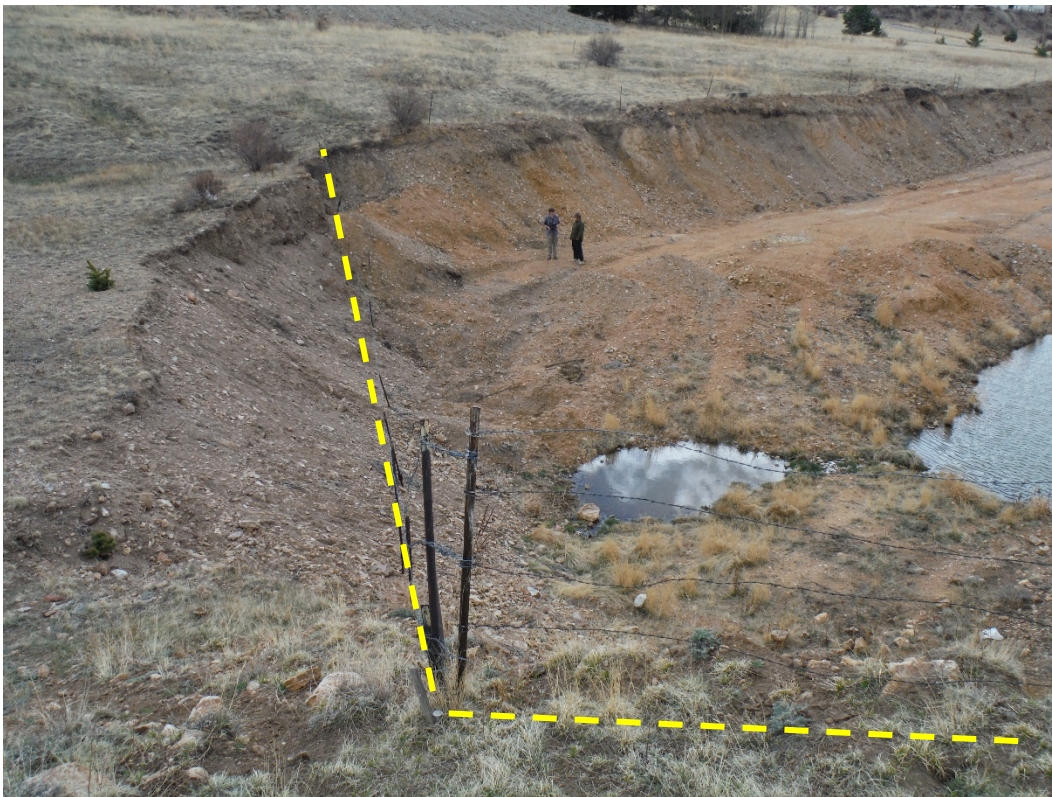
**Photo 9.** Head cut erosional feature migrating upstream of the permit boundary (yellow line); looking southeast.

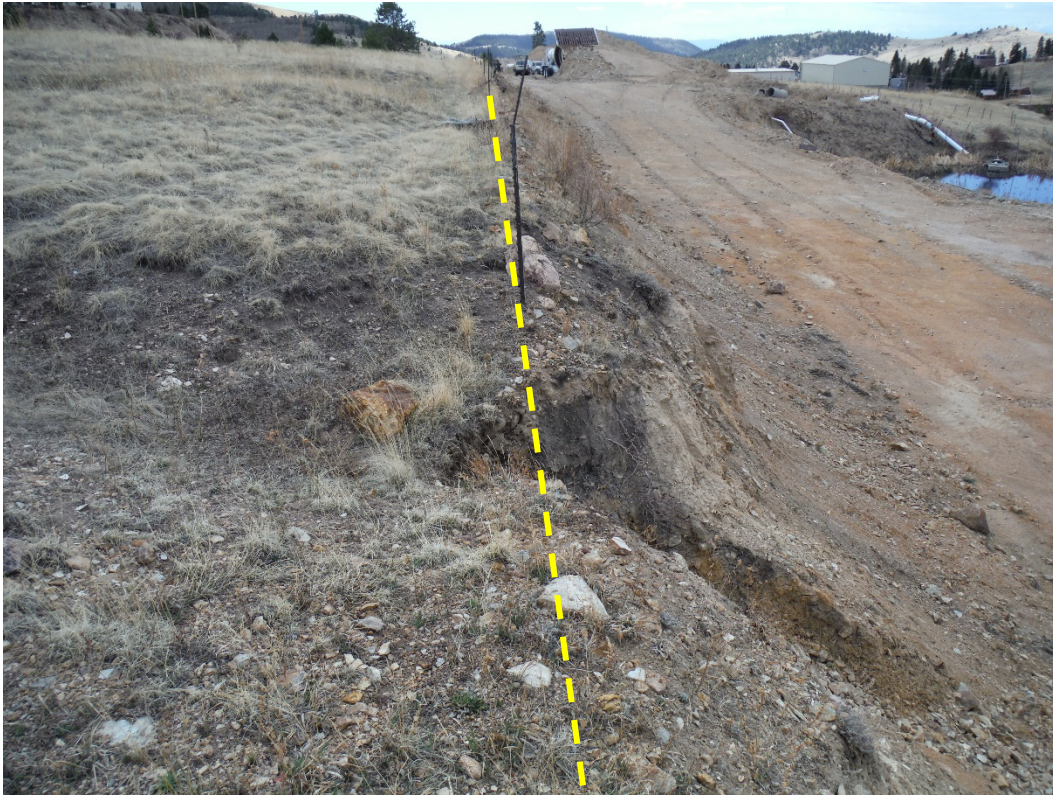
**Photo 10.** Erosional feature migrating uphill of the eastern permit boundary (yellow line); looking southeast.

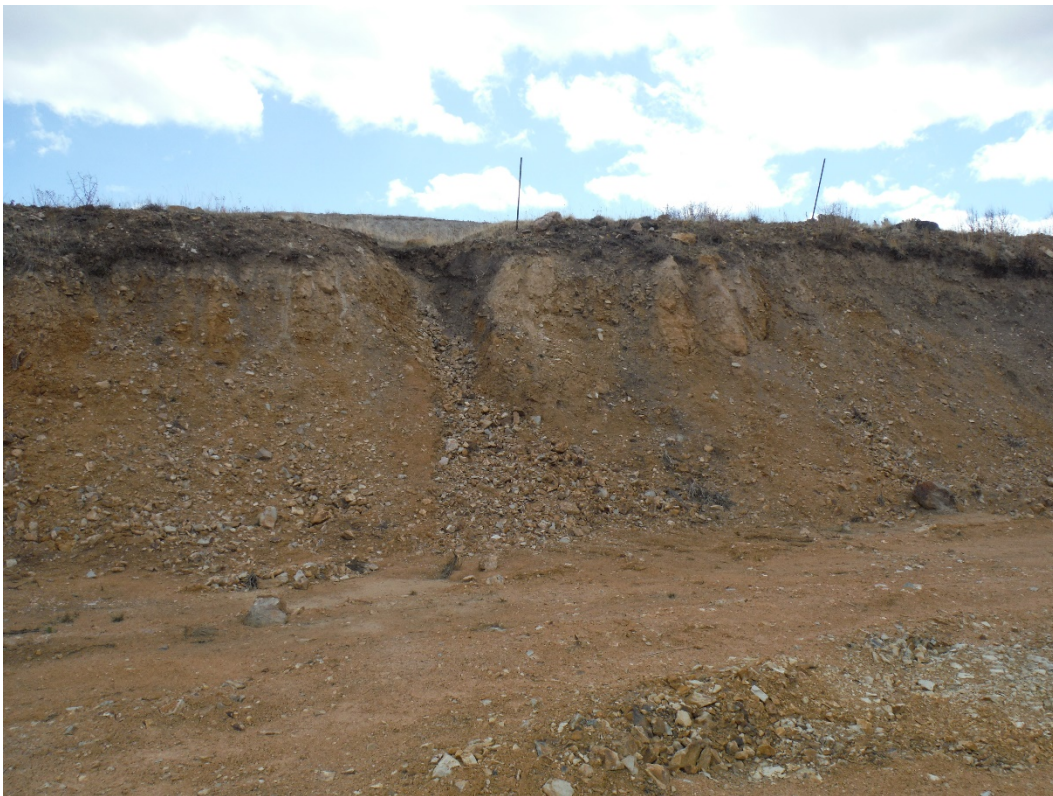
**Photo 11.** Base of erosional feature along eastern permit boundary; looking east.

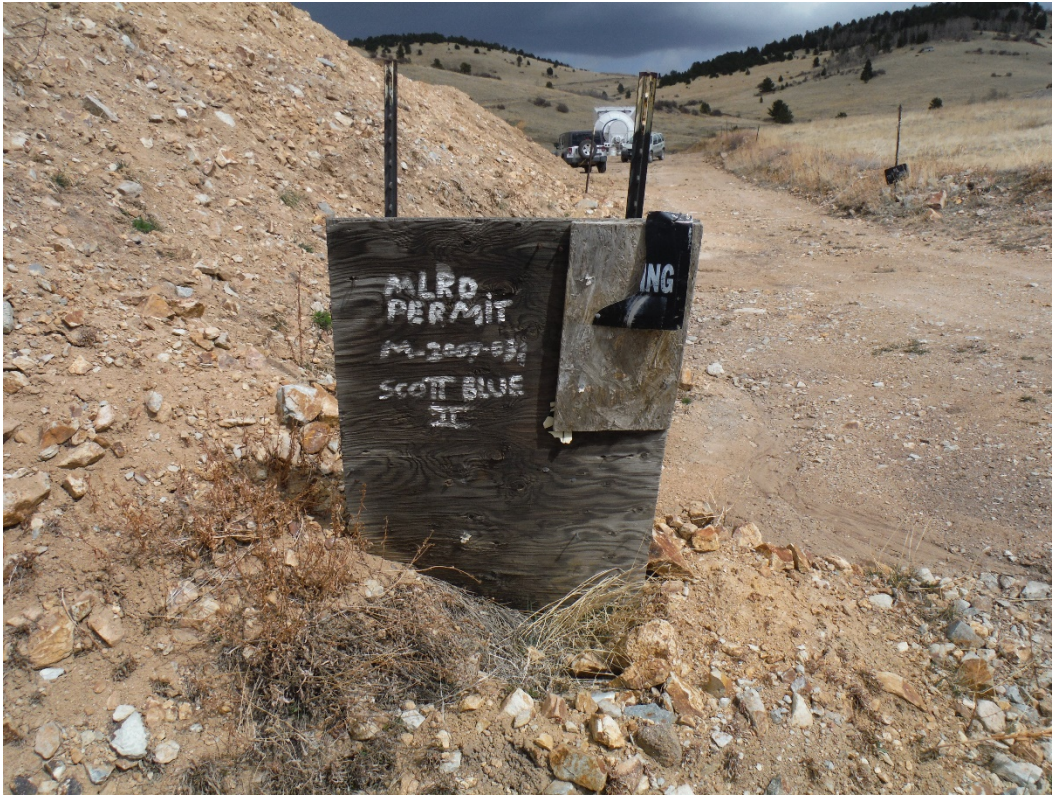
**COMPLIANCE PROBLEM #2:** The mine identification sign needs to be refreshed or replaced, pursuant to Rule 3.1.12(1).

Signs and Markers: The permit identification sign was posted at the entrance of the site, but is illegible and needs to be refreshed or replaced (see **Photo 12**). This is cited as Compliance Problem #2 on page two of this report. The permit boundary is delineated by fence lines and t-posts with survey monuments at the boundary corners.

**Photo 12.** Permit identification sign; looking north.

**CORRECTIVE ACTIONS:** The operator shall submit photo documentation showing a sign posted at the entrance to the mine site, which shall be clearly visible from the access road, specifying the following:

- the name of the operator
- indicate that a reclamation permit for the operation has been issued by the Colorado Mined Land Reclamation Board
- the permit number
