PERMIT INFORMATION

Permit Number: C-1984-065 Mine Name: Coal Ridge No. 1 Mine Operator: C.B. Minerals Company, LLC Operator Address: Mr. James Stover 2352 N 7th St, Ste. B Grand Junction, CO 81501 County: Garfield Operation Type: Underground Permit Status: Inactive Ownership: Private

INSPECTION INFORMATION

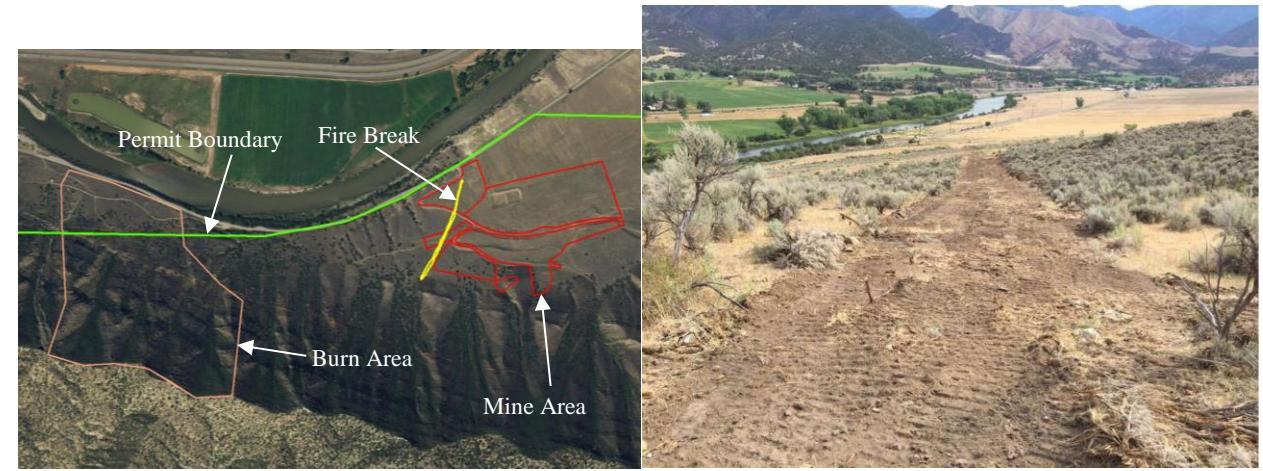
A wildfire burned approximately 100 acres 0.5 mile west of the Coal Ridge Mine on July 3, 2017 (photo 1). About 75 of those acres were within the permit boundary. There were no mine related surface disturbances within the burned area.

Firefighters cut a fire break through undisturbed and reclaimed areas of the Coal Ridge Mine (photo 2). The fire Number of <u>Partial</u> Inspection this Fiscal Year: 0 Number of Complete Inspections this Fiscal Year: 1 break is on the west side of the mine disturbance area and its exact location was documented using a handheld GPS (photo 1). The overall length is 1250' and the width varies from 8' to 30'. The total disturbance is 0.55 acres in size and 0.14 acres of that disturbance was in reclaimed vegetation. The vegetation in the fire break was removed and pushed into small piles on the east side of the break (photo 3). The topsoil was disturbed in the fire break area but remained in place (photo 4). Rocks from the road area were pushed below the road into reclaimed pasture (photo 5). The reclaimed pasture has a post mine land use of wildlife habitat.

Photo 1 – Wildfire Burned Area

Photo 2 - Fire Break Looking North

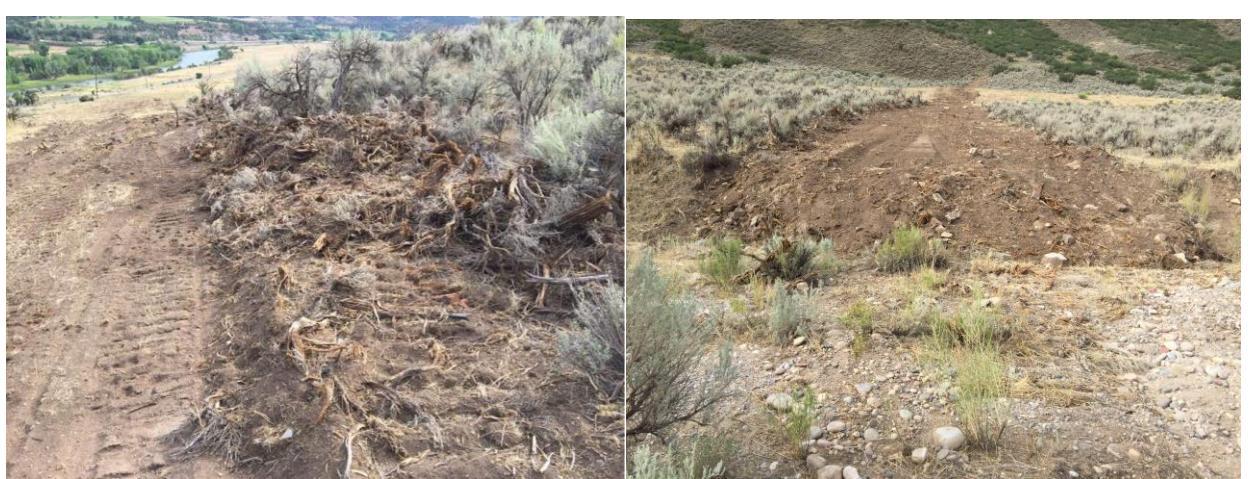
Photo 3 – Vegetation Pushed to Side

Photo 4 – Topsoil Was Not Removed

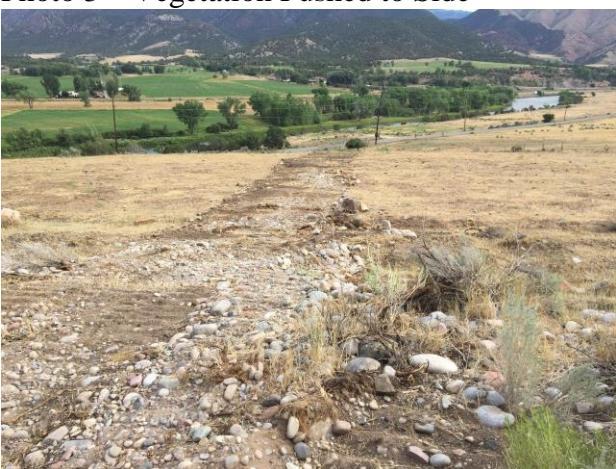
Photo 5 – Fire Break Below the Road
