Weekly Liner Update

Cripple Creek and Victor Gold Mining Co.

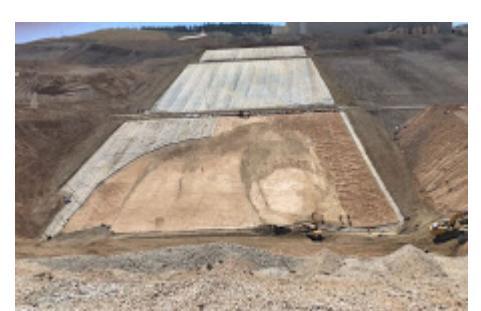
0613_Overview.JPG 100K

The extent of the visible damage to the liner in the area under investigation has been delineated. With the approval of TR100, liner replacement activities have begun. Damaged liner was removed from the southern section of the investigation area between the 9650' and 9750' benches. The anchor trench along the 9750' was excavated using a CAT312C. Additionally, a grid of Soil Liner Fill (SLF) sample locations was laid out between the 9650' and 9750' benches. These sample locations were checked for SLF depth. All locations recorded >12" of clay depth.
