Re: King II Mine Pond Quarterly Inspection 2nd Quarter 2018

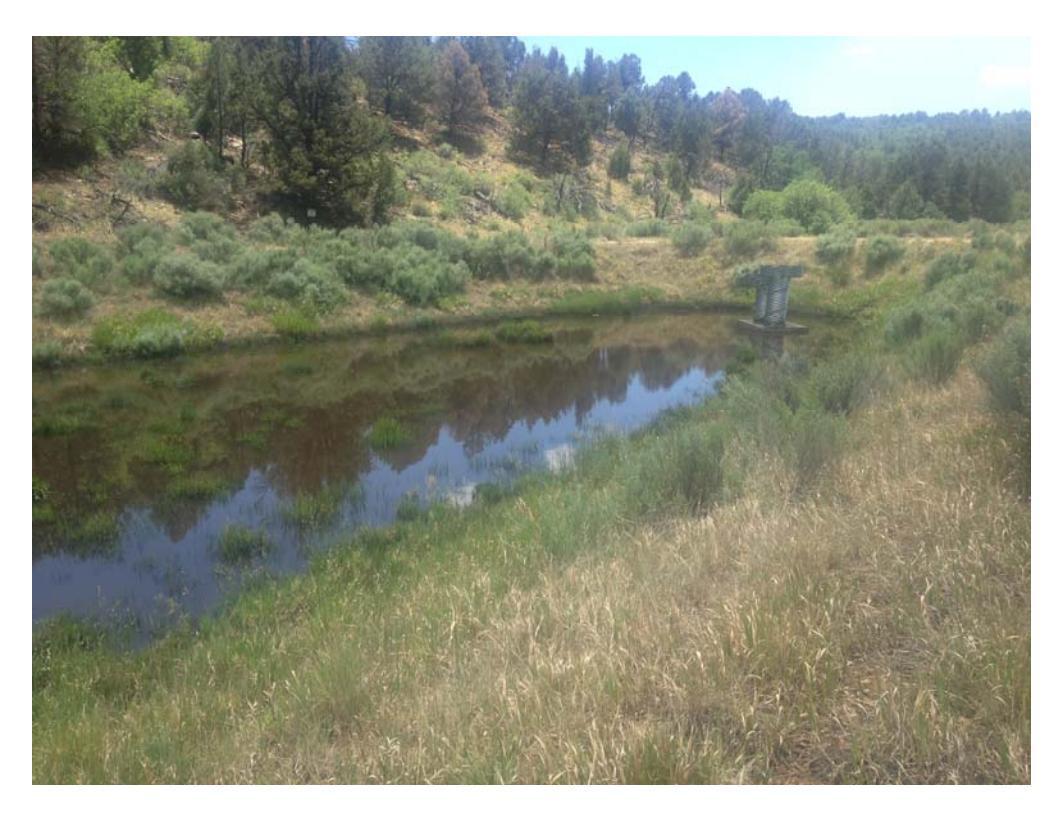
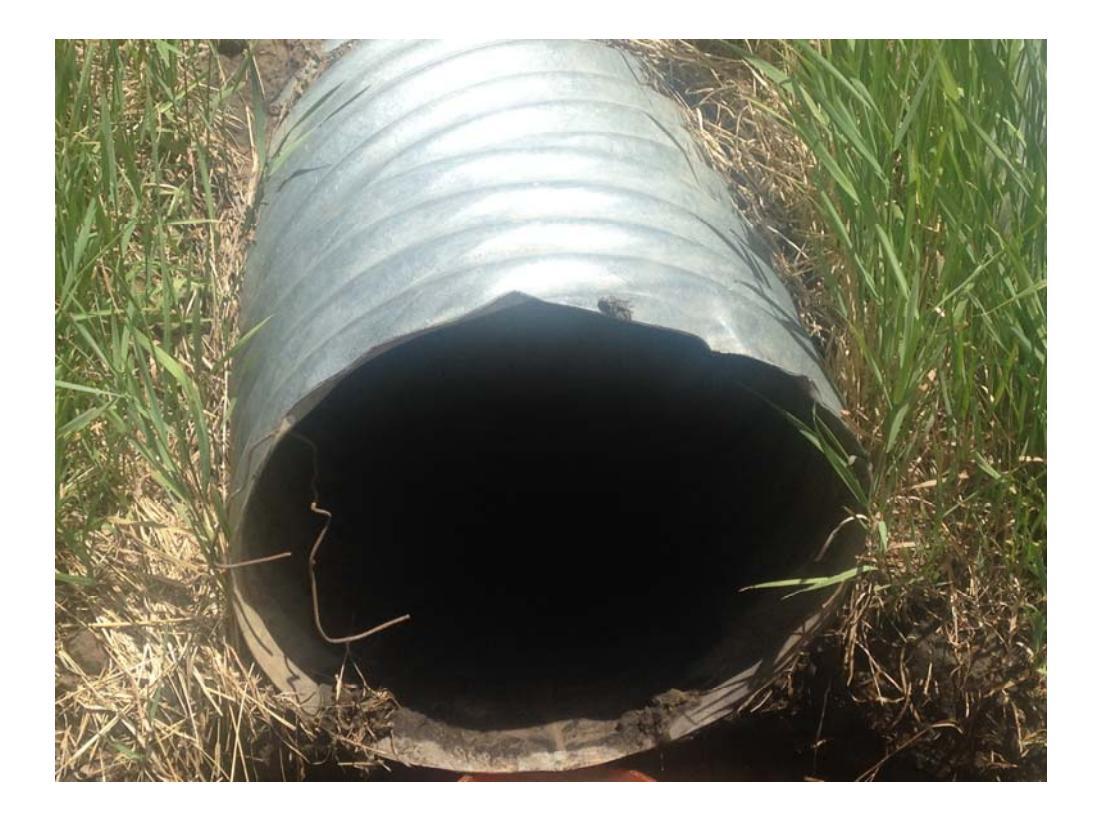
An inspection of the pond at the King II mine was performed on June 18, 2018 for the 2nd quarter of 2018. 1.86" of rain fell over the previous weekend. The pond contained approximately 8 - 10" of water (see photos) and was not discharging. No leaks were observed around the two 24" spillway culverts. The pond embankment, in-slopes and spillway all appeared stable with no evidence of slumping, settling or excessive erosion. All features appeared to be in place and functioning as designed.
