MINERALS PROGRAM INSPECTION REPORT PHONE: (303) 866-3567

MINE NAME:		MINE/PROSPECTING ID#:	MINERAL:	COUNTY:
Schmidt Site		M-2011-014	Borrow material for	Archuleta
INSPECTION TYPE:		INSPECTOR(S):	INSP. DATE:	INSP. TIME:
Monitoring		Lucas J. West	June 7, 2018	09:30
OPERATOR:		OPERATOR REPRESENTATIVE:	TYPE OF OPERATION:	
Dale and Ellen Schmidt		Dale and Ellen Schmidt	110c - Construction Limited Impact	
REASON FOR INSPECTION:		BOND CALCULATION TYPE:	BOND AMOUNT:	
Priority		Complete Bond	\$7,404.00	
DATE OF COMPLAINT:		POST INSP. CONTACTS:	JOINT INSP. AGENCY:	
NA		None	None	
WEATHER:	INSPECTOR'S SIGNATURE:		SIGNATURE DATE:	
Clear	June 22, 2018

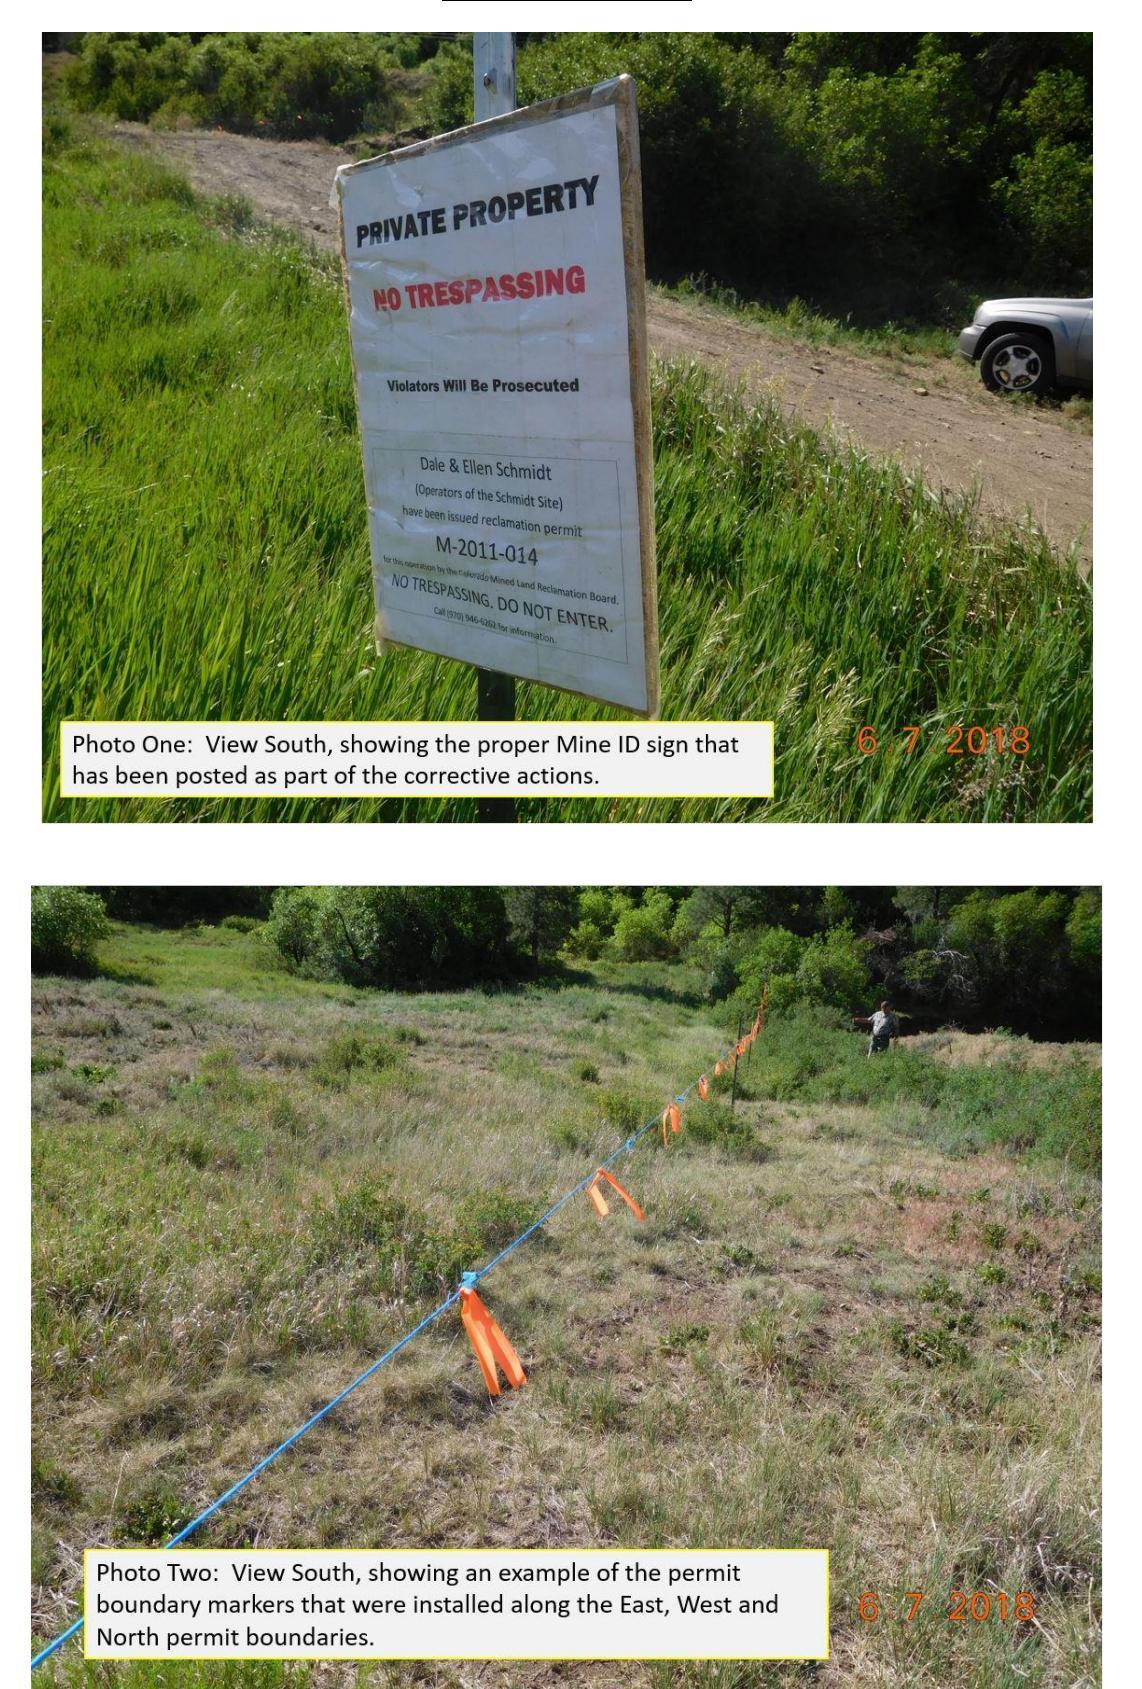
During the previous inspection several site problems including offsite impacts and failure to follow the approved Mine plan were cited. Enforcement action for the outstanding problems and offsite impacts is pending. The proper mine identification signage has been posted as seen in Photo One. Photos Two and three show that the Operator has properly marked the permit boundaries. Both items were part of the corrective actions required by the May 2, 2018 Inspection. These two problems are considered abated. The remaining problems that will need to be addressed will be the submission of a Technical Revision to address the highwall near the entrance to the site, a construction schedule for the storm water management structures as well as the submission of an interim bond. The details of these corrective actions have been addressed through the Consent Agreement that has been signed by the Operator and will be considered by the Mined Land Reclamation Board during the June Hearing.

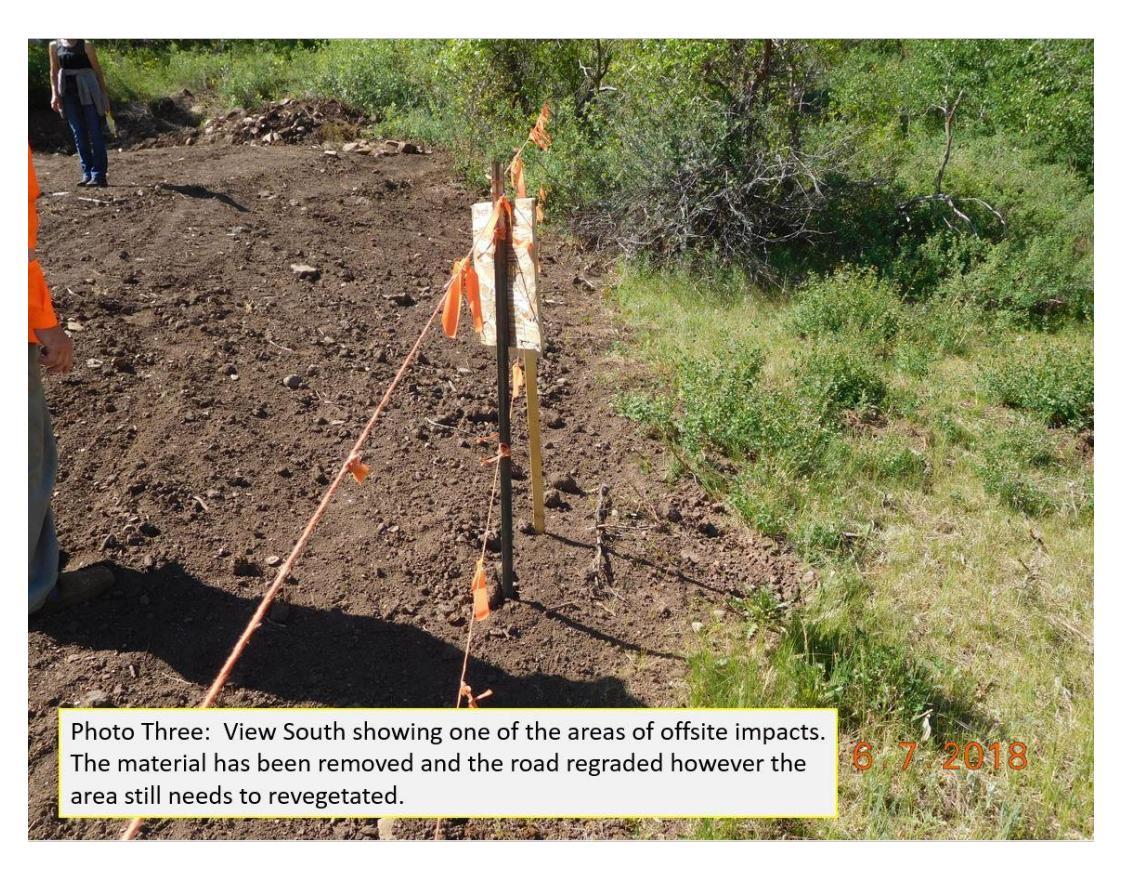
Two areas were identified to have possible offsite impacts, have been verified by a survey and are the subject of the enforcement action. The two areas are along the access road leading from the parking and storage area up to the home site. During the improvement of the road, material generated by the activity was pushed offsite. The total offsite impact was measured at less than 110 Square Feet as verified by the independent survey of the site. Without the advisement of the Division, the Operator removed the material from neighboring properties and adjusted the road to ensure no further impacts to offsite areas occur. The areas of offsite impacts with the material removed can be seen in Photos Three and Four.

The Consent Agreement will address the remaining corrective actions required of the areas of offsite impacts, the required Technical Revision as well as the interim bond amount. Once approved by the Mined Land Reclamation Board during the June 27-28, 2018 hearing the Division will contact the Operator to provide guidance in completing the corrective actions. All responses to this report should be directed to Lucas West at the Colorado Division of Reclamation, Mining and Safety at 1313 Sherman Street, Room 215 Denver, CO 80203, by phone at (970)-243-6368 or by email at lucas.west@state.co.us.
