Weekly Liner Update

Cripple Creek and Victor Gold Mining Co.

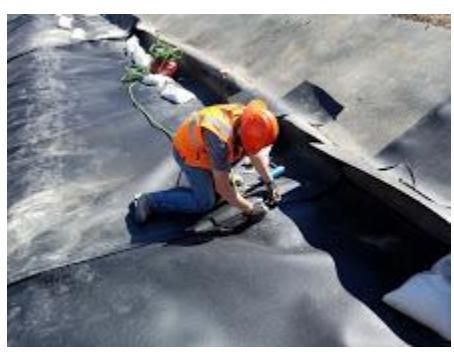
07.07_ND_testing.jpg 179K

Additionally, the geomembrane liner between the 9850'-9900' elevations was removed using a CX210C CASE excavator. A CAT 336F and CAT 305.5 E mini excavator were used to complete excavation of the anchor trench on the 9900' bench. Approximately, 22,275 square feet of 80 MIL LLDPE double sided textured geomembrane was installed by Comanco between 9850-and 9900' on July 7, 2018. The liner panel seaming was performed using one fusion machine/operator method. Non-destructive testing was performed for fusion welded seams. Repairs were performed using the extrusion welding method for all marked defects.

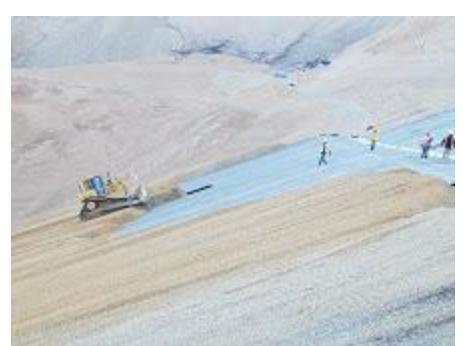
07.06_DCF.jpg 174K

Drain Cover Fill (DCF) placement was completed between the 9650' and 9750' elevation on Friday, July 6. The QA/QC monitoring report for the DCF phase of the 9650-9750' elevations was submitted to the Division on July 11, 2018.
