COLORADO Division of Reclamation, Mining and Safety Department of Natural Resources

MINERALS PROGRAM INSPECTION REPORT PHONE: (303) 866-3567

MINE NAME:	MINE/PROSPECTING ID#:	MINERAL:	COUNTY:
Crow Feather/Spider Pocket	M-2017-045	Gemstones	El Paso
(CMC 287325/287326)			
INSPECTION TYPE:	INSPECTOR(S):	INSP. DATE:	INSP. TIME:
Illegal(Unpermitted Operation)	Timothy A. Cazier	October 12, 2017	11:05
OPERATOR:	OPERATOR REPRESENTATIVE:	TYPE OF OPERATION:	
Shawn Parker	None	UN - Unknown	
REASON FOR INSPECTION:	BOND CALCULATION TYPE:	BOND AMOUNT:	
Citizen Complaint	None	No Bond Held	
DATE OF COMPLAINT:	POST INSP. CONTACTS:	JOINT INSP. AGENCY:	
NA	U.S.Forest Service	U.S.Forest Service	
WEATHER:	INSPECTOR'S SIGNATURE:	SIGNATURE DATE:	
Clear		July 23, 2018	
	Thing US-

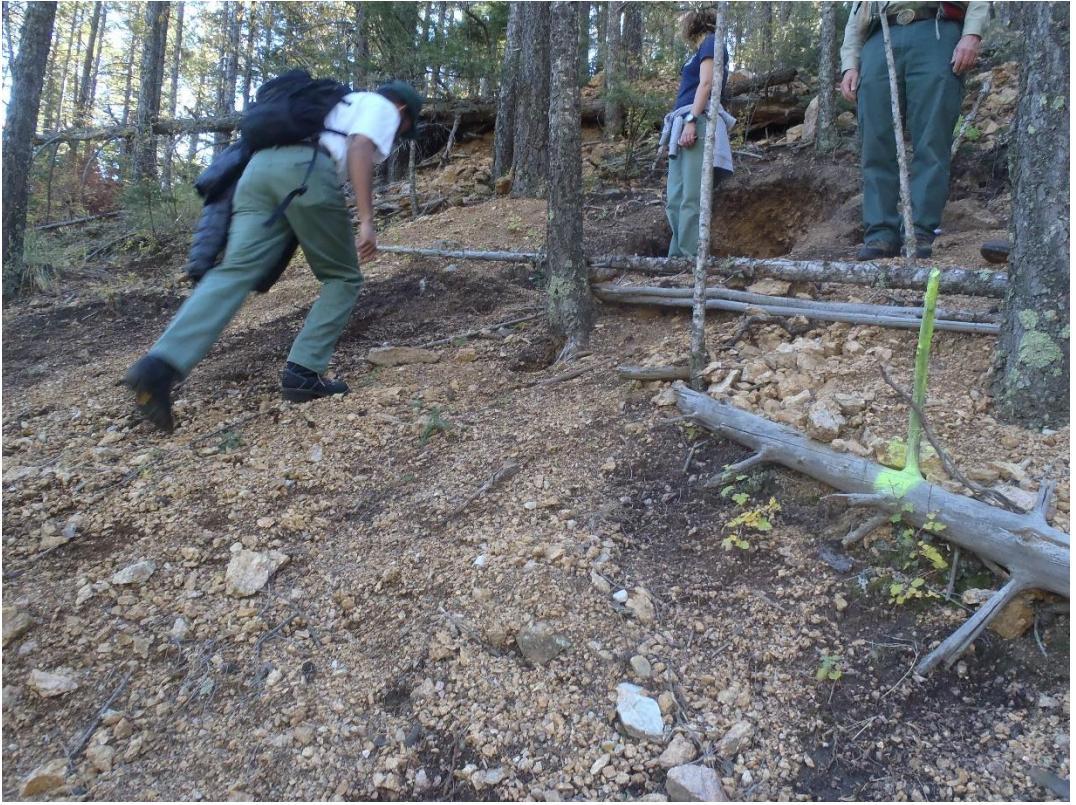
<u>Backfilling and Grading</u>: Backfill material appeared to be available for the digs observed, but was spread out from each dig (see **Photos 1** and **2**). The dig in Photo 1 appeared post inspection to be on the Sky High Hopes claim (CMC 287324) rather than on either the Crow Feather or Spider Pocket claims.

Photo 1. Typical dig site (1 of 2).

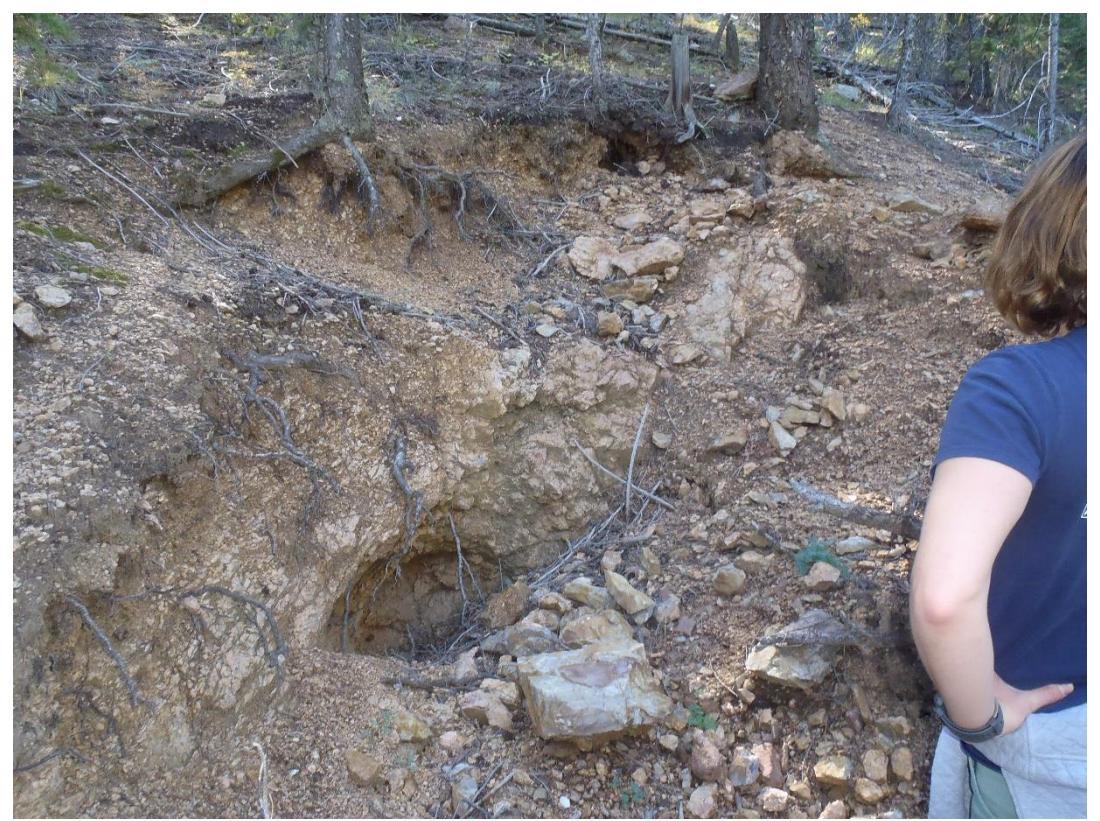
Photo 2. Typical dig site (2 of 2).

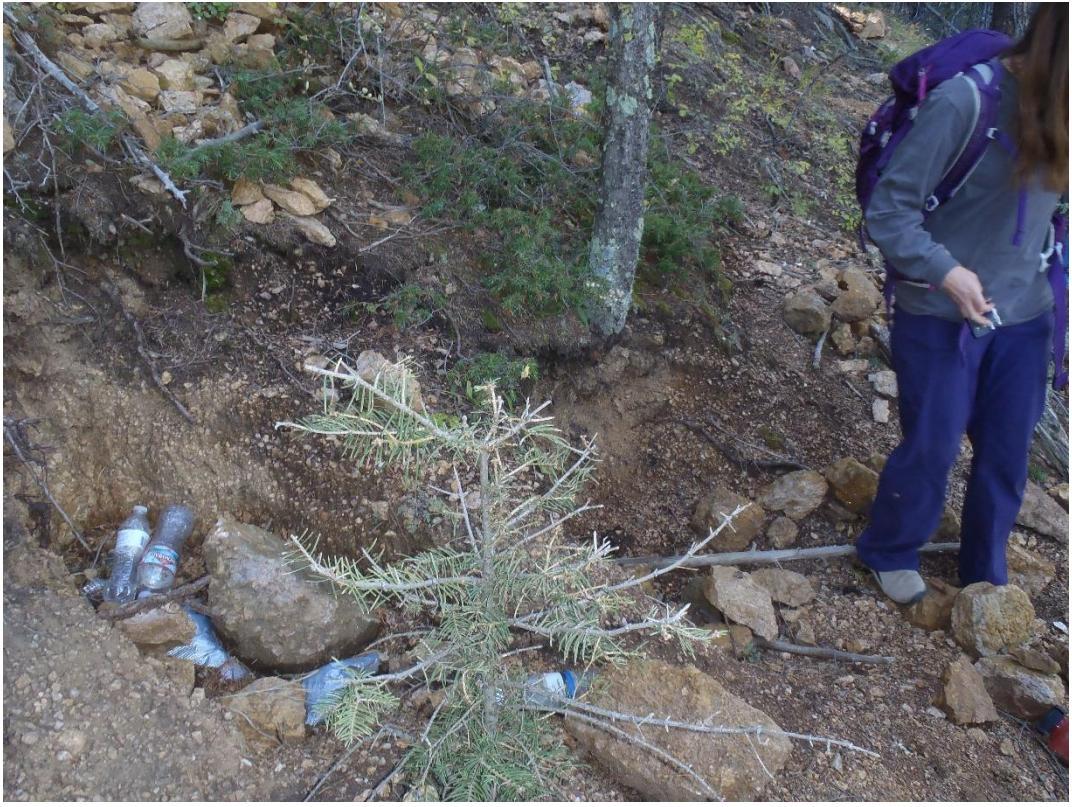
<u>Excess Spoil and Dev. Waste:</u> The available backfill material discussed above appears to be primarily development waste as is typical for this type of mining activity. Trash was observed at two of the did sites

<u>Hydrologic Balance</u>: No stormwater or exposed groundwater was observed at any of the dig sites (see **Photos 3** and **4**).

Photo 3. Dig site with trash (1 of 2).

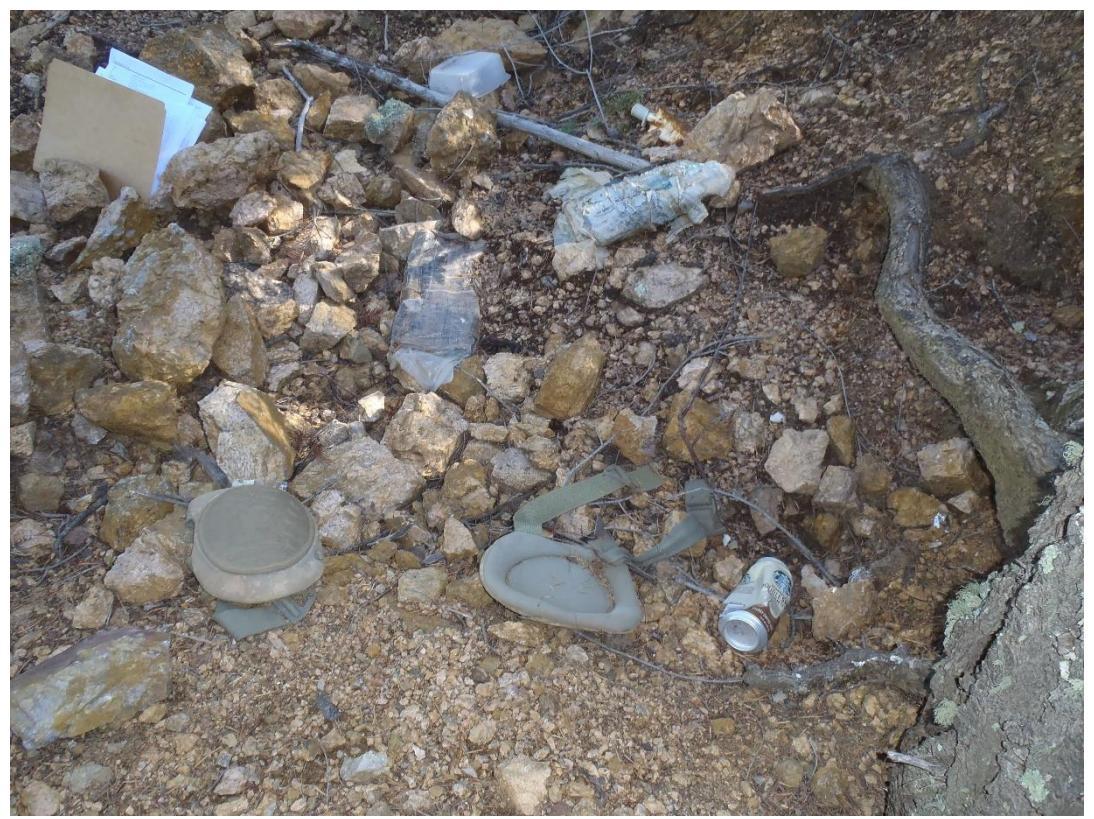
Photo 4. Dig site with trash (2 of 2).
