COLORADO Division of Reclamation, Mining and Safety Department of Natural Resources

MINERALS PROGRAM INSPECTION REPORT PHONE: (303) 866-3567

MINE NAME:	MINE/PROSPECTING ID#:	MINERAL:	COUNTY:
Ard Property Borrow	M-2017-002	Borrow material	Weld
INSPECTION TYPE:	INSPECTOR(S):	INSP. DATE:	INSP. TIME:
Surety Release Inspection	Peter S. Hays	September 6, 2018	13:00
OPERATOR:	OPERATOR REPRESENTATIVE:	TYPE OF OPERATION:	
Ames Construction, Inc.	Mike Volosin	111 - Construction by Goverment Agency

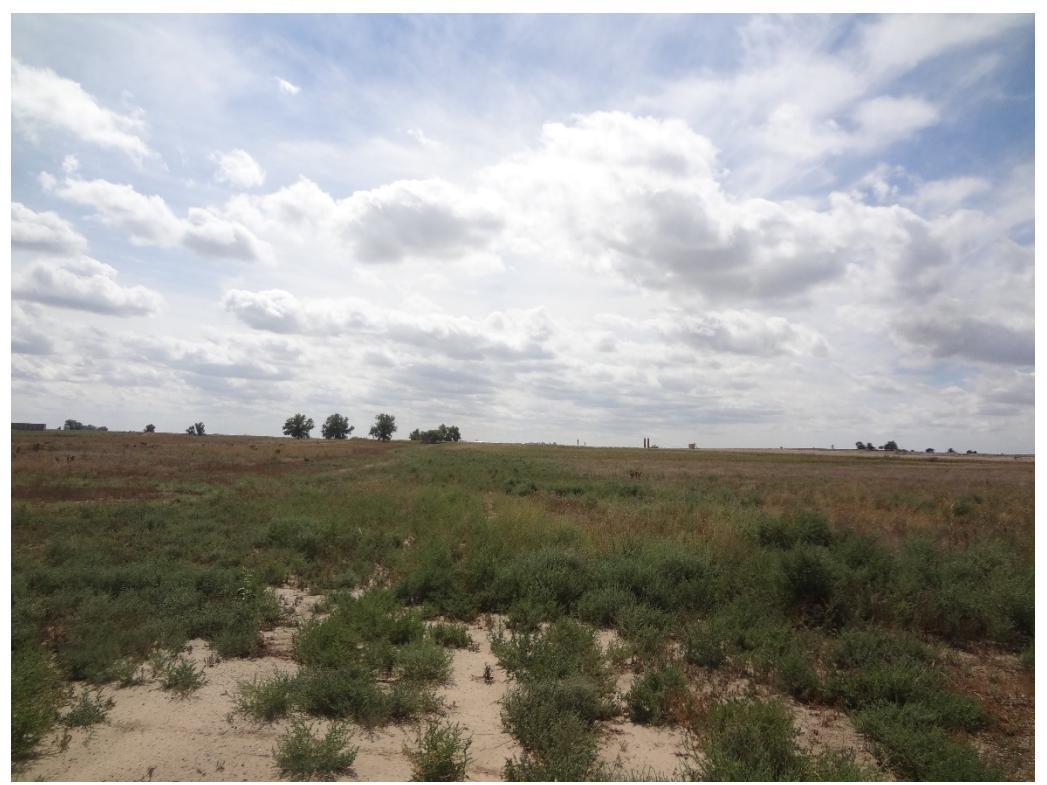
The Operator stated the site was revegetated in March/April of 2018. The site vegetation consisted of kochia and Halogeton with patches of a grass species not included in the approved dryland pasture mix for the site. Halogeton is a List C noxious weed by the Colorado Weed Management Association. The Operator will be required to control the spread of noxious weeds at the site. The lack of well-established and self-sustaining vegetation and the presence of noxious weeds at the site is the reason the Division denied the final release request. The site slopes appeared stable and no erosion features were observed during the inspection.

View of access road vegetation from WCR 50

The Division recommends the Operator control the kochia and Halogeton and reseed the site with the approved seed mixture to establish reclamation vegetation. Noxious and annual weed control measures must continue until the reclamation vegetation is well-established and the permit is released by the Division.

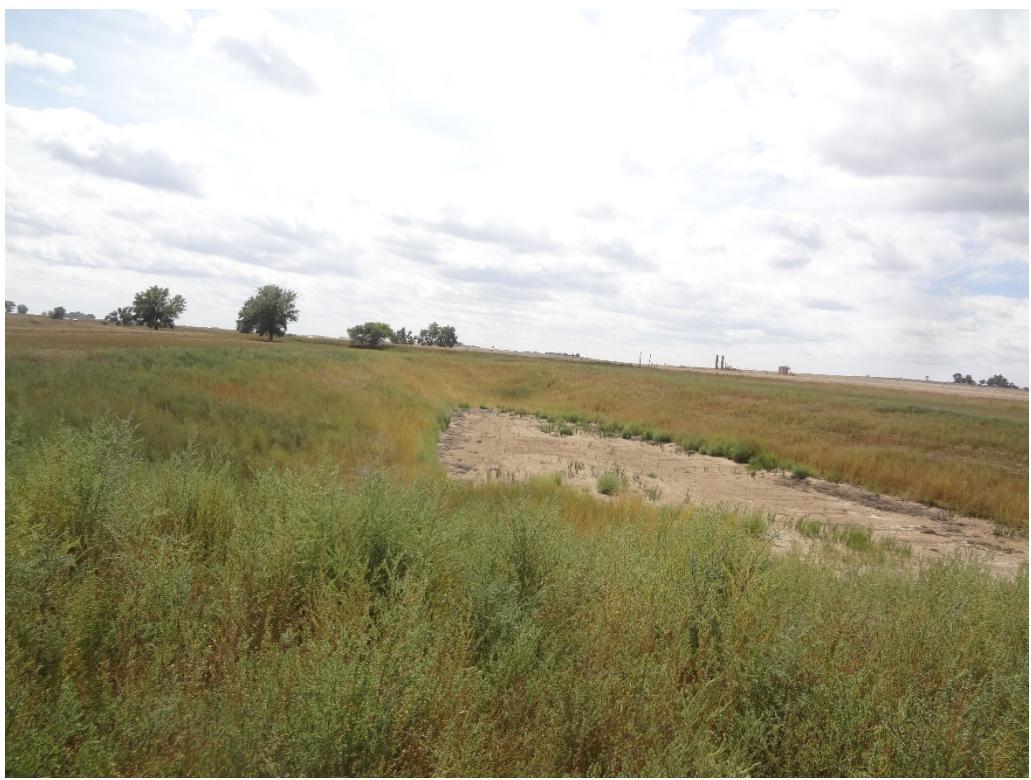
View of pit from the NE corner looking south

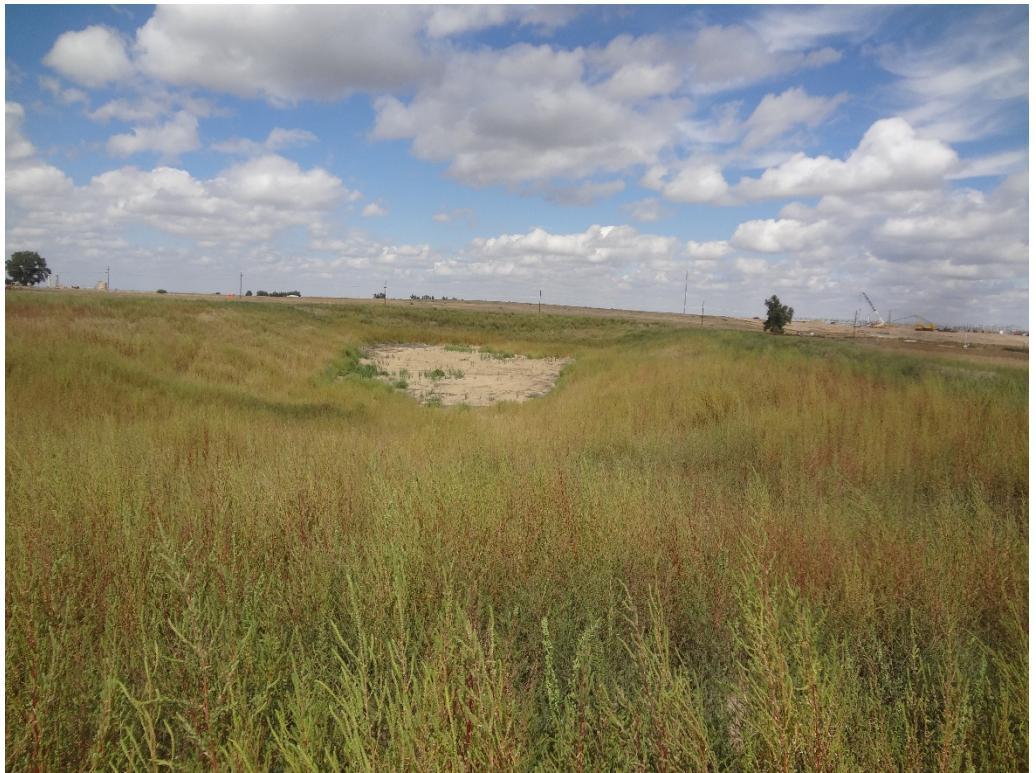
View of pit from the south side of the pit looking north

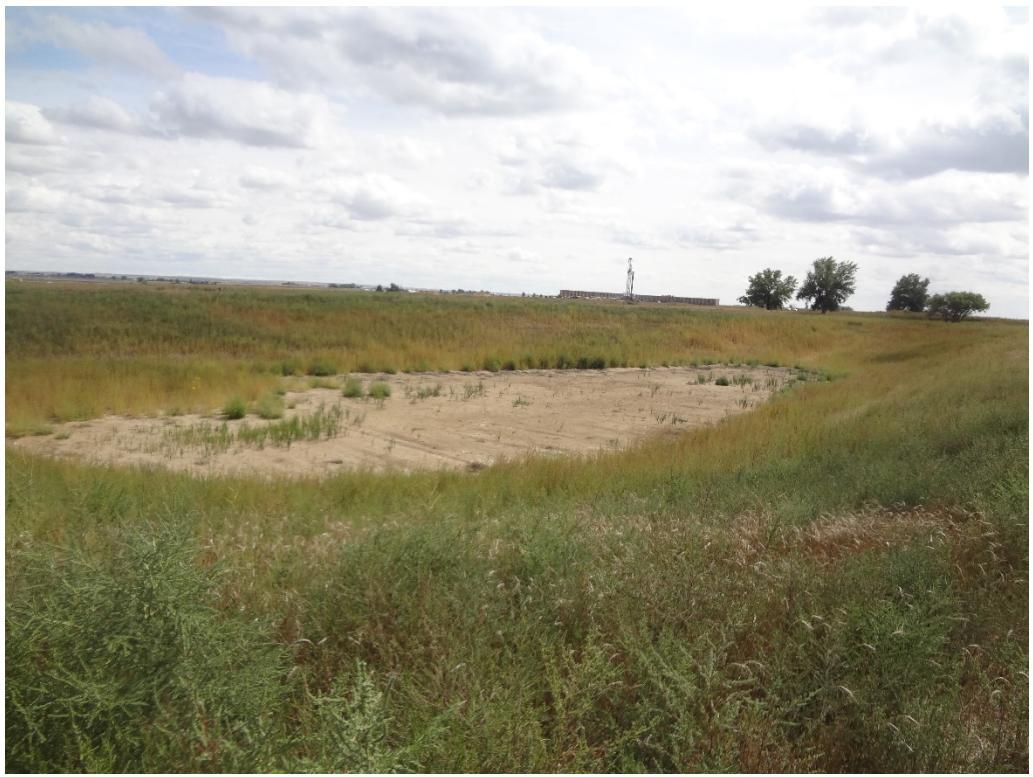
View of pit from the NW corner looking southeast
