# **PERMIT INFORMATION**

Permit Number: C-1981-033 Mine Name: Bear Mine Operator: Bear Coal Company, Inc. Operator Address: NA	County: Gunnison Operation Type: Underground Permit Status: Revoked Ownership: Federal Operator Representative Present: None
<b>Operator Representative Signature: (Field Issua</b>	nce Only)

# **INSPECTION INFORMATION**

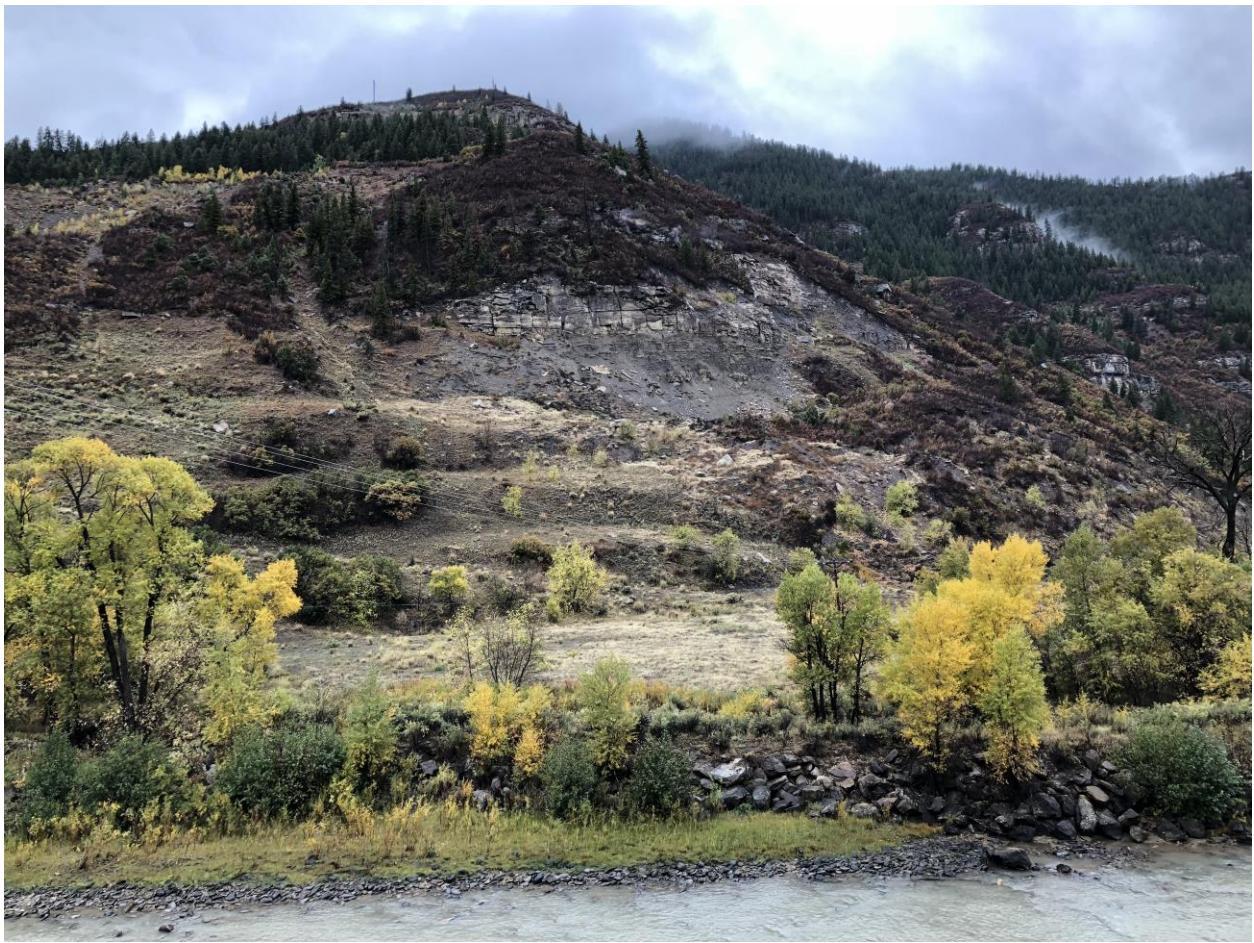
The Bear Mine from the highway

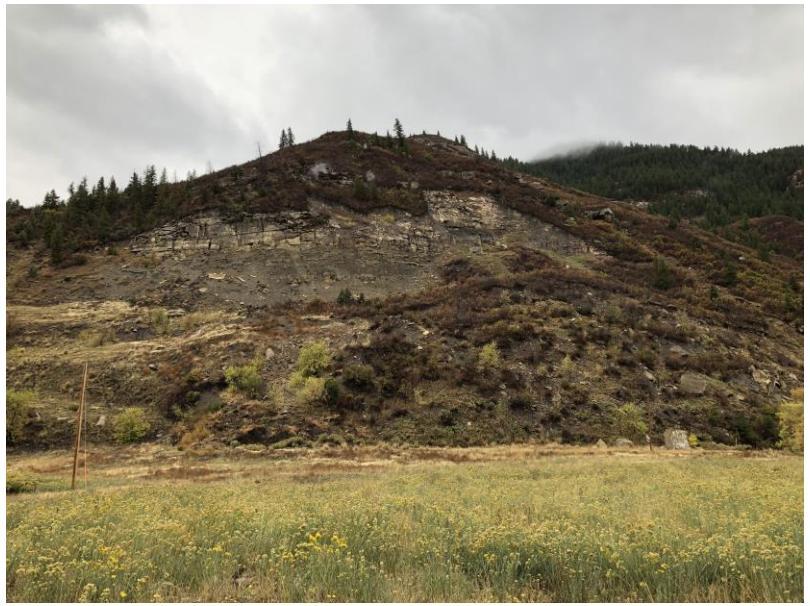
Smoke from coal fires on the hill could be seen.

Smoke from coal fire was seen above the scarp

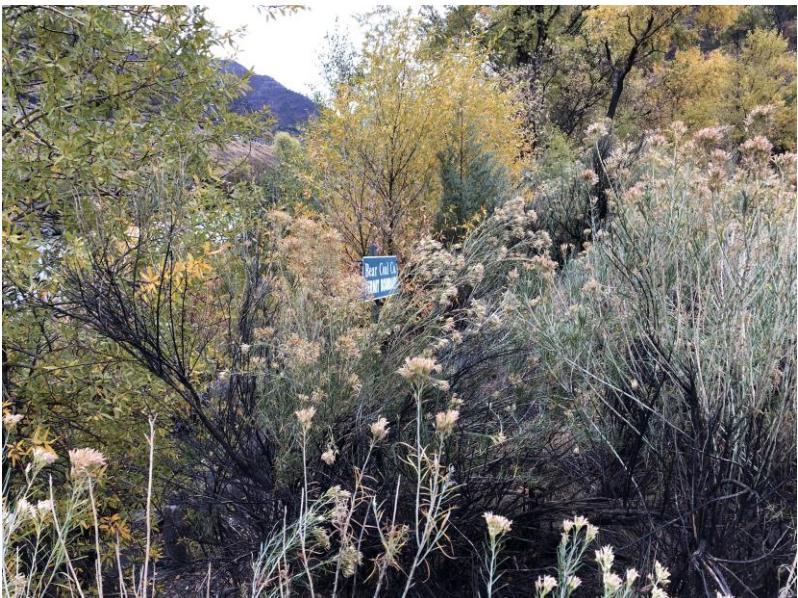
Signs were in place at both ends of the site (east and west).

Permit Boundary sign at east end of site
