COLORADO Division of Reclamation, Mining and Safety Department of Natural Resources

MINERALS PROGRAM INSPECTION REPORT PHONE: (303) 866-3567

MINE/PROSPECTING ID#:	MINERAL:	COUNTY:
M-1980-027	Sand and gravel	Grand
INSPECTOR(S):	INSP. DATE:	INSP. TIME:
Peter S. Hays	October 3, 2018	11:00
OPERATOR REPRESENTATIVE:	TYPE OF OPERATION:	
Bud Carpenter	112c - Construction Regular Operation	
	M-1980-027 INSPECTOR(S): Peter S. Hays OPERATOR REPRESENTATIVE:	M-1980-027Sand and gravelINSPECTOR(S):INSP. DATE:Peter S. HaysOctober 3, 2018OPERATOR REPRESENTATIVE:TYPE OF OPERATOR

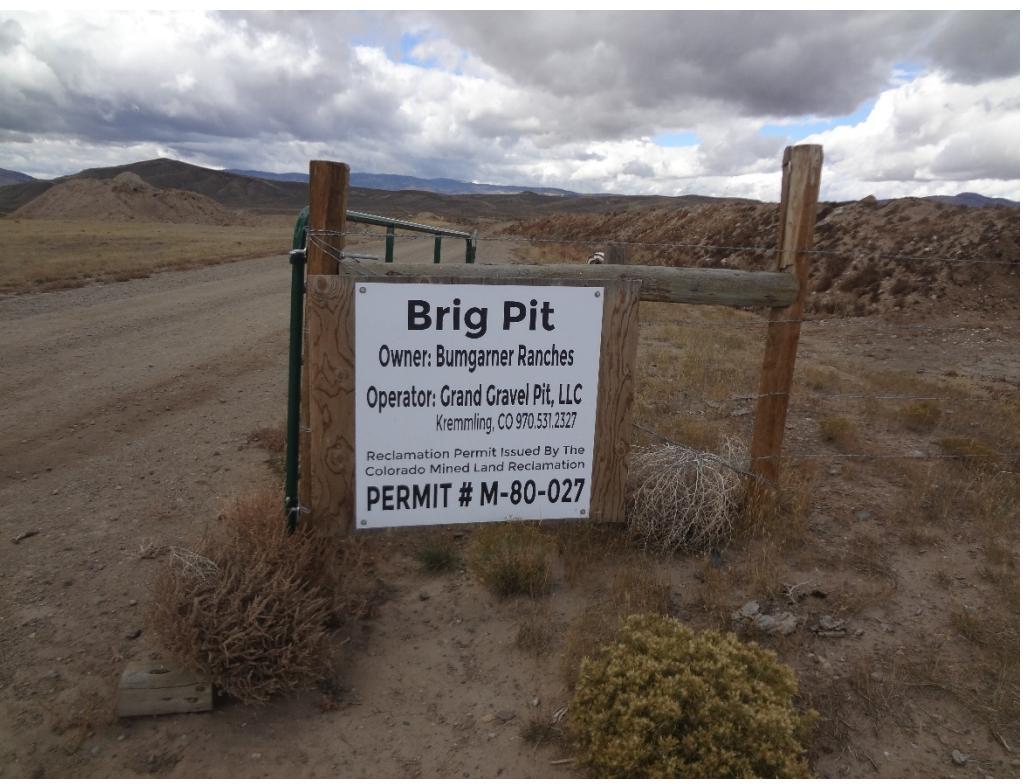
An entrance sign was posted and permit boundary markers were observed as required by Rule 3.1.12. Photographs taken during the inspection are attached.

Bumgarner Ranches Gravel Pit mine sign

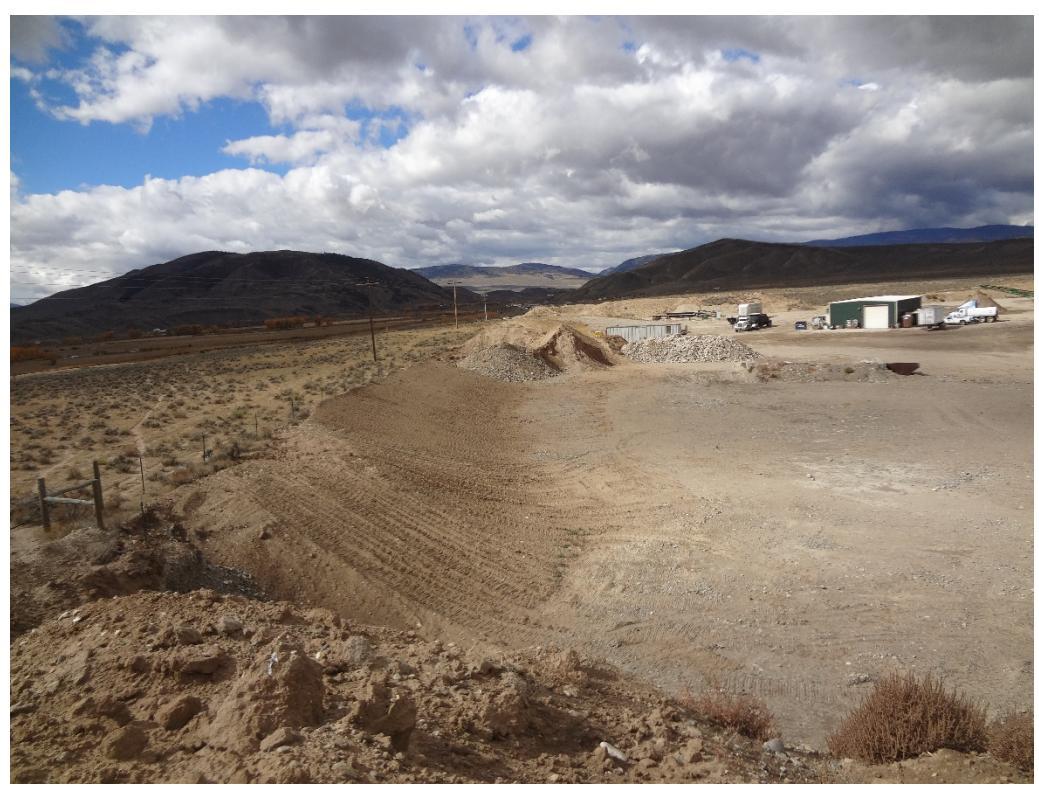
The approved post-mining land use is rangeland. Reclamation activities, highwall backfilling to 3H:1V slopes, were observed along the west, south and north boundaries of Phases 1 and 2. The recently backfilled areas had not been topsoiled or seeded. Topsoil stockpiles were located on the north and west sides of the site. The Operator was aware of a small erosion feature in the northwest corner of the site near the sedimentation ponds.

View of the graded south highwall from the current east highwall looking west

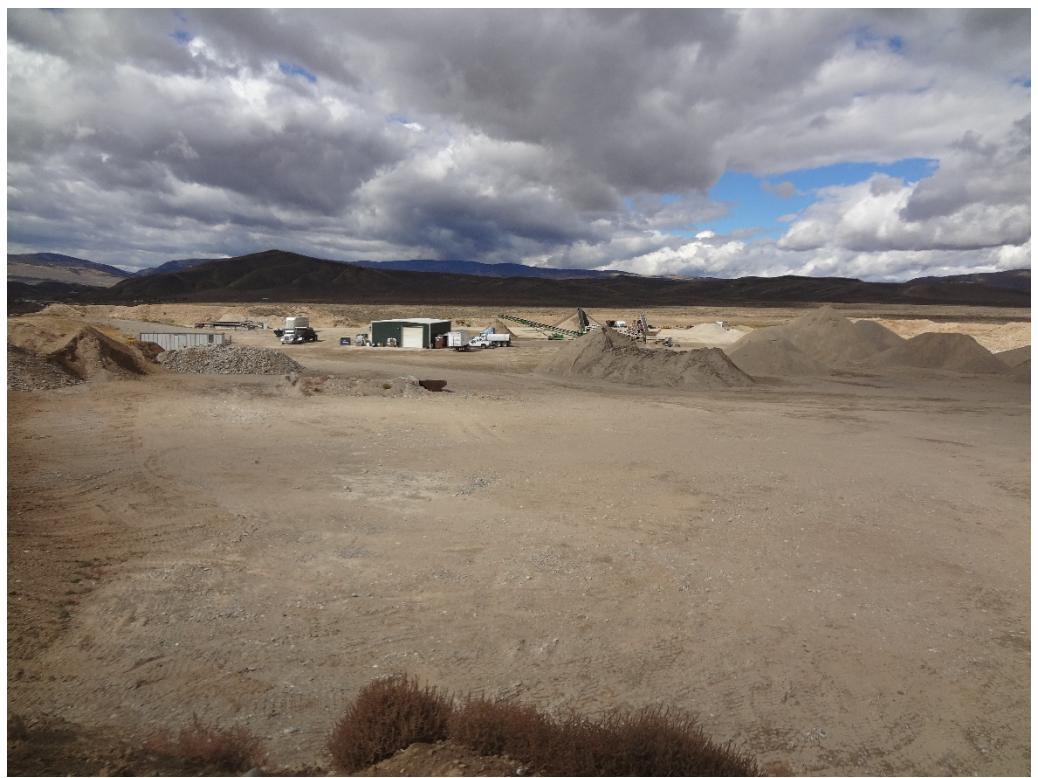
The Bumgarner Ranches Gravel Pit is divided into four (4) mining phases. The mine site was active during the inspection. The processing plant was operational and material was being hauled from stockpiles on the pit floor. The highwall has advanced east into Phase 3 since the last inspection. The highwall was estimated at fifteen (15) feet high at a 0.5H:1V slope. The mining excavation has reached the stripped area boundary above the highwall. The Operator will need to strip and stockpile topsoil and overburden before mining further to the east. The sedimentation ponds were observed in the northwest corner of Phase 1. The ponds will be moved east as the mining operation moves to the east. The concrete batch plant and the associated fuel tanks observed during the last inspection have been removed from the site.

View of the processing plant and stockpiles from the current east highwall looking west

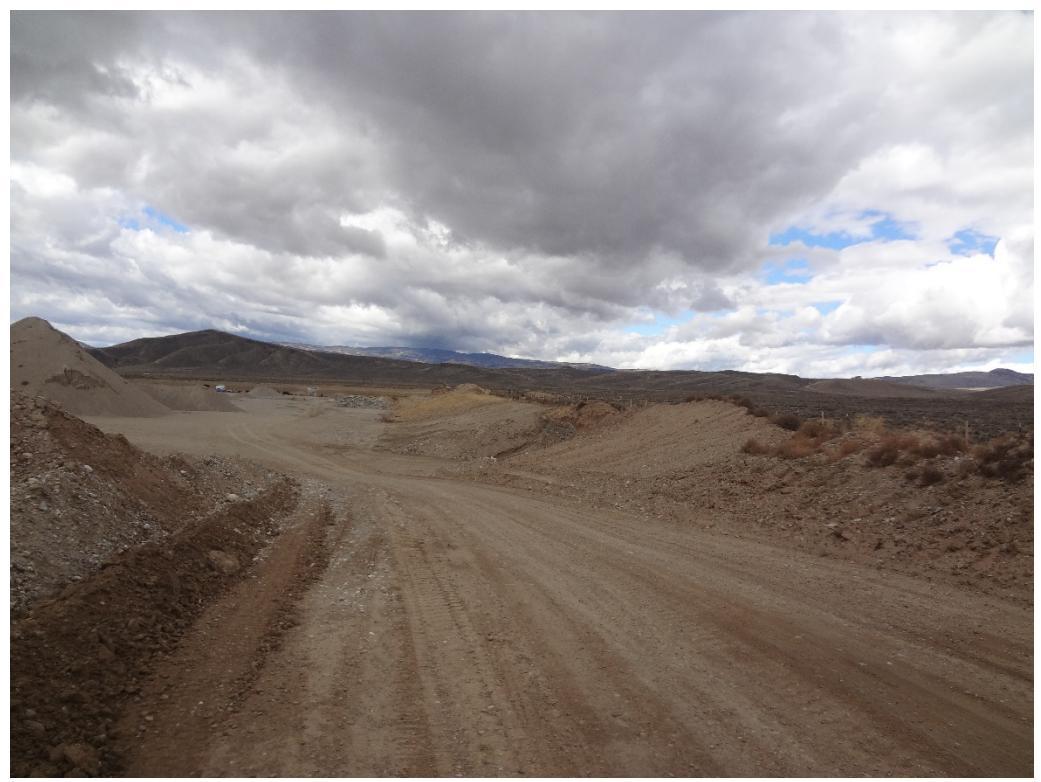
View of the graded north highwall from the current entrance location looking west

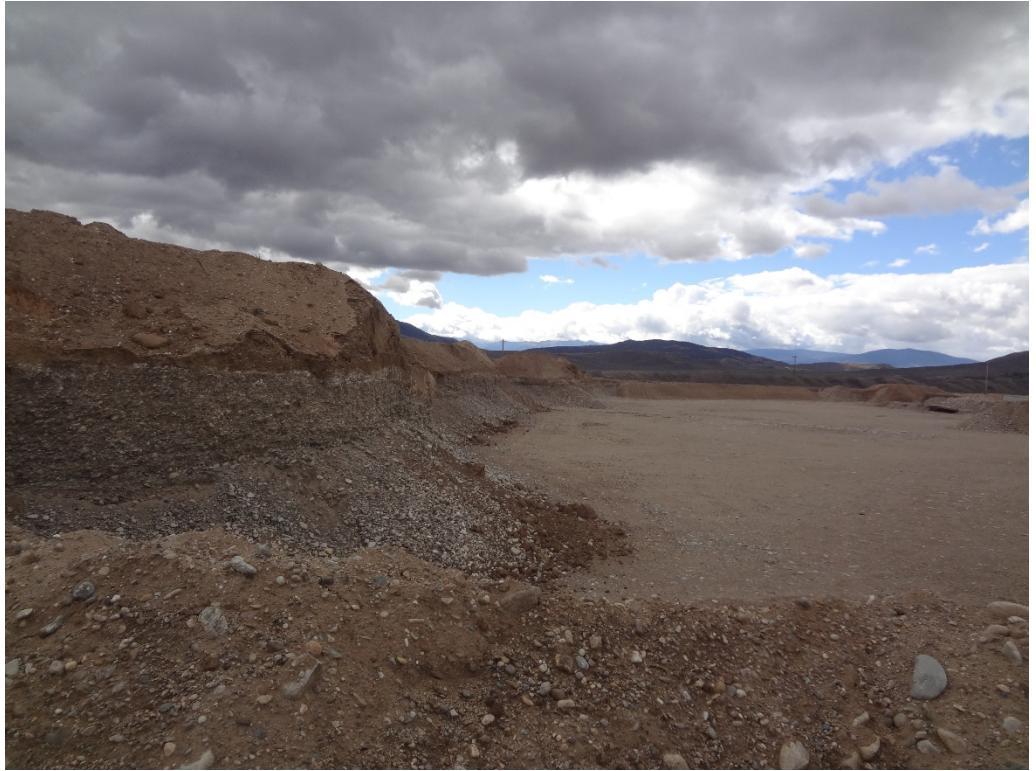
View of current east highwall from north end looking south

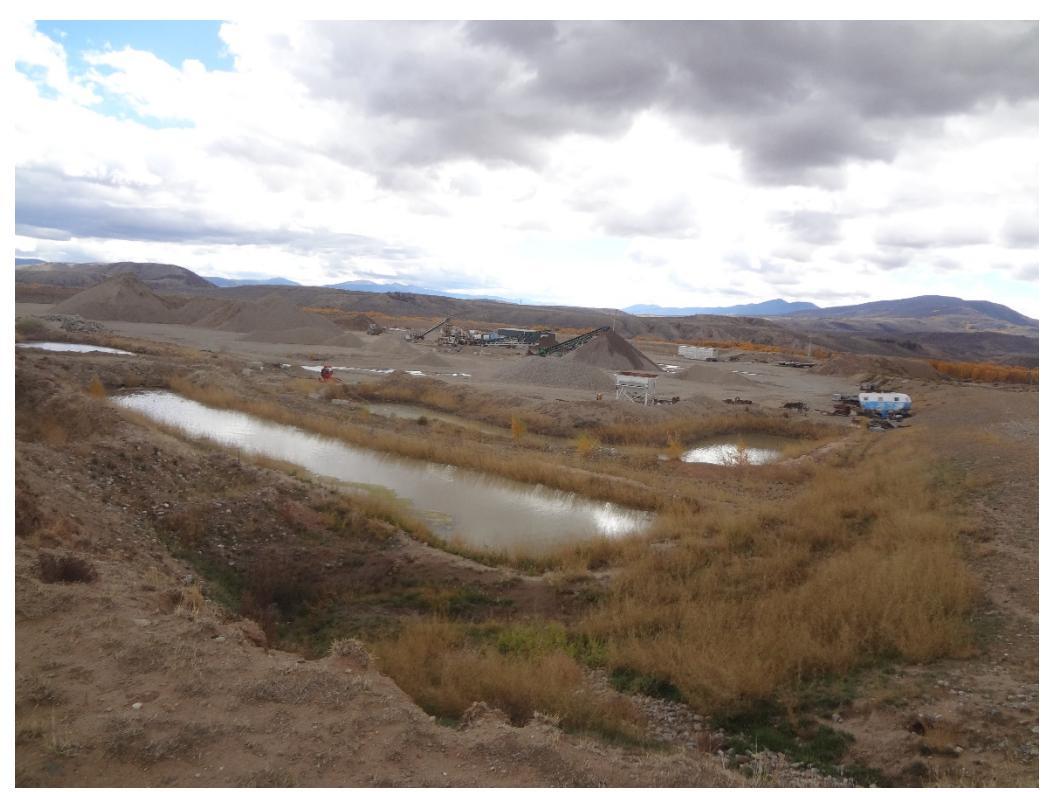
View of site and sedimentation ponds from northwest corner looking southeast

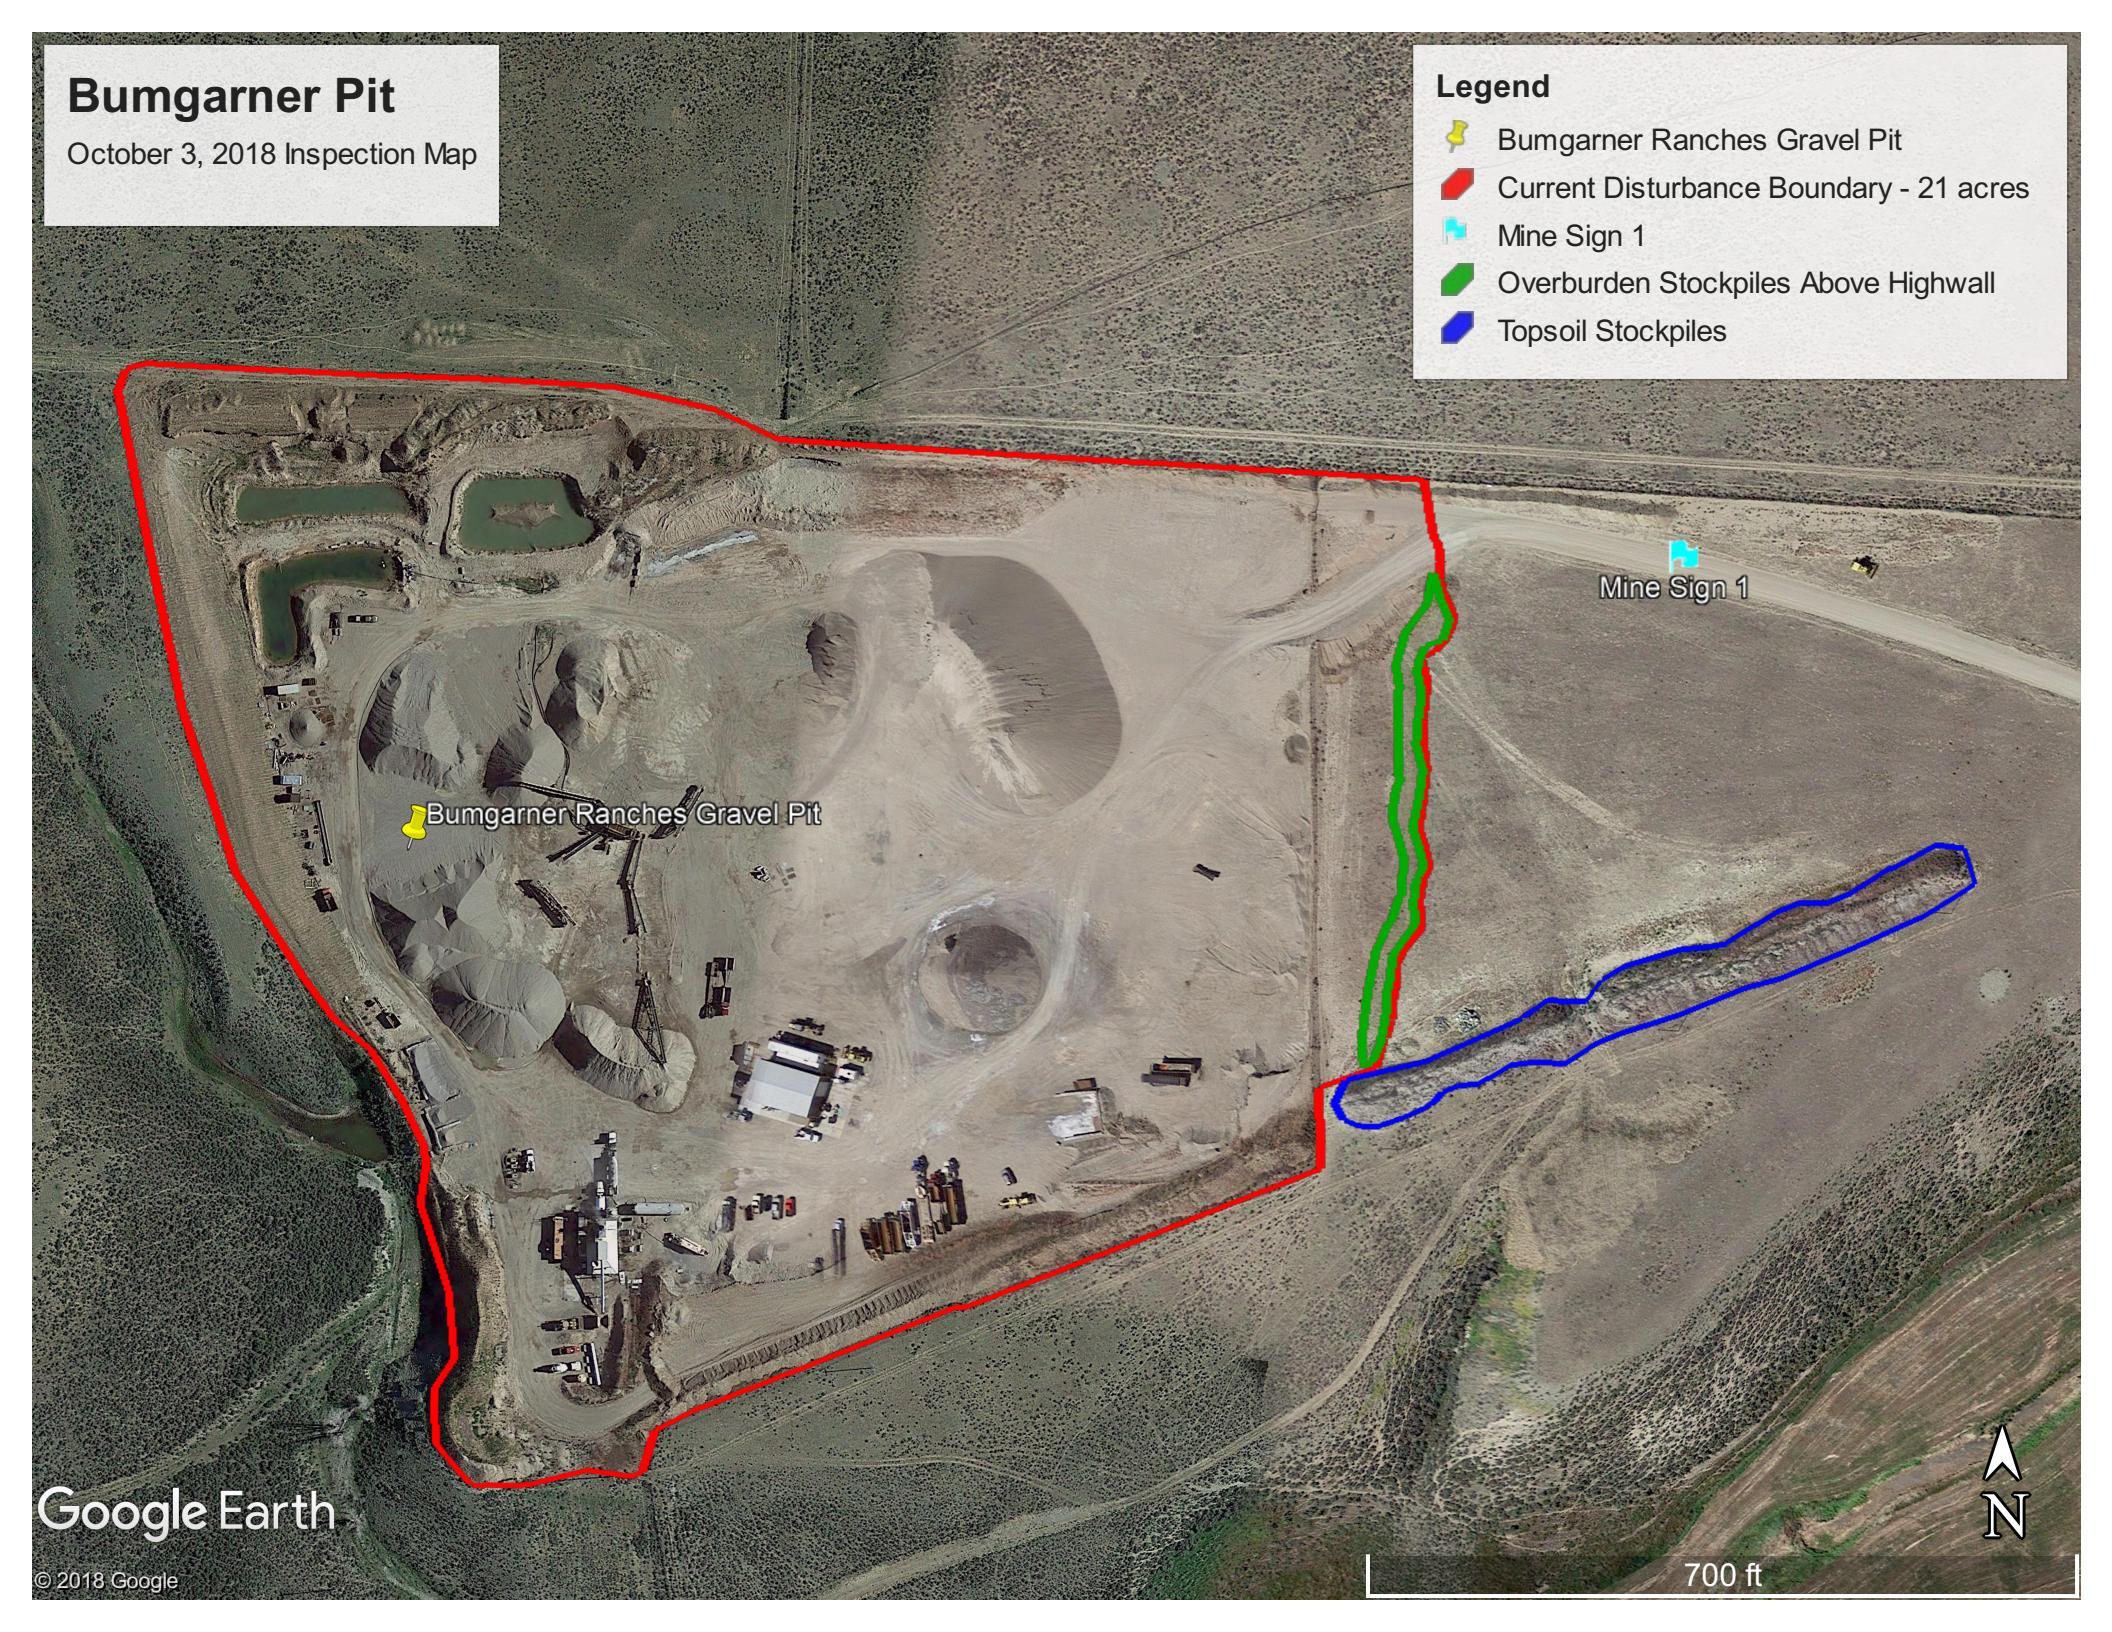
The affected area were GPS surveyed with a Juno 3B by the Division during the inspection. A map indicating the results of the GPS survey and observations from this inspection is attached. The surveyed affected area measured 21 acres, which is greater than the approved maximum disturbance area of 17 acres. As cited as a problem, the Operator has affected more than the approved 17 acres disturbance area. The Operator must submit a technical revision to modify the Mining Plan to allow for more affected acreage and provide an updated bond calculation based on the increased affected acreage limit chosen by the Operator. The Division recommends the Operator remove the maximum allowable disturbance acreage option and bond for the entire planned disturbance acreage.

CORRECTIVE ACTIONS: The Operator shall submit adequate financial warranty, as determined by the Division, for the currently affected 21 acres. A copy of the Division's estimate is attached for review. The Division will allow the Operator 14 days to review and comment on the estimate before issuing the notice of surety increase. The Division will send a separate surety increase notice to the Operator regarding the increase of the financial warranty. The Operator will have 60 days from the date of the surety increase notice to post the additional financial warranty.
