COLORADO Division of Reclamation, Mining and Safety Department of Natural Resources

MINERALS PROGRAM INSPECTION REPORT PHONE: (303) 866-3567

MINE NAME:		MINE/PROSPECTING ID#:	MINERAL:	COUNTY:		
Harms Pit		M-2013-018	Sand and gravel	Weld		
INSPECTION TYPE:		INSPECTOR(S):	INSP. DATE:	INSP. TIME:		
Monitoring		Peter S. Hays	October 10, 2018	10:00		
OPERATOR:		OPERATOR REPRESENTATIVE:	TYPE OF OPERATION:			
Pine Bluffs Gravel & Excavating, Inc.		Lonny Graves	112c - Construction Regular Operation			
REASON FOR INSPECTION:		BOND CALCULATION TYPE:	BOND AMOUNT:			
Normal I&E Program		Complete Bond	\$61,267.33			
DATE OF COMPLAINT:		POST INSP. CONTACTS:	JOINT INSP. AGENCY:			
NA		None	None			
WEATHER:	INSPECTOR'S SIGNATURE:		SIGNATURE DATE:			
Clear	f.A.m.		October 16, 2018

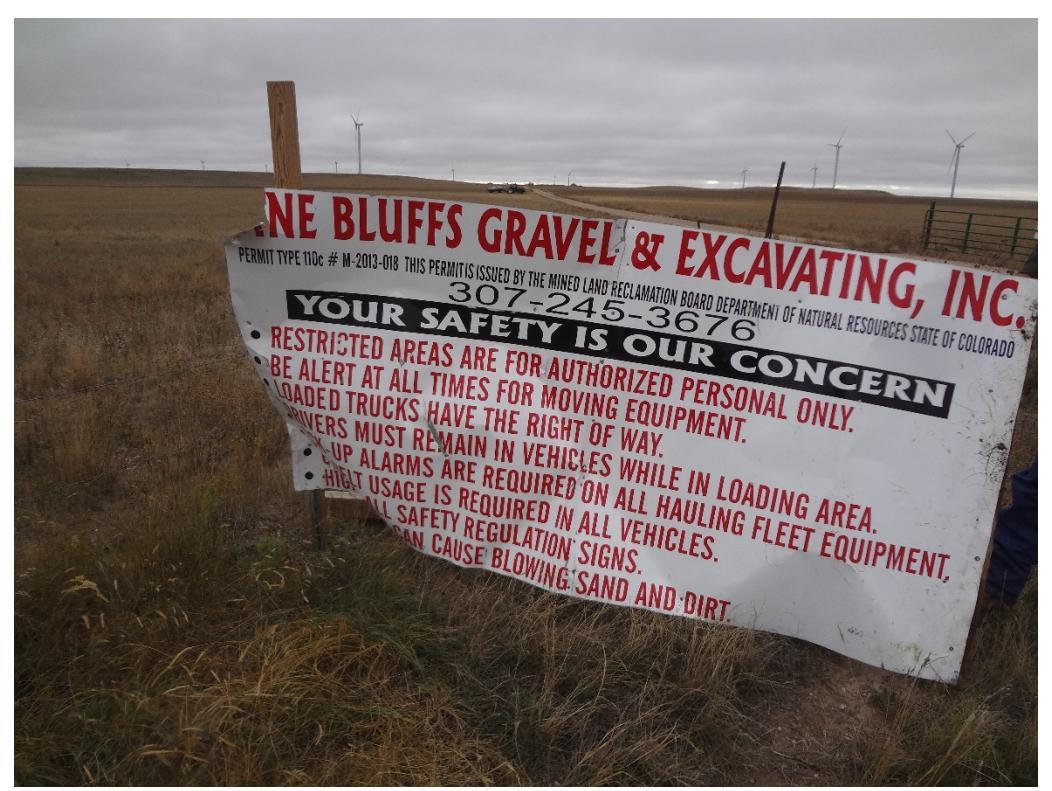
Damage Harms Pit mine sign

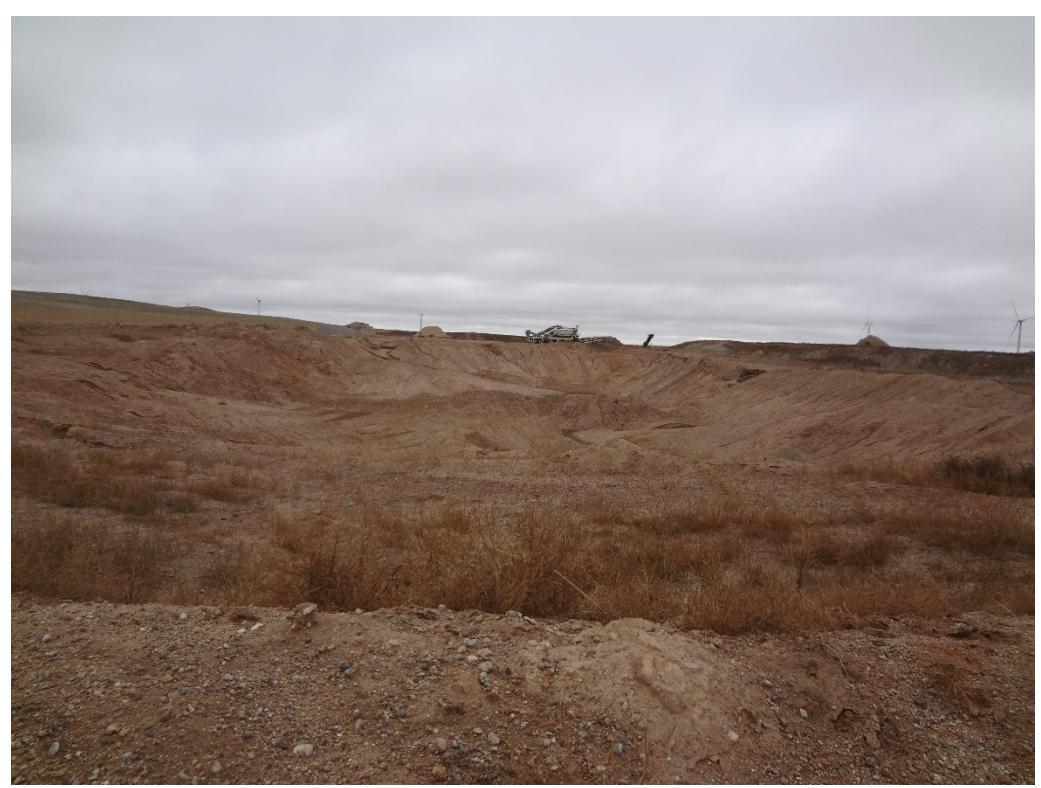
View of pit from the west side looking east

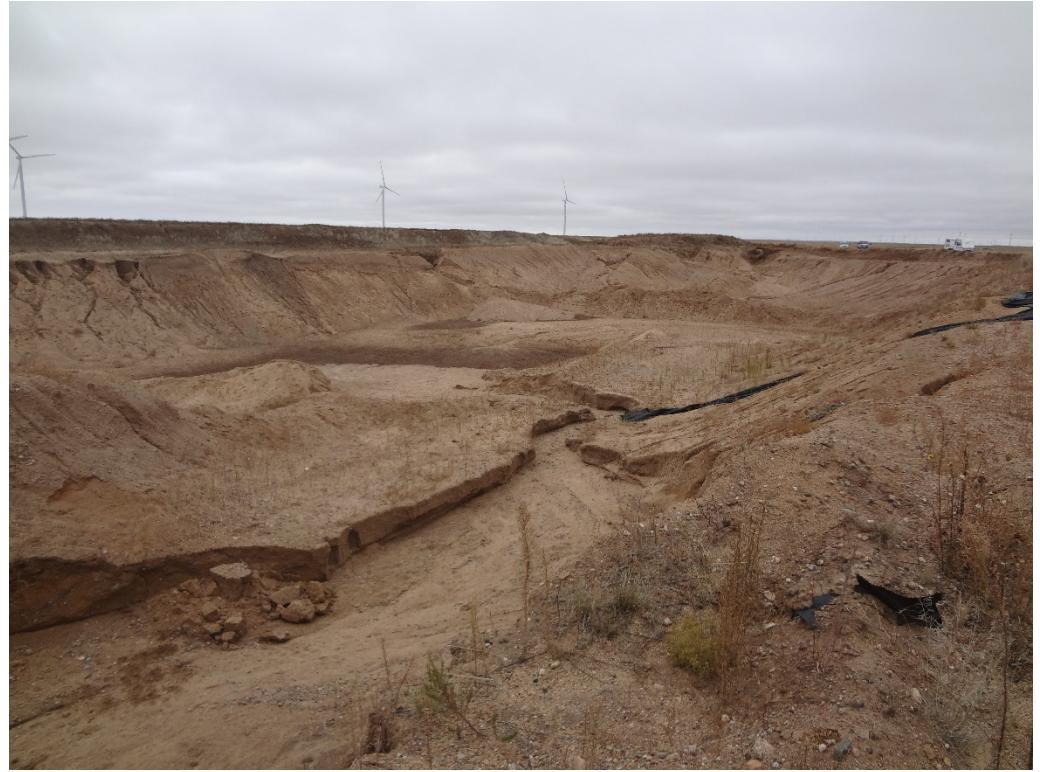
View of pit from the northeast corner looking southwest

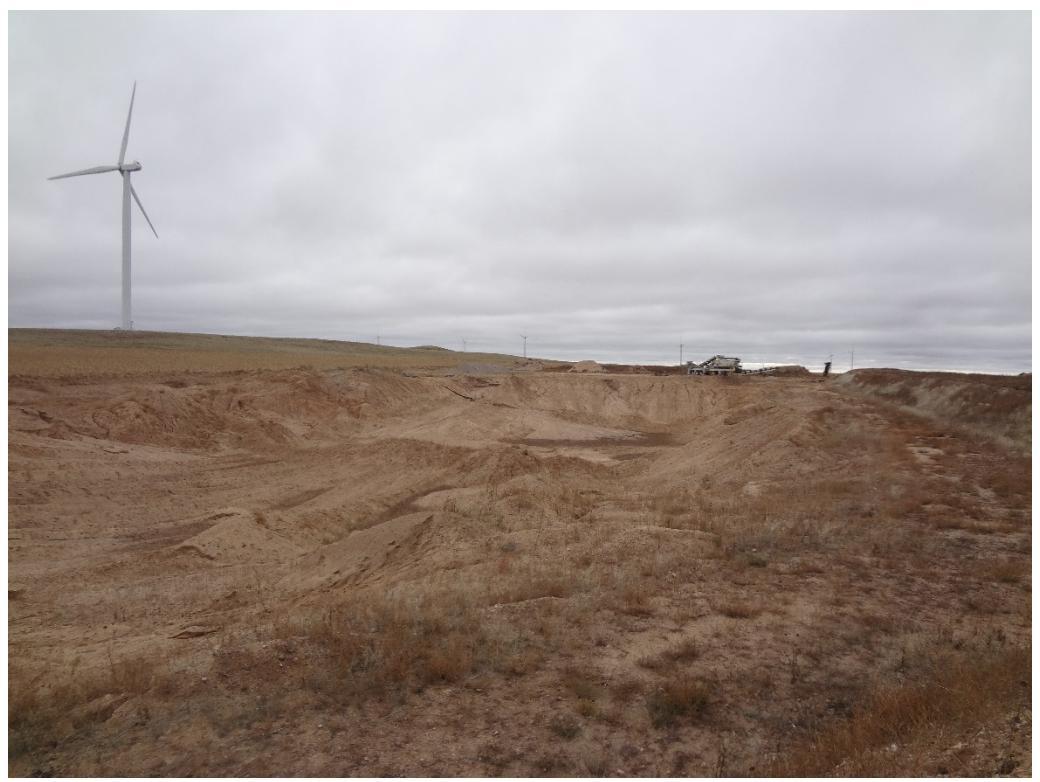
View of pit from the southwest corner looking northeast

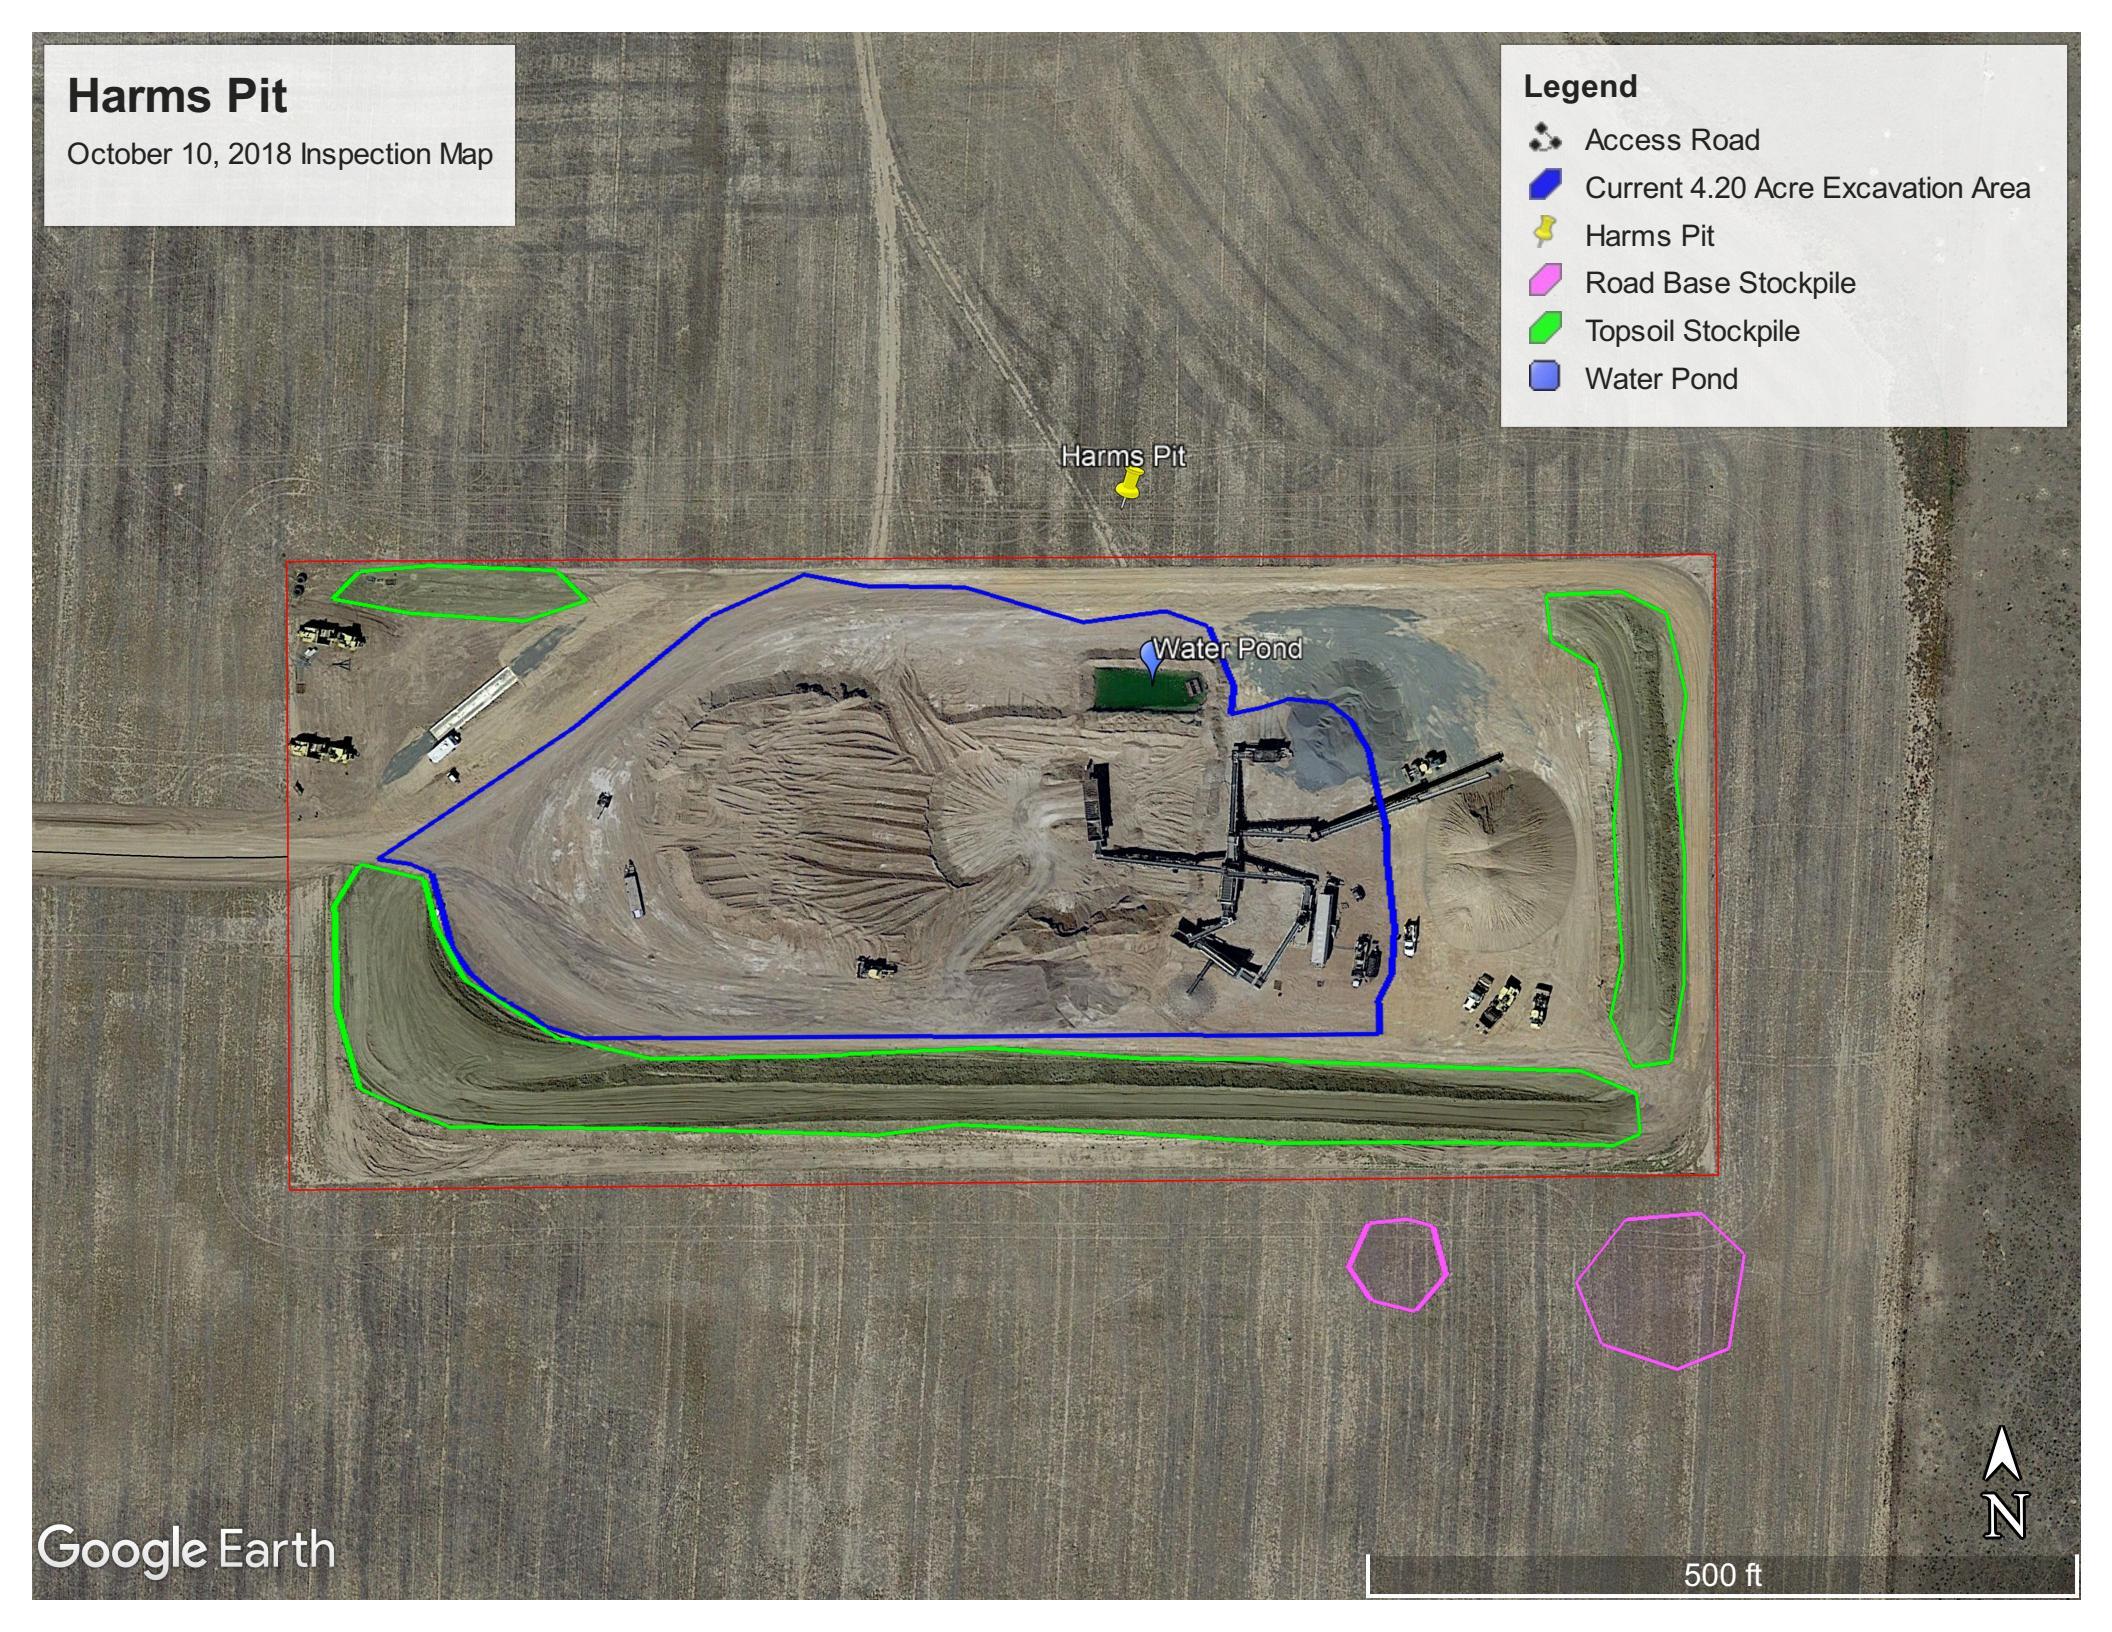
Enclosure – Inspection Map

The excavation area were GPS surveyed with a Juno 3B by the Division during the inspection. A map indicating the results of the GPS survey and observations from this inspection is attached.
