Minerals Plan of Operations Inspection U.S. Department of the Interior Bureau of Land Management Royal Gorge Field Office

Date: Nov 9, 2018	Operation Name: Gold Tamers LLC			
Time: 09:58	Case Number: COC73930			
Weather: Sunny	CDRMS Number: M-2009-056			
Attendees	General			
BLM: S. Carter & A. Sanderson	Operation(s) are in compliance with documentation on file			
	\Box Yes \checkmark No \Box N/A			
Operator(s): Scheduled 10:00 am inspection with Matt	Operation(s) and disturbance on-site coincide with the			
Donnelly, but not present	operations and access on file			
	\Box Yes \checkmark No \Box N/A			
Other(s): None

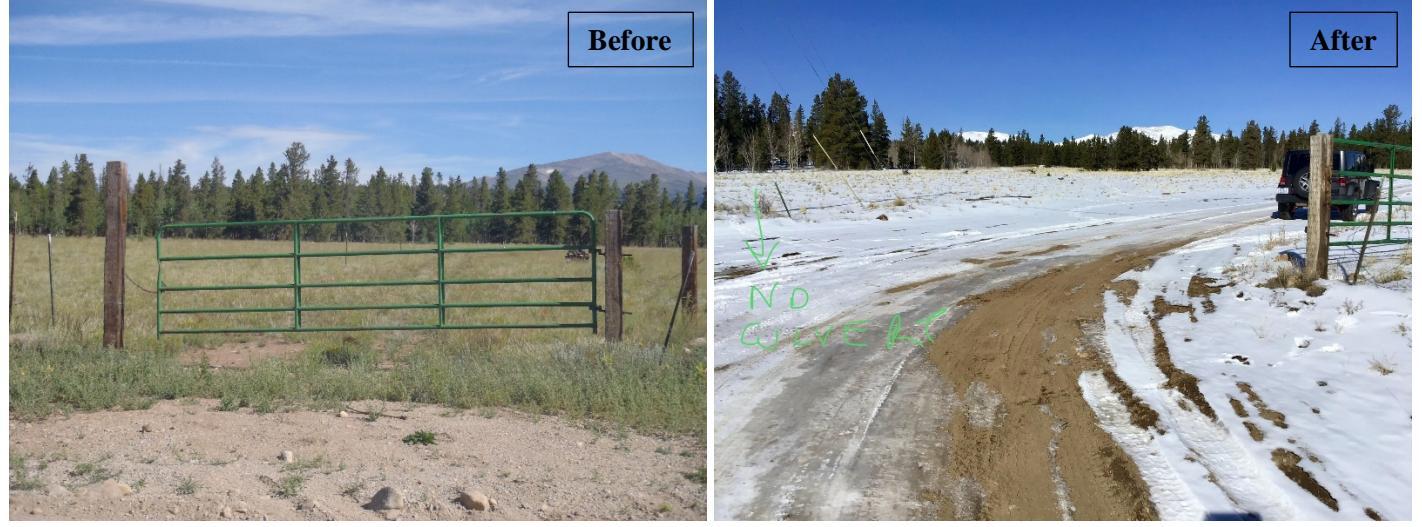
- <u>Park Co. Road Compliance:</u> Park Co. requested the operator obtain a driveway permit to prevent flooding and degradation of Thompson Park Road (access road). It appears that the operator widened the entrance into the site which blocked the drainage channel along Thompson Park Road (ref. images 1-2). In Section G of the Mining Plan, an 18" x 40' culvert would be installed where the access road meets Thompson Park Road. All drainage would be diverted toward the open pit.

Comment: Before and after images of the entrance to the Field of Dreams mine site from Thompson Park Road. No culvert is present at the entrance in either image.

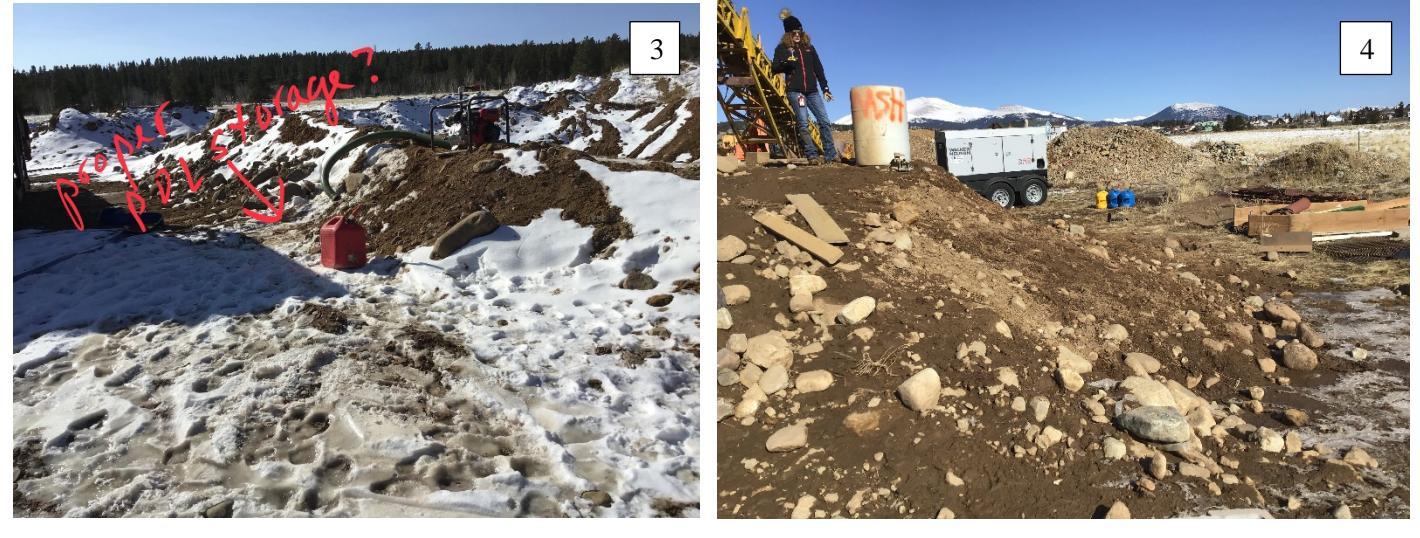
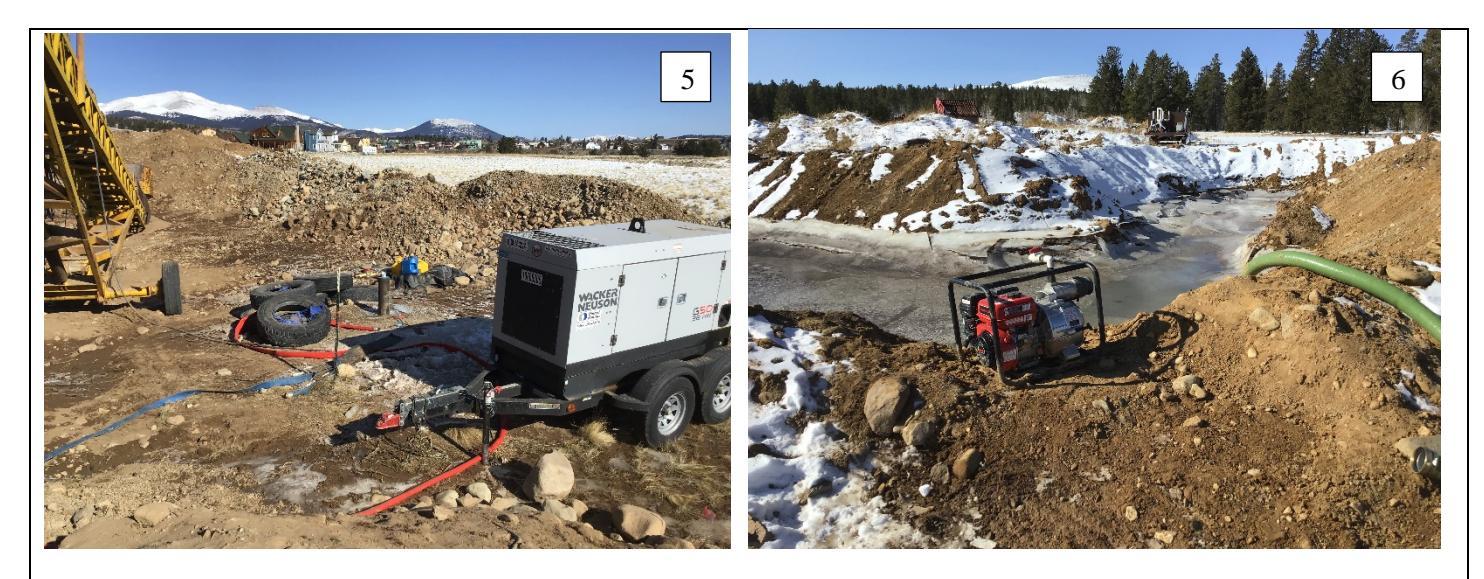
Image 3-6:

3.a. Non-compliant. *Gasoline, diesel and kerosene POL containers are not properly stored on-site. A designated storage area with the addition of secondary containment vessels is required to prevent potential spills and/or leaks. Several containers were stored a few feet north of the water well within a kiddie pool. These containers were the only POLs stored within secondary containment. Best Management Practices suggest to store all POLs away from water resources. Note: No sheen was observed on water surfaces. *All POLs will need to be removed off-site prior to the seasonal shut-down. Generators will also need to be properly stored during non-operational seasons.

Comment: Nine POL containers are improperly stored along the eastern and southern boundaries of the site (images 3-5). Three generators will need to be stored in a designated area during the non-operational season. Bung-hole 55 gal. drum now labeled "TRASH" (image 4).

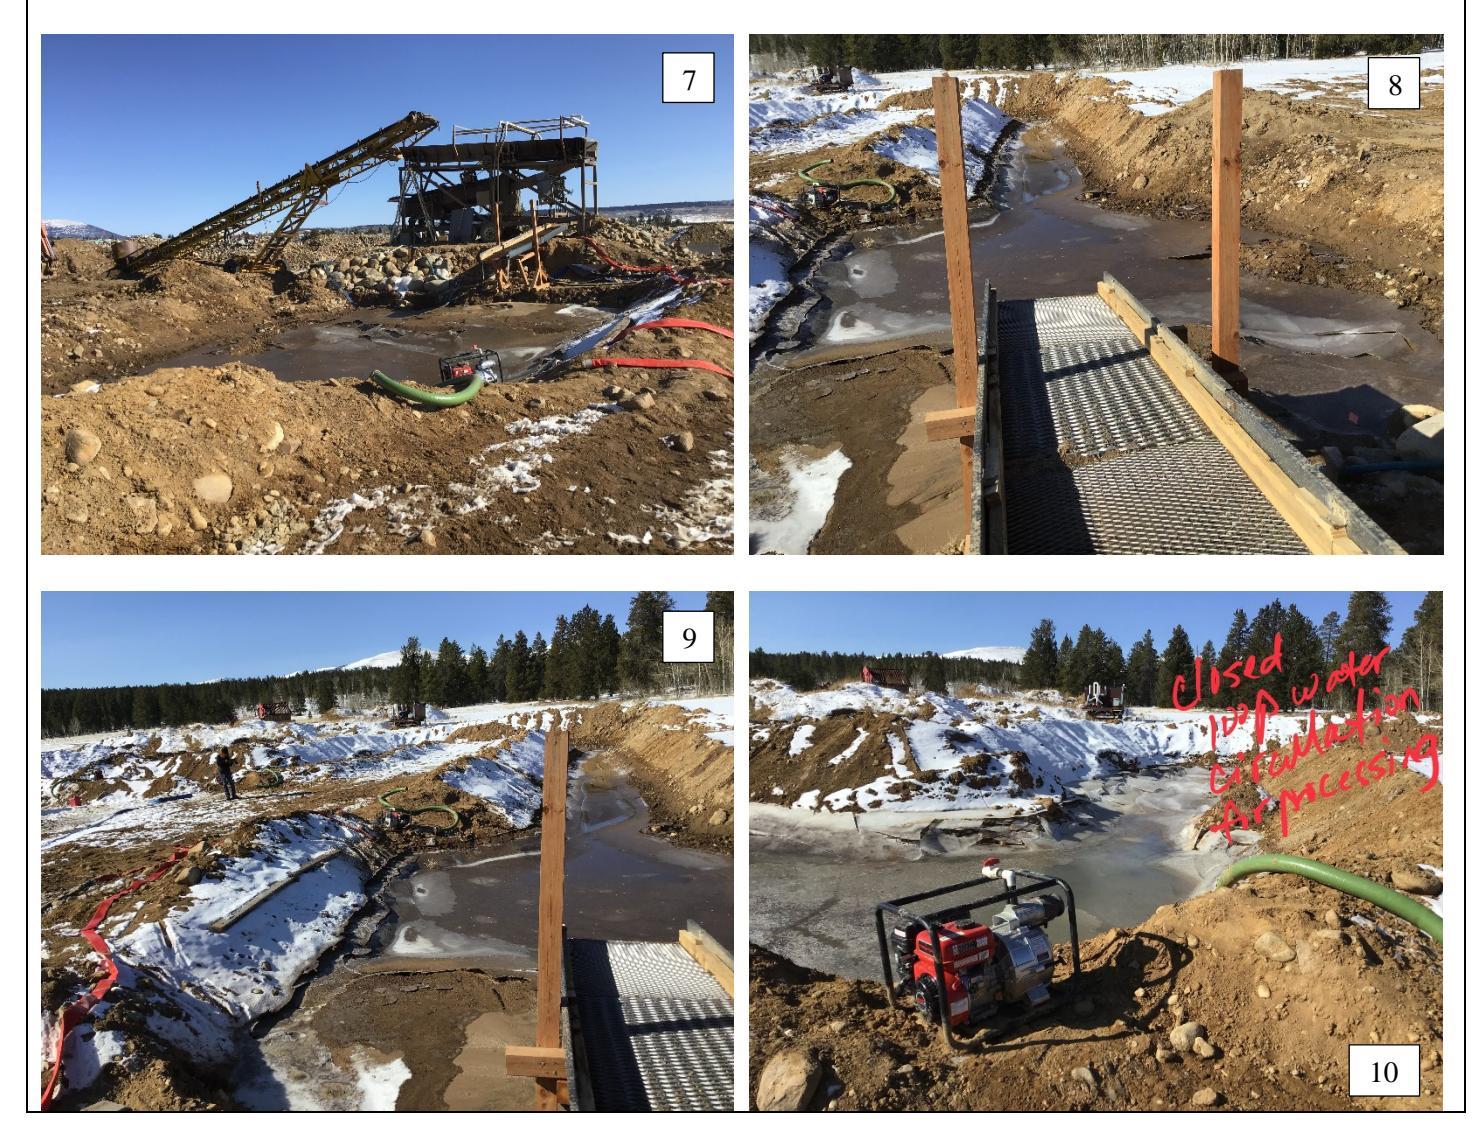
Image 7-10:

Comment: Newly excavated closed loop pond to circulate water during material processing. Multiple pumps and generators circulate the water while the grated sluice attached to the hopper sorts the material.

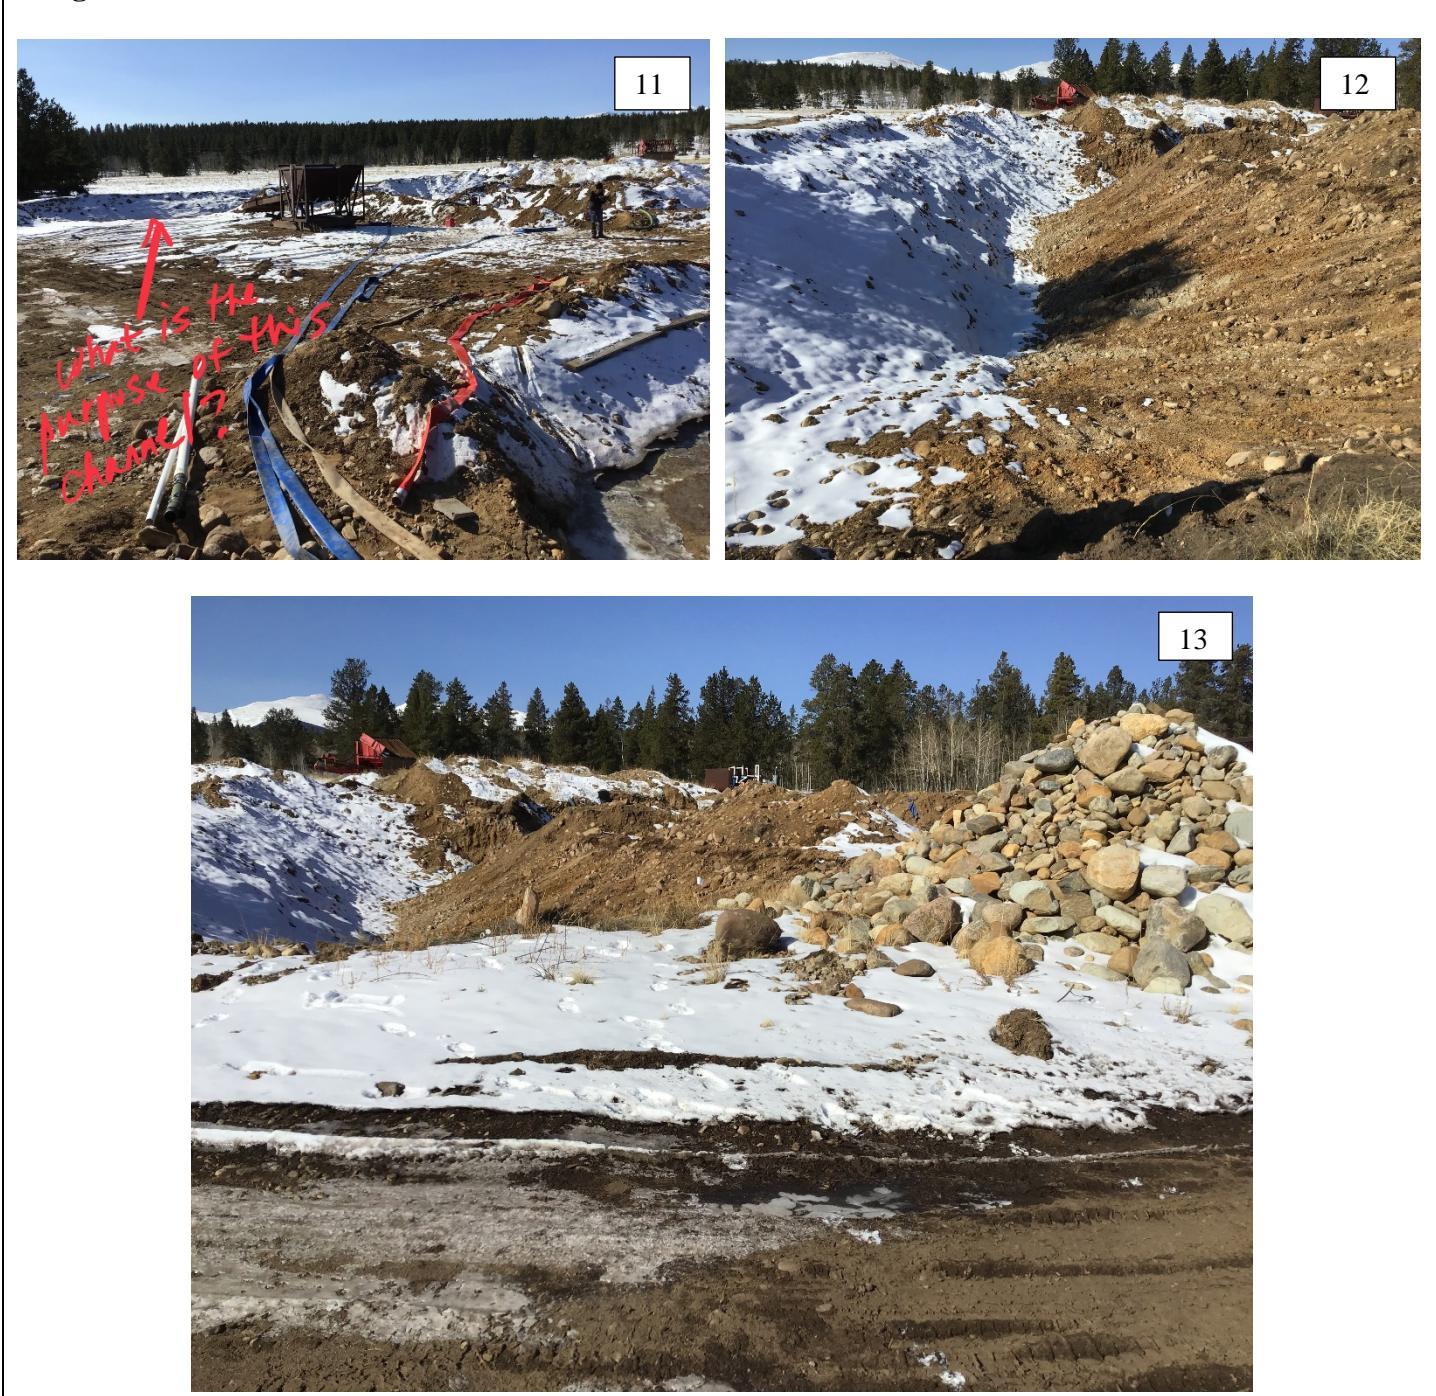
Image 11-13:

- Inspection and monitoring plan is required during the non-operational season. Ref. 5.a-c. above.
 - What is the purpose of the southern newly excavated trench? Ref. images 11-13. Will the old water storage channel, excavated prior to the Gold Tamer's ownership be backfilled or further excavated?

A newly excavated trench along the southern boundary has been dug. What is the purpose of this trench/channel? Is this trench a part of the water storage pond? Mineral materials stockpile located on the eastern portion of the excavated trench (image 13).

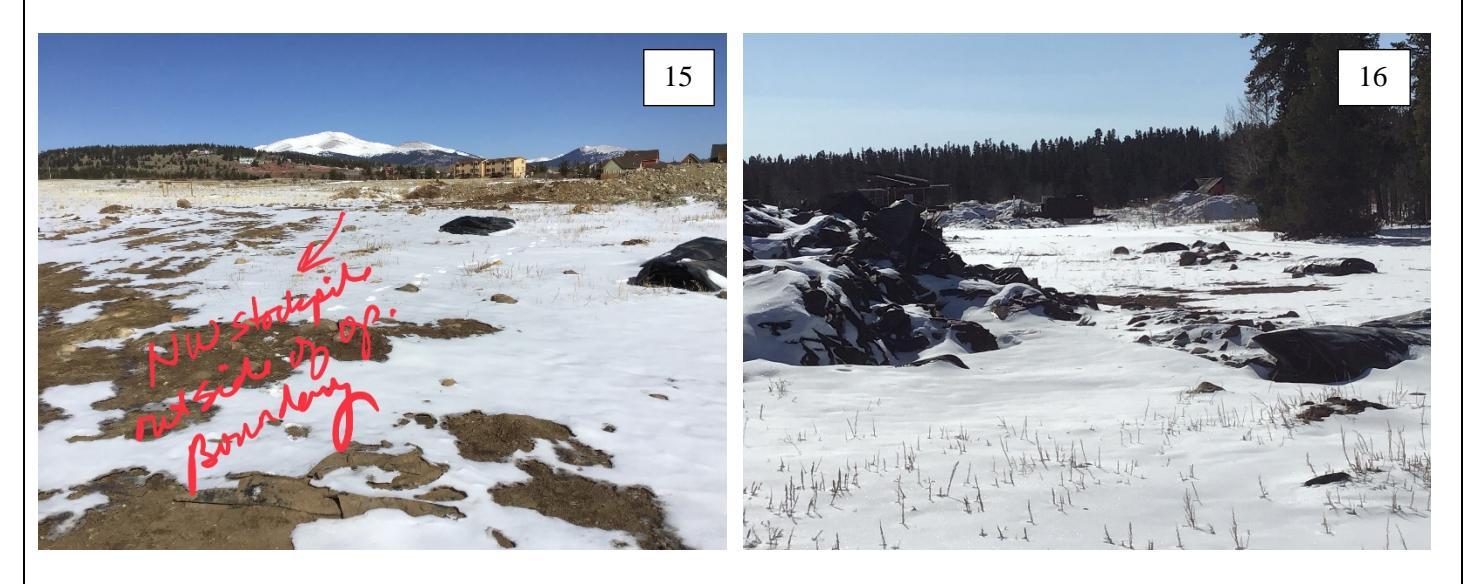
Image 15-16:

#8 As of 11/09/18, the dirt work noted as a non-compliance item for the past few months remains non-compliant. The remaining dirt was scheduled to be complete NLT 10/19/18. Ref. images 15-16.

NW and SW stockpiles located outside of authorized operational boundary. Dirt work still remains in non-compliance.

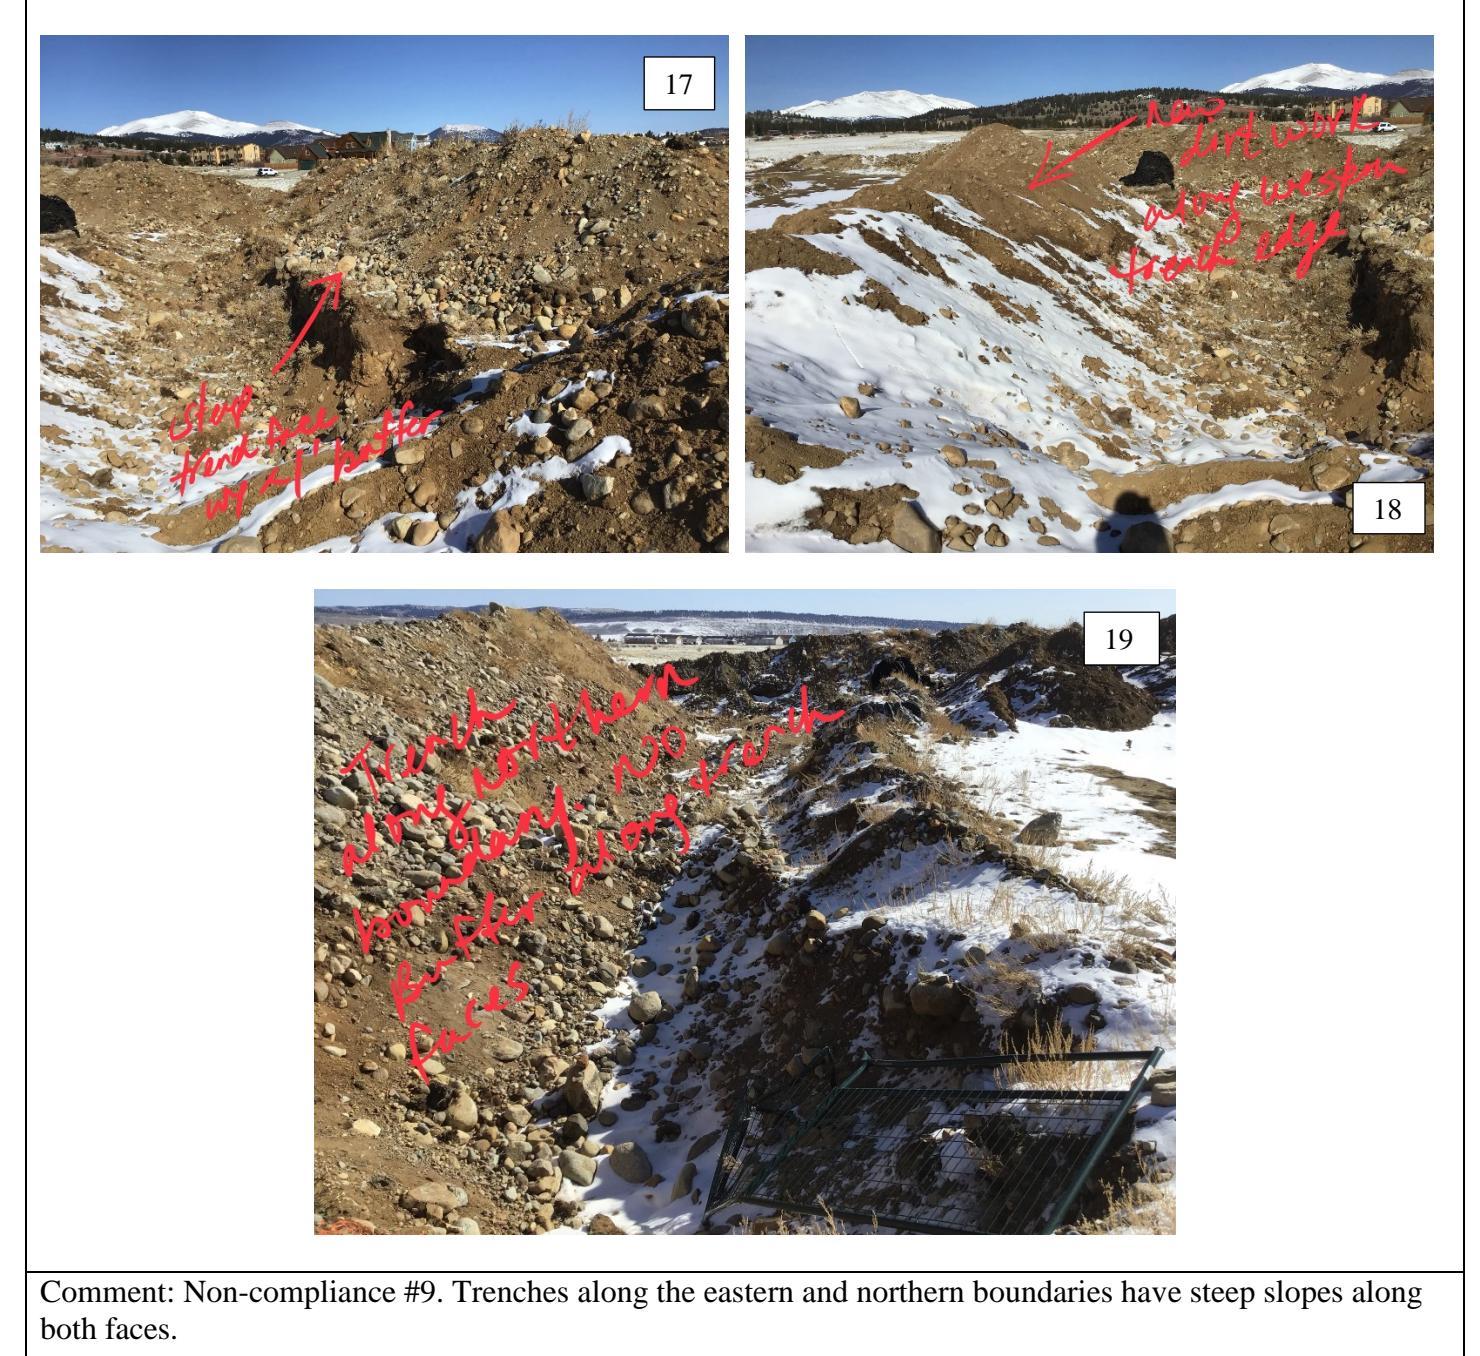
Image 17-19:

#9 As of 11/09/18, the dirt work noted as a non-compliance item for the past few months remains non-compliant. The remaining dirt was scheduled to be complete NLT 10/19/18. Ref. images 17-19.

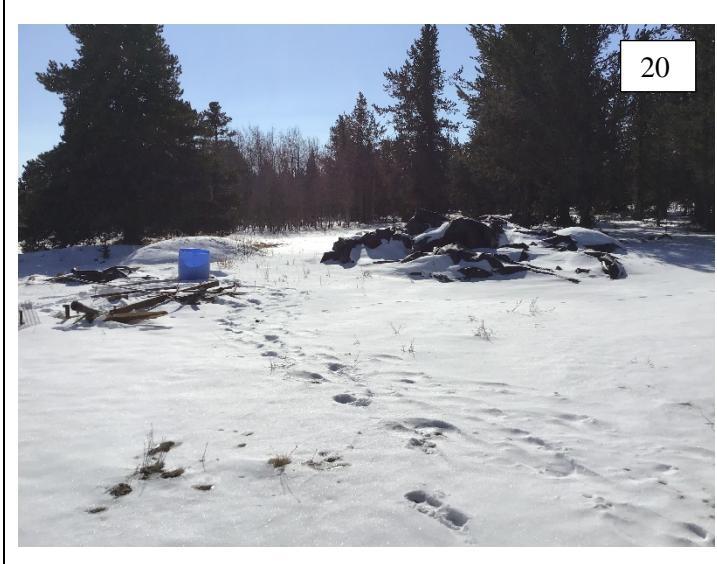
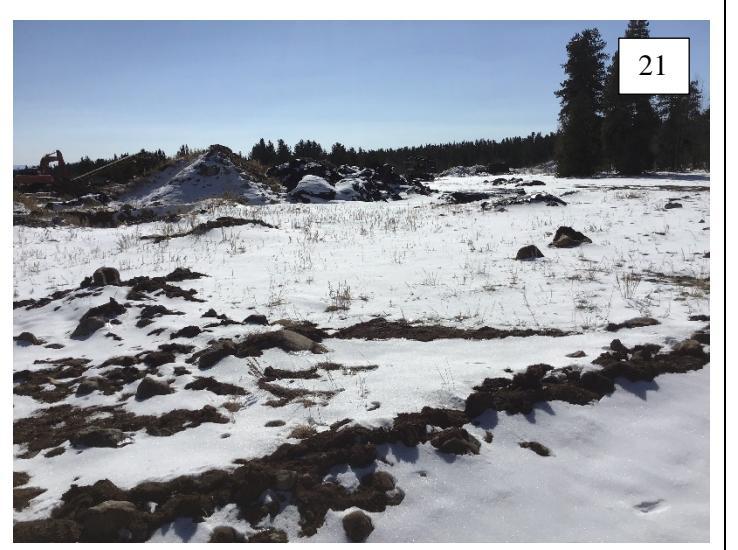
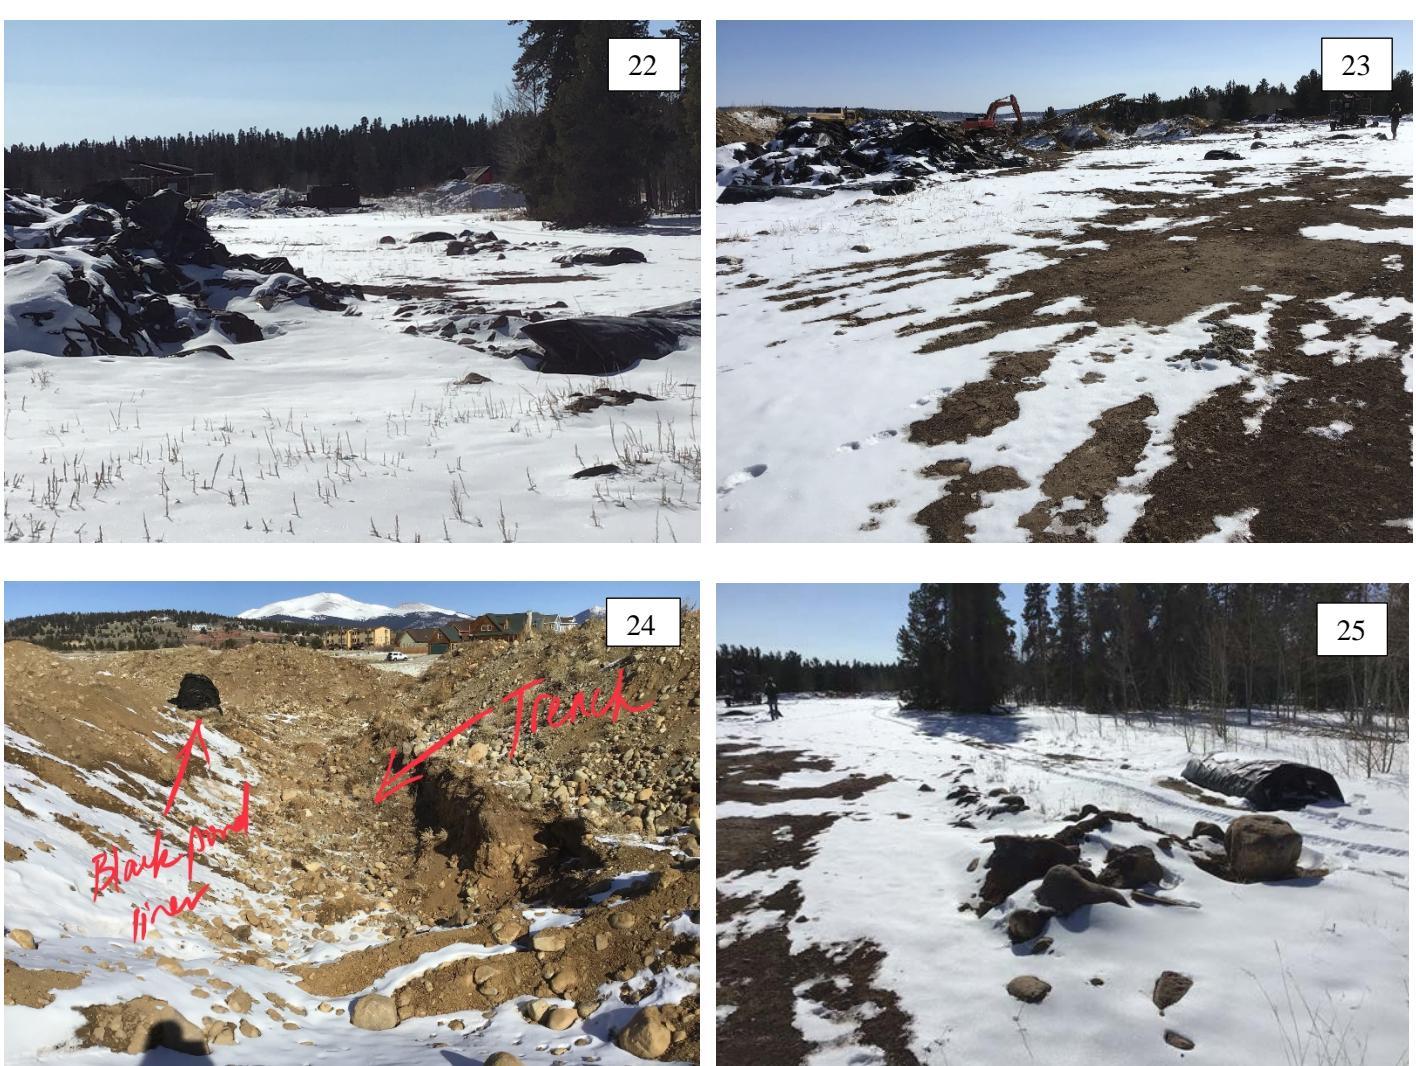
Image 20-25:

#7 Operator stated the pond liner would be either re-salvaged and stored in a general location or removed from the site NLT 10/19/18. As of 11/09/18 inspection, some of the pond liner on the western boundary was folded and stored, however portions of the pond liner located along the eastern trench and center open pit remain to be scattered and disorganized throughout the site. *Some of the folded pond liner has been stored outside the authorized boundary. Ref. image 20-25. The liner will need to be stored within the authorized boundary (Map 1; red boundary).

Comment: No designated area for pond liner. Some of the pond liner has been folded and organized along the western boundary. Folded pond liner is located outside of the authorized boundary (image 25).

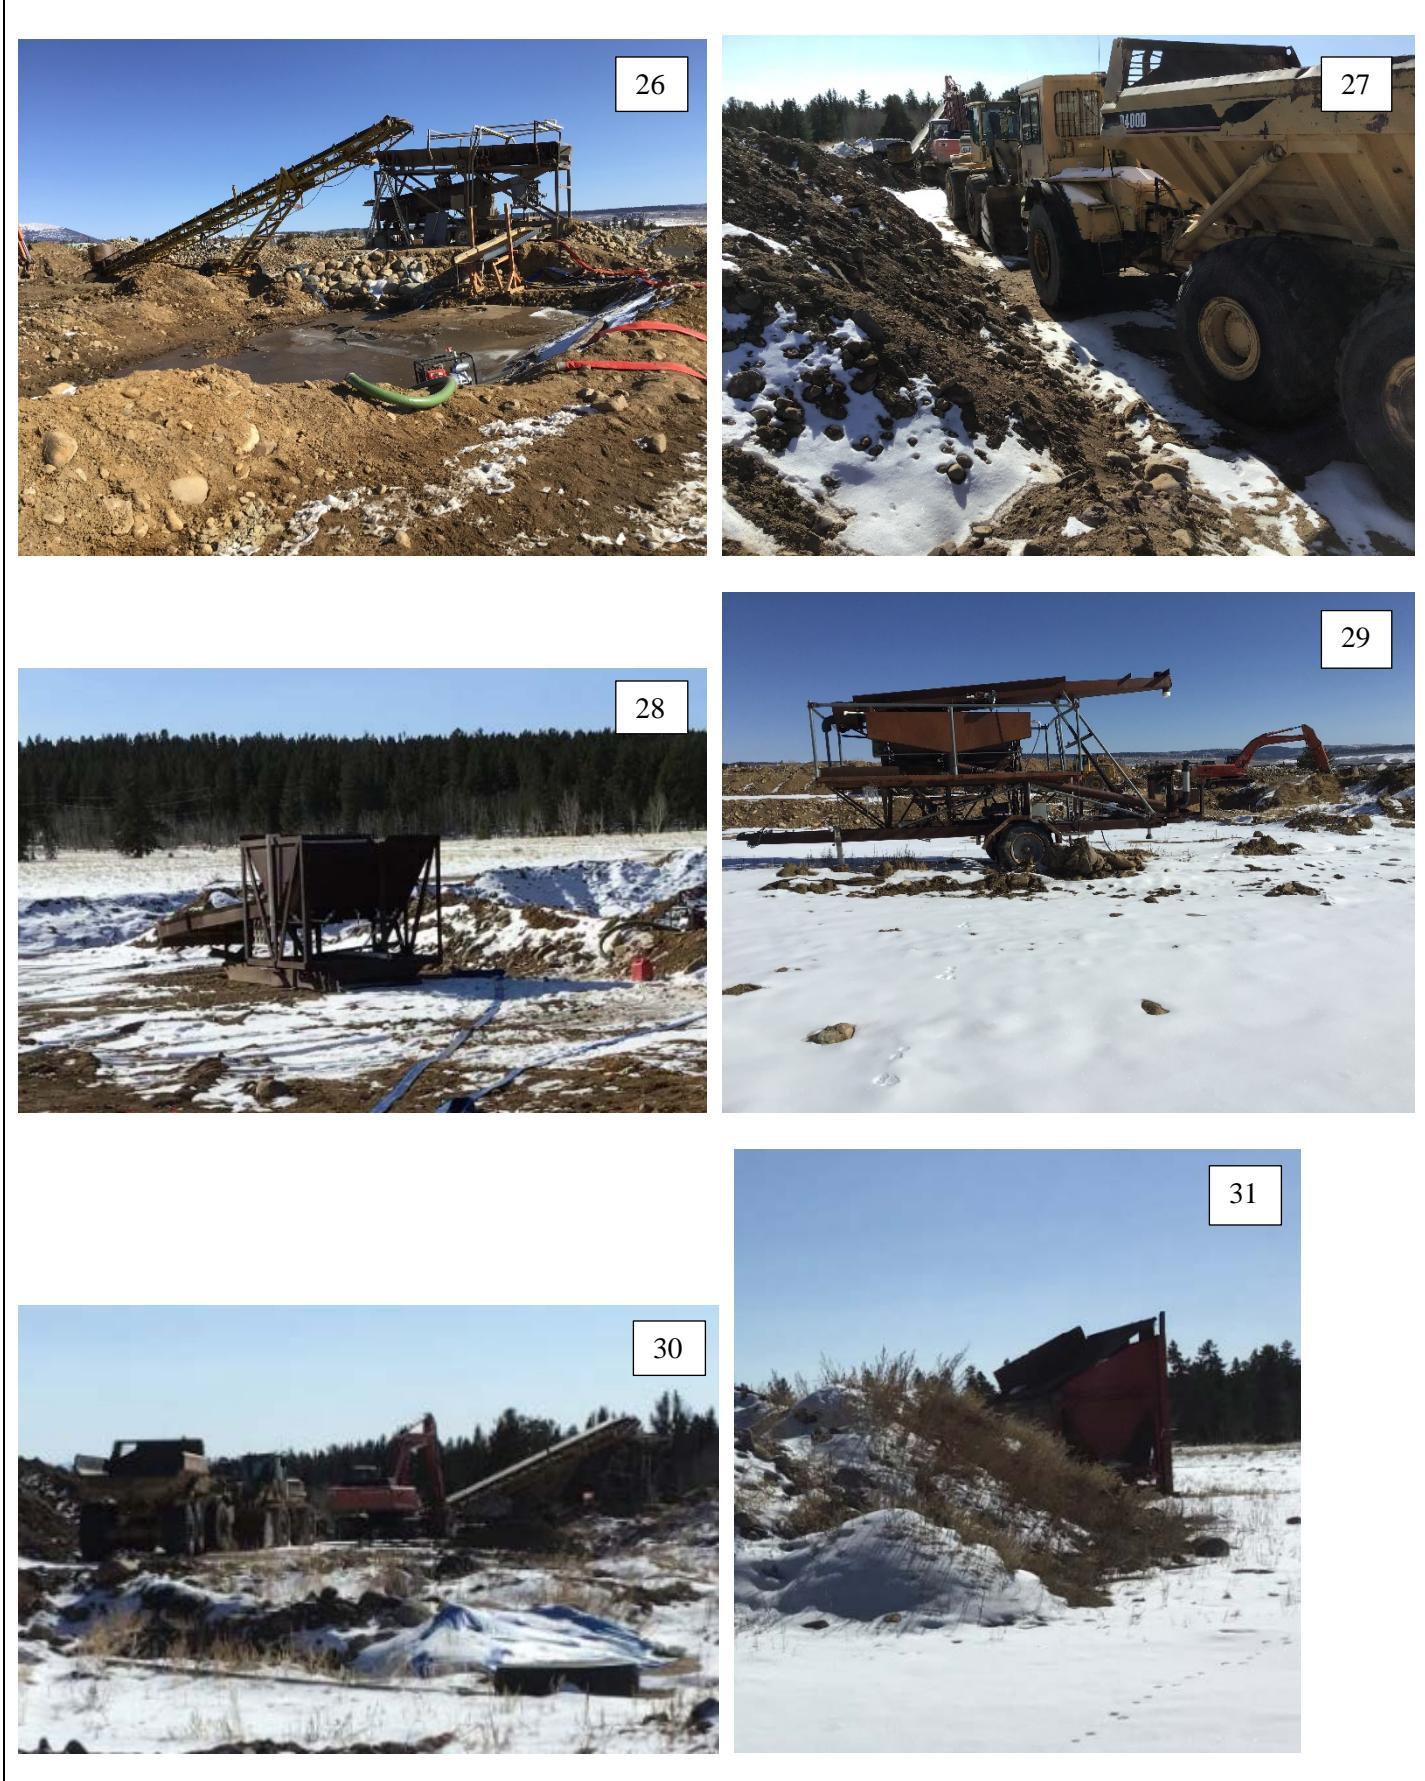
Image 26-31:

- <u>Equipment on-site:</u> An equipment modification will need to be requested by the operator to the current Plan of Operations. The equipment on-site is the following:

Comment: Equipment currently on-site.

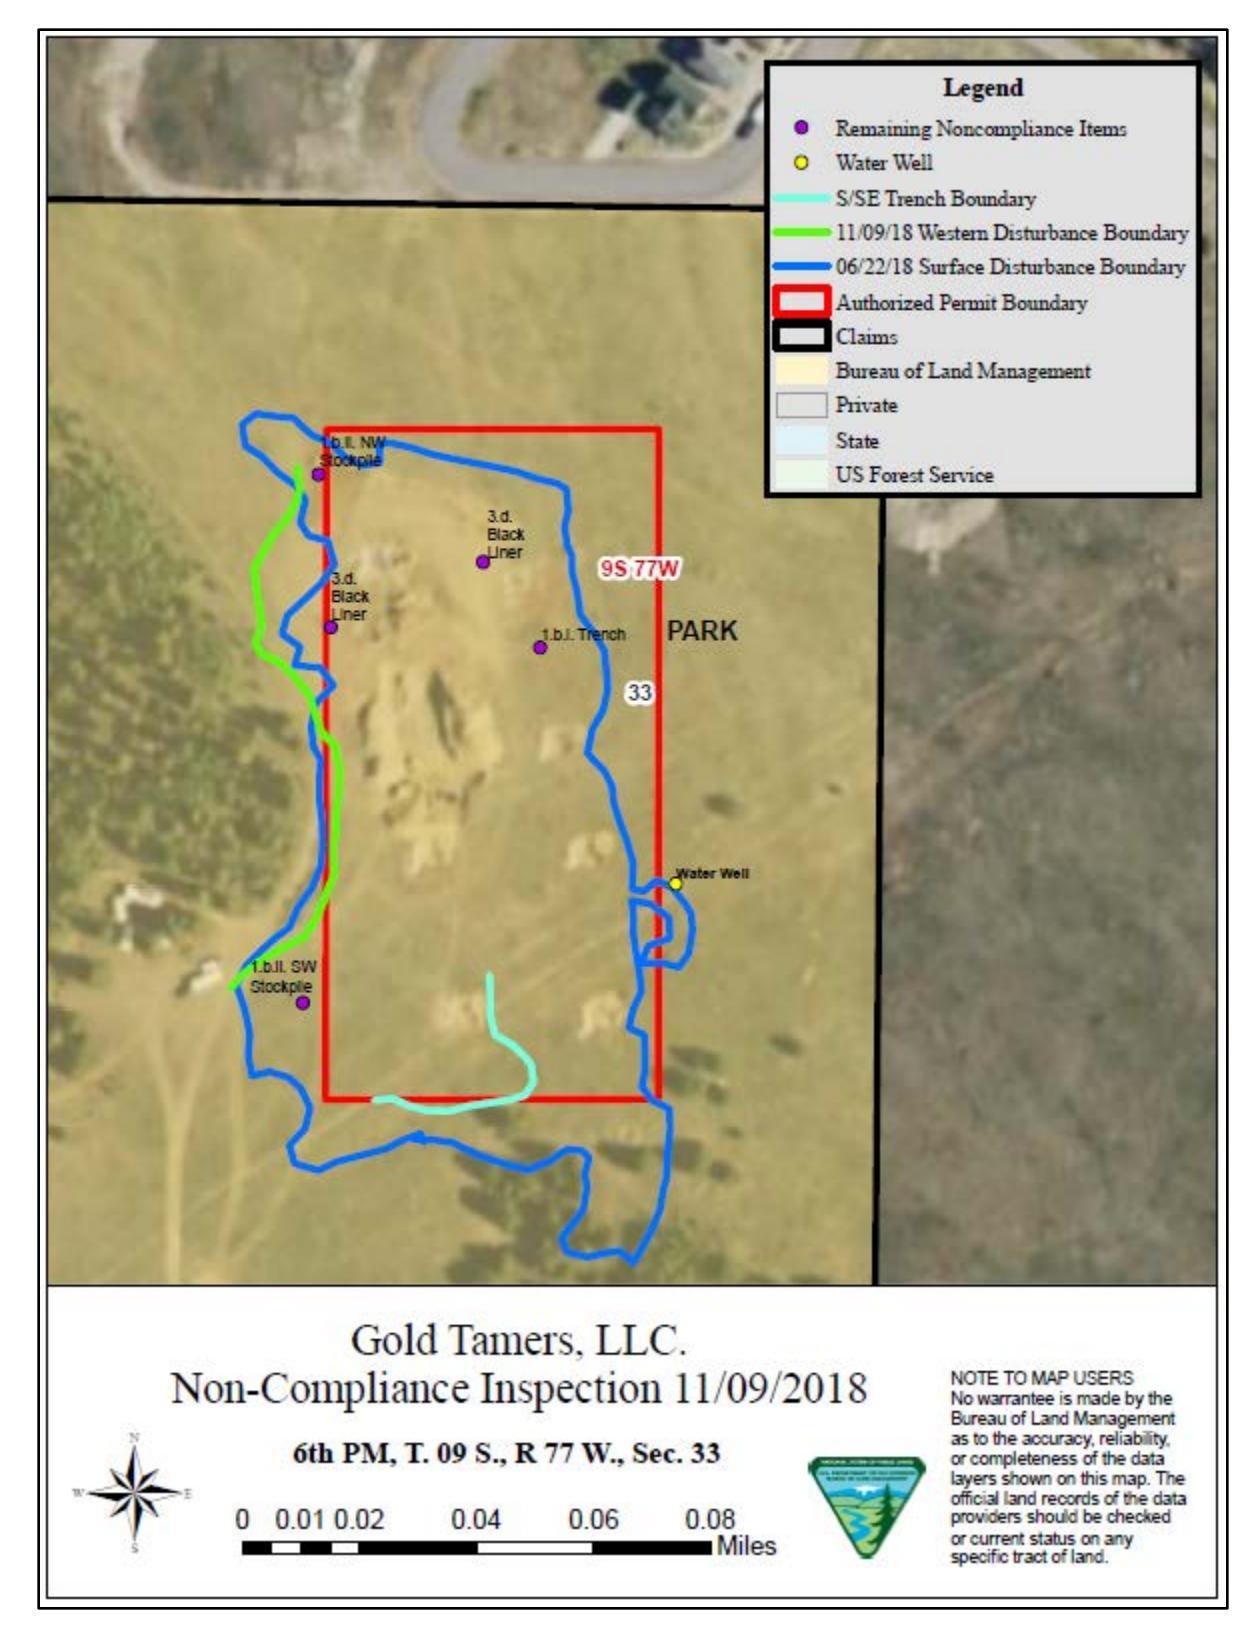
Map 1: Surface disturbance along the western boundary collected during the 11/09/18 inspection. This boundary denotes the operator's recent dirt work to resolve non-compliance items #8 and #9. Non-compliance items that remain to be completed are labeled in purple.
