**COLORADO Division of Reclamation, Mining and Safety** Department of Natural Resources

# MINERALS PROGRAM INSPECTION REPORT PHONE: (303) 866-3567

MINE NAME:		MINE/PROSPECTING ID#:	MINERAL:	COUNTY:
Schwartzwalder Mine		M-1977-300	Uranium	Jefferson
<b>INSPECTION TYPE:</b>		INSPECTOR(S):	INSP. DATE:	INSP. TIME:
Monitoring		Michael A. Cunningham	September 11, 2018	09:30
OPERATOR:		<b>OPERATOR REPRESENTATIVE:</b>	TYPE OF OPERATION:	
Colorado Legacy Land, LLC		Billy Ray, Paul Newman, Elizabeth Busby	112d-2 - Designated Mining Operation	
DELGON FOR INGREGEION			DOND AMOUNT	
<b>REASON FOR INSPECTION:</b>		BOND CALCULATION TYPE:	BOND AMOUNT:	
Normal I&E Program		None	\$8,900,000.00	
DATE OF COMPLAINT:		POST INSP. CONTACTS:	JOINT INSP. AGENCY:	
NA		None	None	
WEATHER:	INSPECTOR'S SIGNATURE:		SIGNATURE DATE:	
Clear	U	il C.f	September 25, 2018

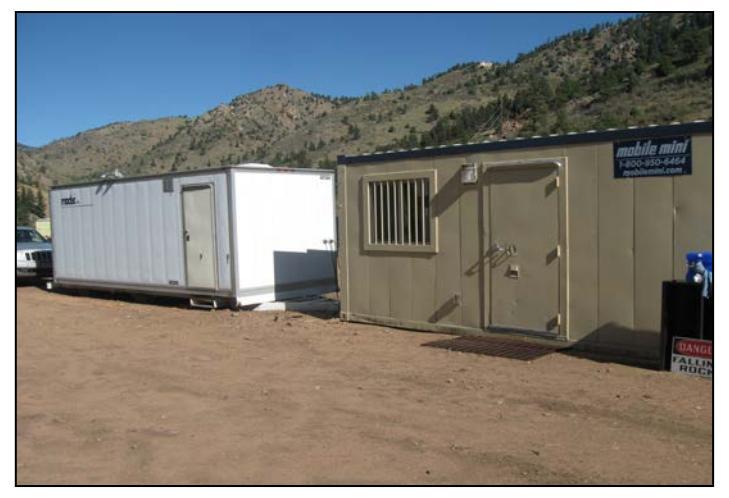
The Operator has installed a new portable office trailer on the mesa adjacent to the water treatment plant. In addition, two sea can storage containers have been installed next to the new water treatment plant. The Operator anticipates demolishing the old office trailer, the old water treatment plant and the concrete containment ponds by the end of 2018. All asbestos materials have been abated and removed from the site.

1. Office and lavatory trailers.

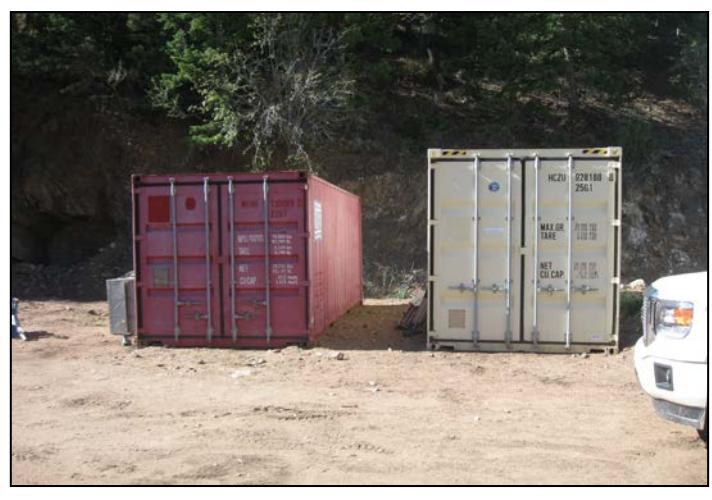
2. Sea can storage containers.

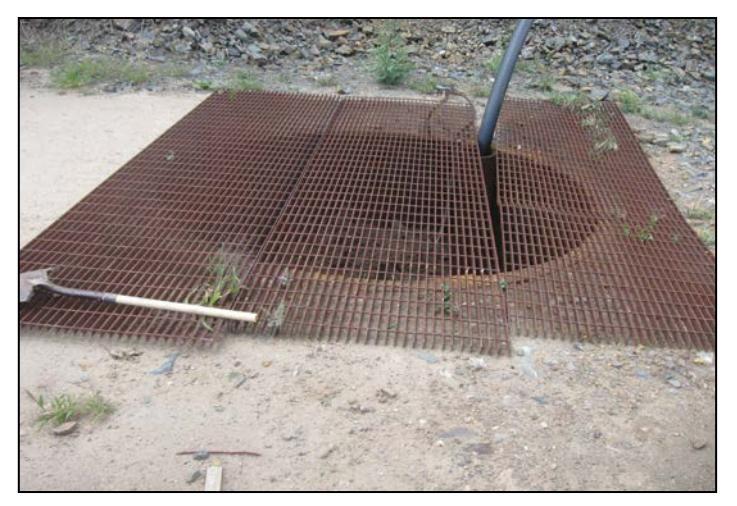
3. Jeffrey Air Shaft.

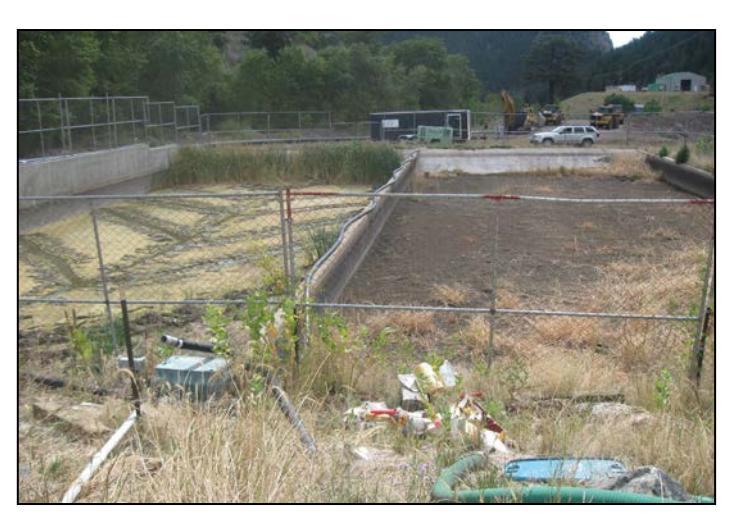
4. Concrete containment ponds to be demolished.

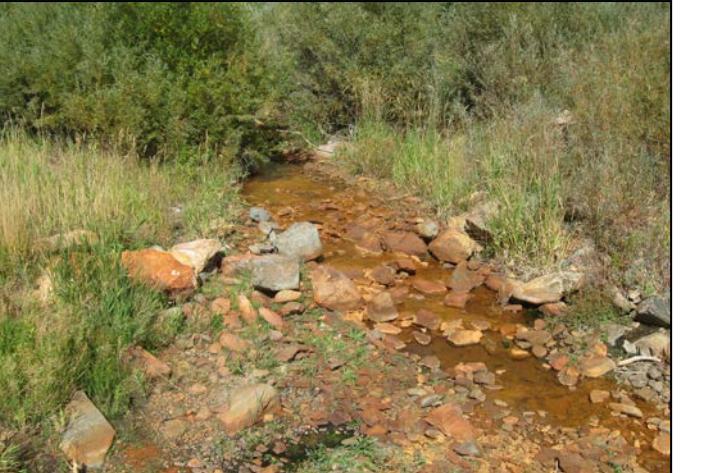
5. Ralston Creek, upstream of cut-off wall.

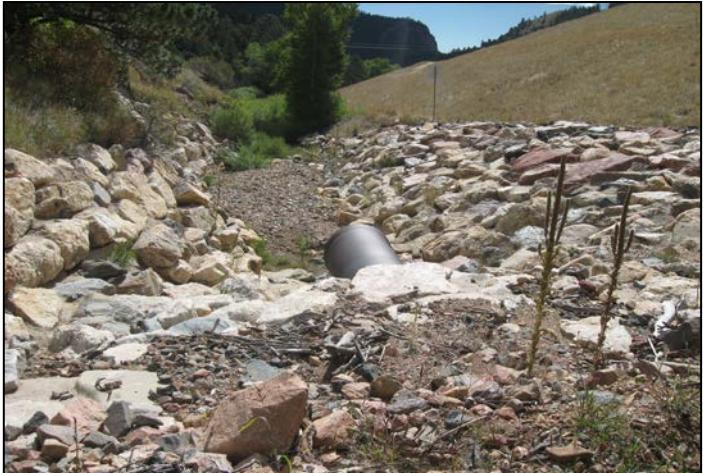
6. Ralston Creek, downstream of cut-off wall.
