COLORADO Division of Reclamation, Mining and Safety Department of Natural Resources

MINERALS PROGRAM INSPECTION REPORT PHONE: (303) 866-3567

MINE NAME:		MINE/PROSPECTING ID#:	MINERAL:	COUNTY:
West Farm Pit		M-2008-078	Gravel and sand	Prowers
INSPECTION TYPE:		INSPECTOR(S):	INSP. DATE:	INSP. TIME:
Preoperation Inspection		Amy Eschberger	November 29, 2018	13:30
OPERATOR:		OPERATOR REPRESENTATIVE:	TYPE OF OPERATION:	
Prowers Aggregate Operators, LLC		Roy Cue	112c - Construction Regular Operation	
REASON FOR INSPECTION:		BOND CALCULATION TYPE:	BOND AMOUNT:	
Preoperation Inspection		Complete Bond	\$575,000.00	
DATE OF COMPLAINT:		POST INSP. CONTACTS:	JOINT INSP. AGENCY:	
NA		None	None	
WEATHER:	INSPECTOR'S SIGNATURE:		SIGNATURE DATE:	
Clear	1 5 .		January 25, 2019	
	11	my Crehluger	•

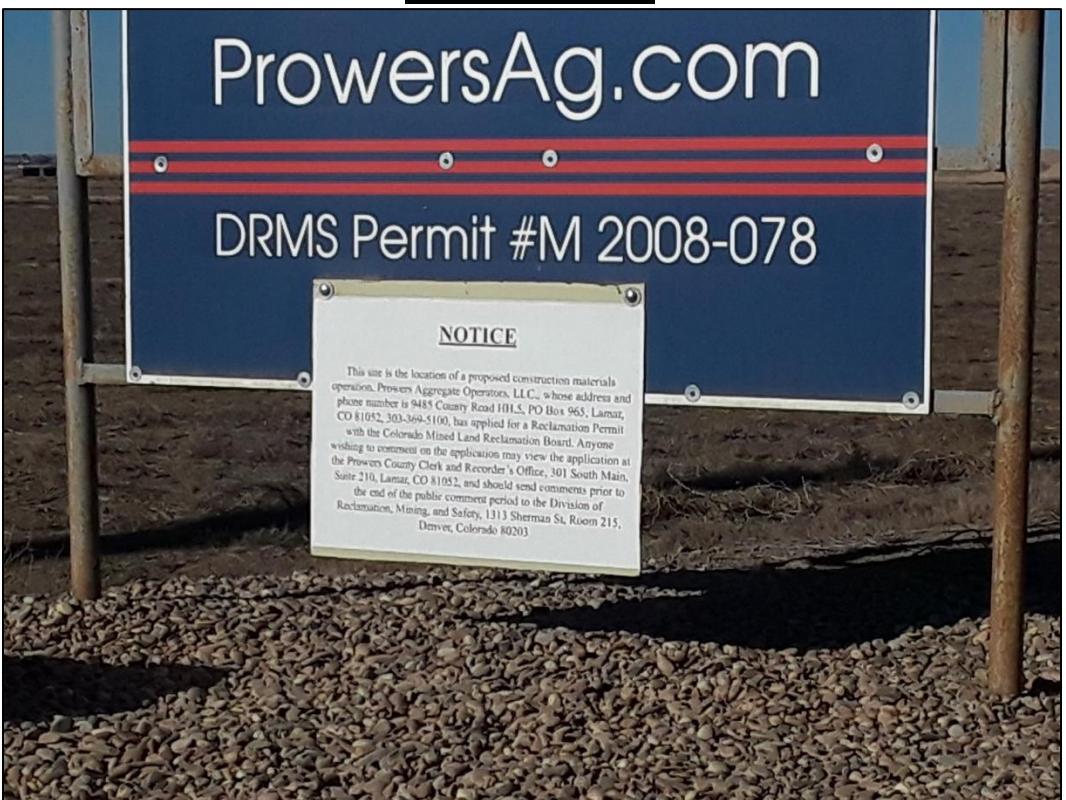
The site was active during the inspection. A public notice sign for AM-1 was posted at the main site entrance in accordance with Rule 1.6.2(1)(b) (**Photo 1**). The proposed expansion areas were delineated with wooden stakes. The operation is currently mining in phases 8 and 11 of the North Mining Area (**Photos 2-4**). The pit is approximately 60 feet deep. A series of settling ponds have been constructed on the pit floor from which water is pumped out to an adjacent farm ditch that ultimately discharges to the Arkansas River. This discharge activity is covered by the operator's discharge permit. Some portions of the pit highwalls have been graded to 3H:1V, while other portions have slope gradients at approximately 0.5H:1V. AM-01 proposes mining at a 3H:1V slope and therefore, does not include costs in the bond estimate for grading pit slopes to 3H:1V for reclamation. If the operation does not intend to mine slopes at 3H:1V, costs for grading a maximum length of active highwall to 3H:1V will need to be included in the bond estimate.

Photo 1. View of public notice sign posted at main entrance to site in accordance with Rule 1.6.2(1)(b).

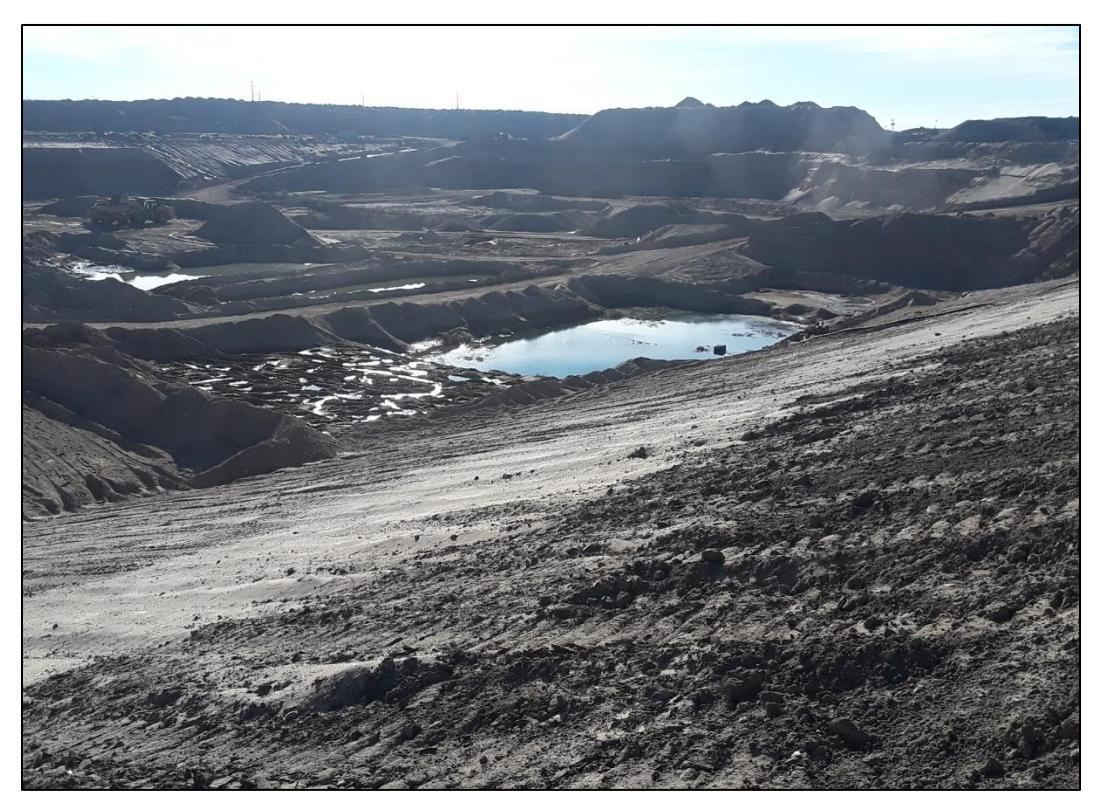
Photo 2. View looking southwest across active pit located in phases 8 and 11 of North Mining Area.

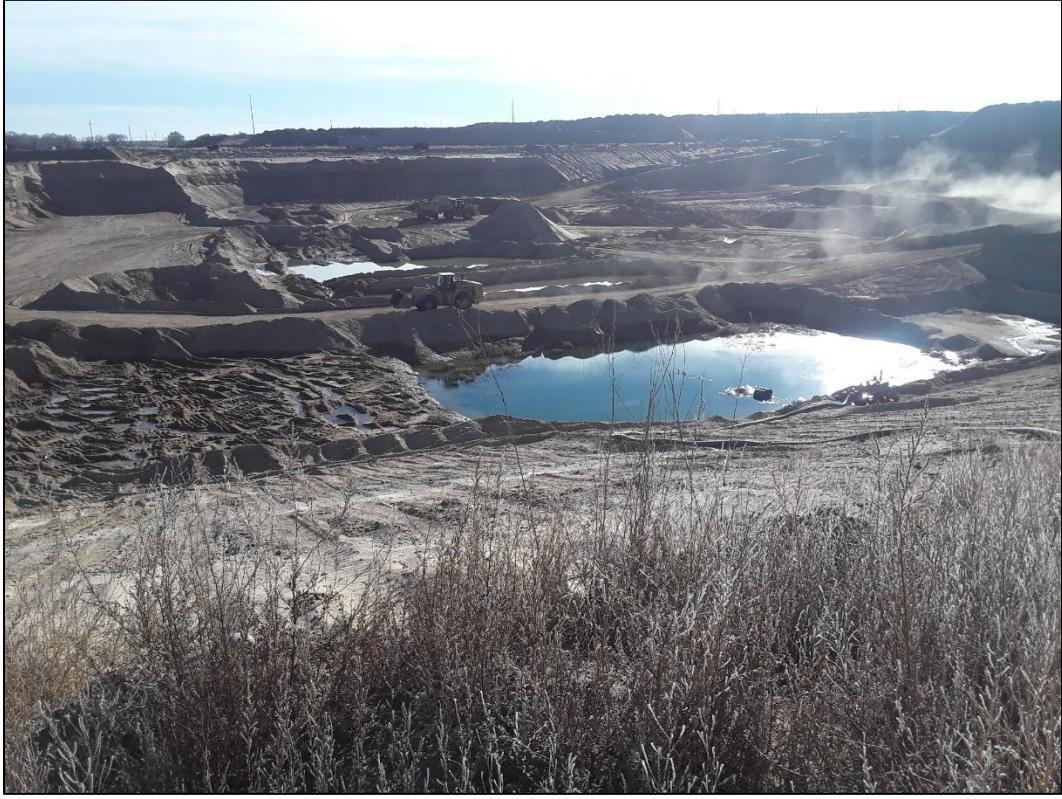
Photo 3. View looking south across active pit located in phases 8 and 11 of North Mining Area. Note settling ponds on pit floor from which water is pumped to adjacent farm ditch.

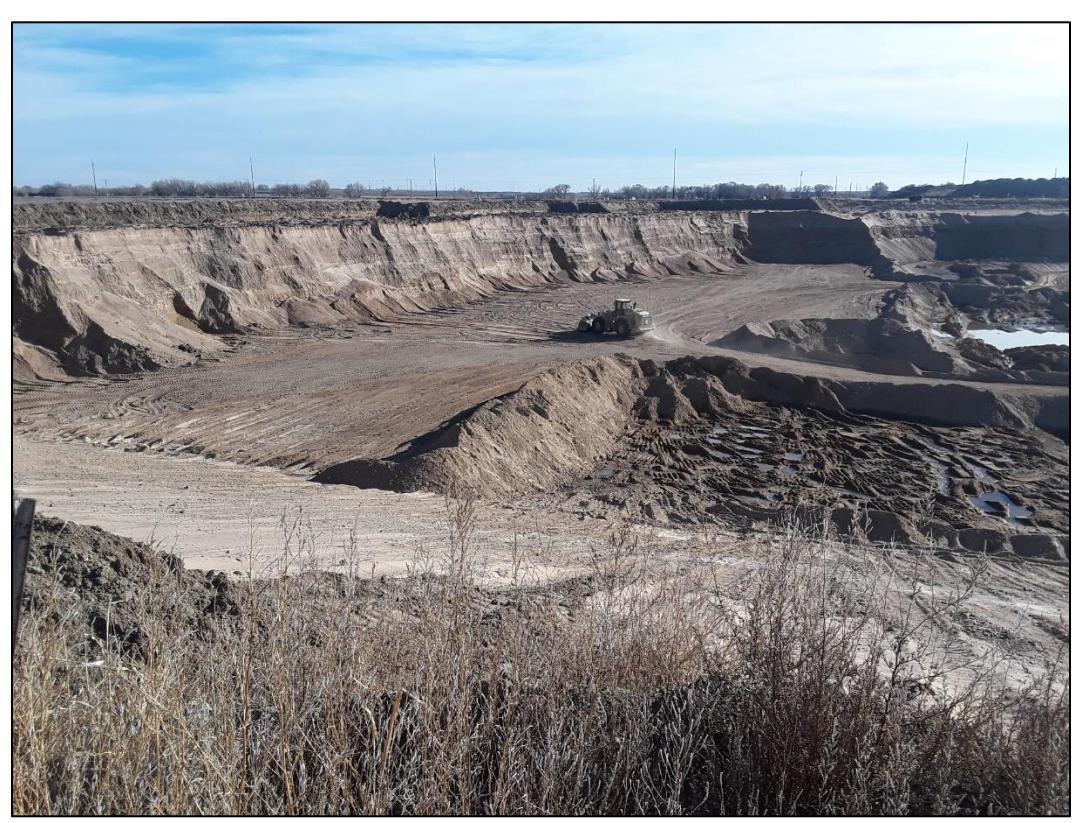
Photo 4. View looking southeast across active pit located in phases 8 and 11 of North Mining Area. Note mining wall (at left) with slope gradient of ~ 0.5 H:1V.

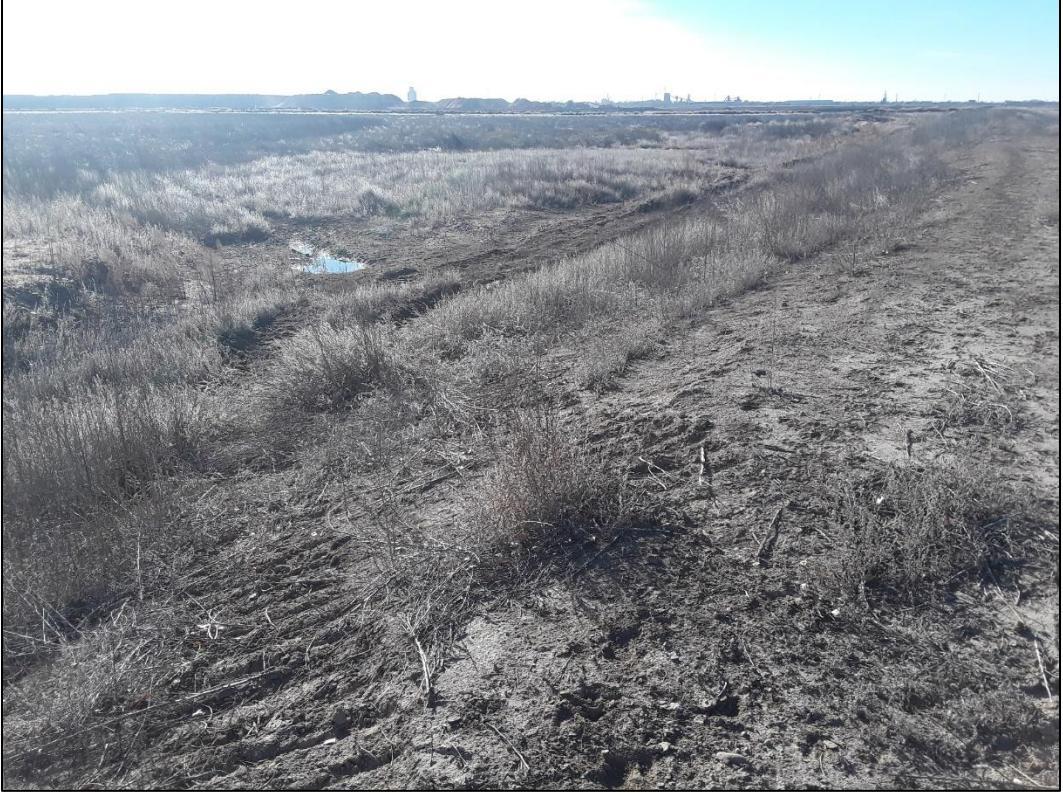
Phases 5-7 and 10 in the North Mining Area currently have minimal disturbance, mostly from the slurry wall installation (**Photo 5**). The crushing/screening plant is operated in phase 9 (**Photo 6**). Processed material is currently stored in phases 9 and 12 (in the North Mining Area; **Photos 7 and 8**) and phase 17 (in the South

Photo 5. View looking southwest across phase 5 in North Mining Area, from top of slurry wall berm.

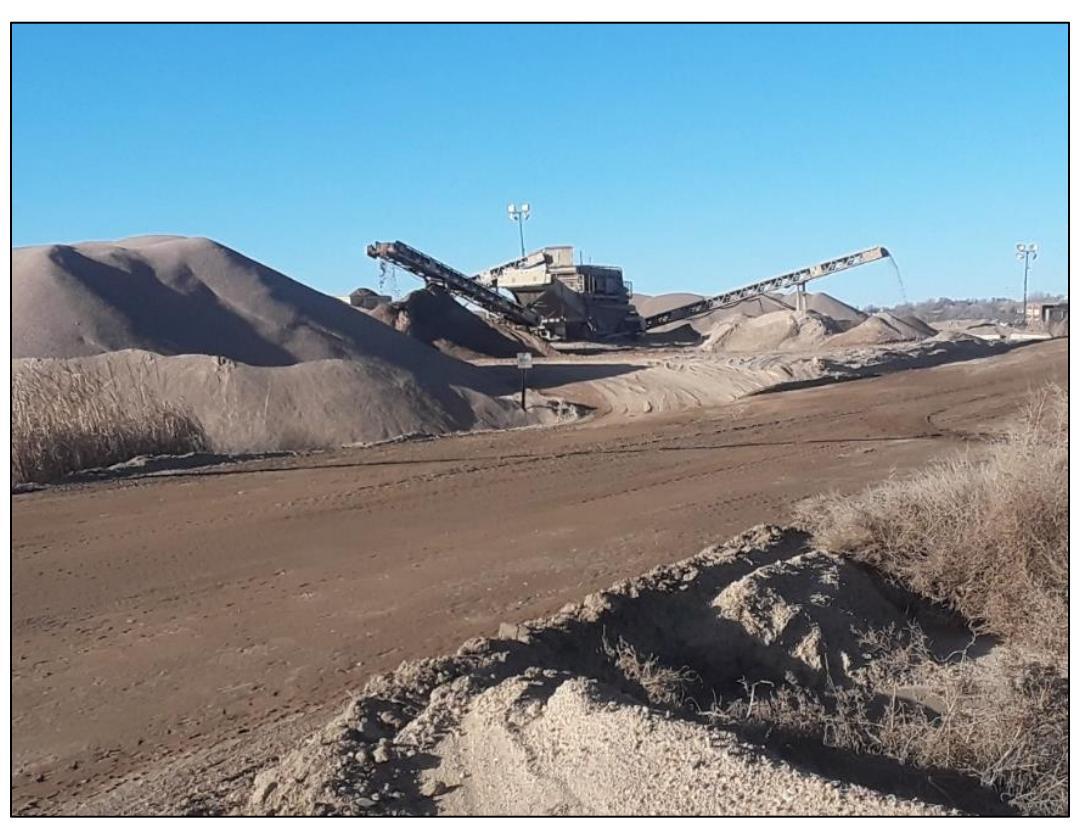
Photo 6. View looking northwest at crushing/screening plant operating in phase 9 of North Mining Area.

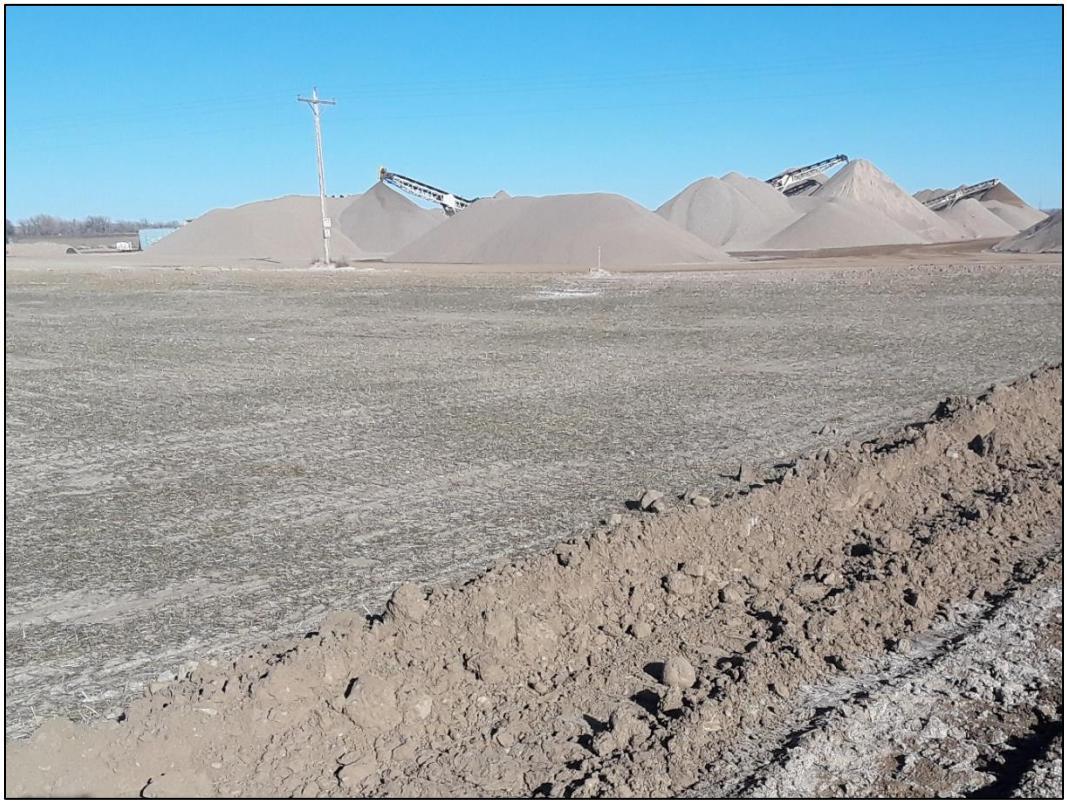
Photo 7. View looking northeast, showing processed material stockpiled in phase 9 of North Mining Area.

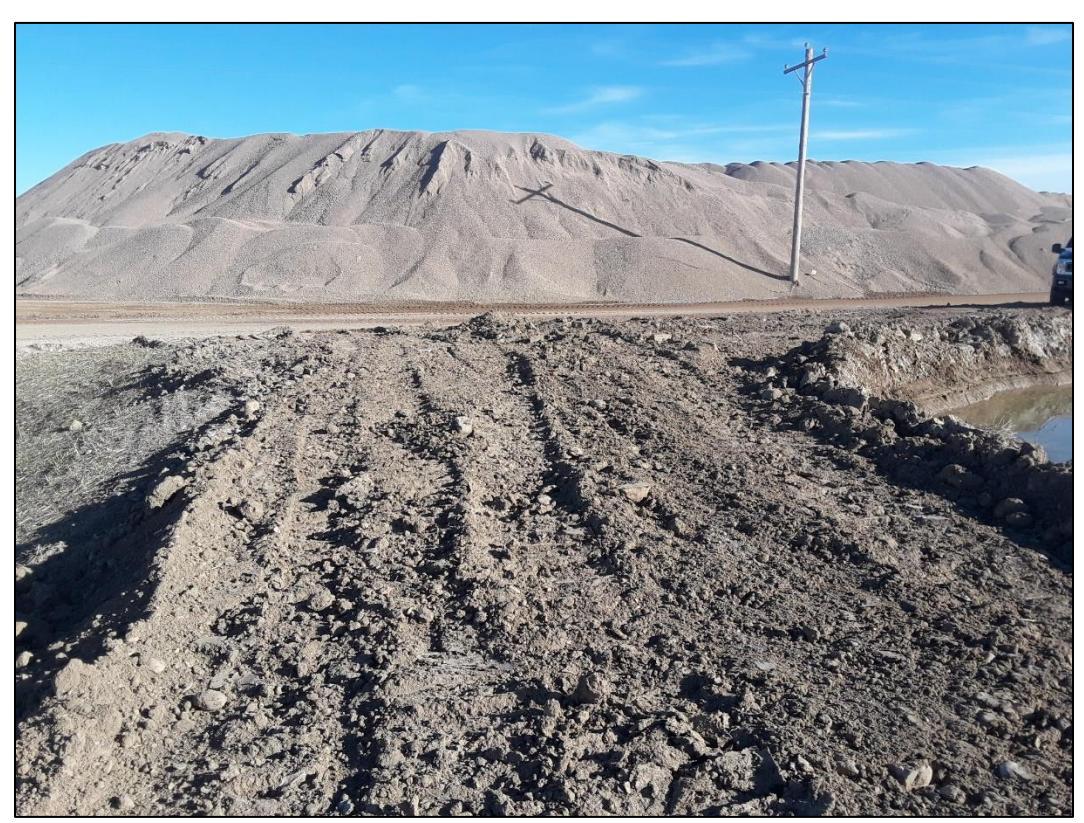
Photo 8. View looking east, showing processed material stockpiled in phase 12 of North Mining Area.

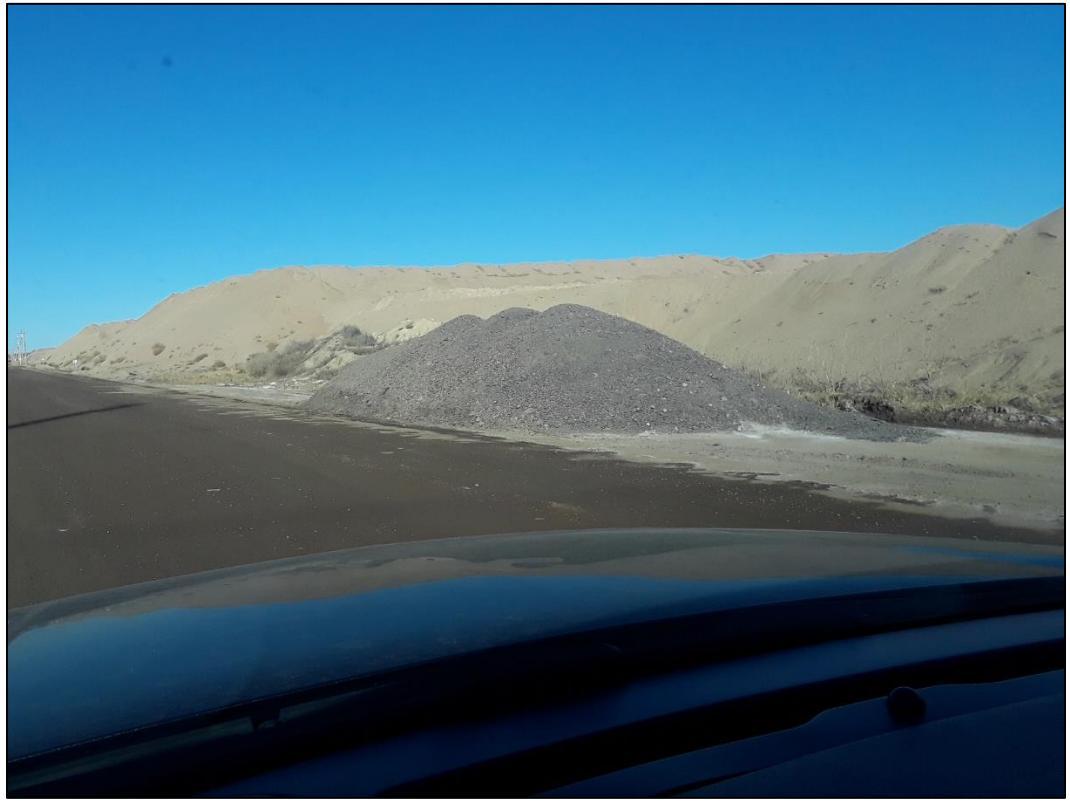
Photo 9. View looking northeast from main access road, showing processed material stockpiled in phase 17 of South Mining Area.

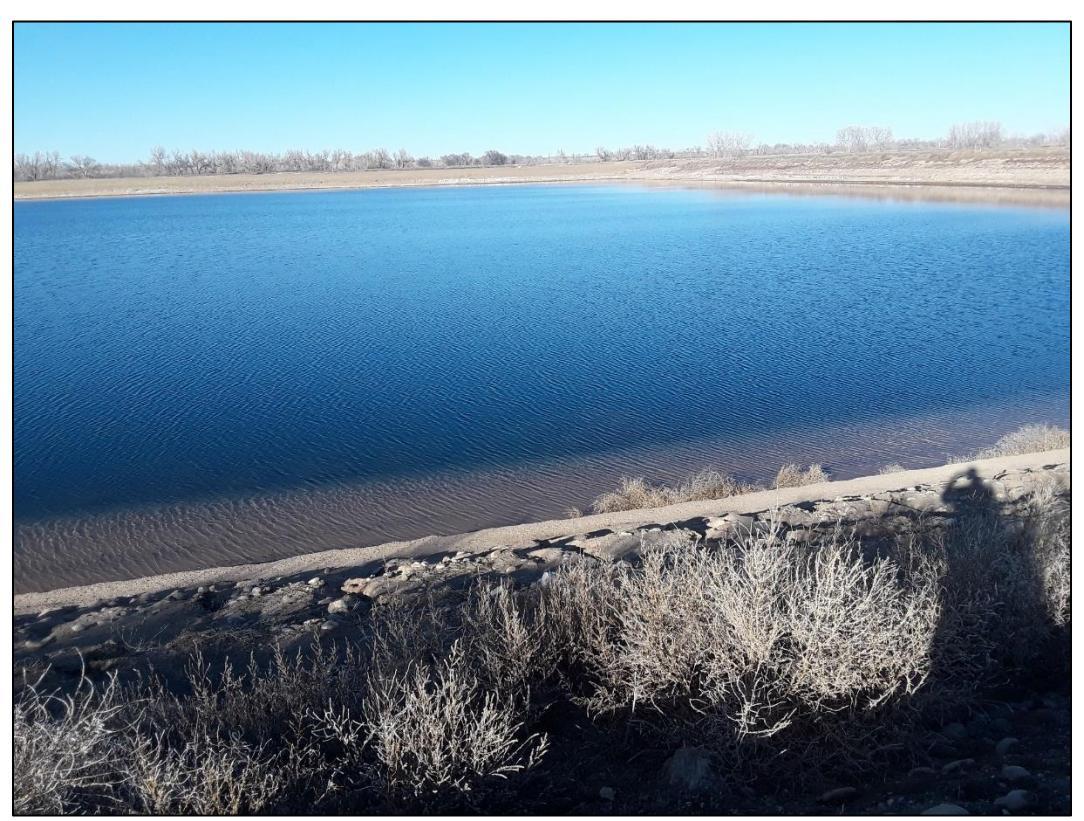
Mining Area; **Photo 9**). As mentioned above, mining in phases 1-4 is complete, and the lined reservoir is filled with water (**Photo 10**). A floating pump station is installed in the reservoir. The slopes of the phase 1-4 reservoir are graded to the final reclamation configuration of 3H:1V down to the pit floor. Since the Division's last inspection on June 14, 2018, the operator has retopsoiled, mulched, and seeded the northern, western, and southwestern slopes of this reservoir above the waterline, and also the strip of land between the reservoir and the main access road (**Photos 11 and 12**). The Division observed grass seedlings poking up through the straw mulch in these areas indicating revegetation is off to a great start.

Photo 10. View looking northeast across phase 1-4 reservoir. The reservoir slopes are graded 3H:1V, and its northern, western, and southwestern slopes have been retopsoiled and seeded.

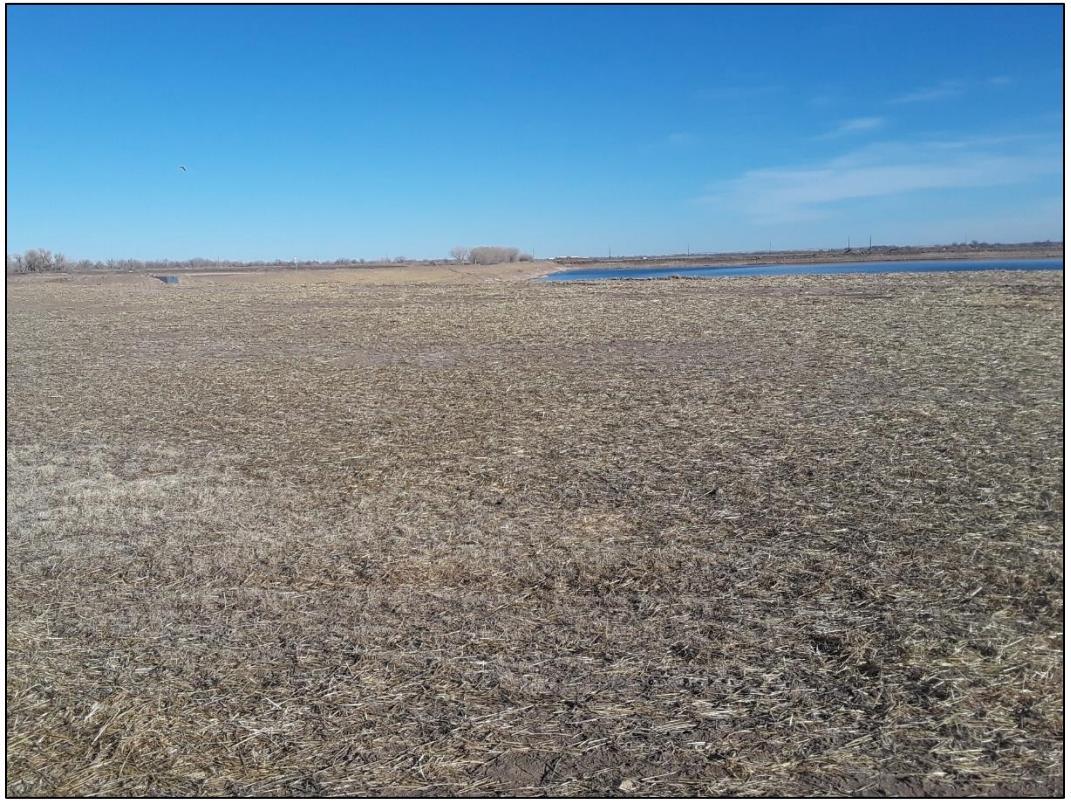
Photo 11. View looking east across area northwest of phase 1-4 reservoir which was graded, retopsoiled, mulched, and seeded since June of 2018.

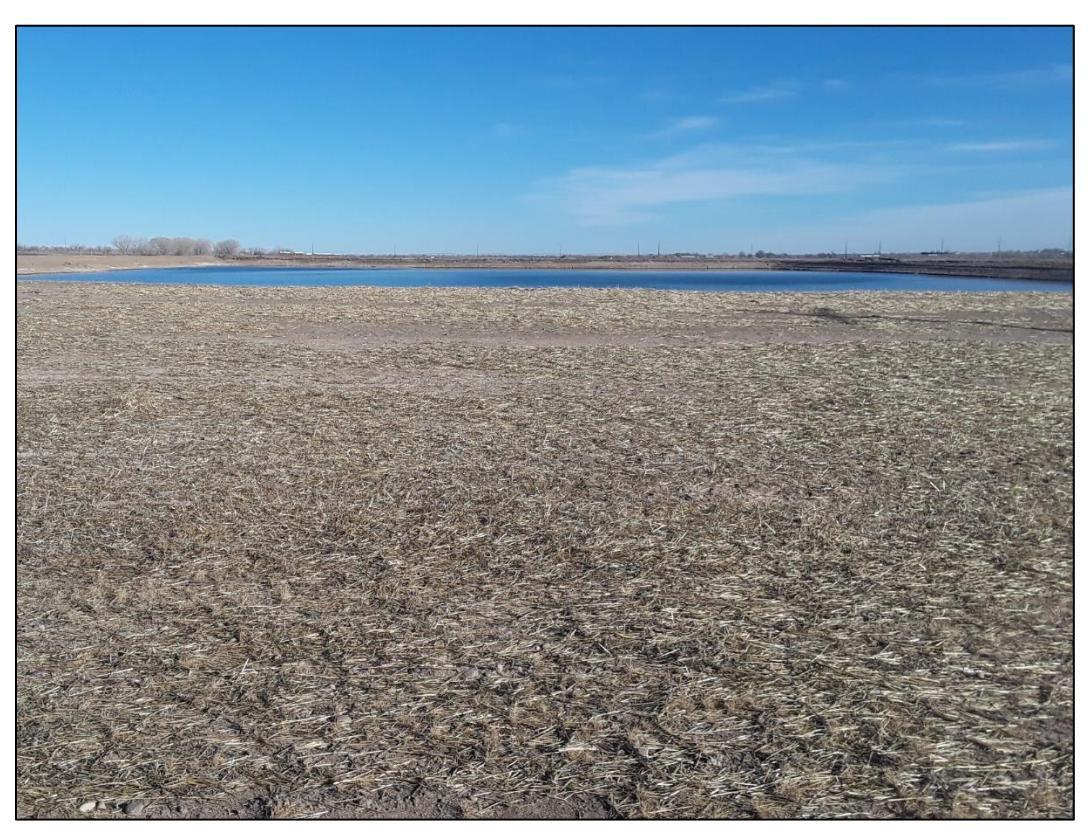
Photo 12. View looking east across area west of phase 1-4 reservoir which was graded, retopsoiled, mulched, and seeded since June of 2018.

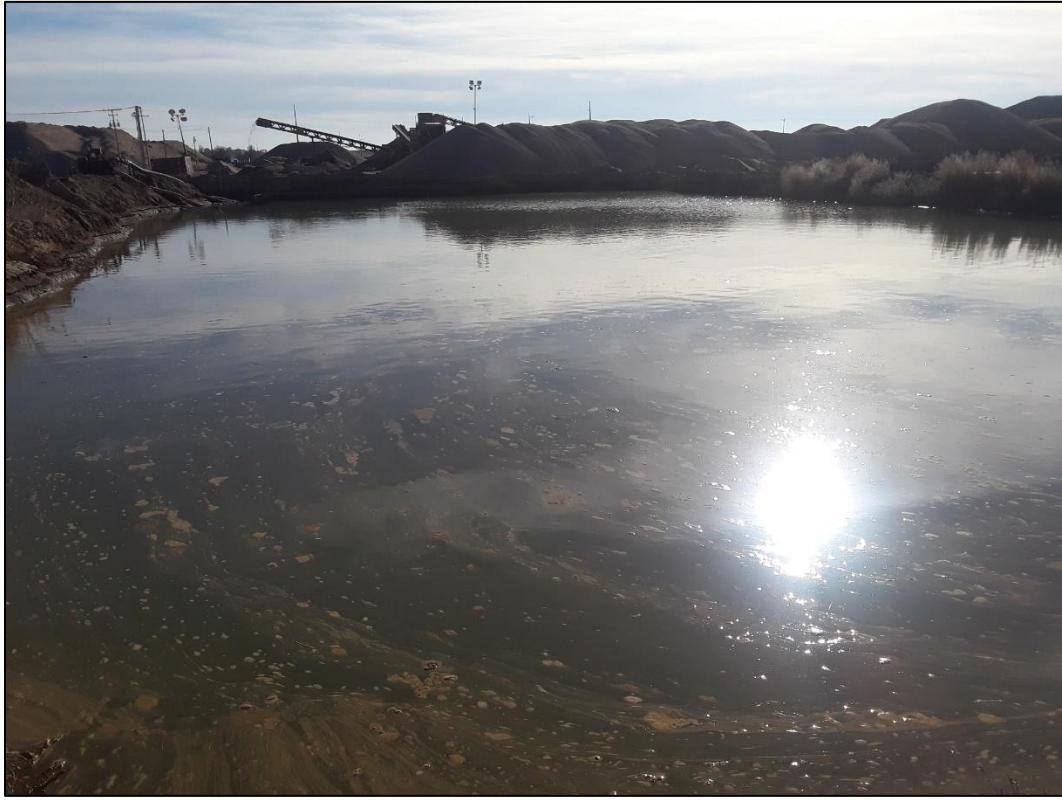
The Division observed the wash plant area located in the western portion of the site. This plant was active during the inspection. The wash plant sediment ponds, which were filled in with sediment during the Division's last inspection, had been cleaned out and were being utilized by the operation (**Photos 13 and 14**). The larger pond that was being constructed to the north of these ponds (outside the affected land boundary), has been graded, retopsoiled, mulched, and seeded (**Photo 15**). The Division observed grass seedlings in this area.

Photo 13. View looking south across one of two sediment ponds located north of wash plant which is currently in use by the operation.

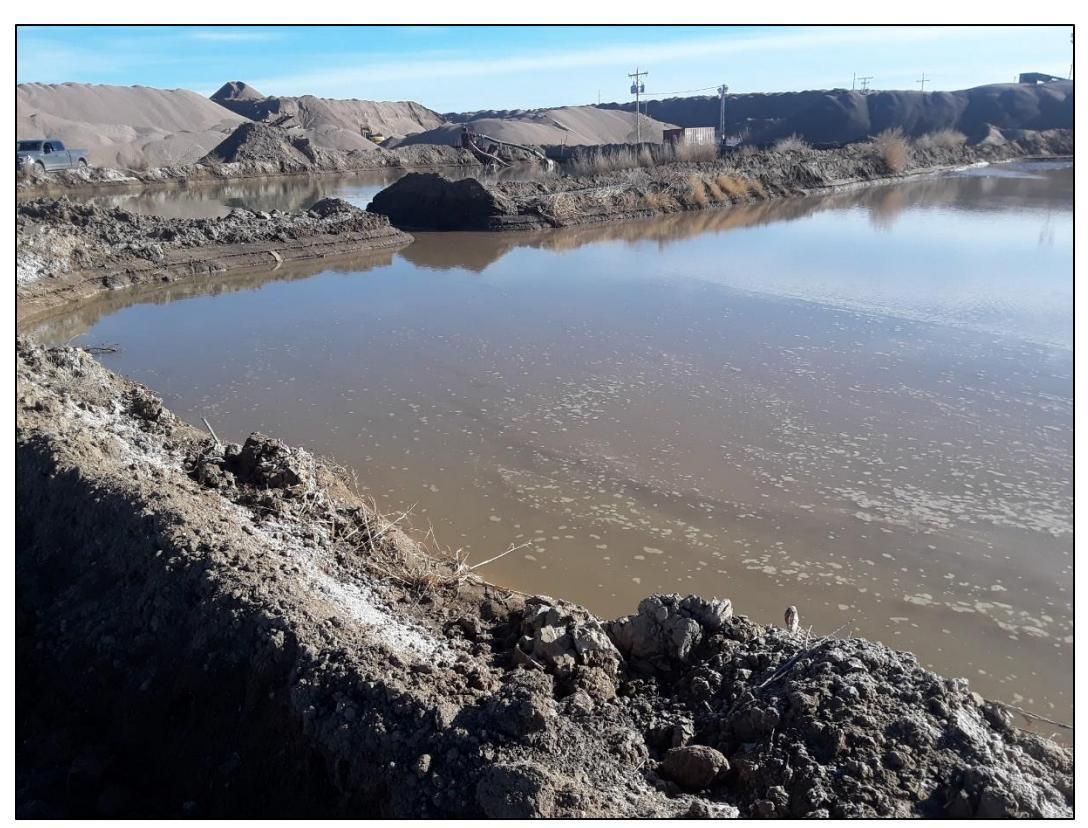
Photo 14. View looking southwest across one of two sediment ponds located north of wash plant which is currently in use by the operation.

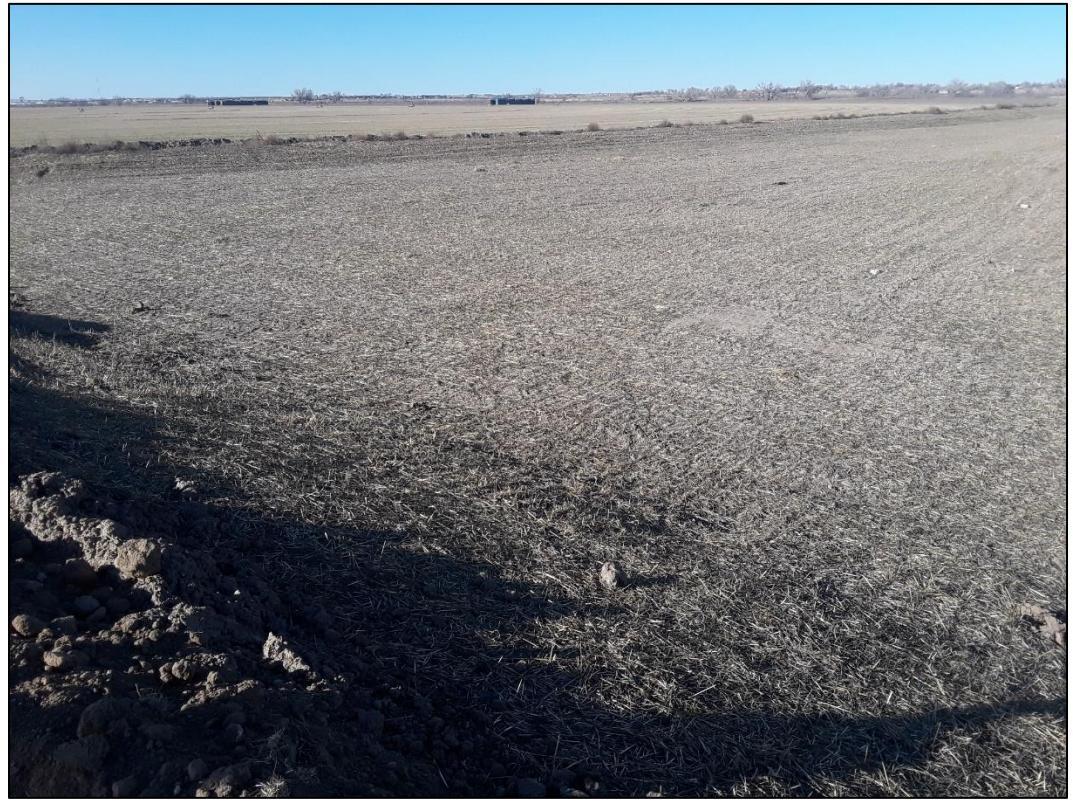
Photo 15. View looking northwest across area where new sediment pond was being constructed north of wash plant ponds during last inspection. This area was graded, retopsoiled. mulched. and seeded since June of 2018.

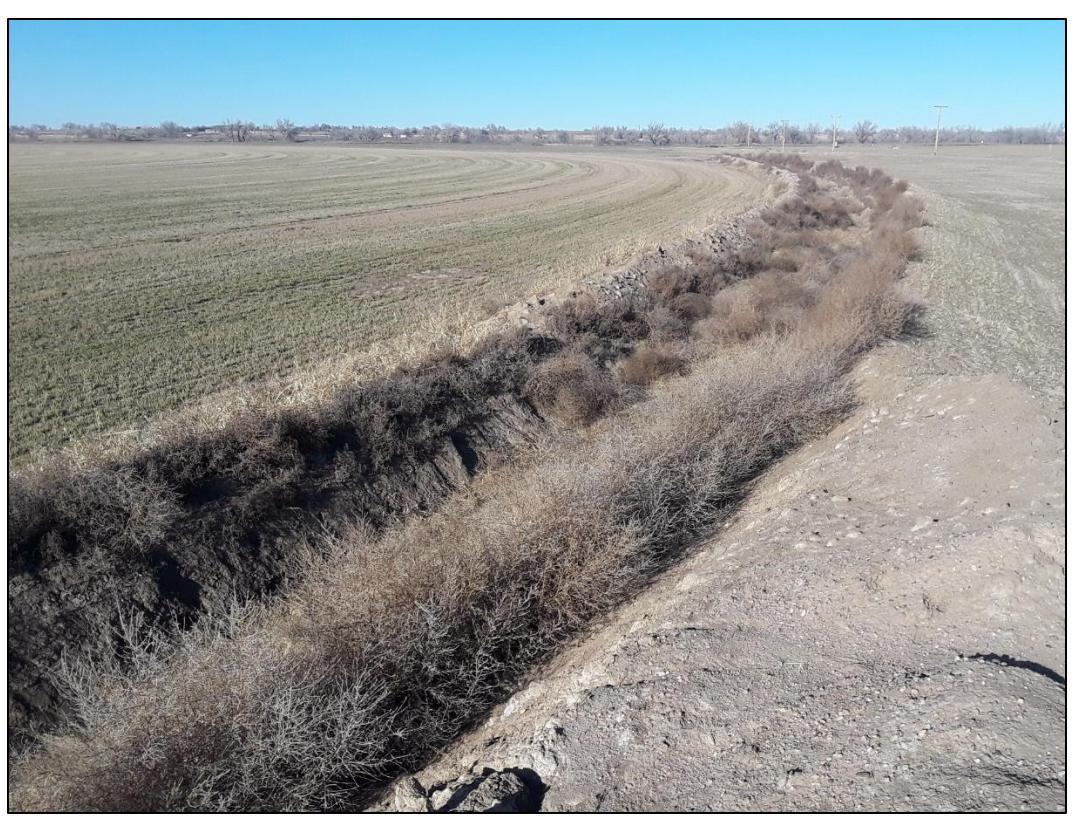
The Division observed the proposed western permit boundary along the western edge of the wash plant area (**Photo 16**). In its preliminary adequacy letter for AM-1, the Division had expressed some concerns about the unusual shape of the permit boundary in this area and its closeness to the mine activities, which could create a situation where land is disturbed outside the boundary. However, after observing this boundary during the inspection, the Division's concerns have been allayed. The concave shape of this portion of the permit boundary is due to it following the outside edge of a crop circle created by a center-pivot irrigation sprinkler. Additionally, this portion of the permit boundary is delineated with an earthen berm (**Photo 17**), which should help keep mining activities within the approved boundary.

Photo 16. View looking northwest along proposed western permit boundary west of wash plant area, delineated with berm. Note boundary follows edge of crop circle.

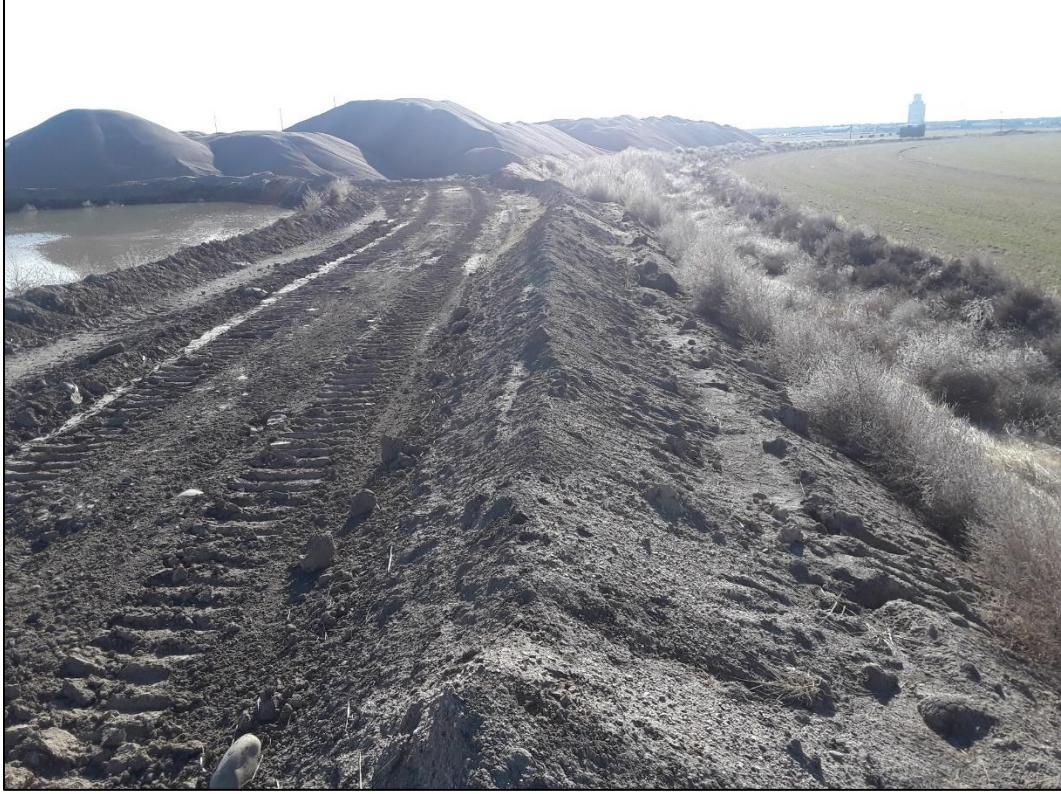
Photo 17. View looking south along proposed western permit boundary west of wash plant, delineated with berm.

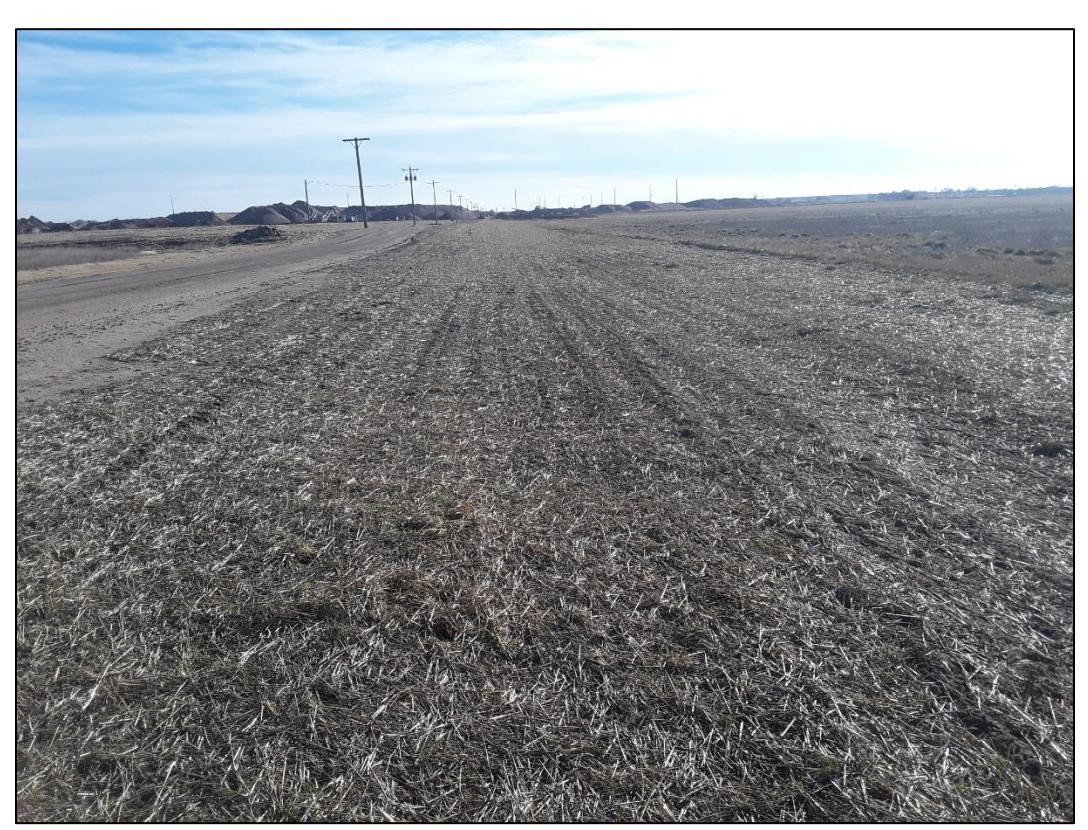
The roadside ditch that was previously used to discharge wastewater from the wash plant to the river (resulting in Violation No. MV-2018-016) had been backfilled, retopsoiled, mulched, and seeded (**Photo 18**). The portion of the ditch located north of the parking/equipment storage area was not backfilled as it was an existing farm ditch. The parking/equipment storage area had been cleared off and also graded, mulched, and seeded (**Photo 19**). The Division observed grass seedlings in these areas (**Photo 20**).

Photo 18. View looking south along roadside ditch which was backfilled, retopsoiled, mulched, and seeded since June of 2018.

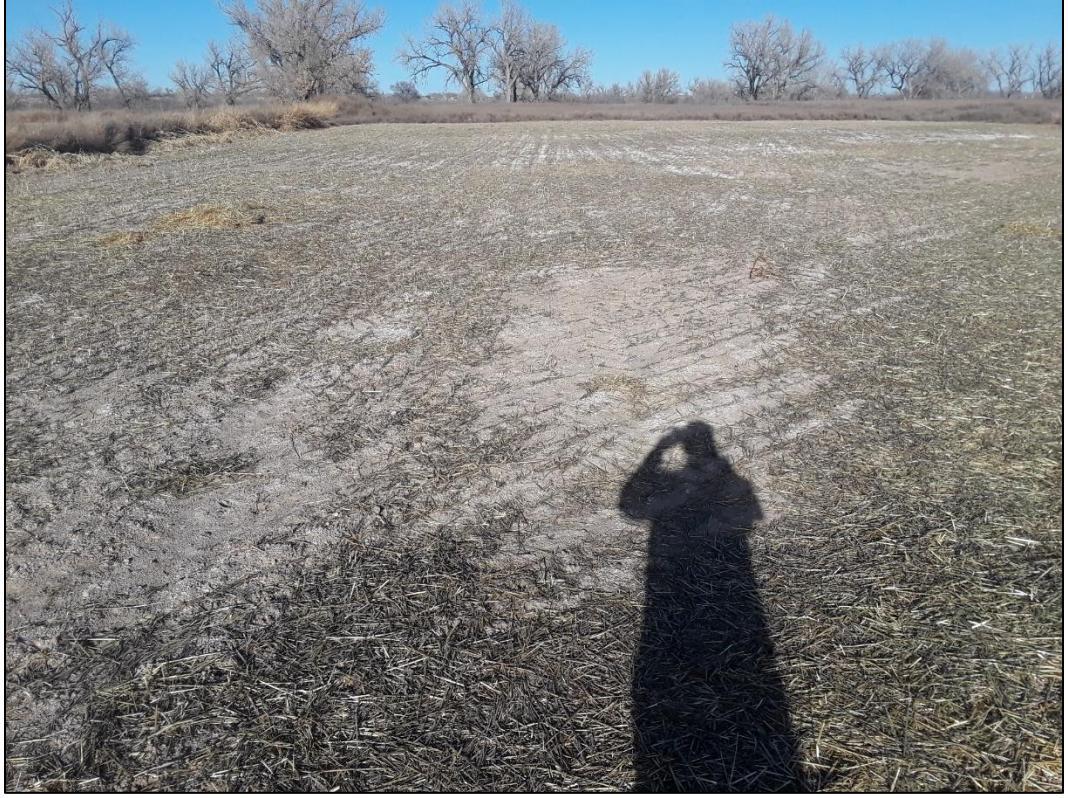
Photo 19. View looking north across parking/equipment storage area which was graded, retopsoiled, mulched, and seeded since June of 2018.

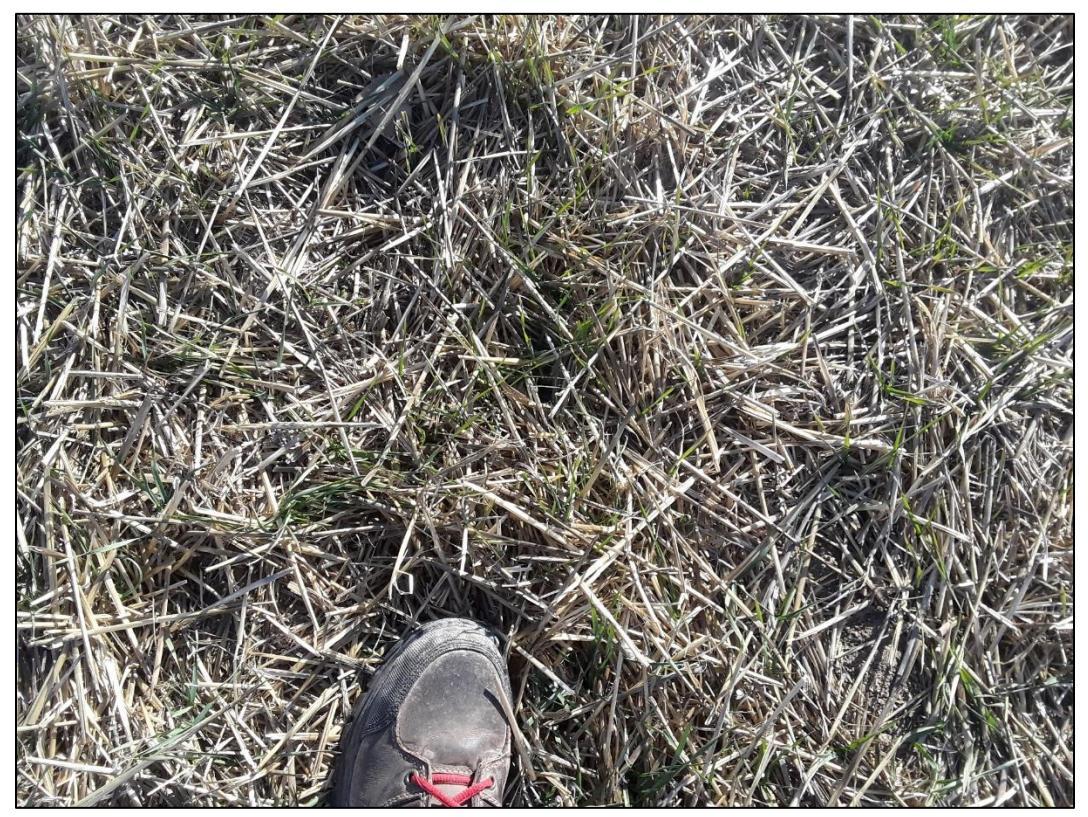
Photo 20. View of ground in parking/equipment storage area, showing grass seedlings poking up through mulch.

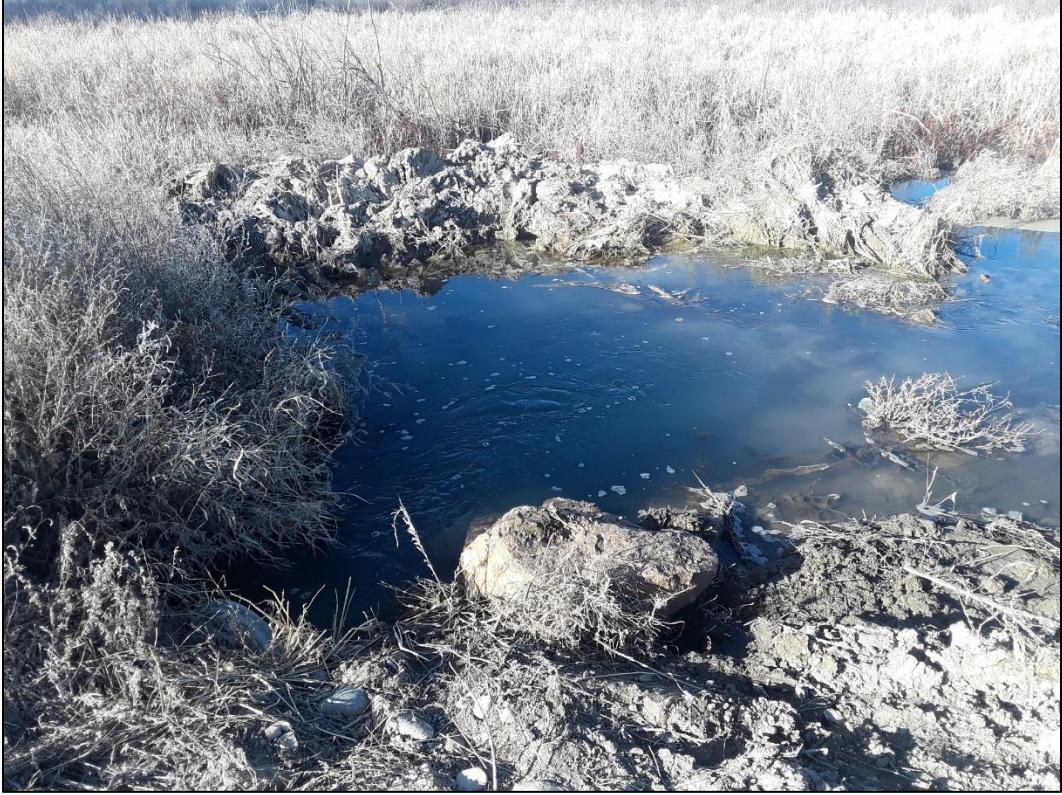
The Division observed the mine discharge sampling point permitted by the operator's discharge permit (**Photo 21**). This point is located near the northeastern corner of the permit area, where an existing north-south oriented farm ditch (aligned with the eastern permit boundary) drains into an existing east-west oriented farm ditch located beneath the City's sewer lagoons. This ditch flows around the perimeter of the sewer lagoons to discharge into the river. Water quality samples are collected from the discharge point twice a month and the results reported to CDPHE, WQCD in accordance with the discharge permit.

Photo 21. View of mine discharge sampling point located just outside of northeastern corner of permit boundary, south of sewer lagoons.

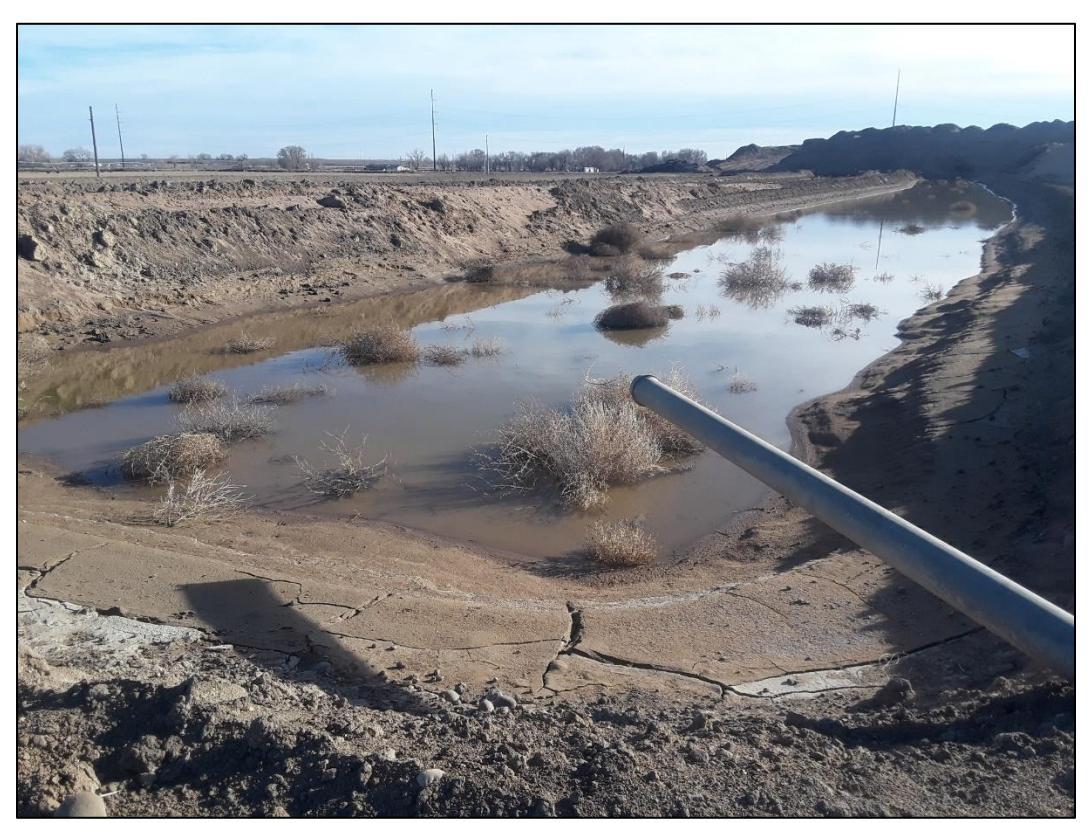
The Division observed the four new sediment ponds constructed in phase 13 in the South Mining Area (**Photos 22 and 23**). At this time, only the western three ponds are in use by the operation. The west wash plant receives fresh water from a well to wash mined material. The discharge from the wash plant is directed to two sediment ponds which drain to the east where flows enter a ditch and are collected in a pond in the phase 12 area. Water from this pond is pumped through a pipe to the three sediment ponds in phase 13. Discharge from the smaller wash plant located near the active pit is directed to a sediment pond on the pit floor then also pumped via pipeline to the three sediment ponds in phase 13. When the sediment has settled in the three sediment ponds in phase 13, the clean water is recycled by the operation by pumping it back to the smaller wash plant. The fourth sediment pond in phase 13 (**Photo 24**) will be used when one of the primary three ponds is being cleaned, to ensure that three sediment ponds are utilized to treat wash plant discharges at all times. A maintenance plan for all sediment ponds was included in AM-1. The fines removed from sediment ponds will be stockpiled either adjacent to the phase 13 ponds or in phase 15.

Photo 22. View of one of four sediment ponds constructed in phase 13 of South Mining Area. This pond is currently being used by the operation.

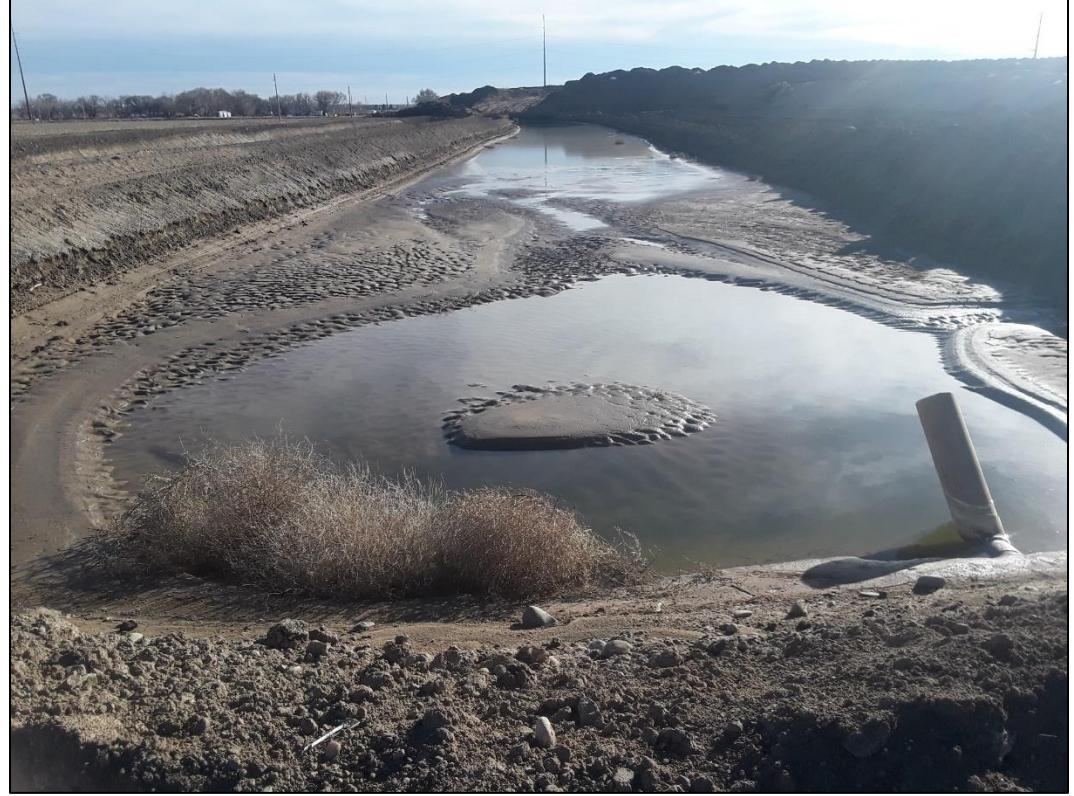
Photo 23. View of one of four sediment ponds constructed in phase 13 of South Mining Area. This pond is currently being used by the operation.
