COLORADO Division of Reclamation, Mining and Safety Department of Natural Resources

MINERALS PROGRAM INSPECTION REPORT PHONE: (303) 866-3567

MINE NAME:		MINE/PROSPECTING ID#:	MINERAL:	COUNTY:
West Farm Pit		M-2008-078	Gravel and sand	Prowers
INSPECTION TYPE:		INSPECTOR(S):	INSP. DATE:	INSP. TIME:
Preoperation Inspection		Amy Eschberger	November 29, 2018	13:30
OPERATOR:		OPERATOR REPRESENTATIVE:	TYPE OF OPERATION:	
Prowers Aggregate Operators, LLC		Roy Cue	112c - Construction Regular Operation	
REASON FOR INSPECTION:		BOND CALCULATION TYPE:	BOND AMOUNT:	
Preoperation Inspection		Complete Bond	\$575,000.00	
DATE OF COMPLAINT:		POST INSP. CONTACTS:	JOINT INSP. AGENCY:	
NA		None	None	
WEATHER:	INSPECTOR'S SIGNATURE:		SIGNATURE DATE:	
Clear	1 5 .		January 25, 2019	
	11	my Crehluger	•

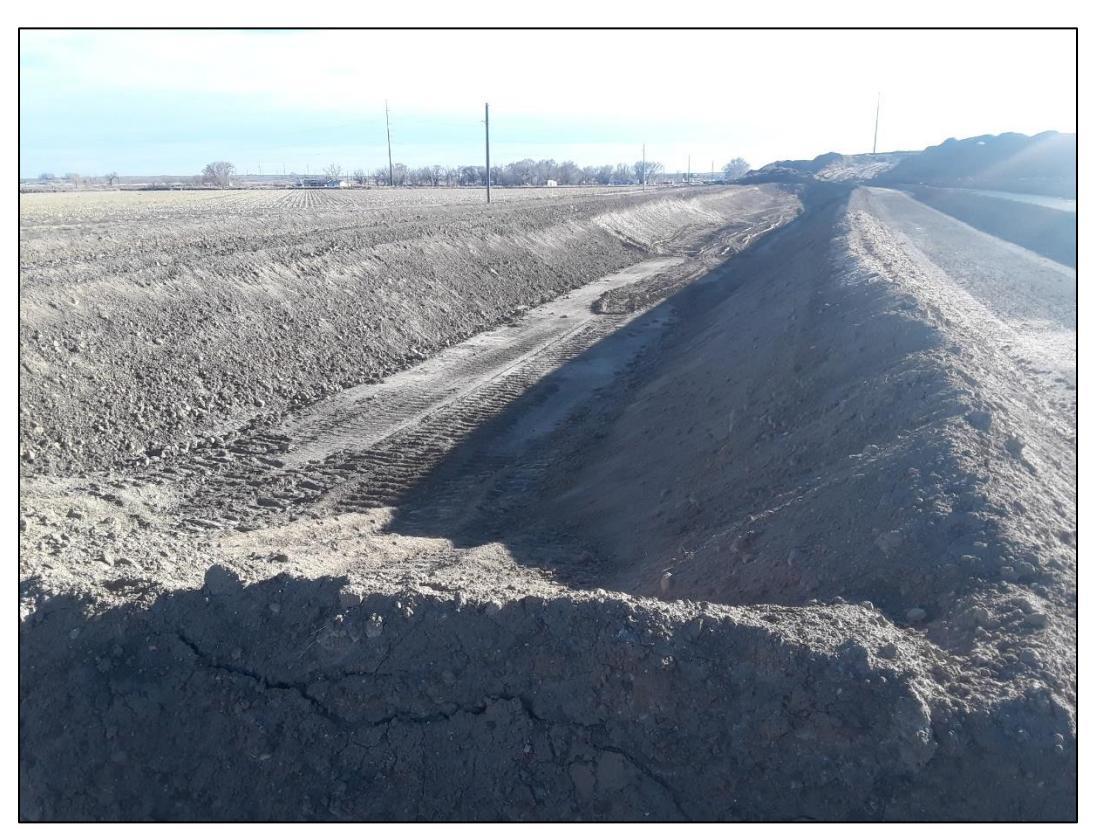
Photo 24. View of one of four sediment ponds constructed in phase 13 of South Mining Area. This pond will be used as a back-up pond when one of the other three ponds are being cleaned.

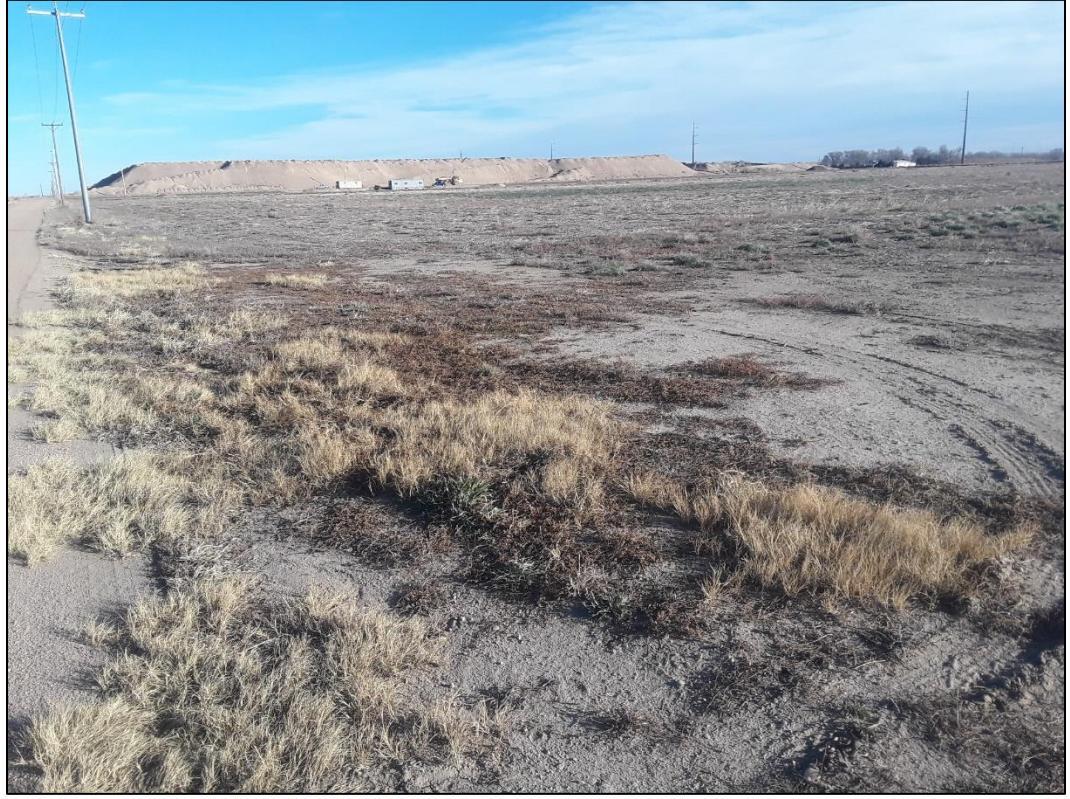
The Division observed the field located west of the scale house, where AM-1 initially discussed plans to construct a conveyor for transporting product from the wash plant south to the load-out area near the railroad (**Photo 25**). AM-1 has since then removed plans for constructing the conveyor and commits to submitting a permit revision with more details on the conveyor and a revised reclamation cost estimate prior to its construction. No other uses of this area have been proposed by AM-1.

Photo 25. View looking east across proposed permit area west of main access road and south of wash plant, where a conveyor may be installed in the future.

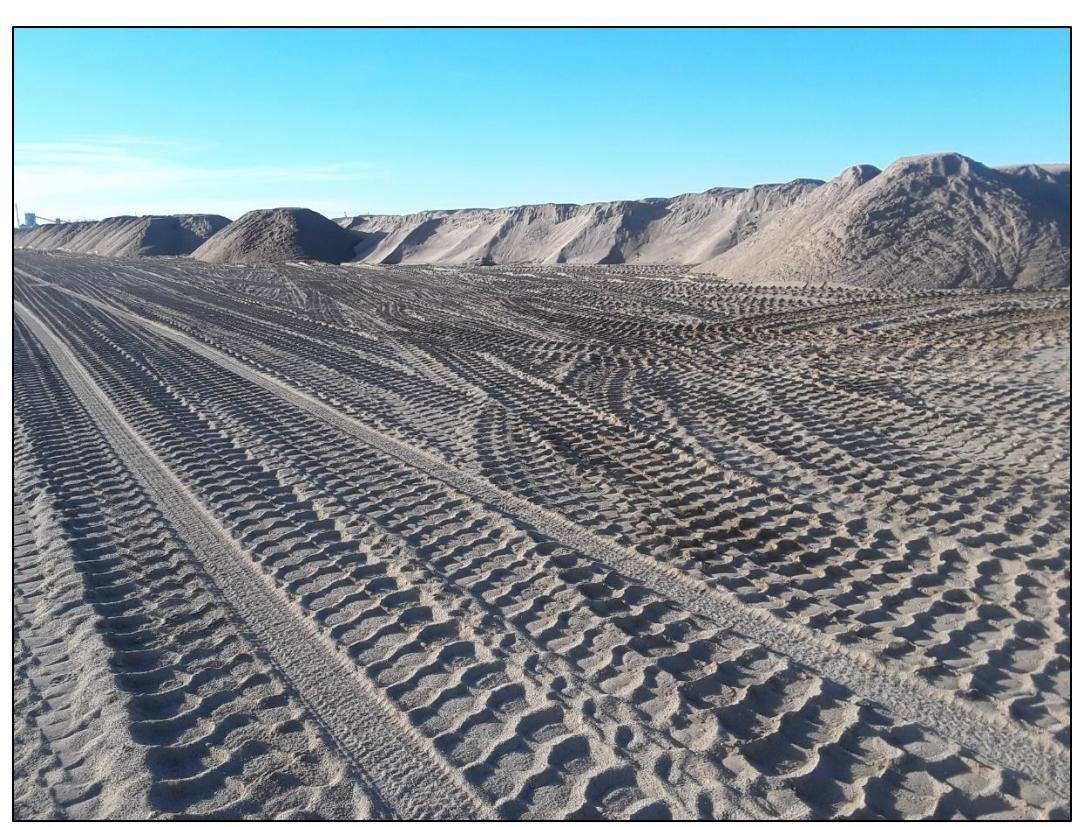
The Division observed the load-out area near the railroad, referred to in AM-1 as Parcel B. This area is currently being utilized by the operation. Several sand stockpiles are stored along the southern edge of the parcel (**Photo 26**). A topsoil stockpile is stored along the eastern edge of the parcel, and is stable with vegetative growth (**Photo 27**). This topsoil will be used for reclamation of the area after mining is complete. In its recent adequacy review letter, the Division asked the operator to include this stockpile on the Exhibit C mining plan map and the Exhibit L reclamation phasing map.

Photo 26. View looking west across Parcel B, showing sand stockpiles stored along southern edge of parcel, near railroad.

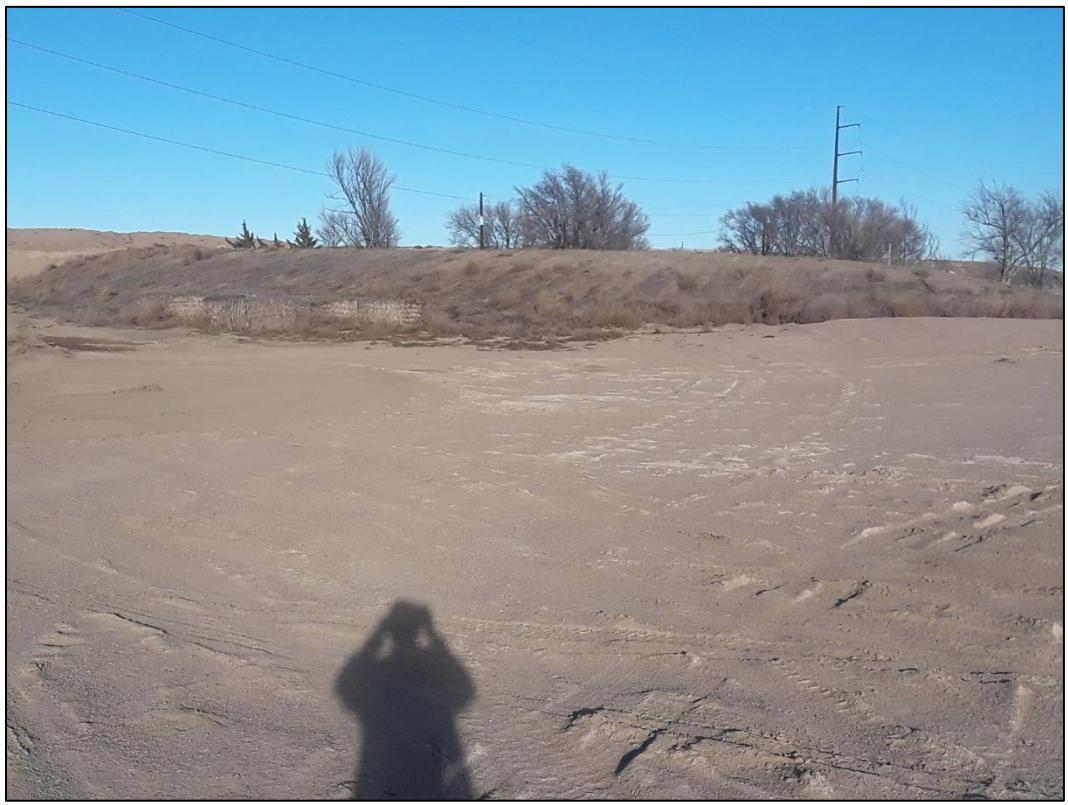
Photo 27. View looking east across Parcel B, showing topsoil stockpile stored at eastern edge of parcel. This stockpile appeared to be stable with vegetative cover.

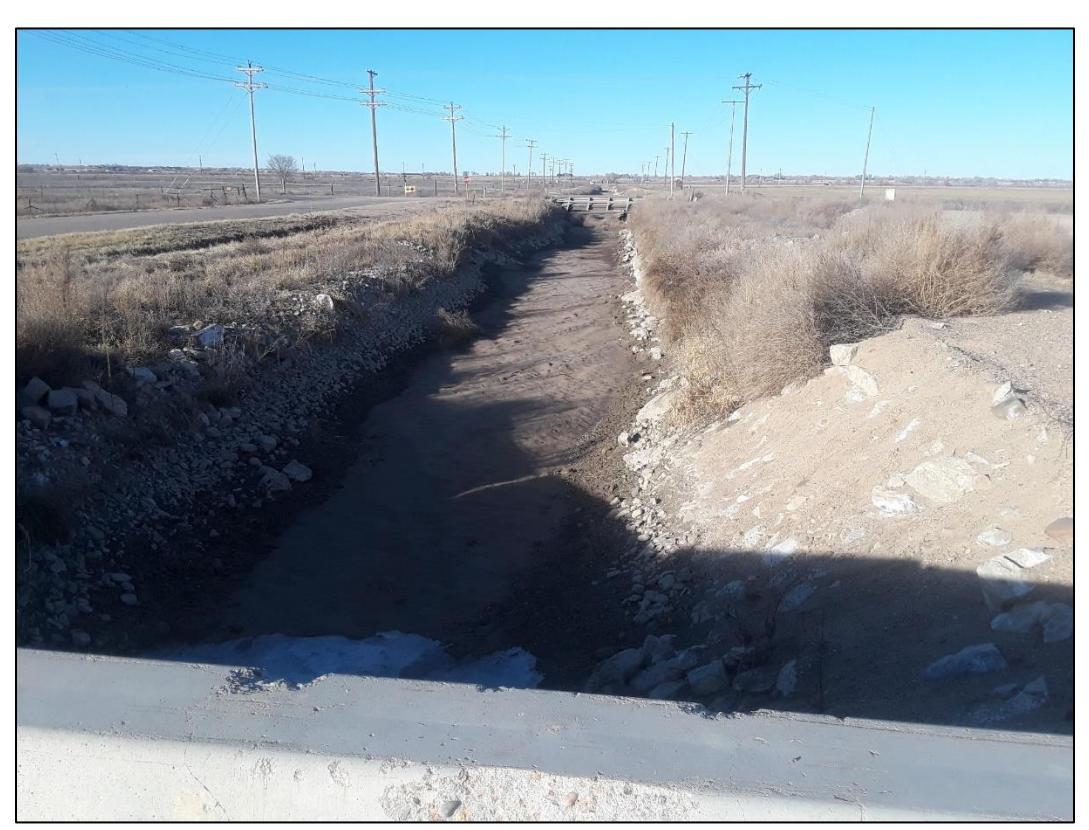
There are numerous permanent, man-made structures located to the south and east of Parcel B, as identified on the Exhibit C-2 map submitted with AM-1. One of these structures is the Lamar Canal, which runs north-south across the western edge of the parcel (**Photo 28**). AM-1 proposes the Parcel B permit boundary be inset to the east of this canal so as not to include this structure in the permit area. Therefore, the Parcel B permit area does not include the entire parcel. The operator has demonstrated that structure agreements were attempted for all structures located within 200 feet of the proposed permit area. However, at this time, executed agreements have only been reached for structures owned by the City of Lamar, Prowers County, Sutphin Petroleum, LLC, and GP Irrigated Farms, LLC. Therefore, pursuant to Rule 6.4.19(b), the Division has accepted an engineering evaluation submitted by the operator to demonstrate such structures will not be damaged by activities occurring at the mining operation.

Photo 28. View looking north, showing Lamar Canal which runs north-south at the western edge of Parcel B. The proposed permit area does not include this structure.
