COLORADO Division of Reclamation, Mining and Safety Department of Natural Resources

MINERALS PROGRAM INSPECTION REPORT PHONE: (303) 866-3567

MINE NAME:	MINE/PROSPECTING ID#:	MINERAL:	COUNTY:
Rother Gravel Pit	M-1985-173	Sand and gravel	Kiowa
INSPECTION TYPE:	INSPECTOR(S):	INSP. DATE:	INSP. TIME:
Monitoring	Amy Eschberger	October 11, 2018	11:30
OPERATOR:	OPERATOR REPRESENTATIVE:	TYPE OF OPERATION:	
Kiowa County	Allen Watts	112c - Construction Regular Operation	
REASON FOR INSPECTION:	BOND CALCULATION TYPE:	BOND AMOUNT:	
Normal I&E Program	None	\$0.00	
DATE OF COMPLAINT:	POST INSP. CONTACTS:	JOINT INSP. AGENCY:	
NA	None	None	
WEATHER:	INSPECTOR'S SIGNATURE:	SIGNATURE DATE:	
Clear	A 5.	January 30, 2019	
	Uny achluger	-

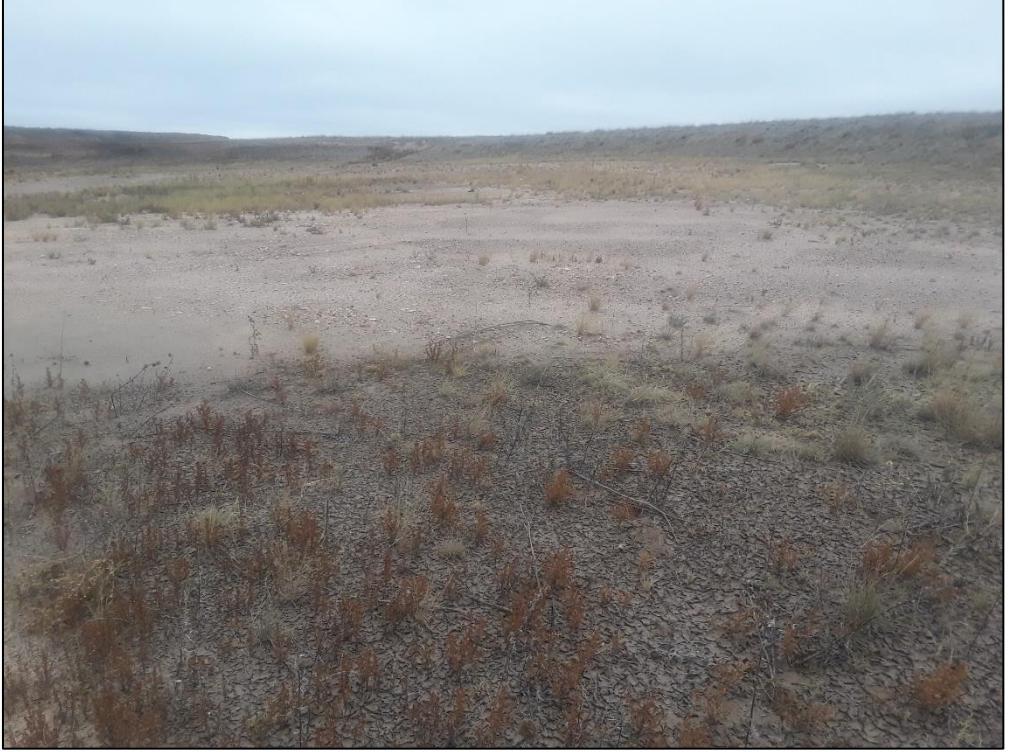
The southern portion of the pit disturbance (primarily in mining phase 2) has slopes graded mostly to 3H:1V, and this area has been retopsoiled and seeded. Portions of this reclaimed area have good grass growth, while other portions have sparse vegetative cover consisting primarily of annual weeds. The Division recommends the operator continue to monitor vegetative growth in this area and reseed the area as needed to achieve successful grass cover. The old pit located west of the active pit (in mining phases 4 and 6) has slope gradients ranging from 1.5H:1V to 2.5H:1V. This pit area is well vegetated with volunteer grasses and shrubs, and appears to be stable at this time.

Photo 1. View looking southeast across southern portion of pit (mining phase 2) in reclamation. Some portions of this area have good grass growth, while other portions have very sparse vegetative cover consisting mainly of annual weeds.

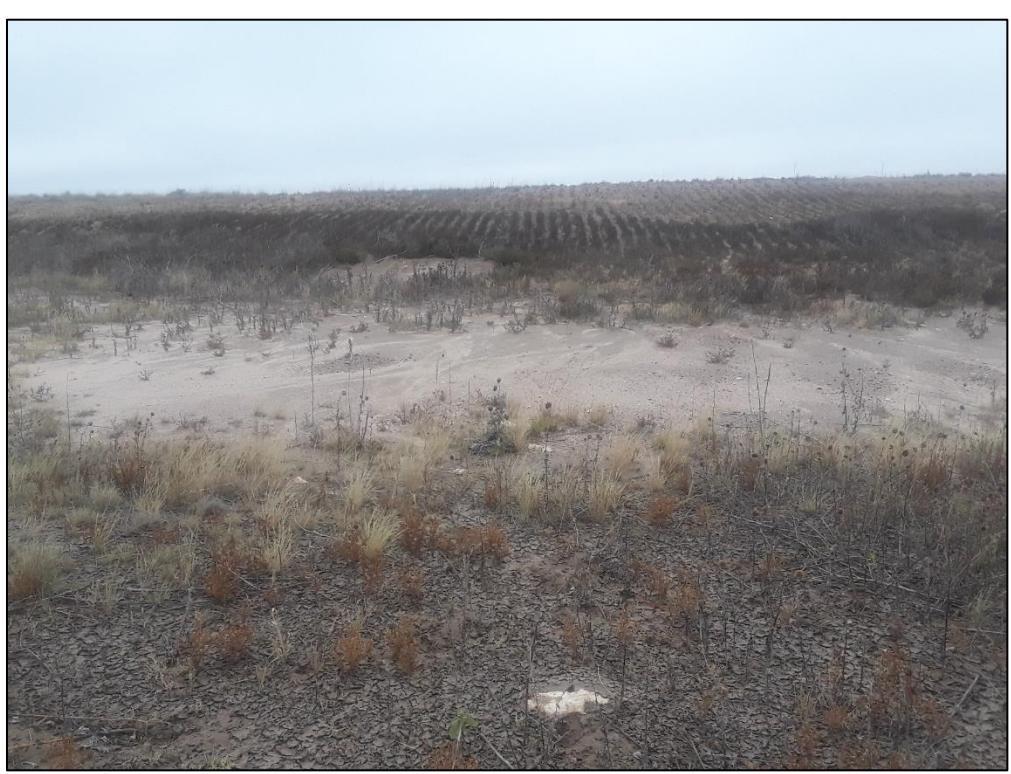
Photo 2. View looking south at southern edge of pit (mining phase 2) in reclamation. Some portions of this area have good grass growth, while other portions have very sparse vegetative cover consisting mainly of annual weeds.

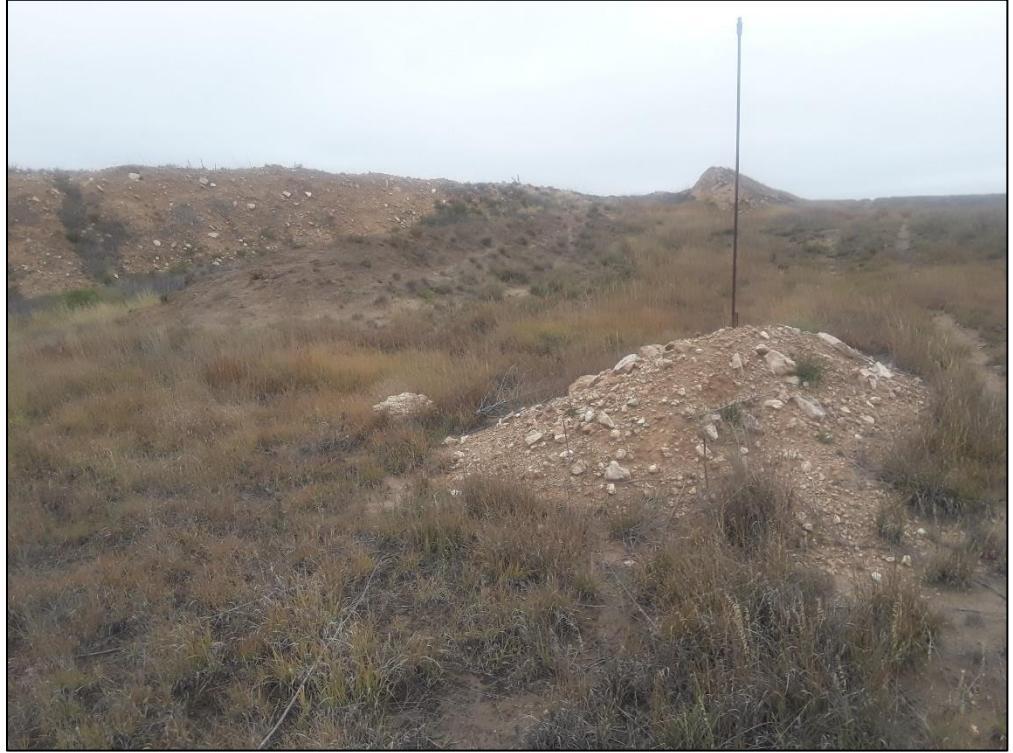
Photo 3. View looking north/northwest, showing metal post marking eastern permit boundary.

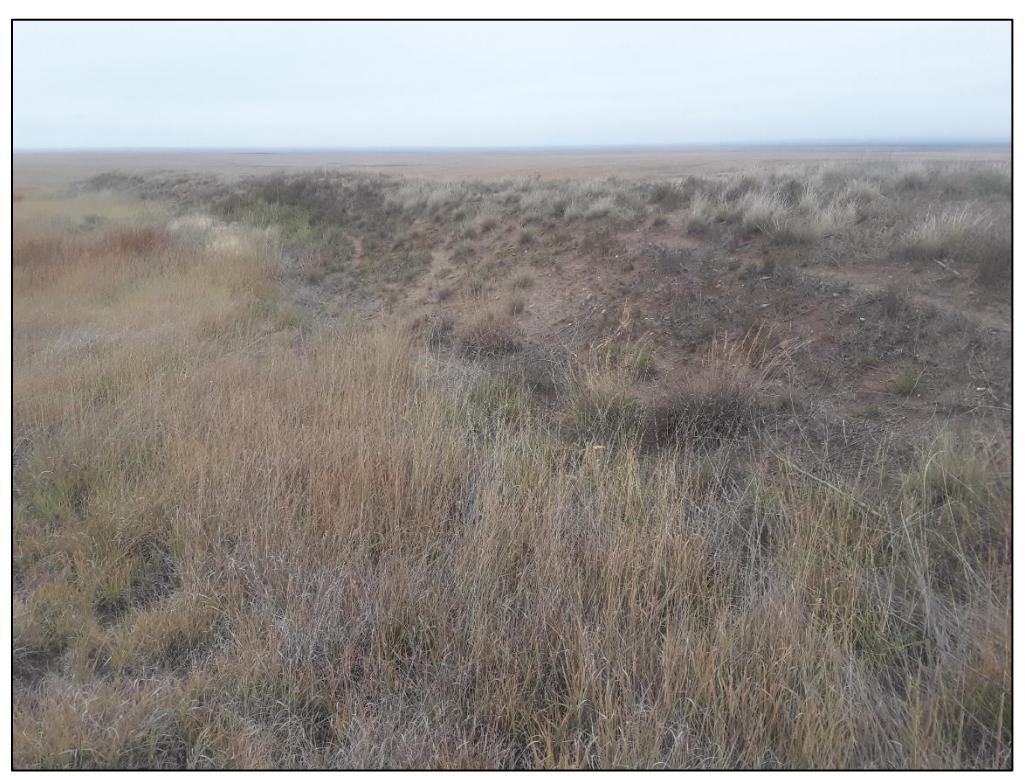
Large topsoil and overburden stockpiles are stored along the eastern edge of the active pit. The topsoil stockpile is stored to the south of the overburden stockpile, and is stable with good grass cover. The overburden stockpile is also stable with some grass cover. The stockpiles are fairly close to the eastern permit boundary, so the operation will need to be careful not to disturb land outside the boundary when accessing the stockpiles for reclamation. The Division estimates the topsoil stockpile to be located 20-40 feet from the eastern permit boundary, and the overburden stockpile to be located 55-65 feet from this boundary.

Photo 4. View looking south/southwest at topsoil stockpile stored at eastern edge of active pit. Note stockpile is stable with good grass cover.

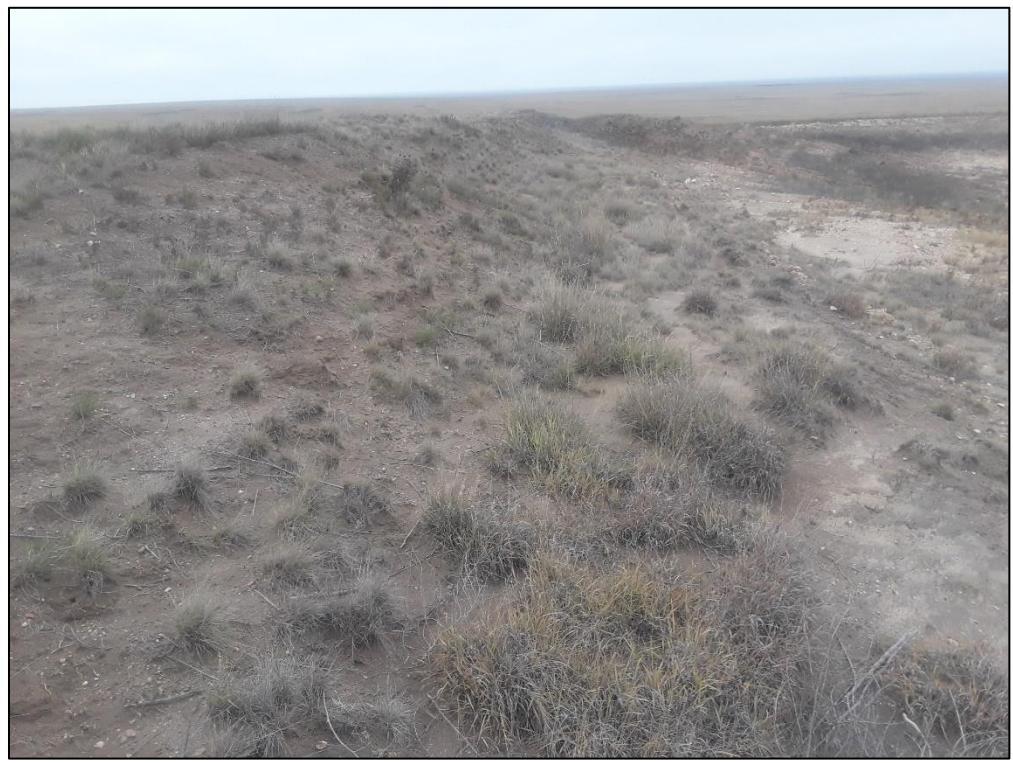
Photo 5. View looking south across topsoil stockpile stored at eastern edge of active pit. Note stockpile is stable with good grass cover.

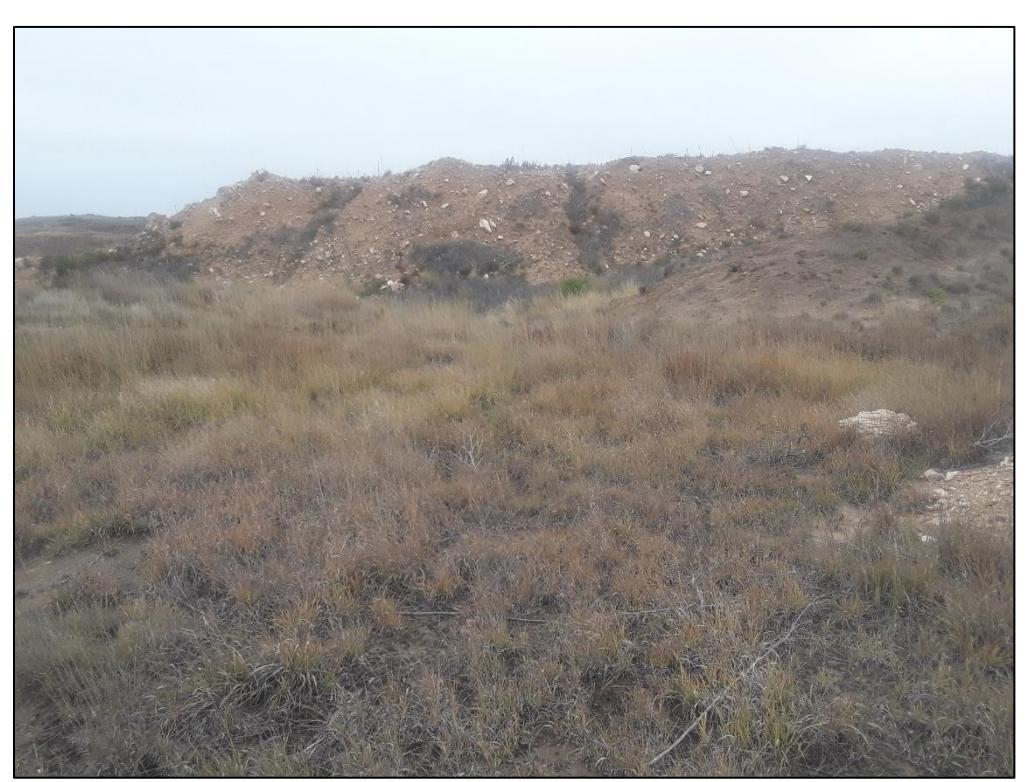
Photo 6. View looking west at overburden stockpile stored at eastern edge of active pit. Note stockpile is stable with some grass cover.

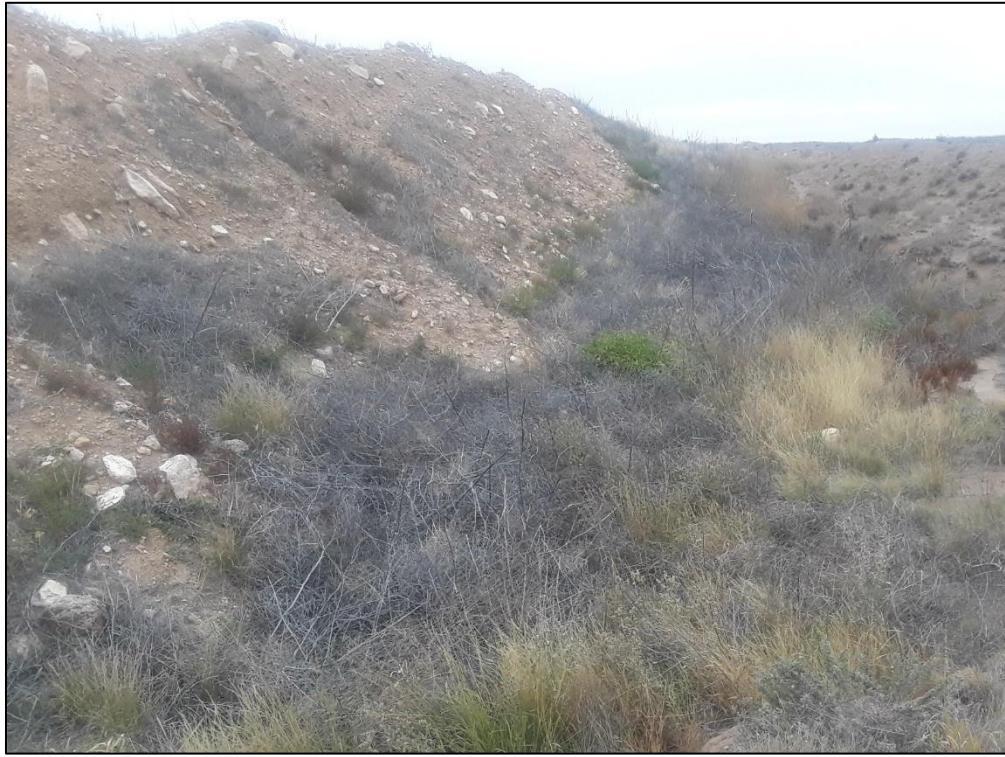
Photo 7. View looking north at overburden stockpile stored at eastern edge of active pit. Note stockpile is stable with some grass cover.

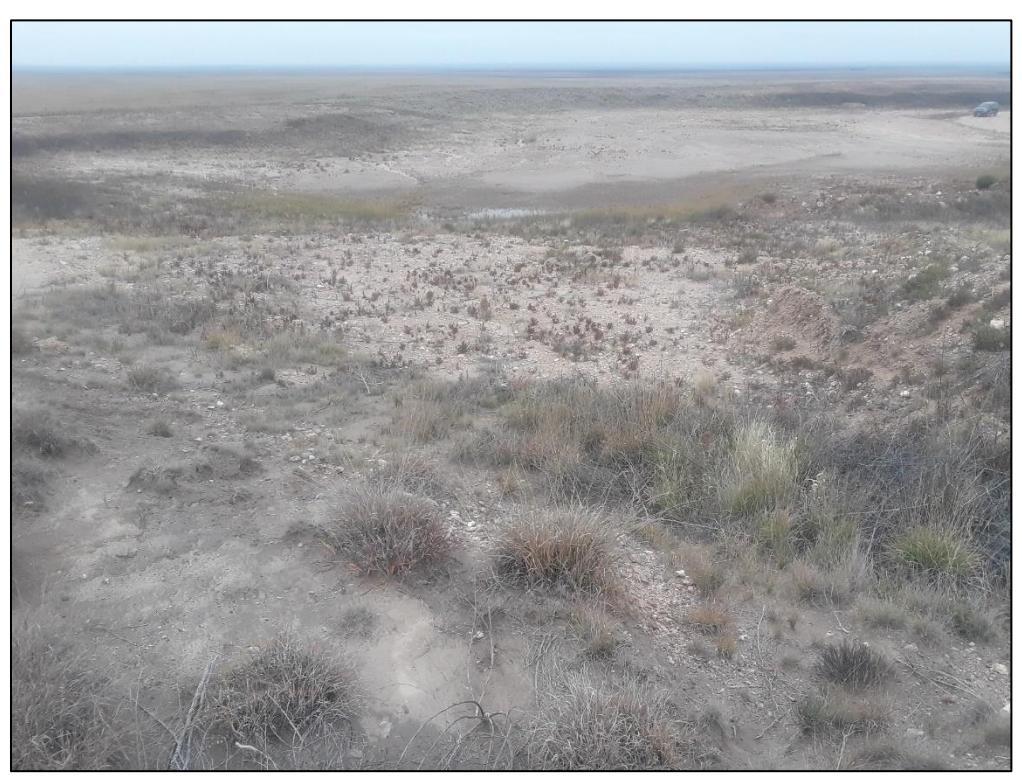
Photo 8. View looking southwest from top of topsoil stockpile across southern portion of pit (mining phase 2) in reclamation.

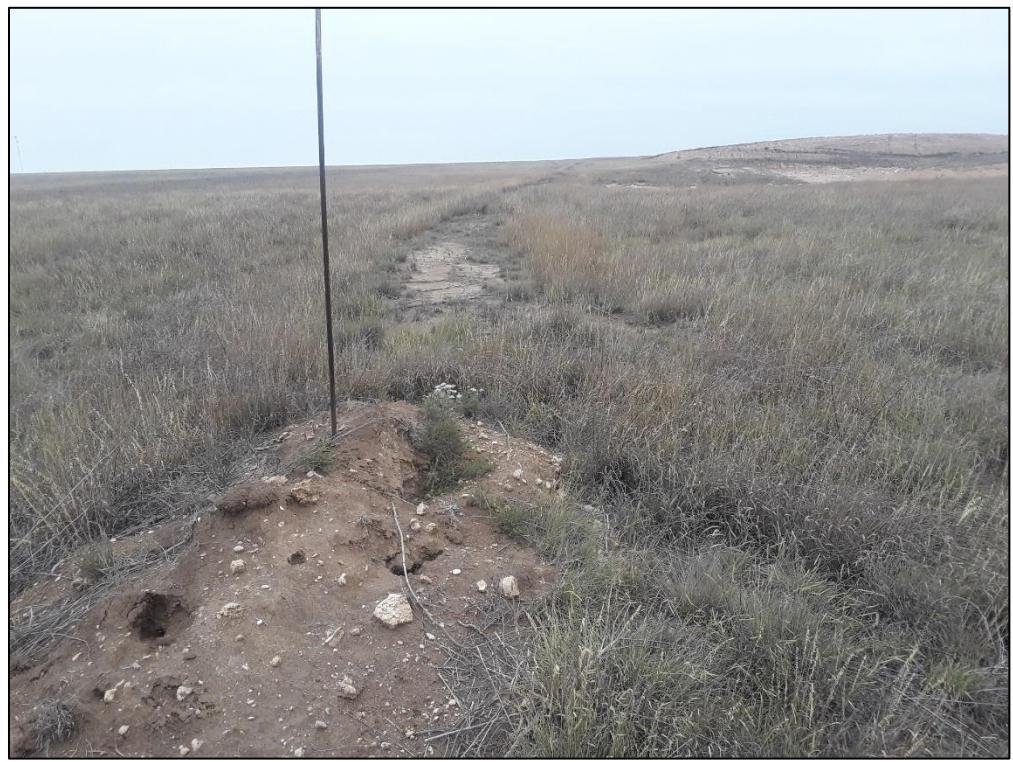
Photo 9. View looking east, showing metal post marking a northern corner of the permit boundary (northwest of active pit).

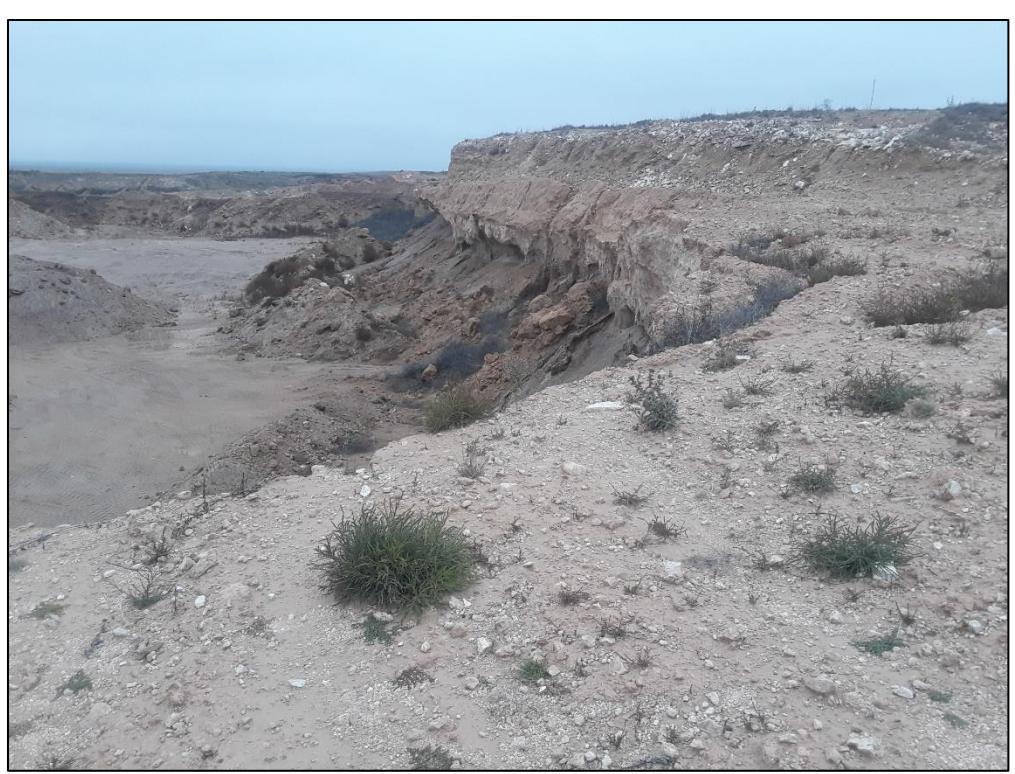
The active highwall is along the northern edge of the pit, and has near vertical slopes. This highwall has some significant erosion at its bottom 5-10 feet where the softer substrate is eroding beneath the harder substrate above. If this highwall will not be mined in the near future, the Division recommends the operator grade the slopes to a more stable configuration to help protect the land surface from erosion in accordance with Rules 3.1.5(3) and 3.1.6(3). According to Mr. Watts, the county does not process material on site. Mined material is directly hauled off site for use or temporarily stockpiled on the pit floor until needed. A few material stockpiles are currently stored on the pit floor, near the active highwall.

Photo 10. View looking west/southwest across portion of active highwall along northern edge of pit. Note erosion of softer substrate at bottom of highwall.

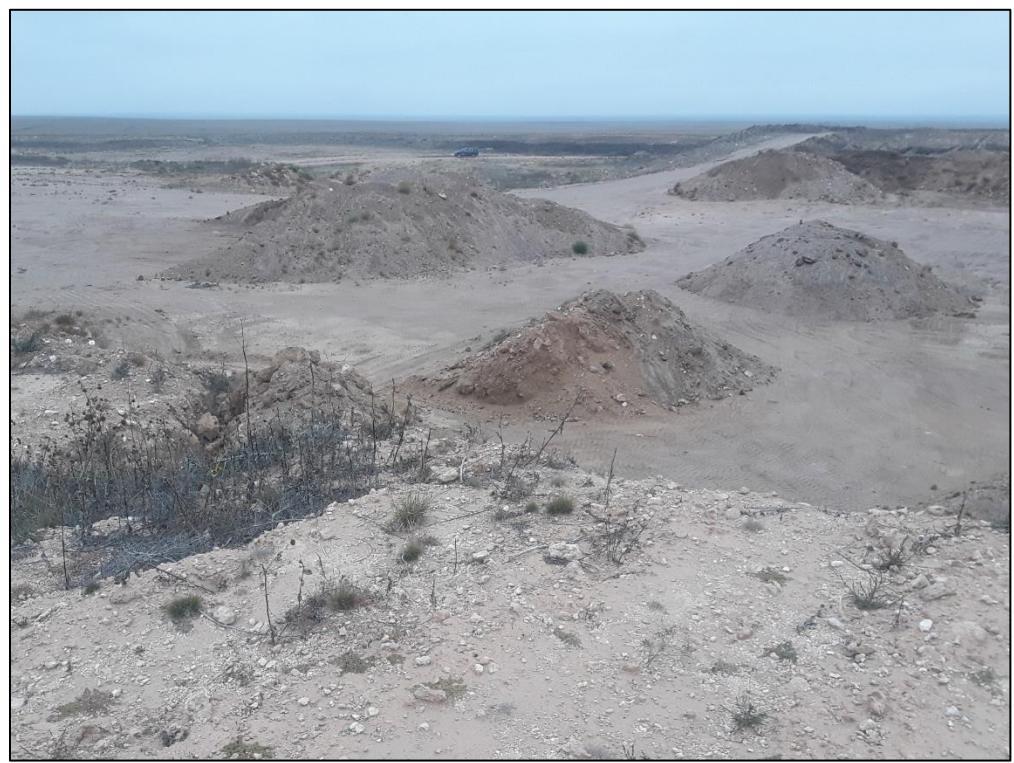
Photo 11. View looking south across northern portion of active pit, showing a few material stockpiles stored on pit floor.

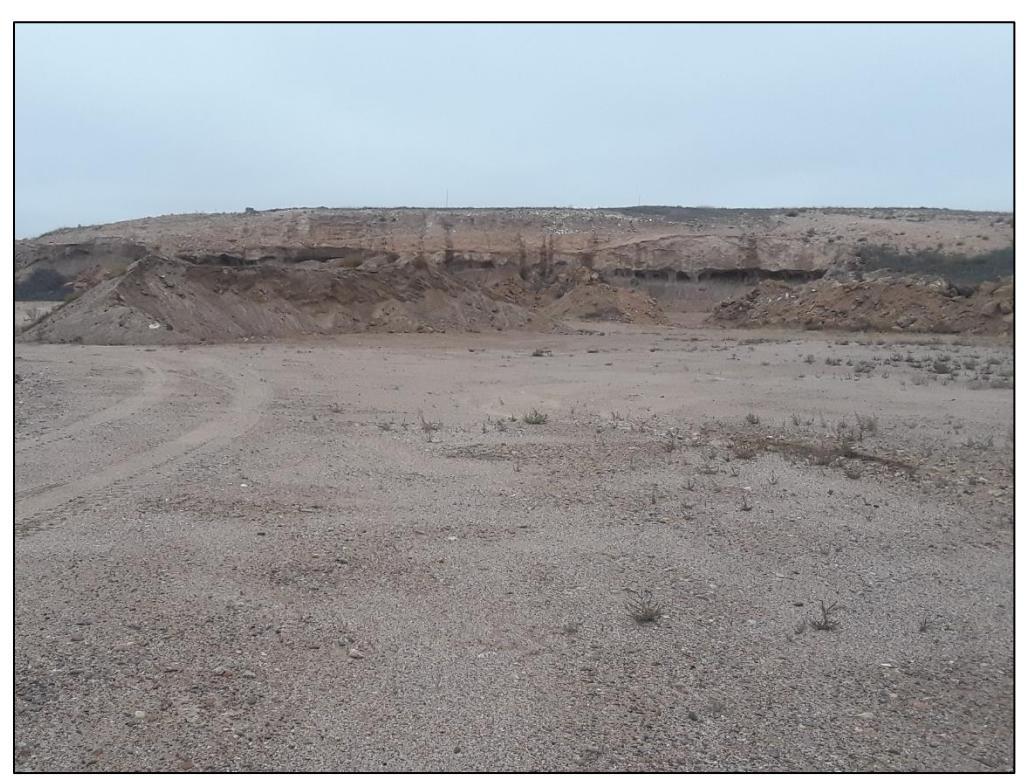
Photo 12. View looking north at active highwall along northern edge of pit. Note material stockpiles stored on pit floor near highwall.

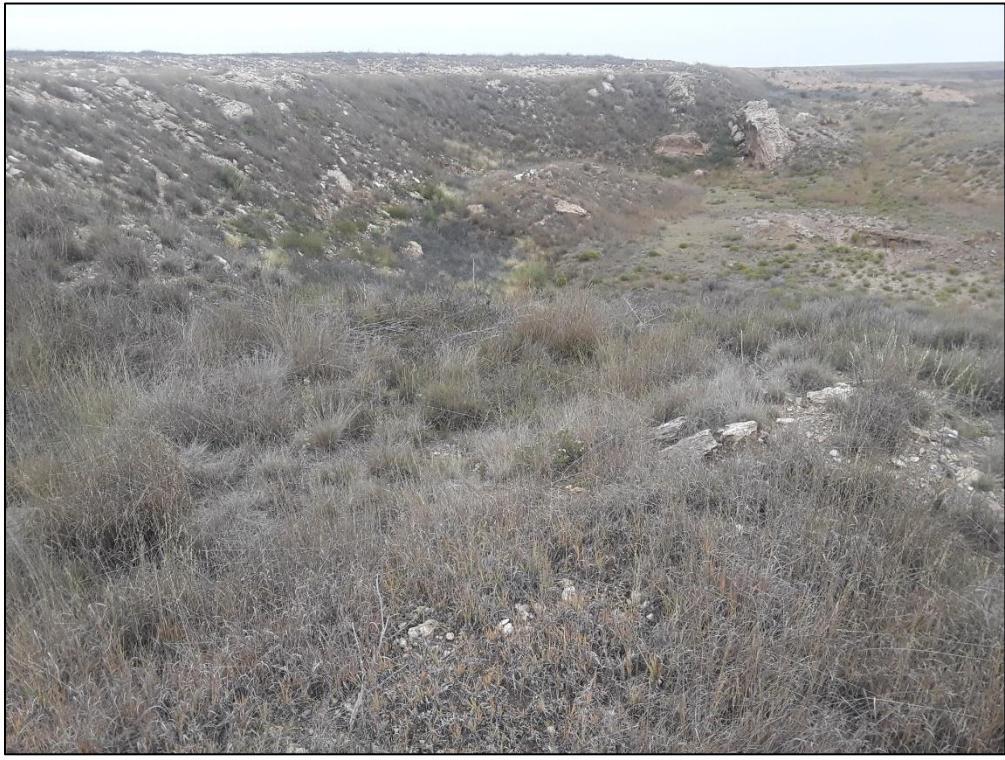
Photo 13. View looking northeast across old pit located west of active pit (in mining phases 4 and 6). Slope gradients in this area range from 1.5H:1V to 2.5H:1V. This area is well vegetated with volunteer grasses and shrubs, and appears to be stable.

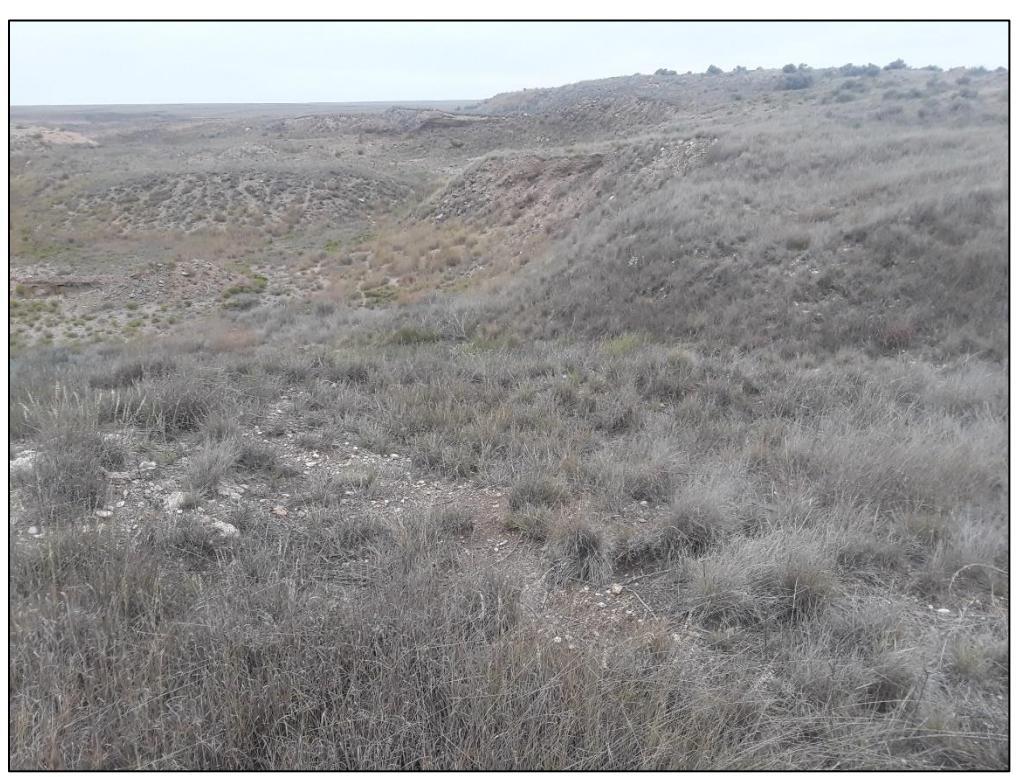
Photo 14. View looking southeast across old pit located west of active pit (in mining phases 4 and 6). Slope gradients in this area range from 1.5H:1V to 2.5H:1V. This area is well vegetated with volunteer grasses and shrubs, and appears to be stable.
