MINERALS PROGRAM INSPECTION REPORT PHONE: (303) 866-3567

MINE NAME:		MINE/PROSPECTING ID#:	MINERAL:	COUNTY:
Verhoeff Gravel Pit #1		M-2014-025	Sand and gravel	Bent
INSPECTION TYPE:		INSPECTOR(S):	INSP. DATE:	INSP. TIME:
Monitoring		Amy Eschberger	March 8, 2019	11:00
OPERATOR:		OPERATOR REPRESENTATIVE:	TYPE OF OPERATION:	
All-Rite Paving & Redi-Mix, Inc.		Herb Pearson	112c - Construction Regular Operation	
REASON FOR INSPECTION:		BOND CALCULATION TYPE:	BOND AMOUNT:	
Normal I&E Program		None	\$133,000.00	
DATE OF COMPLAINT:		POST INSP. CONTACTS:	JOINT INSP. AGENCY:	
NA		None	None	
WEATHER:	INSPECTOR'S SIGNATURE:		SIGNATURE DATE:	
Clear		Clarry Erelienger	March 20, 2019

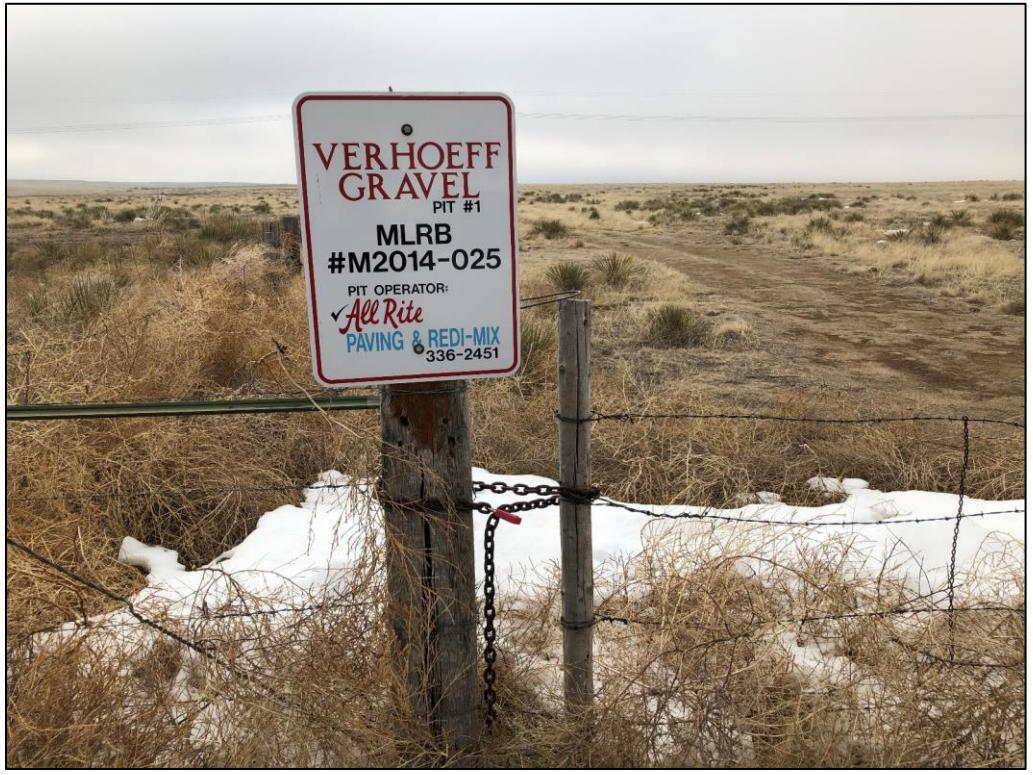
At the time of the inspection, the weather was partly cloudy and cool. A permit sign was posted at the main site entrance off of Co Rd JJ. The permit boundary was delineated by a property fenceline (4-strand barbed wire fence). An electric fence has been installed along the southern edge of mining phase 3, near the cattle corrals. An existing ranch road runs down the eastern edge of the permit area, and has not yet been improved/widened for use by the operation. No mining activities have begun at the site. The permit area consists of undisturbed rangeland. Mr. Pearson was not sure when operations might begin at the site. Nothing in the Construction Materials Act and Rules requires operations to commence within a specified timeframe after permit approval. As long as the land is undisturbed by the operation, Rule 3.1.3 regarding time limit and phased reclamation (complete reclamation within 5 years of mining) does not apply.

Photo 1. View of permit sign posted at main site entrance off Co Rd JJ.

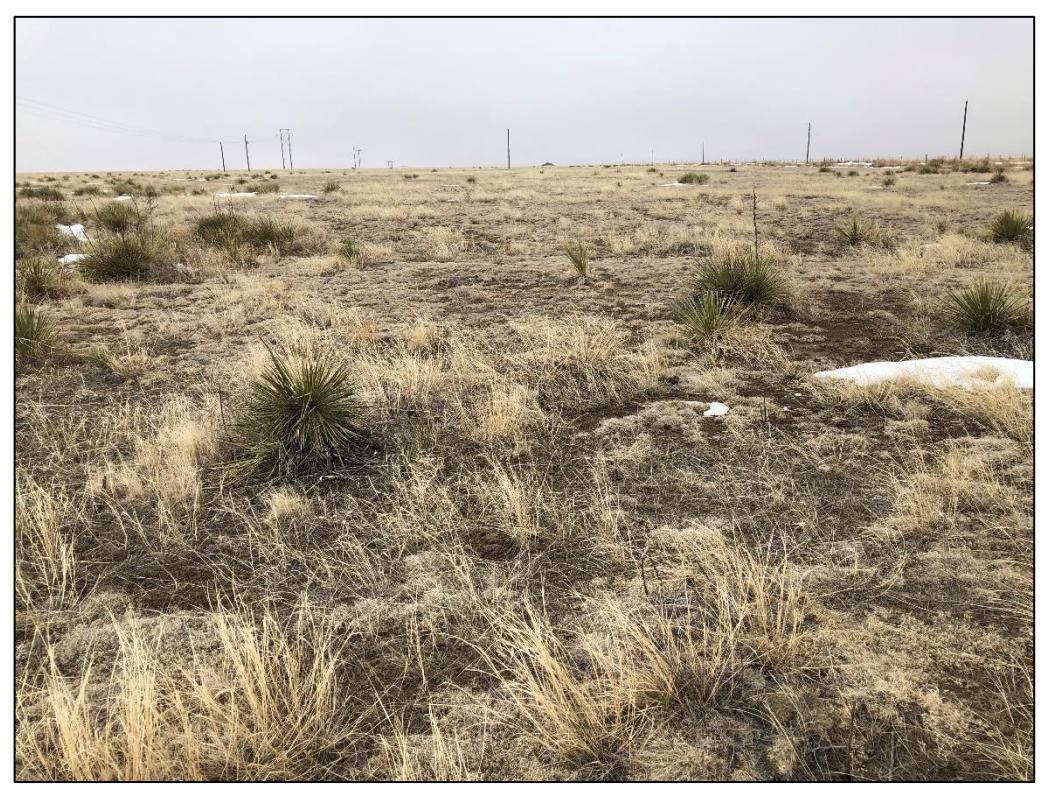
Photo 2. View looking west across undisturbed northern portion of permit area (mining phase 5).

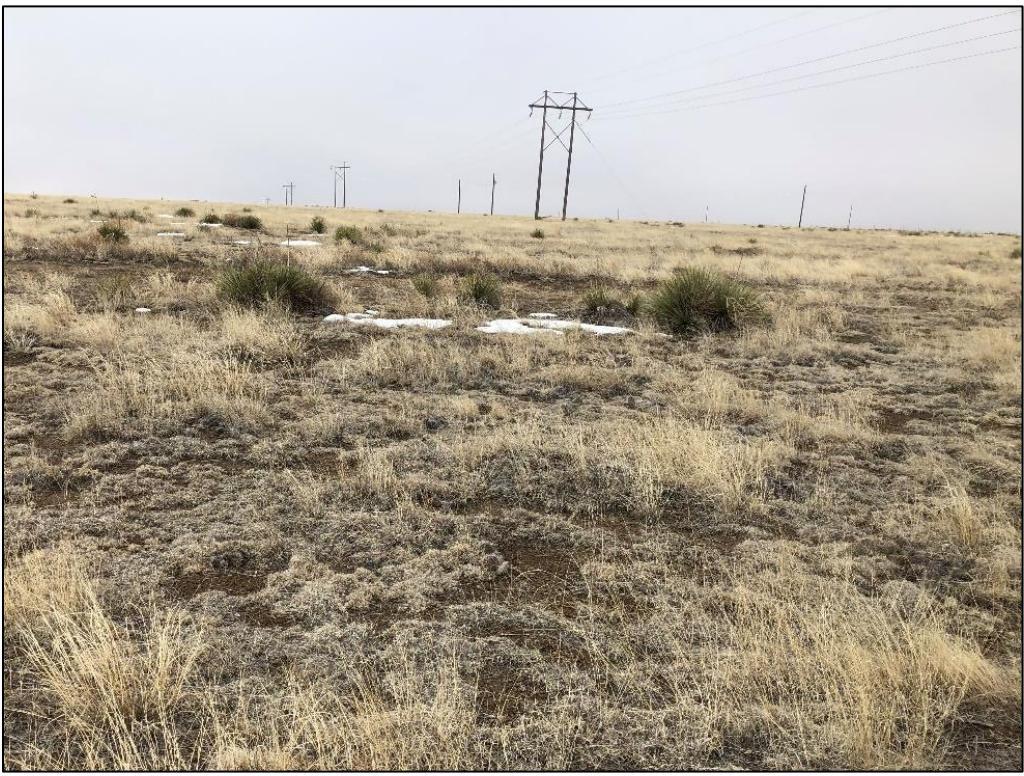
The operation will maintain a minimum mining setback of 50 feet from Co Rd JJ, 25 feet from the permit boundaries, and 50 feet from the landowner's well located in the southeastern portion of the permit area. Additionally, an overhead power line runs east-west across the northern portion of the permit area, from which the operation will maintain a 75-foot radial setback from the poles, and a 50-foot setback from the center of easement (100-foot easement) of the power line. No setback is specified for the landowner's existing cattle corrals, which are present at the eastern edge of the site.

Photo 3. View looking northwest across northern portion of permit area, showing overhead power line which runs east-west across the permit area. The operation will maintain setbacks from the poles and utility easement.

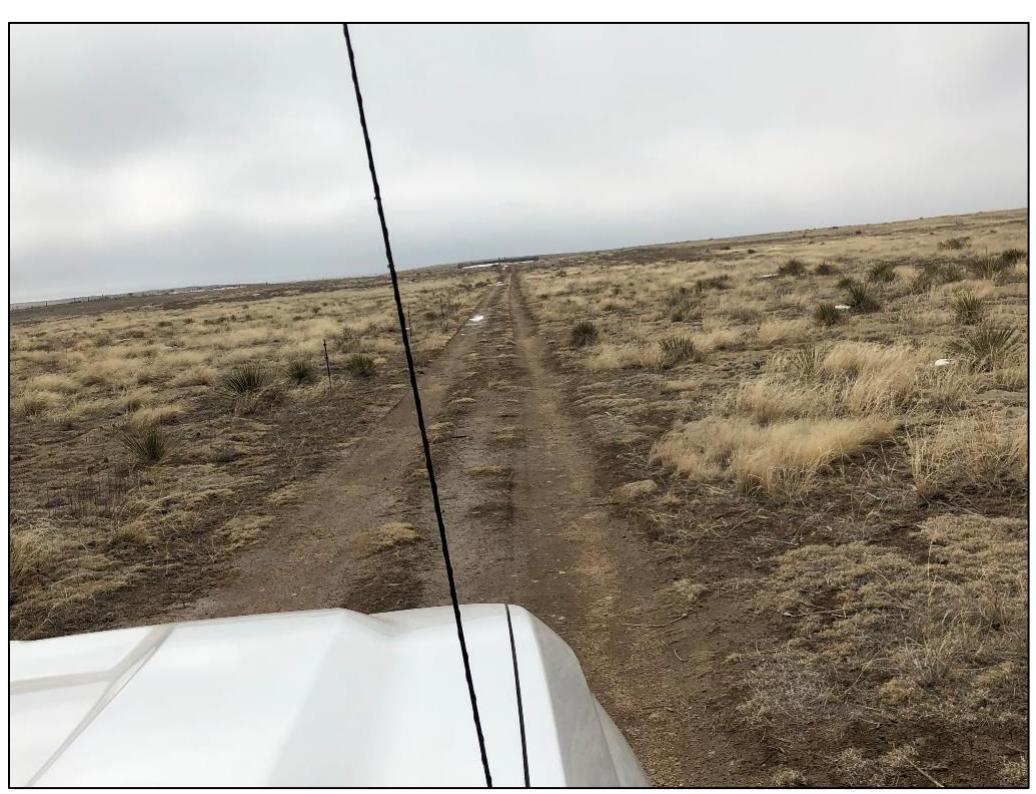
Photo 4. View looking south, showing existing ranch road along eastern edge of permit area.

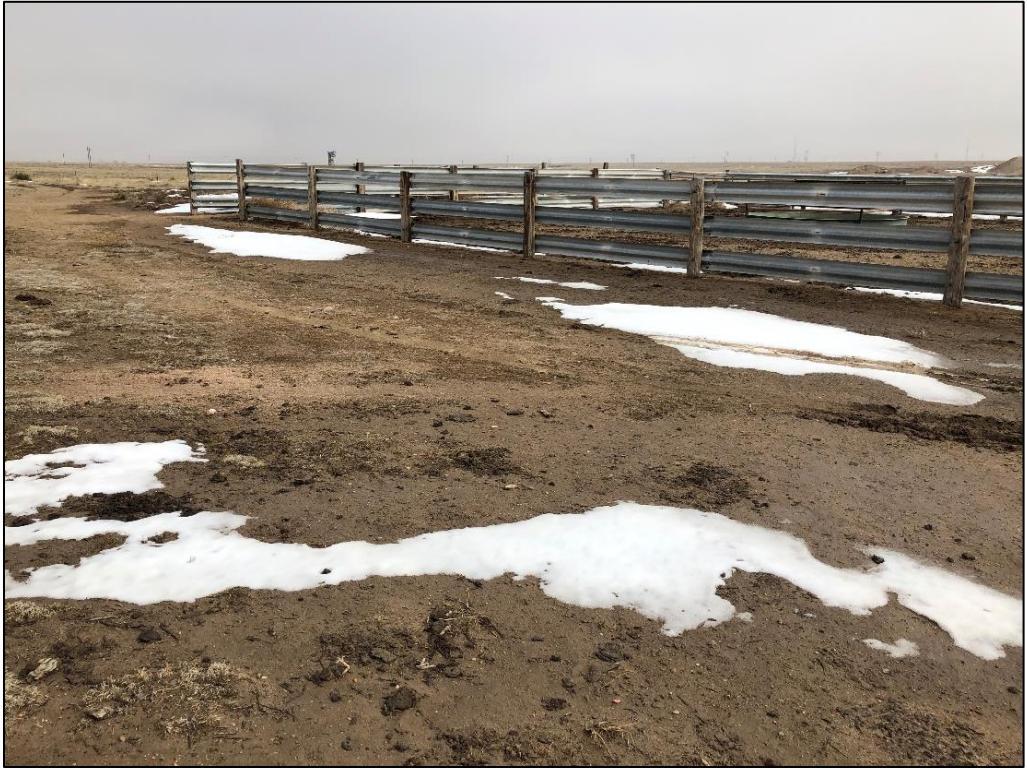
Photo 5. View looking northeast, showing existing cattle corrals at eastern edge of permit area, between mining phases 2 and 3.

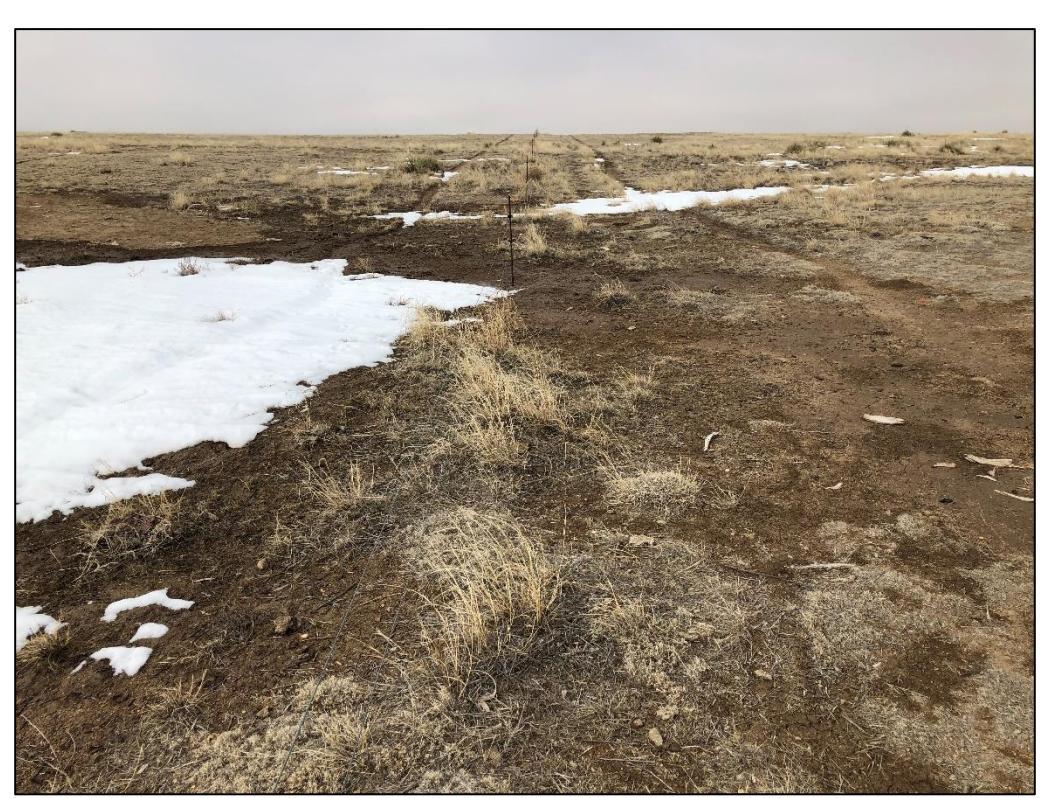
Photo 6. View looking west down electric fence installed across permit area, along southern boundary of mining phase 3.
