Appendix A Logan Wash Mine Pond Facility Relining Project Summary Report

Garfield County, Colorado

Project No. 10202.01

March 27, 2019

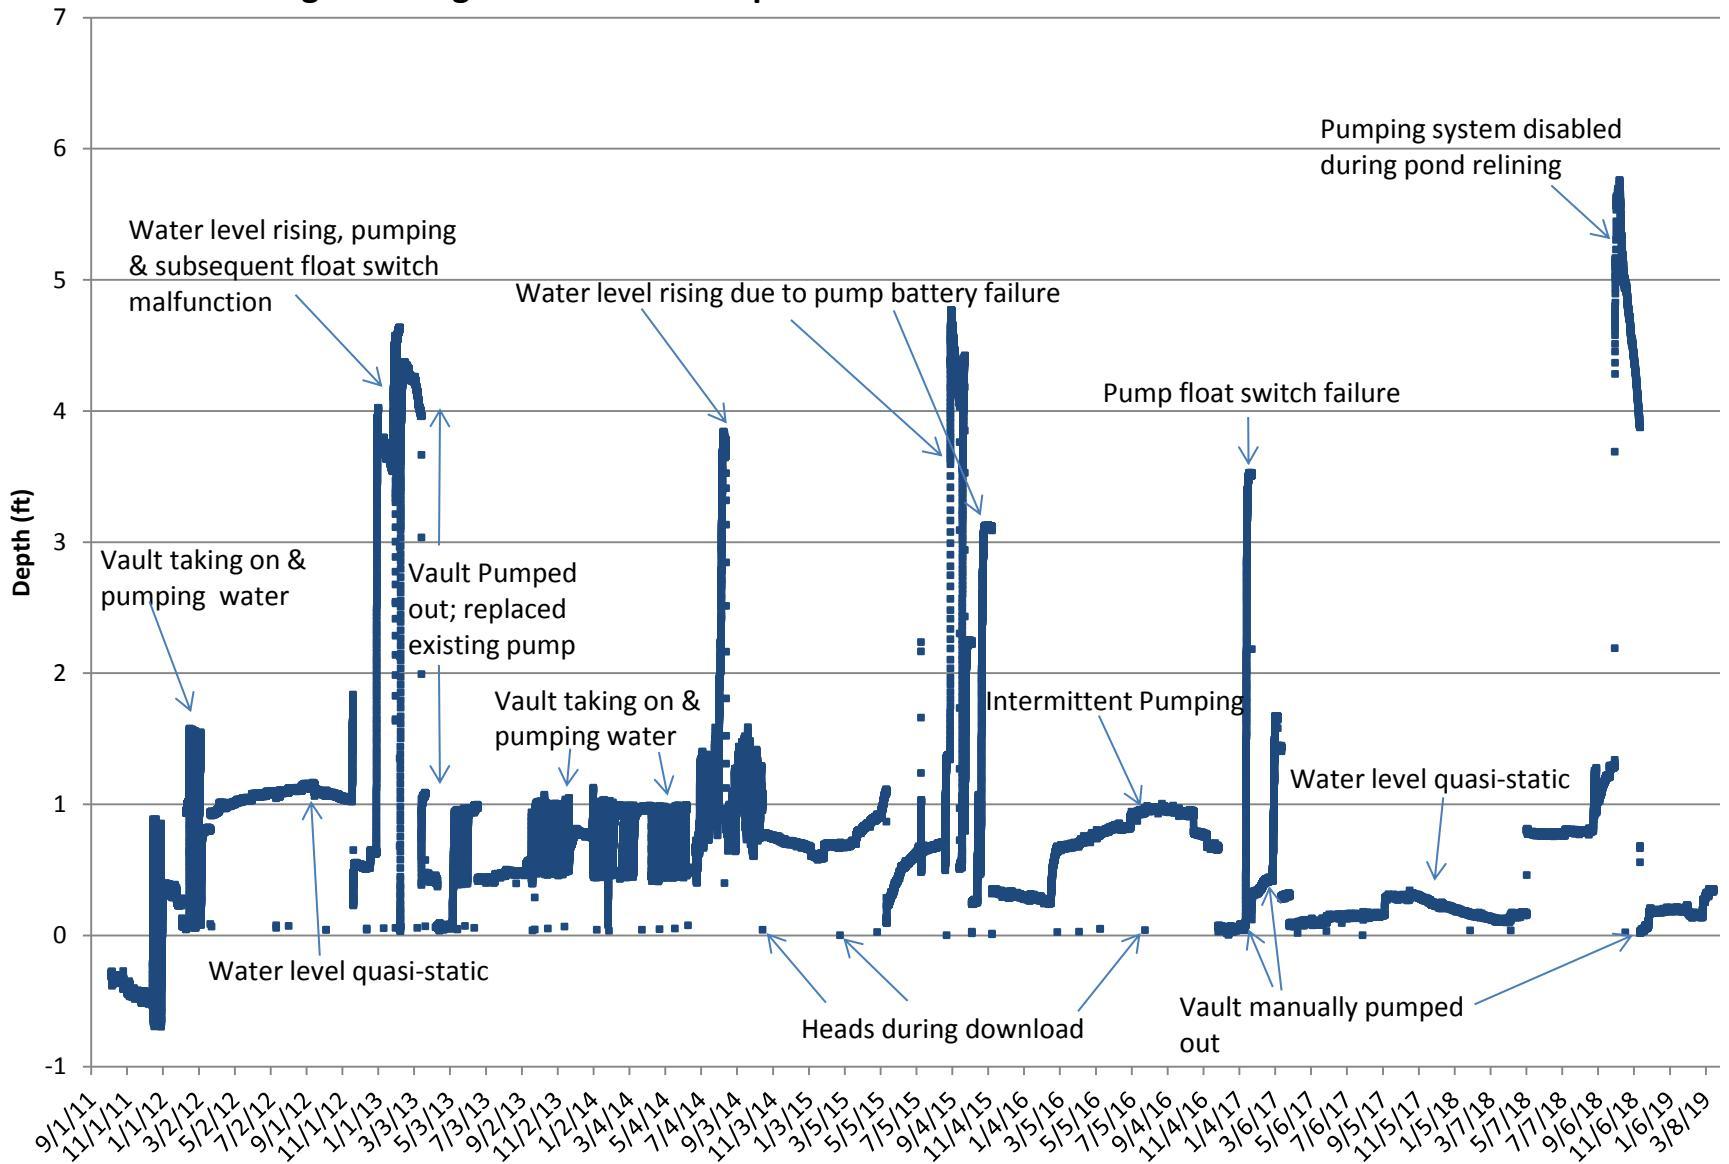
Figure 2. Logan Wash Mine Evaporation Pond Leak Detection Vault Water Levels

In the case of a leak through the HDPE 60-mil liner, the leak detection system is designed to convey leakage to the Leak Detection Vault on the west side of the Evaporation Pond. Leakage water was first discovered in 2011 and has occurred intermittently since that time (see Figure 2). Any water present in the Leak Detection Vault was pumped back into the pond using an automated, solar-powered pump system. Water level within the Leak Detection Vault is continuously monitored with an automated pressure transducer.

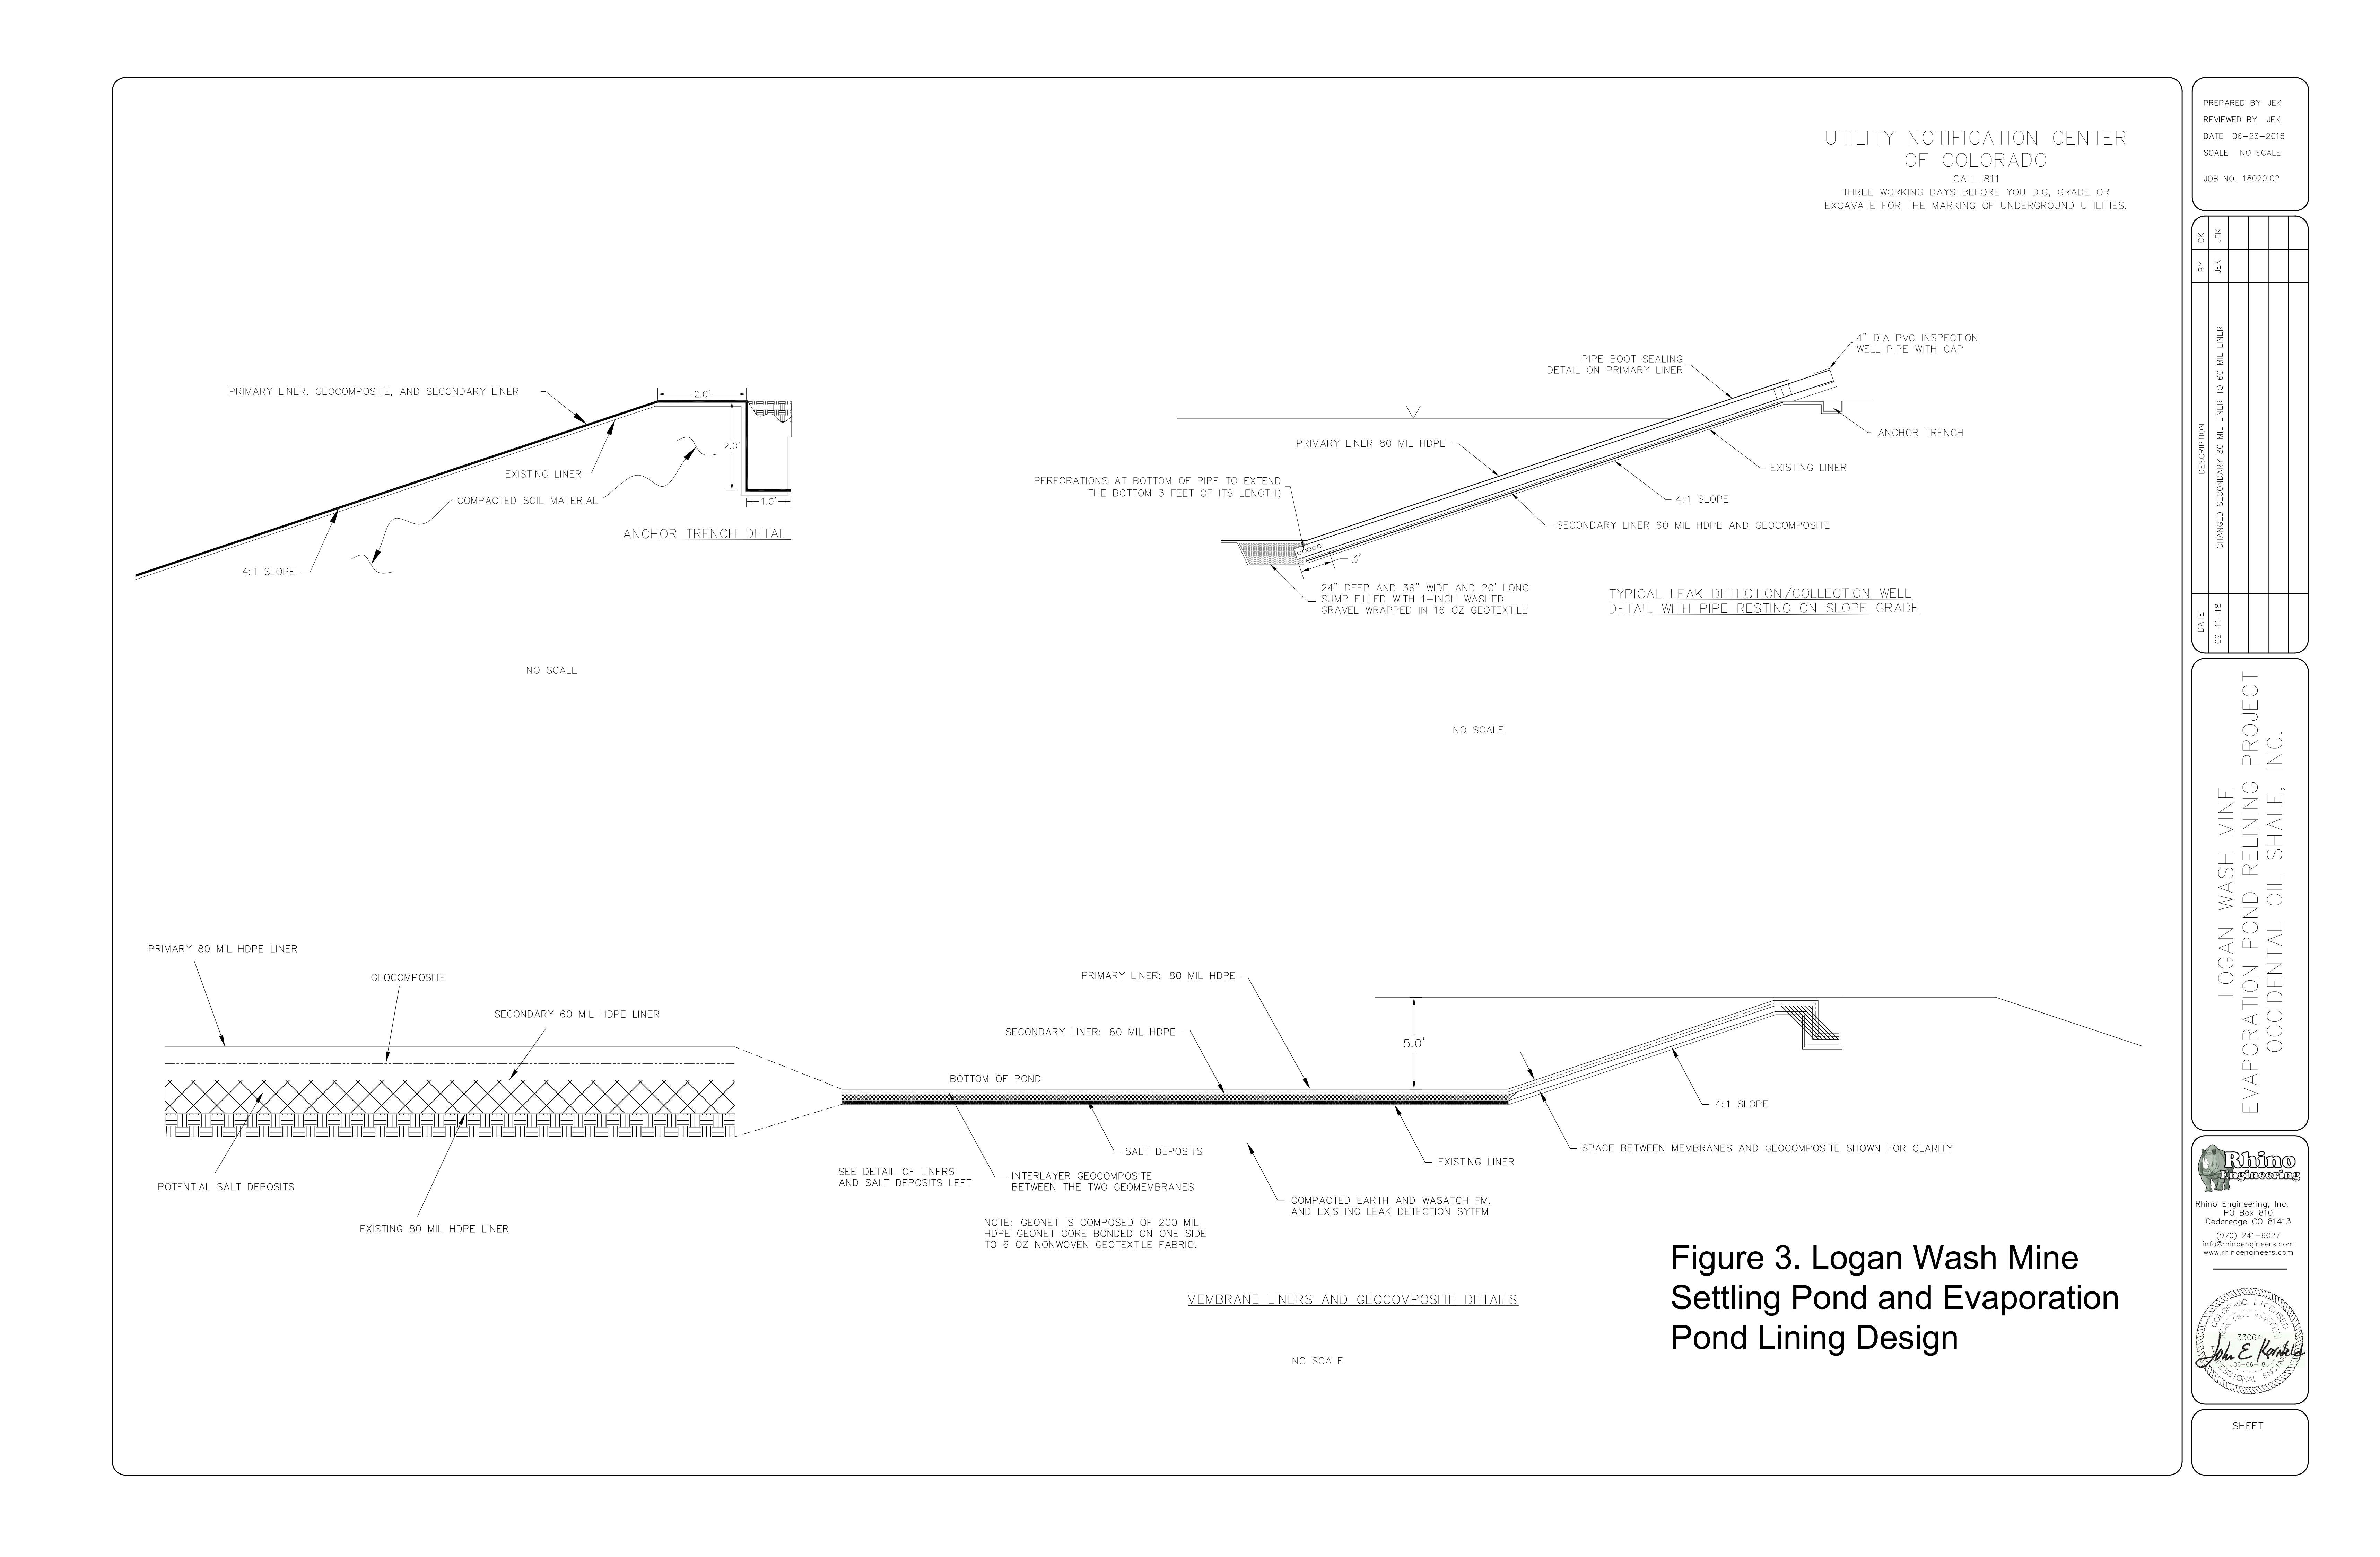
Figure 3 – Settling Pond and Evaporation Pond Lining Design

The relining design included a secondary liner (bottom liner) of 60-mil HDPE, an overlying layer of geocomposite that consisted of 200-mil HDPE geonet bonded to 6-oz nonwoven geotextile, and a primary (top) liner of 80-mil HDPE. Even though the Evaporation Pond is flat-bottomed, two leak detection

sumps were constructed on the east and west sides of the pond to monitor for potential pond leakage through the primary liner. The geocomposite material provides for a transmissive layer that would allow for leakage from the primary liner to potentially be detected at the sump locations. Each sump has a leak detection pipe installed from the bottom of the sump (located at the toe of the pond slope) to the top of the pond slope. The leak detection pipe can be monitored for the presence of retort water, which would indicate a leak in the primary liner. The same design was constructed at the Settling Pond where one leak detection sump and pipe was constructed on the west end of the pond. Figure 3 is a schematic of the pond lining system that was constructed at the pond facility.

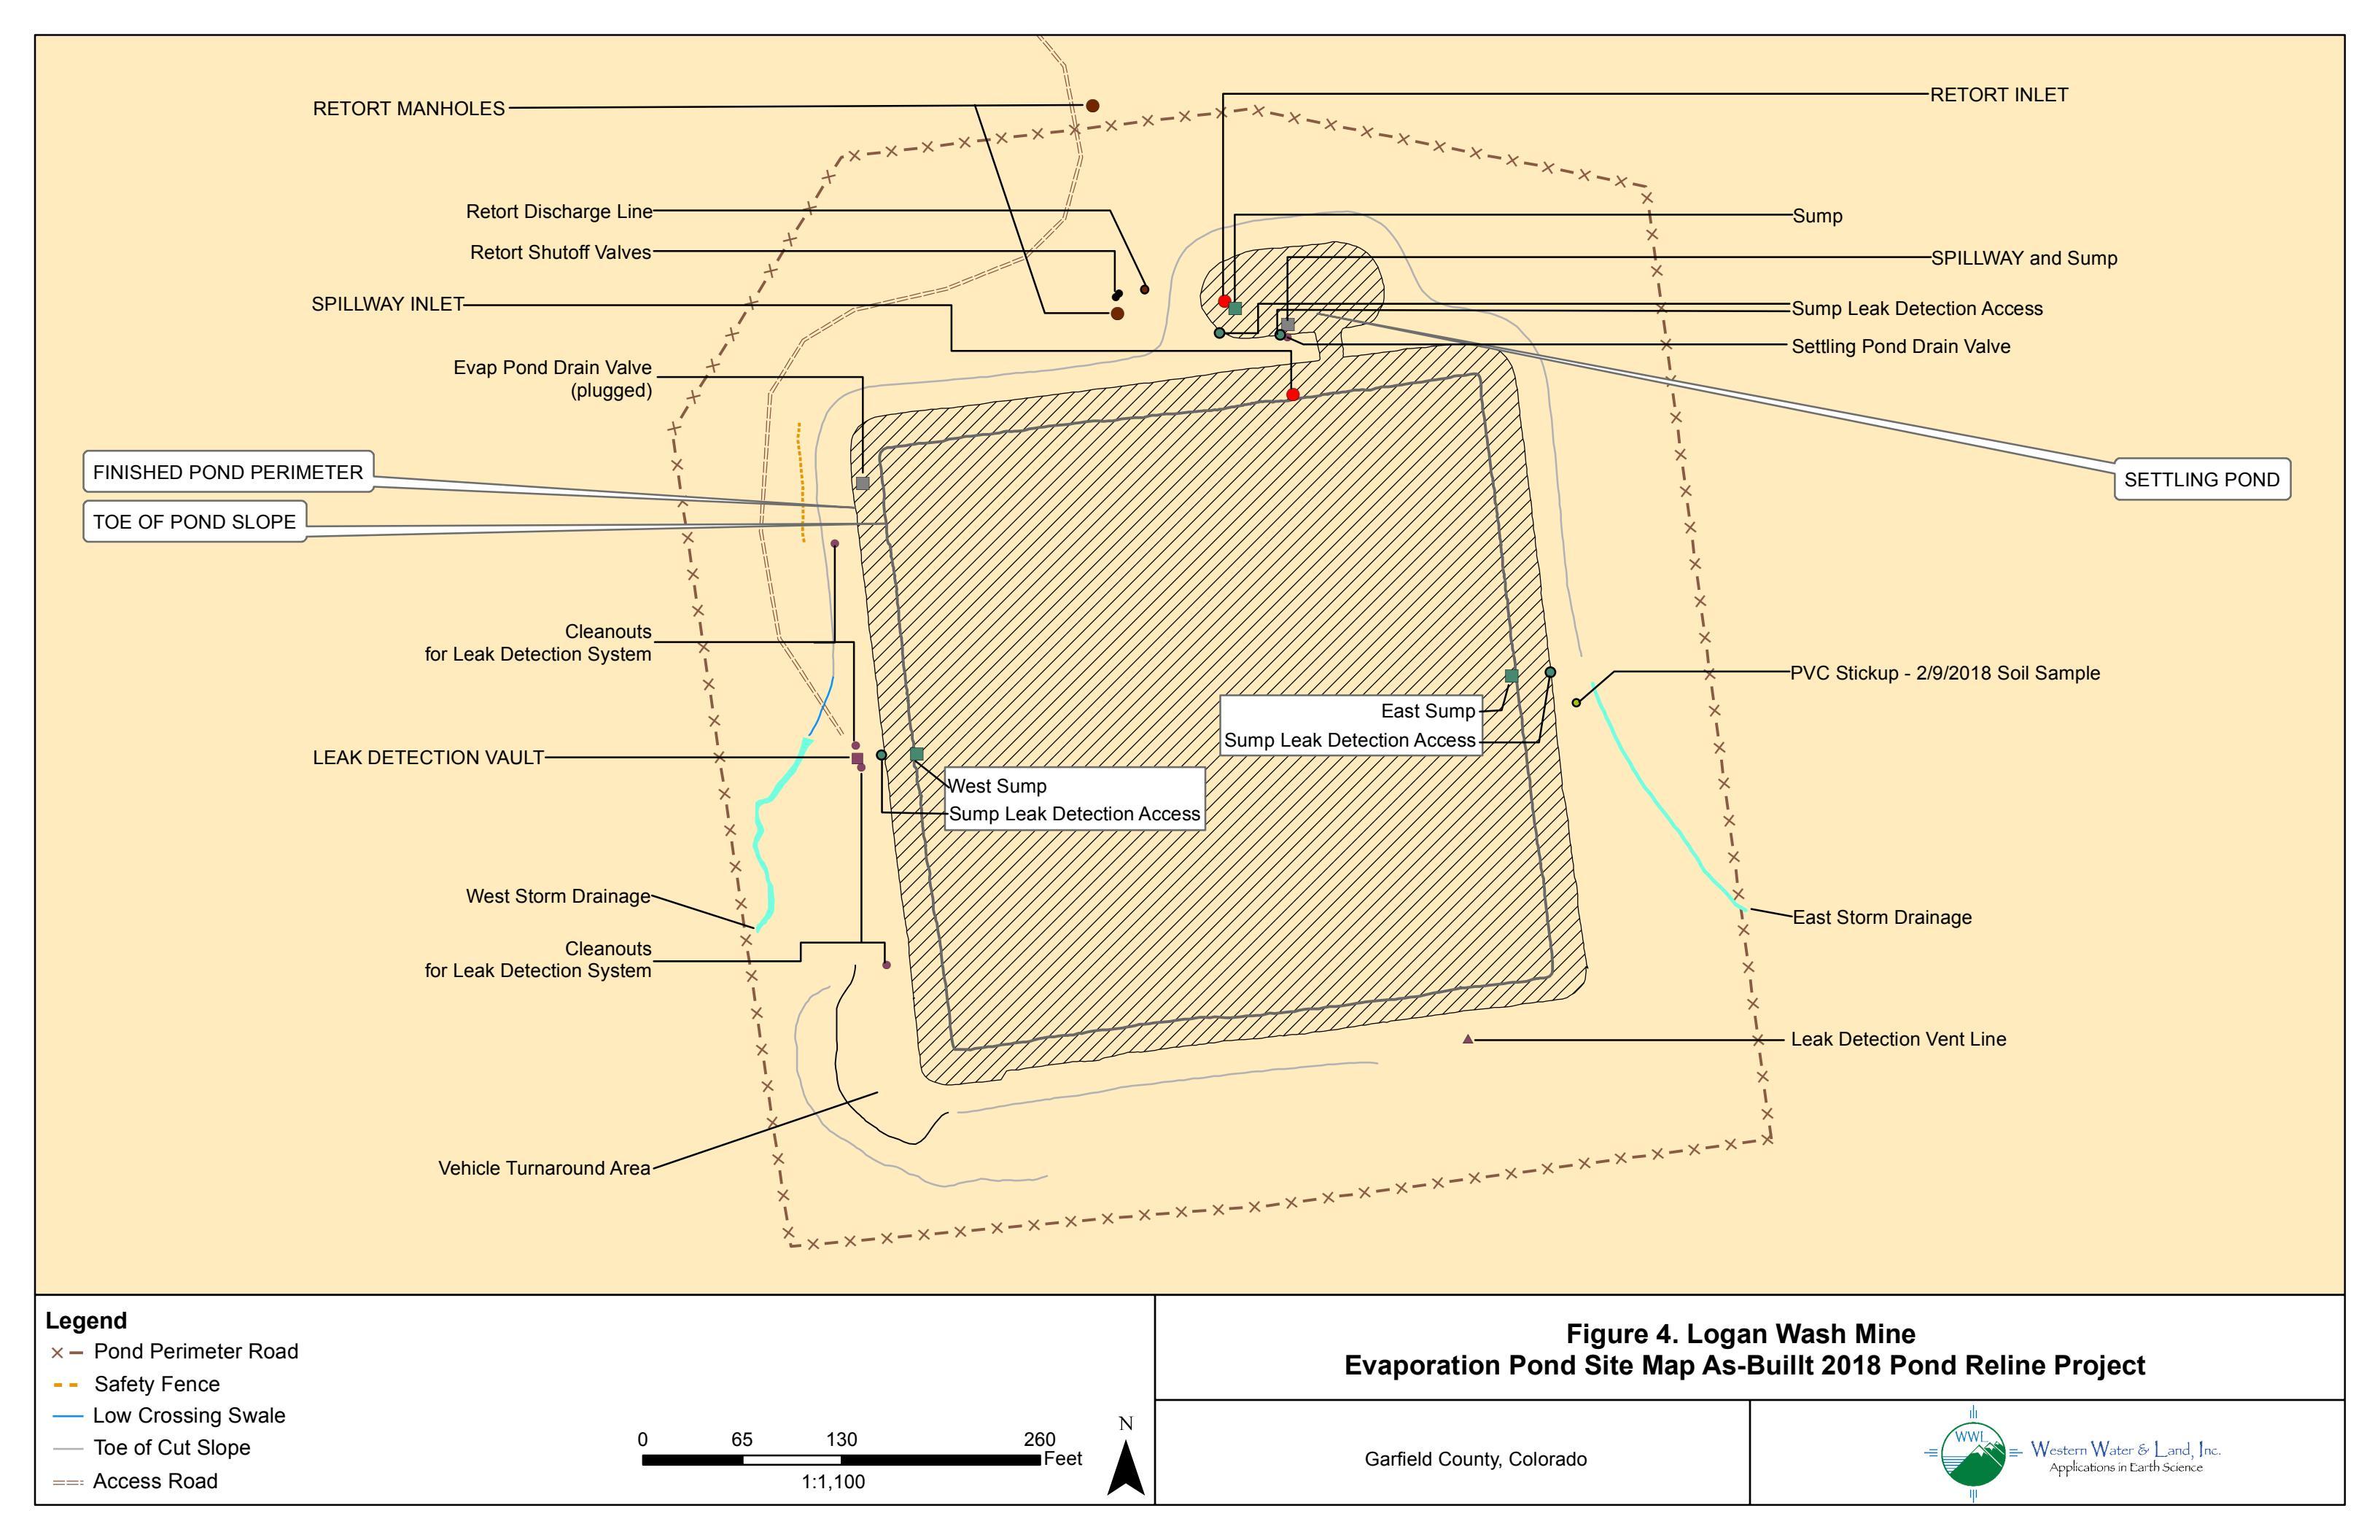
Figure 4 – Evaporation Pond Site Map As-Built 2018 Pond Reline Project

November 12- 16: H & H begins and completes liner testing on 80-mil HDPE on Evaporation Pond. WWL inspects and witnesses liner testing and conducts liner integrity inspections, marks defects and damaged liner locations. H & H and WWL conduct liner inspection walkthrough; Pond good to receive retort water. WWL turns retort water into Settling Pond on November 16, 2018. H & H Settling Pond and Evaporation Pond liner installation is complete.

An As-Built drawing from the 2018 Pond Reline Project is shown in Figure 4.
