**COLORADO Division of Reclamation, Mining and Safety** Department of Natural Resources

# MINERALS PROGRAM INSPECTION REPORT PHONE: (303) 866-3567

| MINE NAME: | MINE/PROSPECTING ID#: | MINERAL: | COUNTY: |
|---|---|---|---|
| Priola Pit | M-2007-087 | Sand and gravel | Adams |
| Surety Release Inspection | Jared L. Ebert | April 18, 2019 | 12:50 |

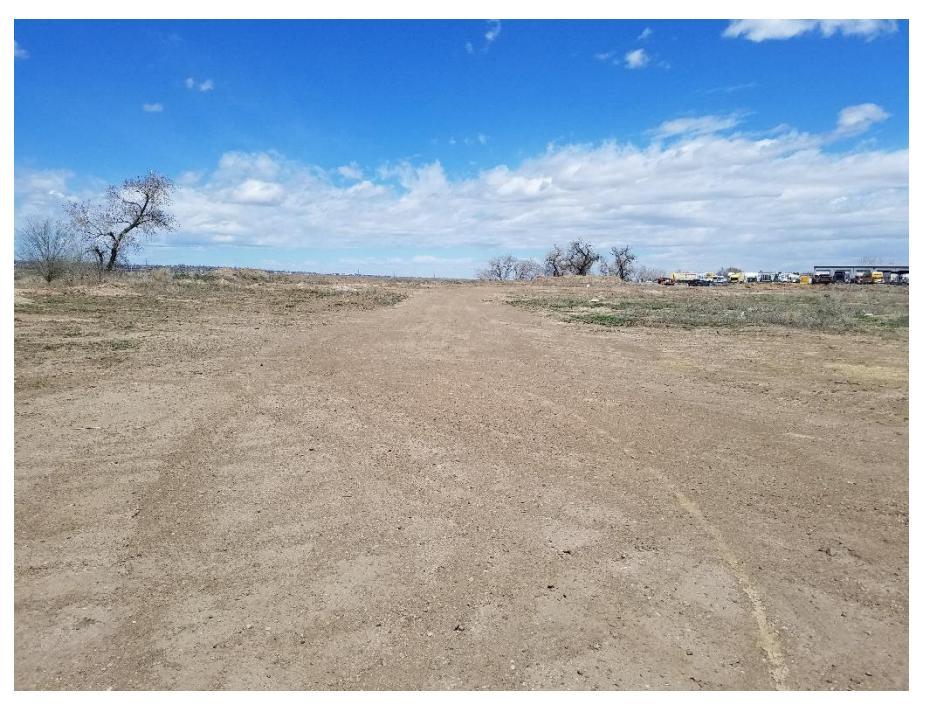
Figure 1. From the southern entrance of the site looking north-northwest.

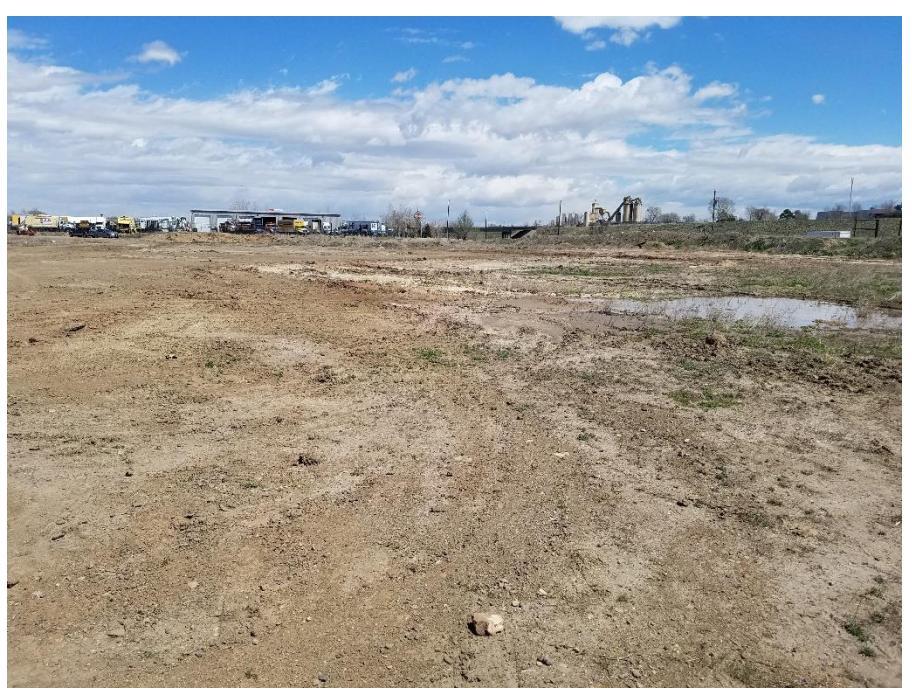
Figure 2. From the center of the site looking northeast.

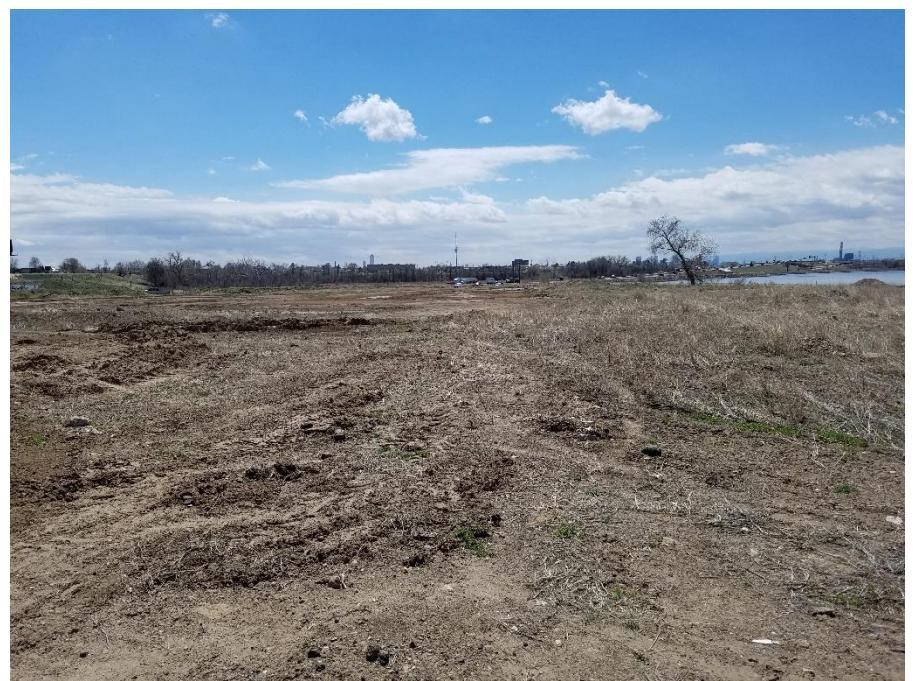
Figure 3. From the northern portion of the site looking southwest.

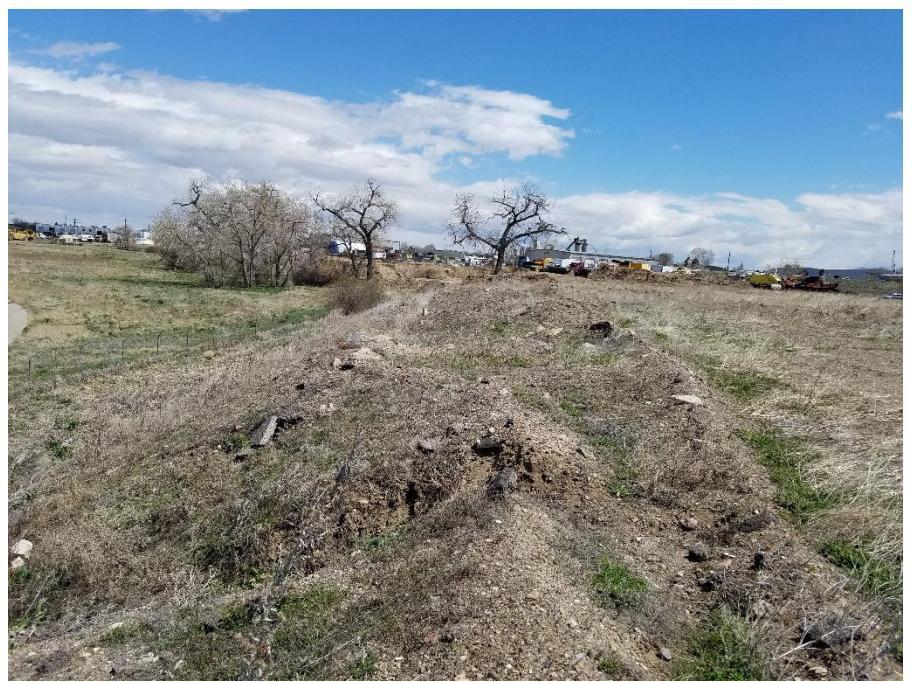
The majority of the earthwork at the site appears to be completed. AFS has backfilled the initial pit excavation and filled the area leaving a fairly level pad with graded side slopes toward the perimeter of the property. The majority of the side slopes have been graded to a 3H:1V slope with a small section of slope on the north side of the site and another small section on the northwest portion of the site where slopes closer to 2H:1V were observed.

The majority of the earthwork required for reclamation is complete with the exception of small localized areas where some additional sloping to the required 3H:1V ratio is necessary. Topsoil remains to be spread over the site and the affected land must be revegetated.

Figure 4. Northern slope needed some re-grade to a 3H:1V.

**CORRECTIVE ACTIONS:** The Operator shall complete the remaining backfilling, grading, topsoiling and seeding as approved in the reclamation plan by the corrective action date. The Operator shall provide notification and documentation these activities have been completed by the corrective action date. **CORRECTIVE ACTION DUE DATE:** 6/24/19
