BLM Inspection 04/26/2019 - Canyon Rim Stone LLC., Cherry Canyon Quarry

Operation Type :	Surface – continual	□ Surface – intermittent		Underground	
Date: Apr 26, 2019 Time: 12:43 Weather: Windy , Sunny		Operation Name: Canyon Rim Stone LLC. – Cherry Canyon Case Number: COC078876 CDRMS #: M-2006-053			
<u>A</u>	<u>Attendees</u>	General			
		Operation (s) are in compliance with documentation on file			
BLM: A. Sanderson & J. R	ambo	✓ Yes	□ No	□ N/A	
Operator(s): Contacted, bu	it not present.	Operation(s) and disturbance on-site coincide with the operations and access on file ☑ Yes □ No □ N/A			
Other(s): None

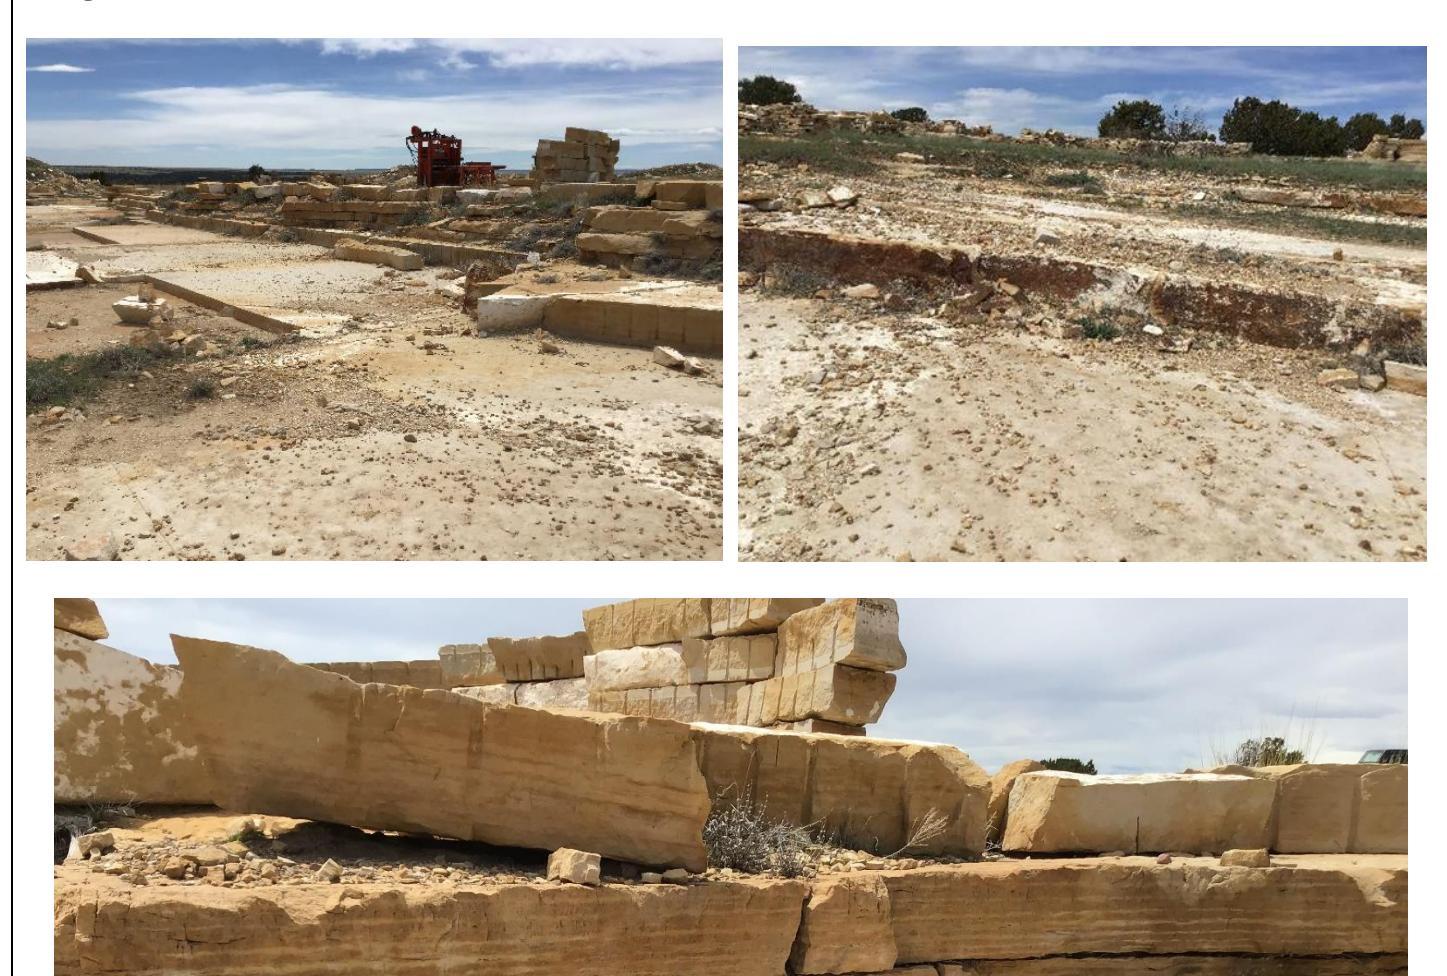
Image 1-3:

Comment: Working floor with splitter in the background. Highwalls are between 1 to 5 feet high. Multiple interim benches are used as highwall height increases.

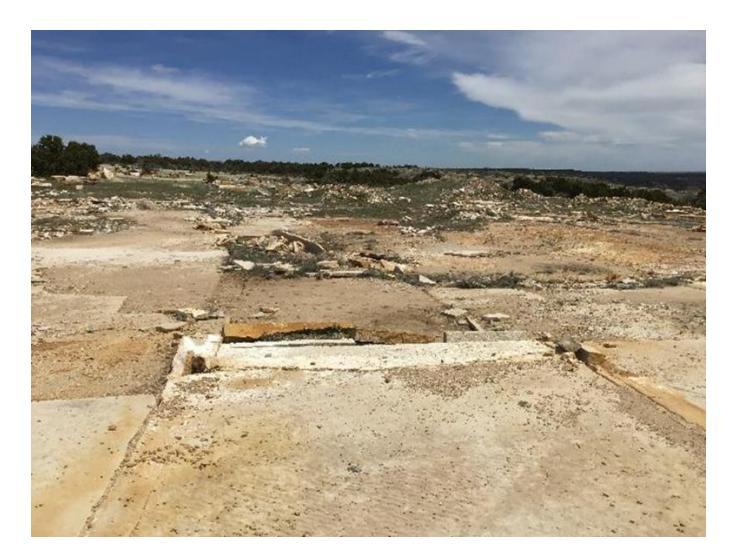
Image 4:

Comment: Eastern view from the 5' highwall

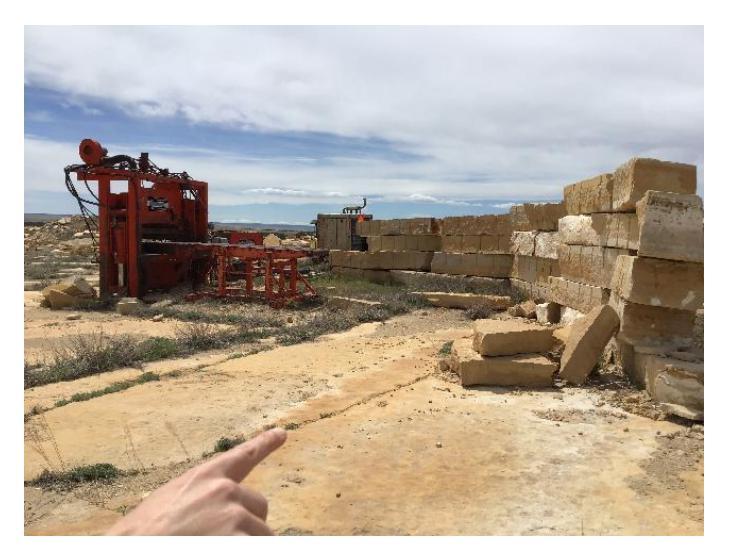
Comment: Hydra splitter rock wall for wind protection/visual barrier **Image 6:**

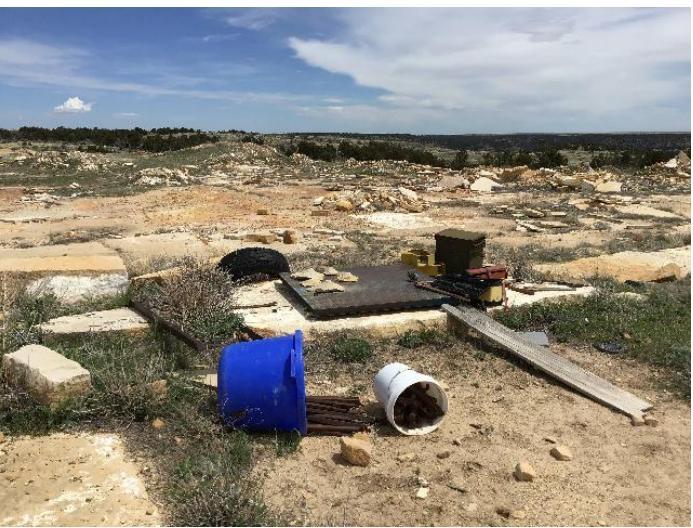
Comment: Storage of POLs and mining related equipment and tools; located east of the splitter

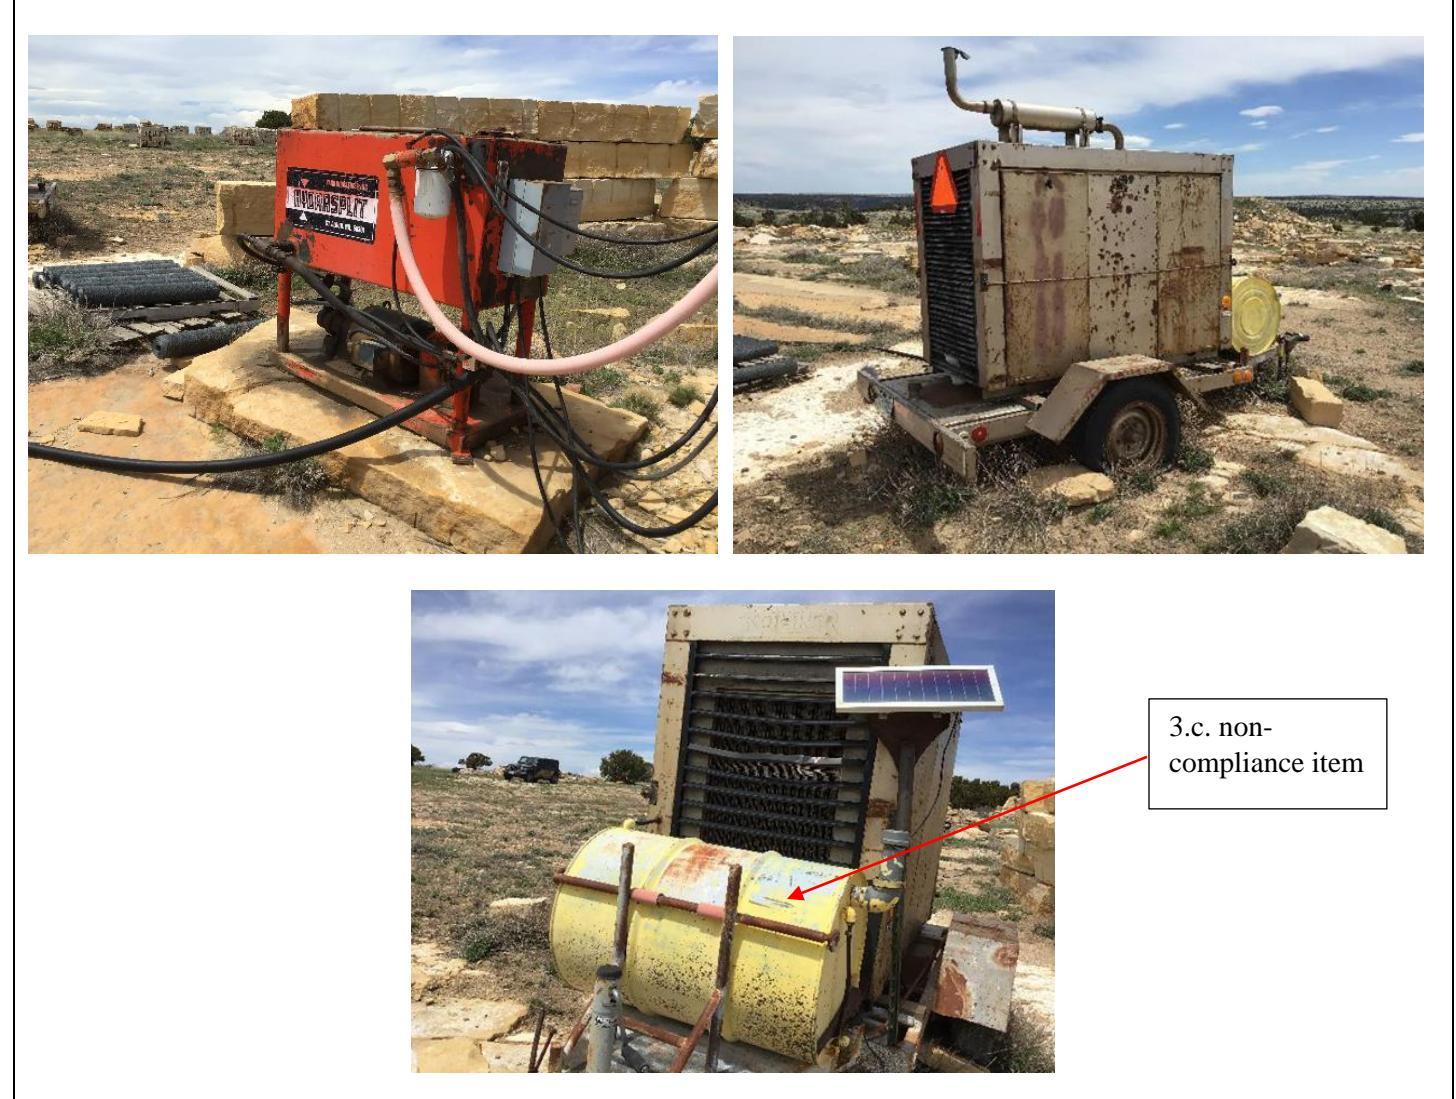
Image 7-9:

3.c. Housekeeping – Hazardous Substance/POL Management: 55 gallon yellow drum located on the southern end of the solar powered generator needs to be re-labeled with the type of material (e.g. non-potable water, diesel, oil, etc.) which is stored. The label seems to have rubbed off due to weather. Ref. image 9.

Comment: Working floor/processing - Water source/generator for the hydro splitter with secondary containment (sandstone slab) and solar powered generator. Image 9 – depicts the yellow 55 gallon drum (3.c. non-compliance item)

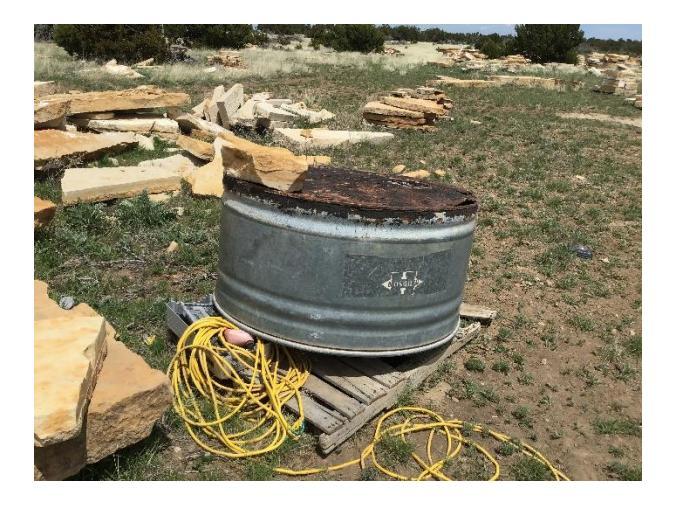
Image 10:

Comment: Portable generator contained in a steel drum and stored along the north/northeastern boundary.

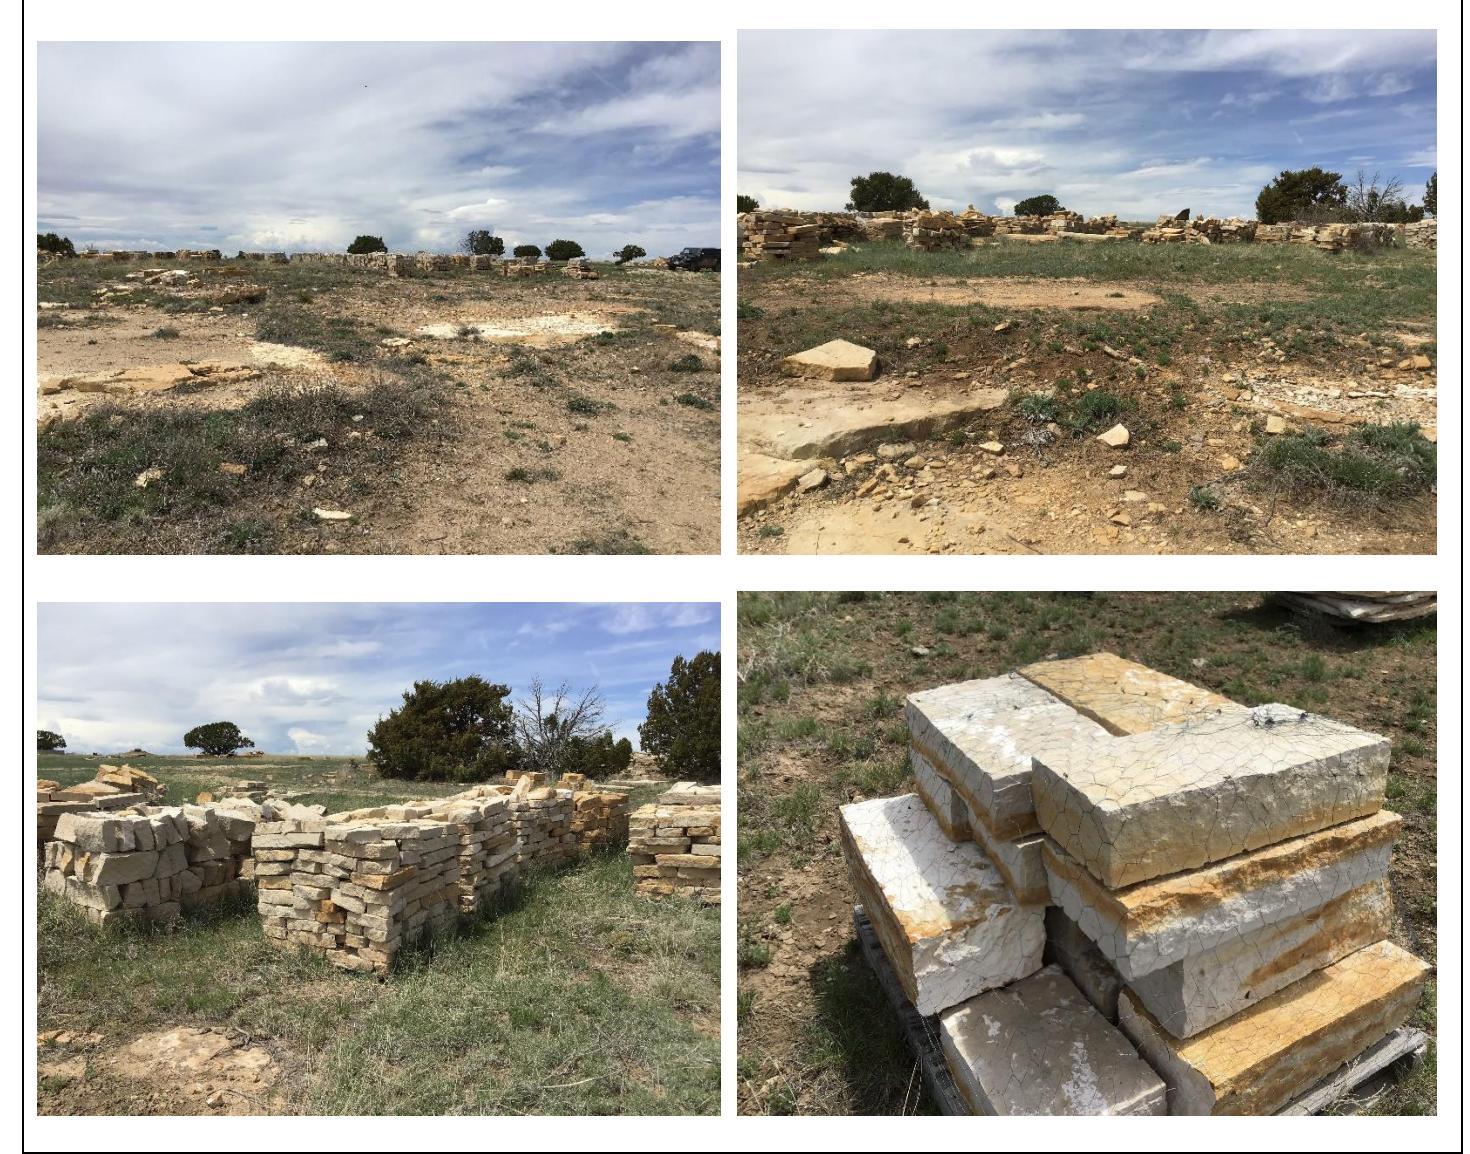
Image 11-14:

Comment: Stockpiled pallets of mined material located along the north/northwestern boundaries
