## **3809 INSPECTION REPORT**

MINE NAME: Jubilee Venture LLC Eagle Mine	SERIAL #/ MINE ID#: COC74961/M2011-029	COMMODITY: All precious mineral	COUNTY: Moffat
LOCATION: 6TH PM, TI0N, R92W Sec. 2 SENE	INSPECTOR(S): BLM: Jennifer Maiolo	INSP. DATE: JUNE 4, 2019	INSP. TIME: 12 PM
<b>OPERATOR NAME:</b> Ferris-Haggarty Mining Corp. (FHMC)	Operator representative present at inspection:	CLAIMANT NAME: Jubilee Venture LLC	
OTHERS PRESENT AT INSPECTION:	х. Х	<b>BOND AMOUNT:</b> \$53,617	
Inspector's signature & date:	Supervisory signature and date:		
gnighth (15/2019	Rathy Milensty 6/5/19

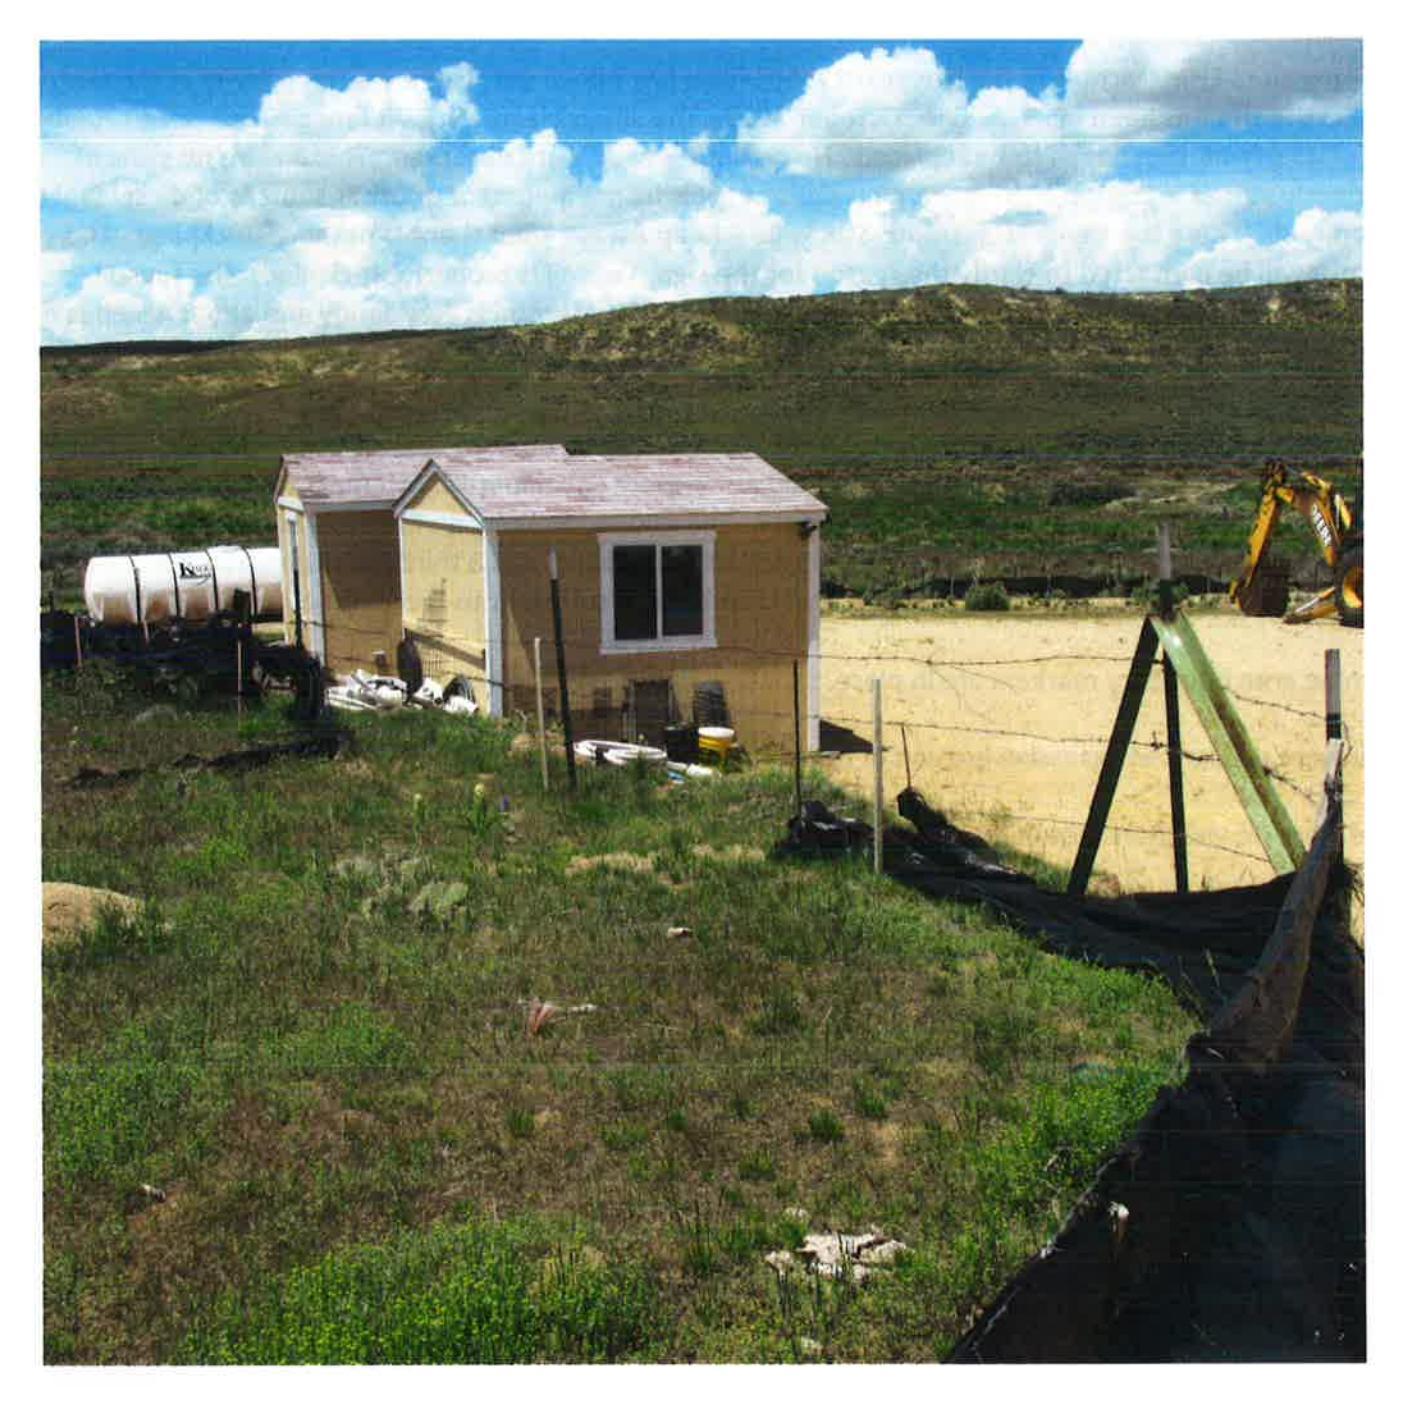
Mine Buildings – looking west

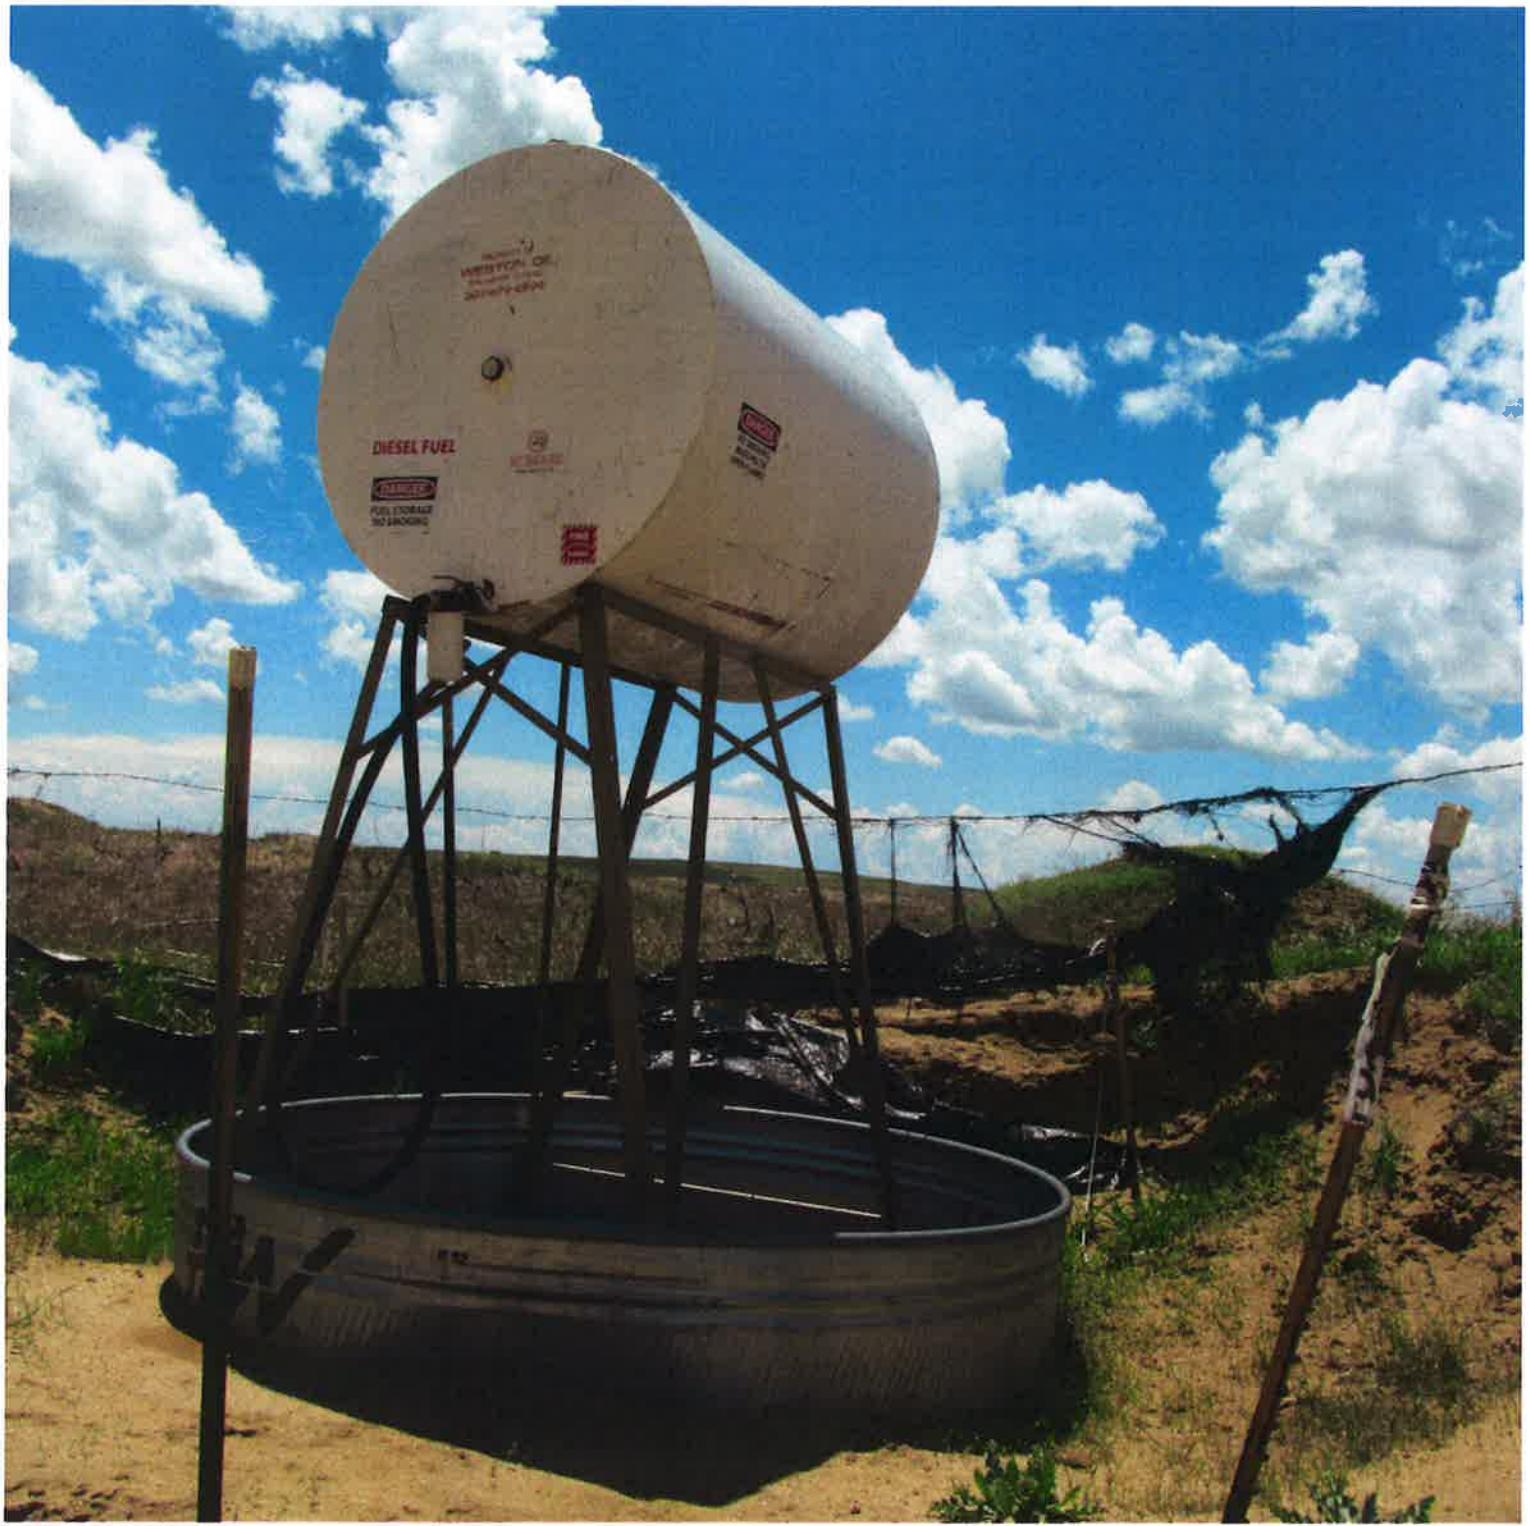
Diesel Fuel tank and containment

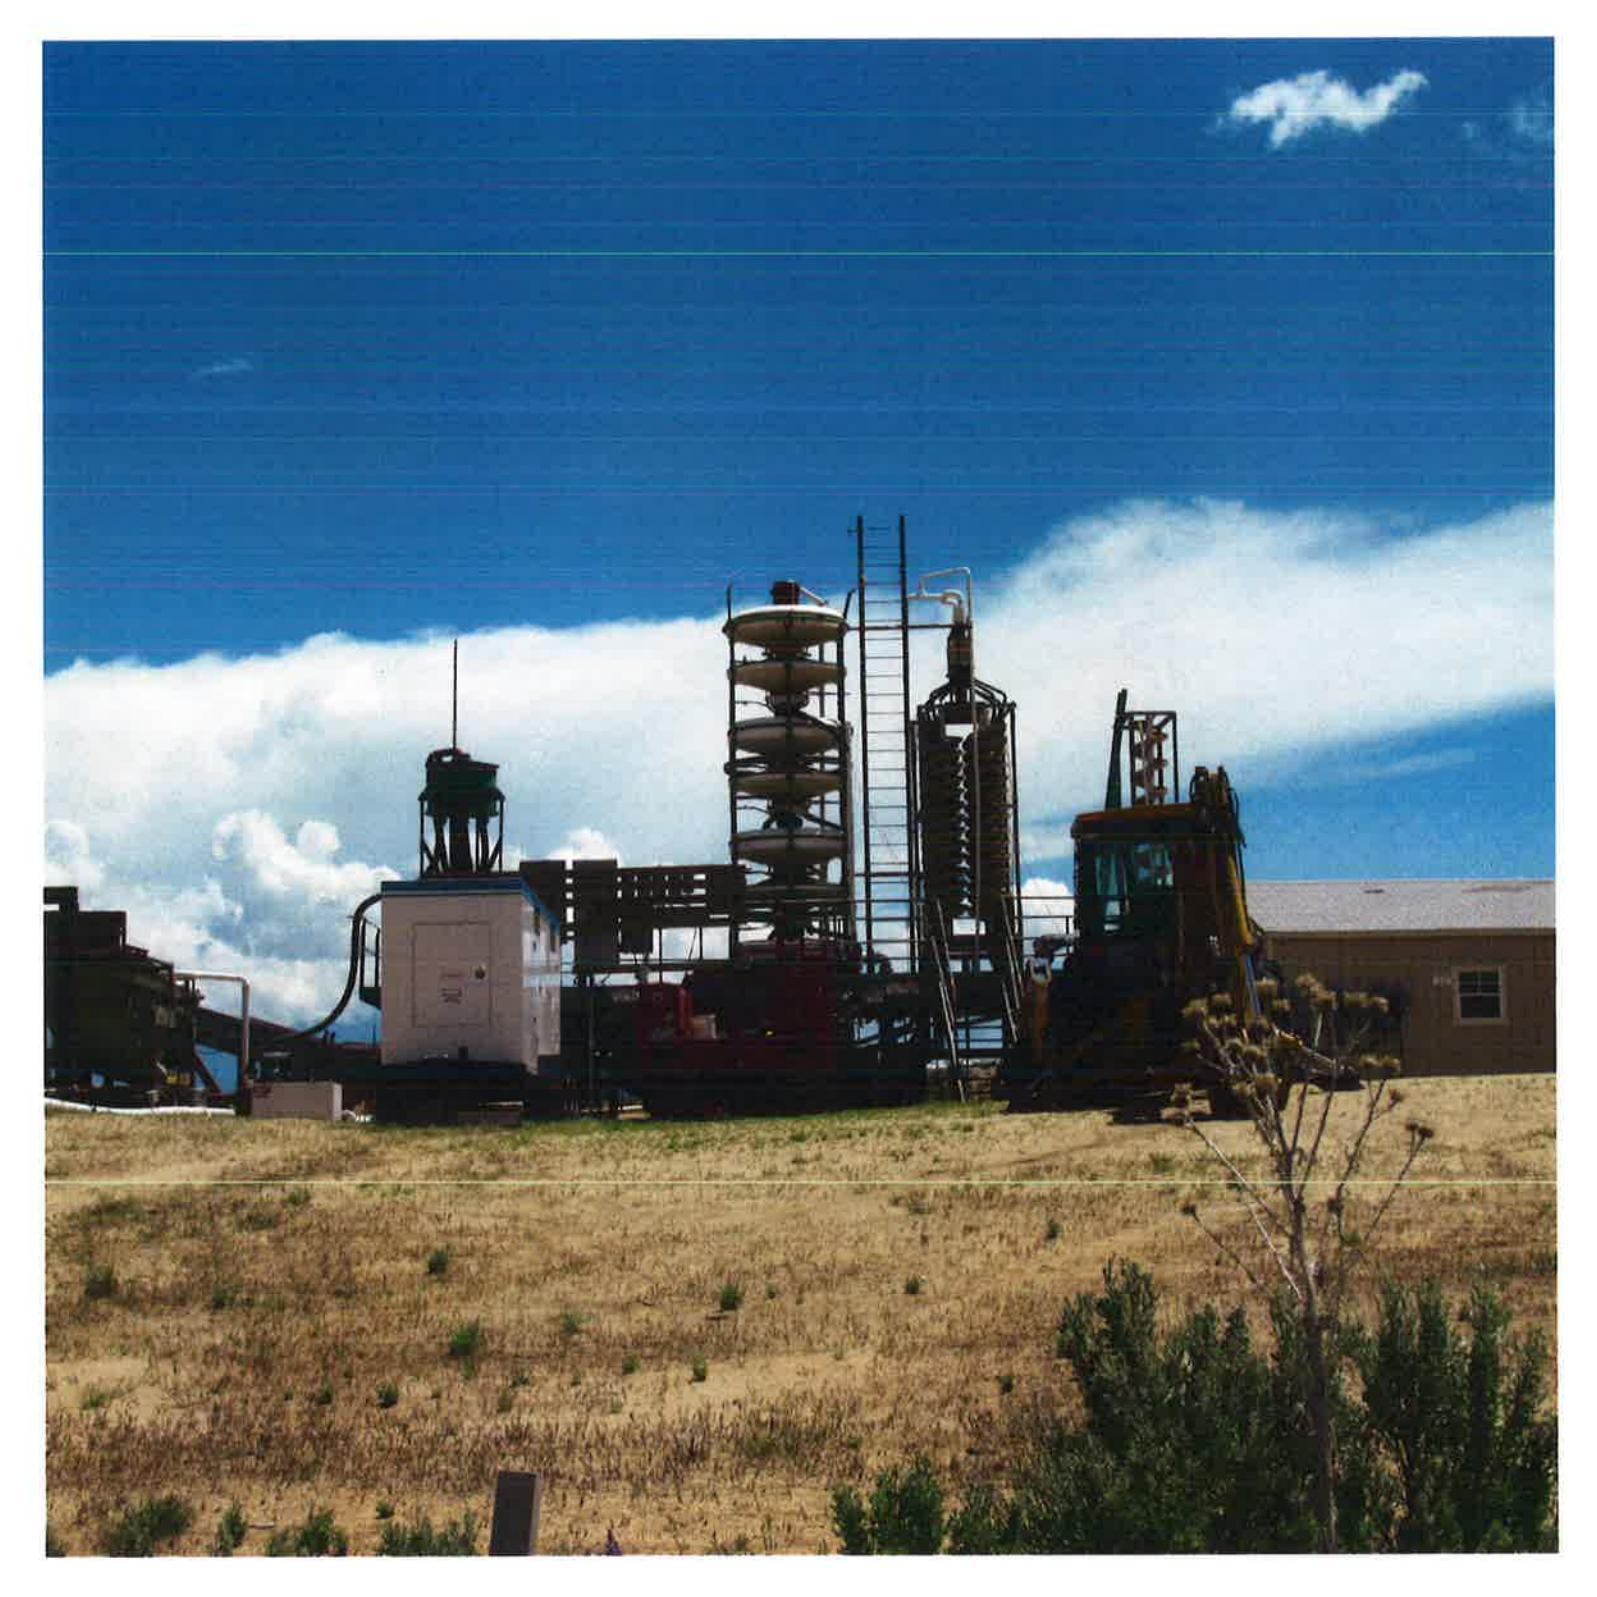
Gravity separation equipment,

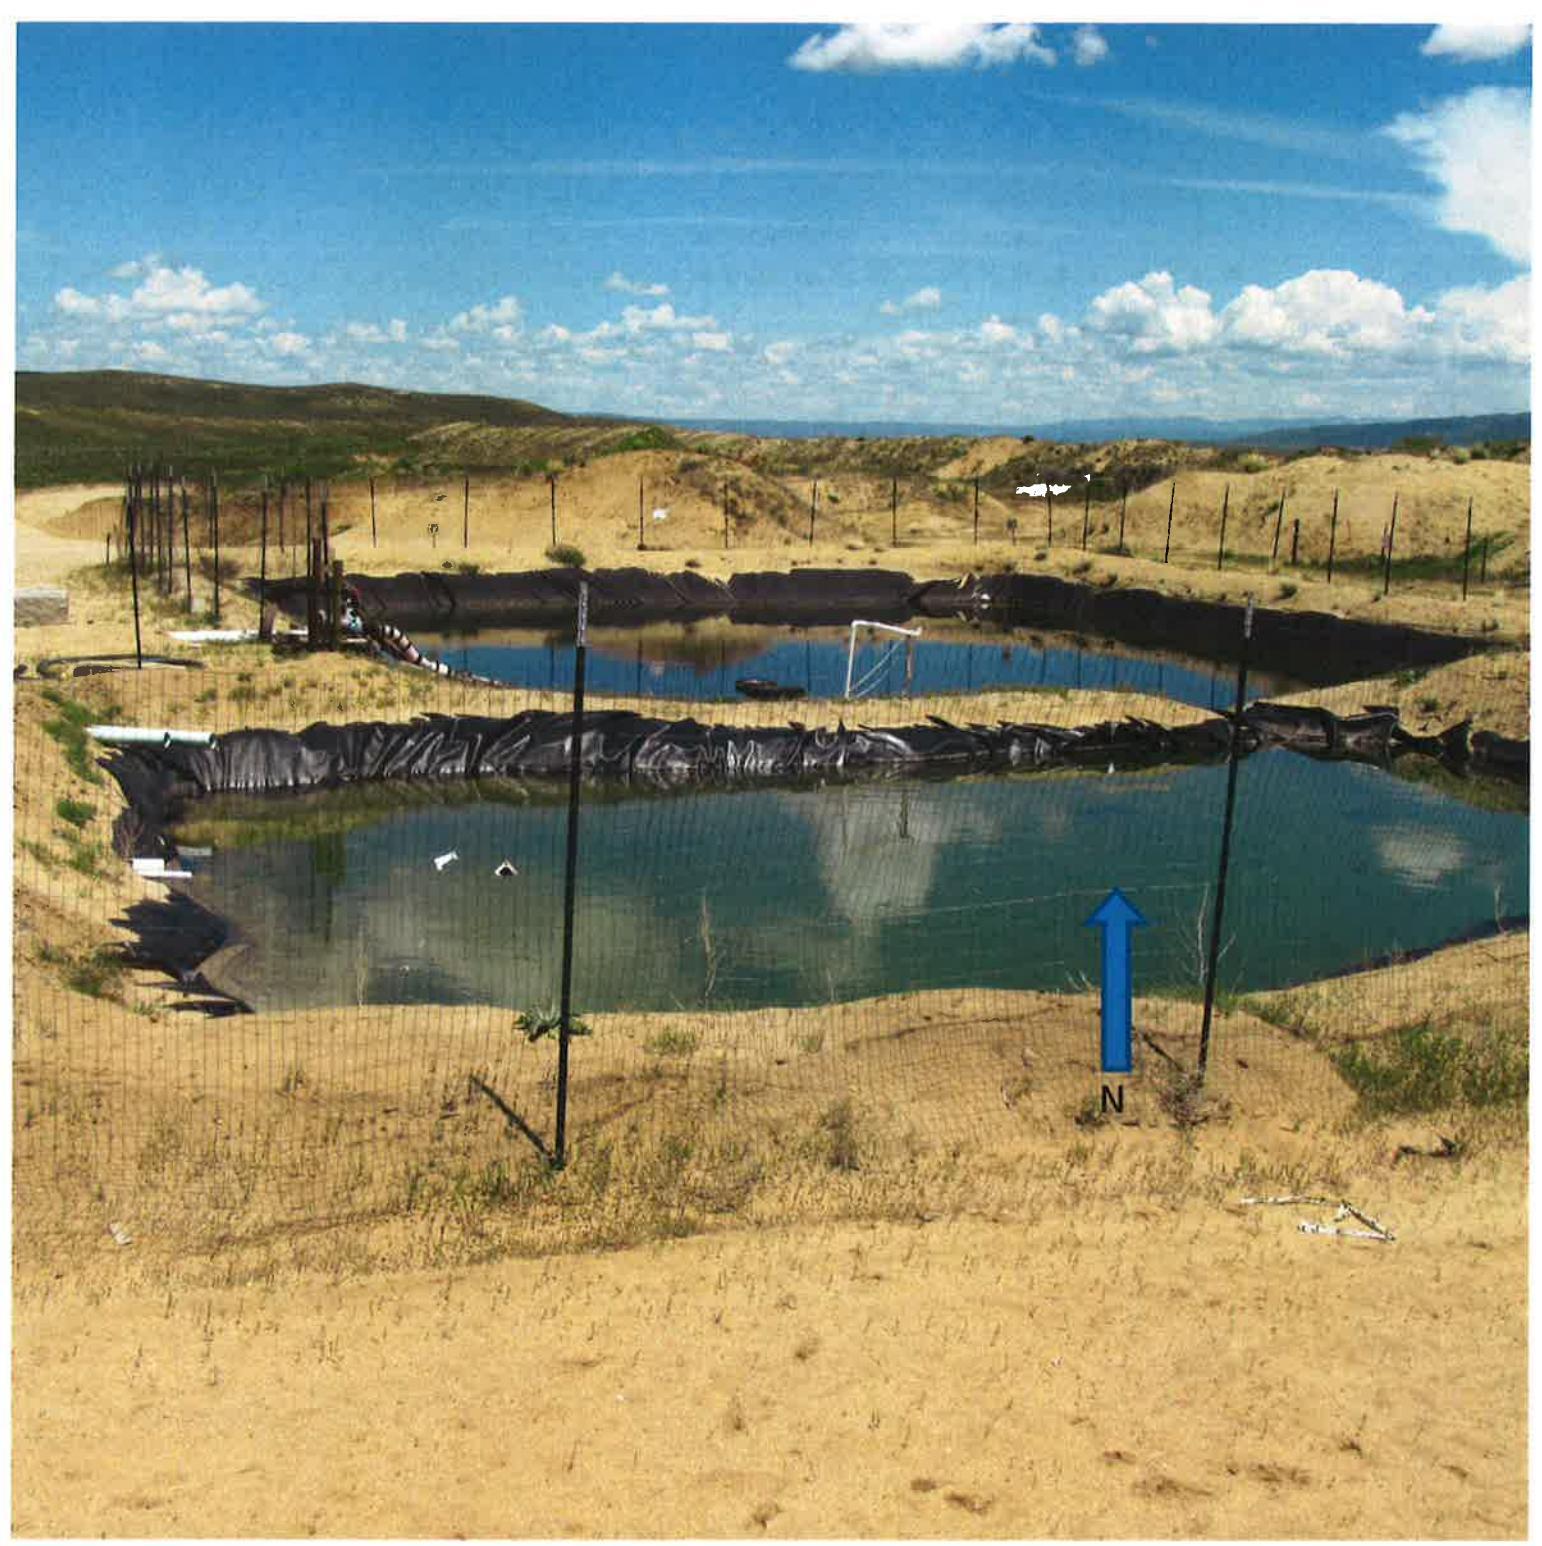
Discharge and supply ponds

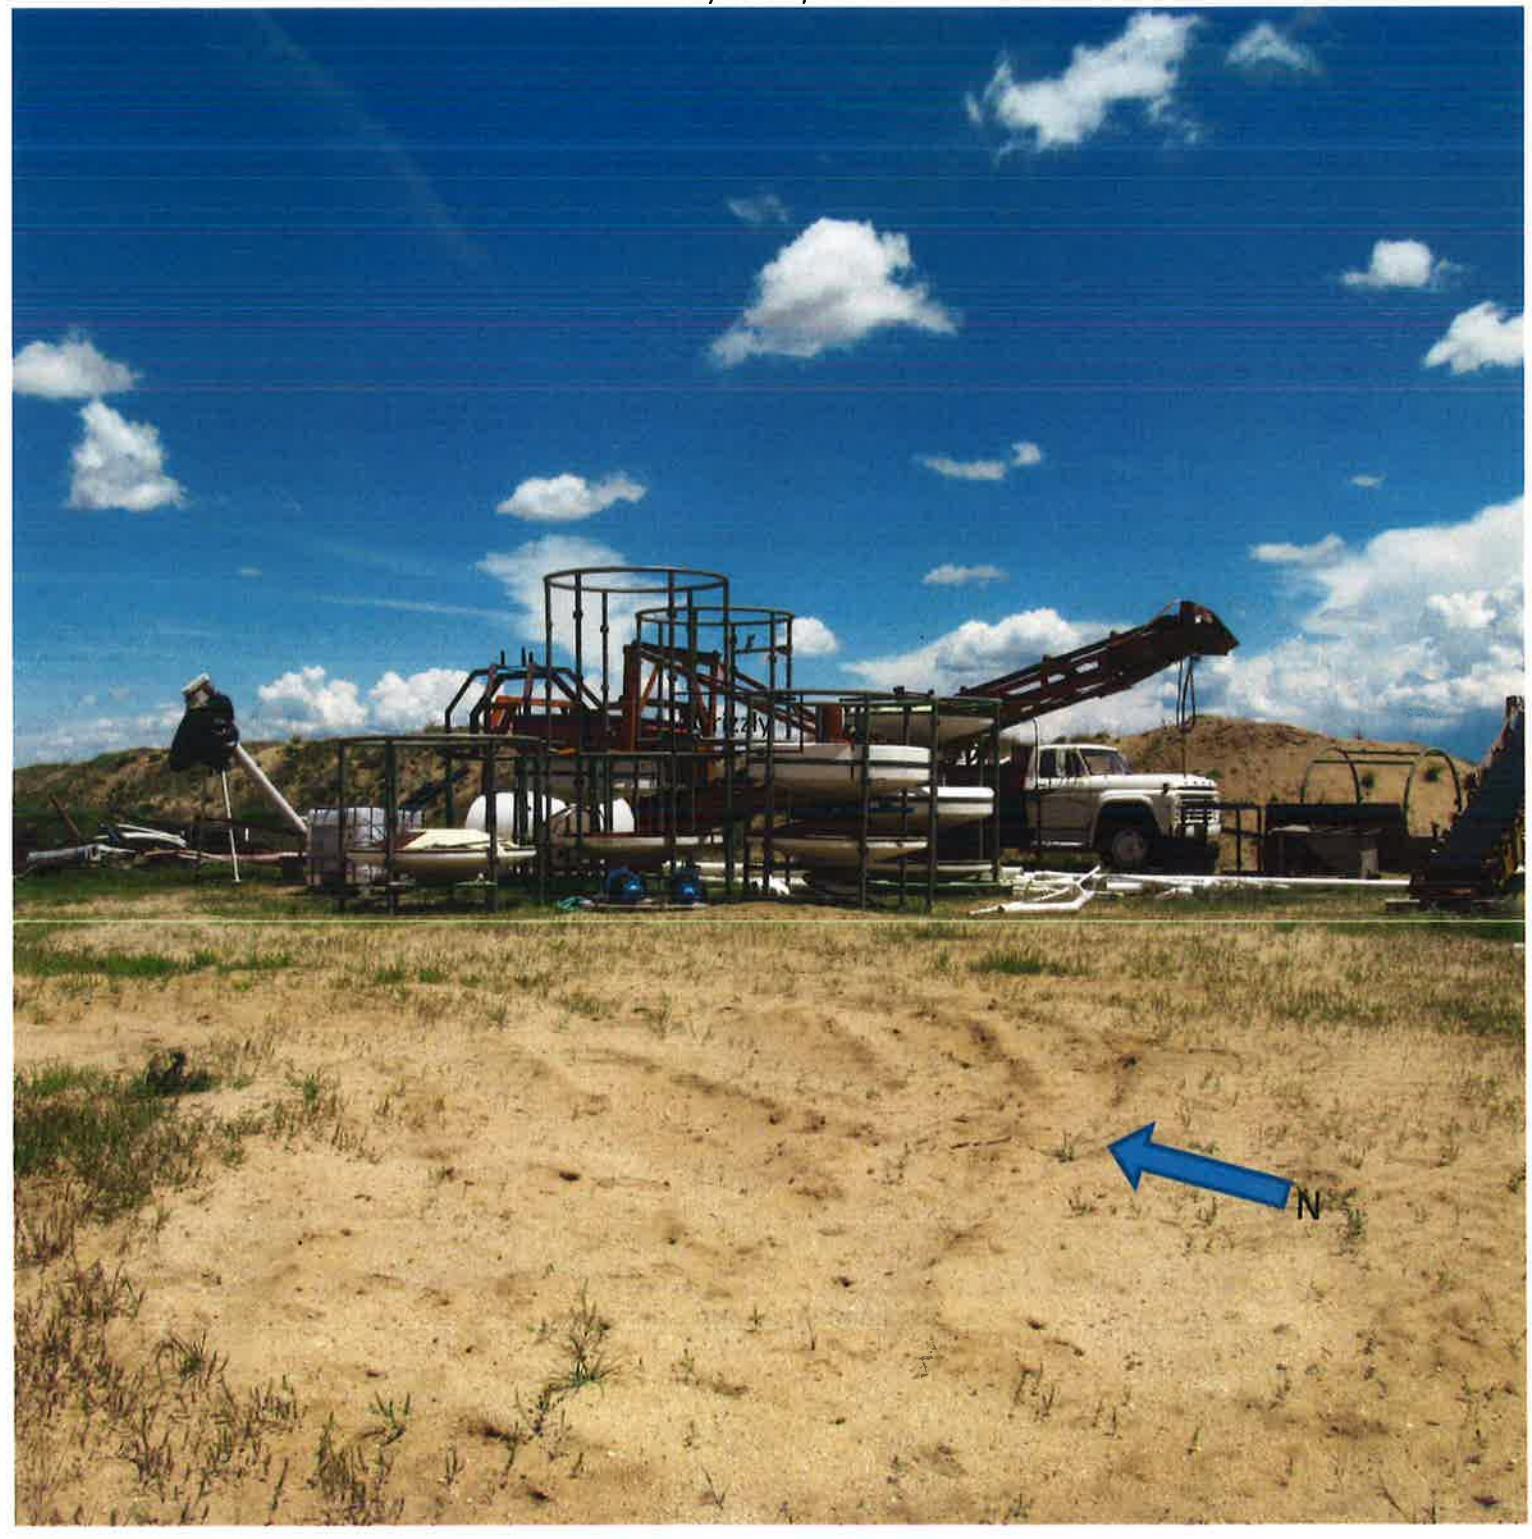
Laydown yard

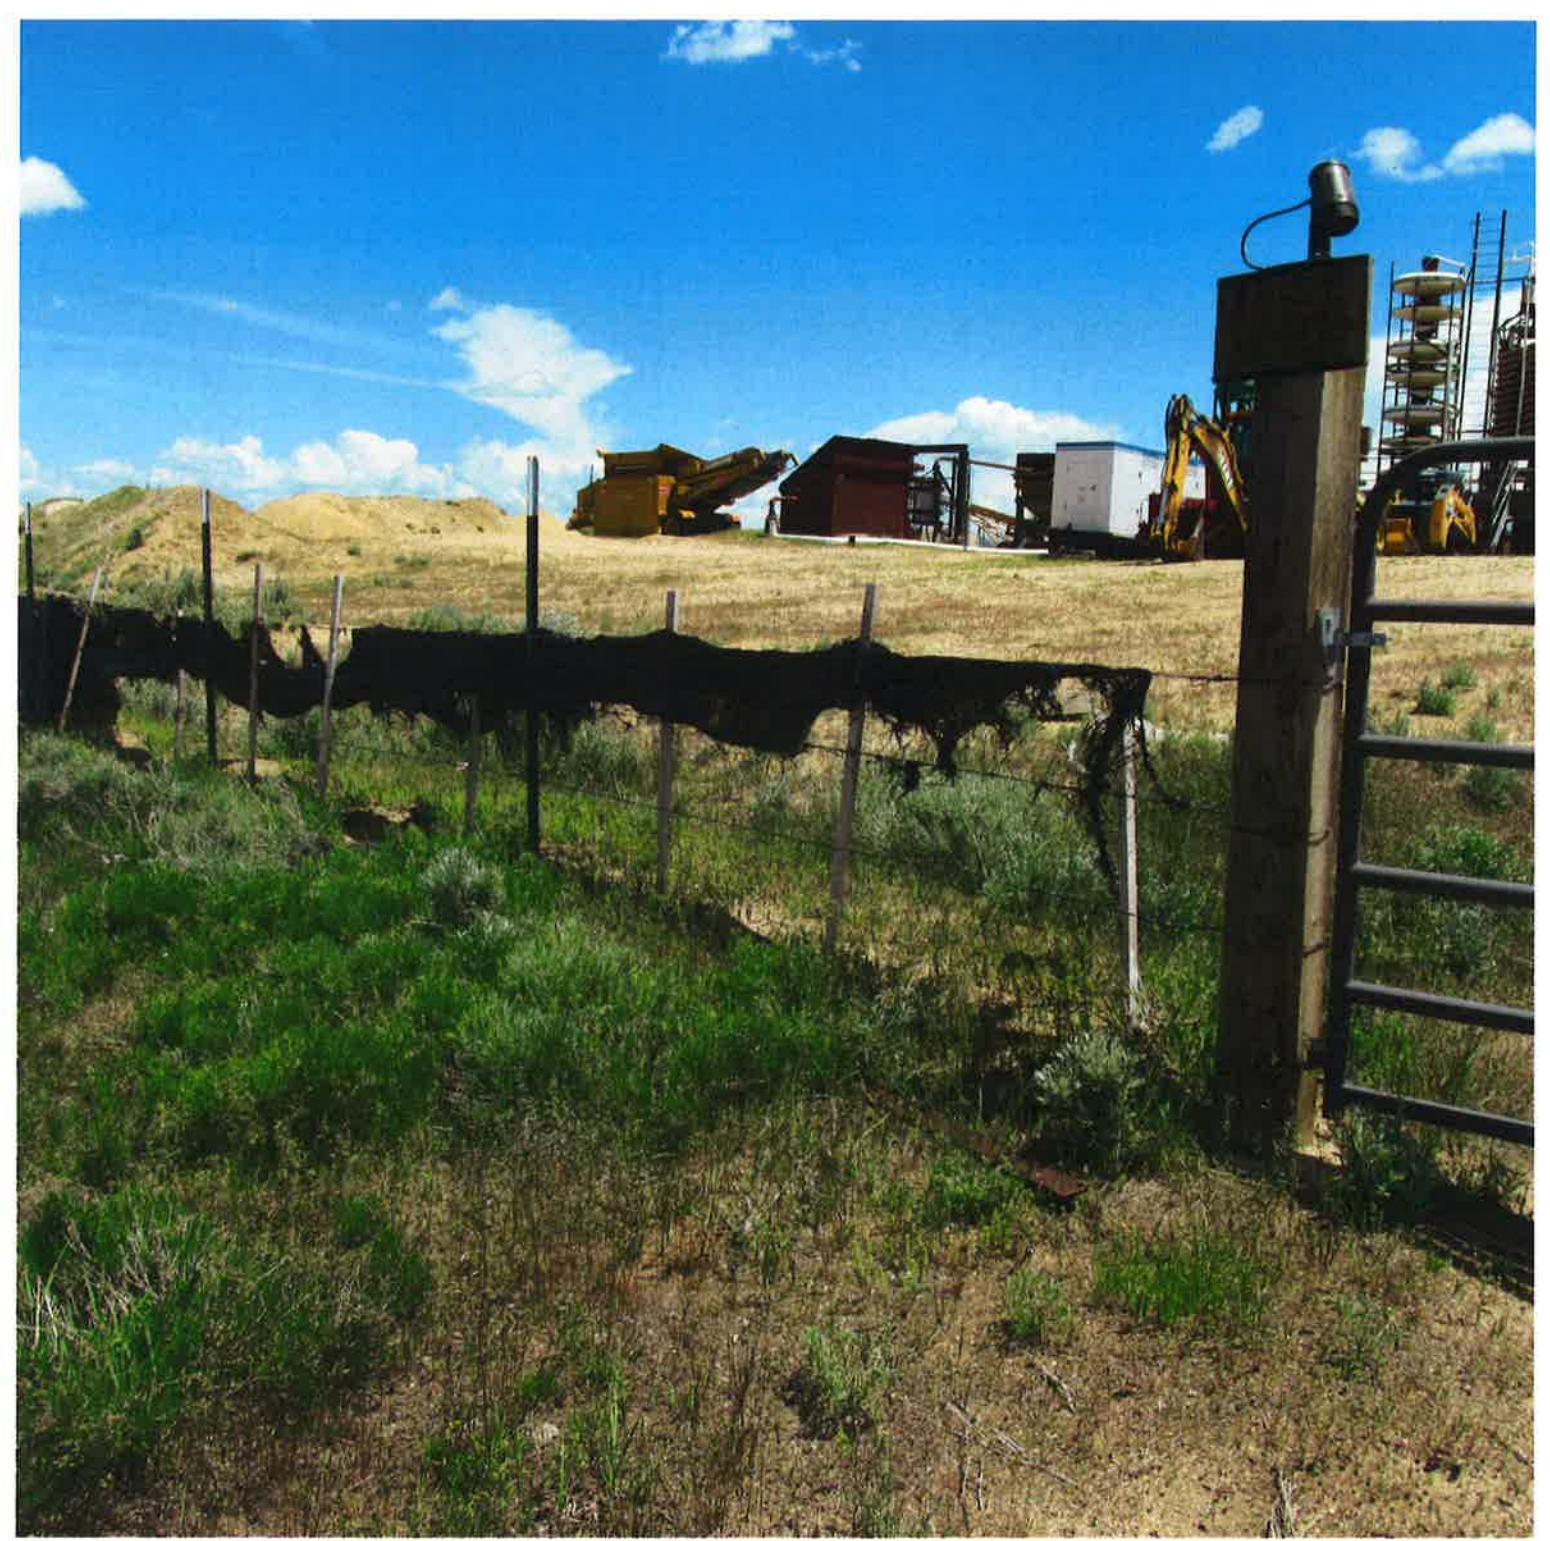
Ragged silt fence on west side of permit boundary

New operators FHMC acquired the site in 2017, but have not mined yet. There was no activity at the site; it appears the site has been inactive since October 2018. The site is clean. The silt fence needs to be replaced. The DRMS permit sign needs to be replaced. No noxious weeds were observed. There were no signs of improperly stored materials. There were no signs of spills from equipment or other sources of diesel fuel or hydraulic oil. There is a sign – "Hazardous Stockpile – Keep Away" – but there is nothing stockpiled. The operator will be contacted to clarify the reason for the sign. Topsoil is properly stockpiled. The topsoil stockpiles have been seeded; there has been some growth. The topsoil is very sandy and about 4 inches deep. The fence around the ponds is in good shape – no holes were observed. The equipment present is incident to mining.

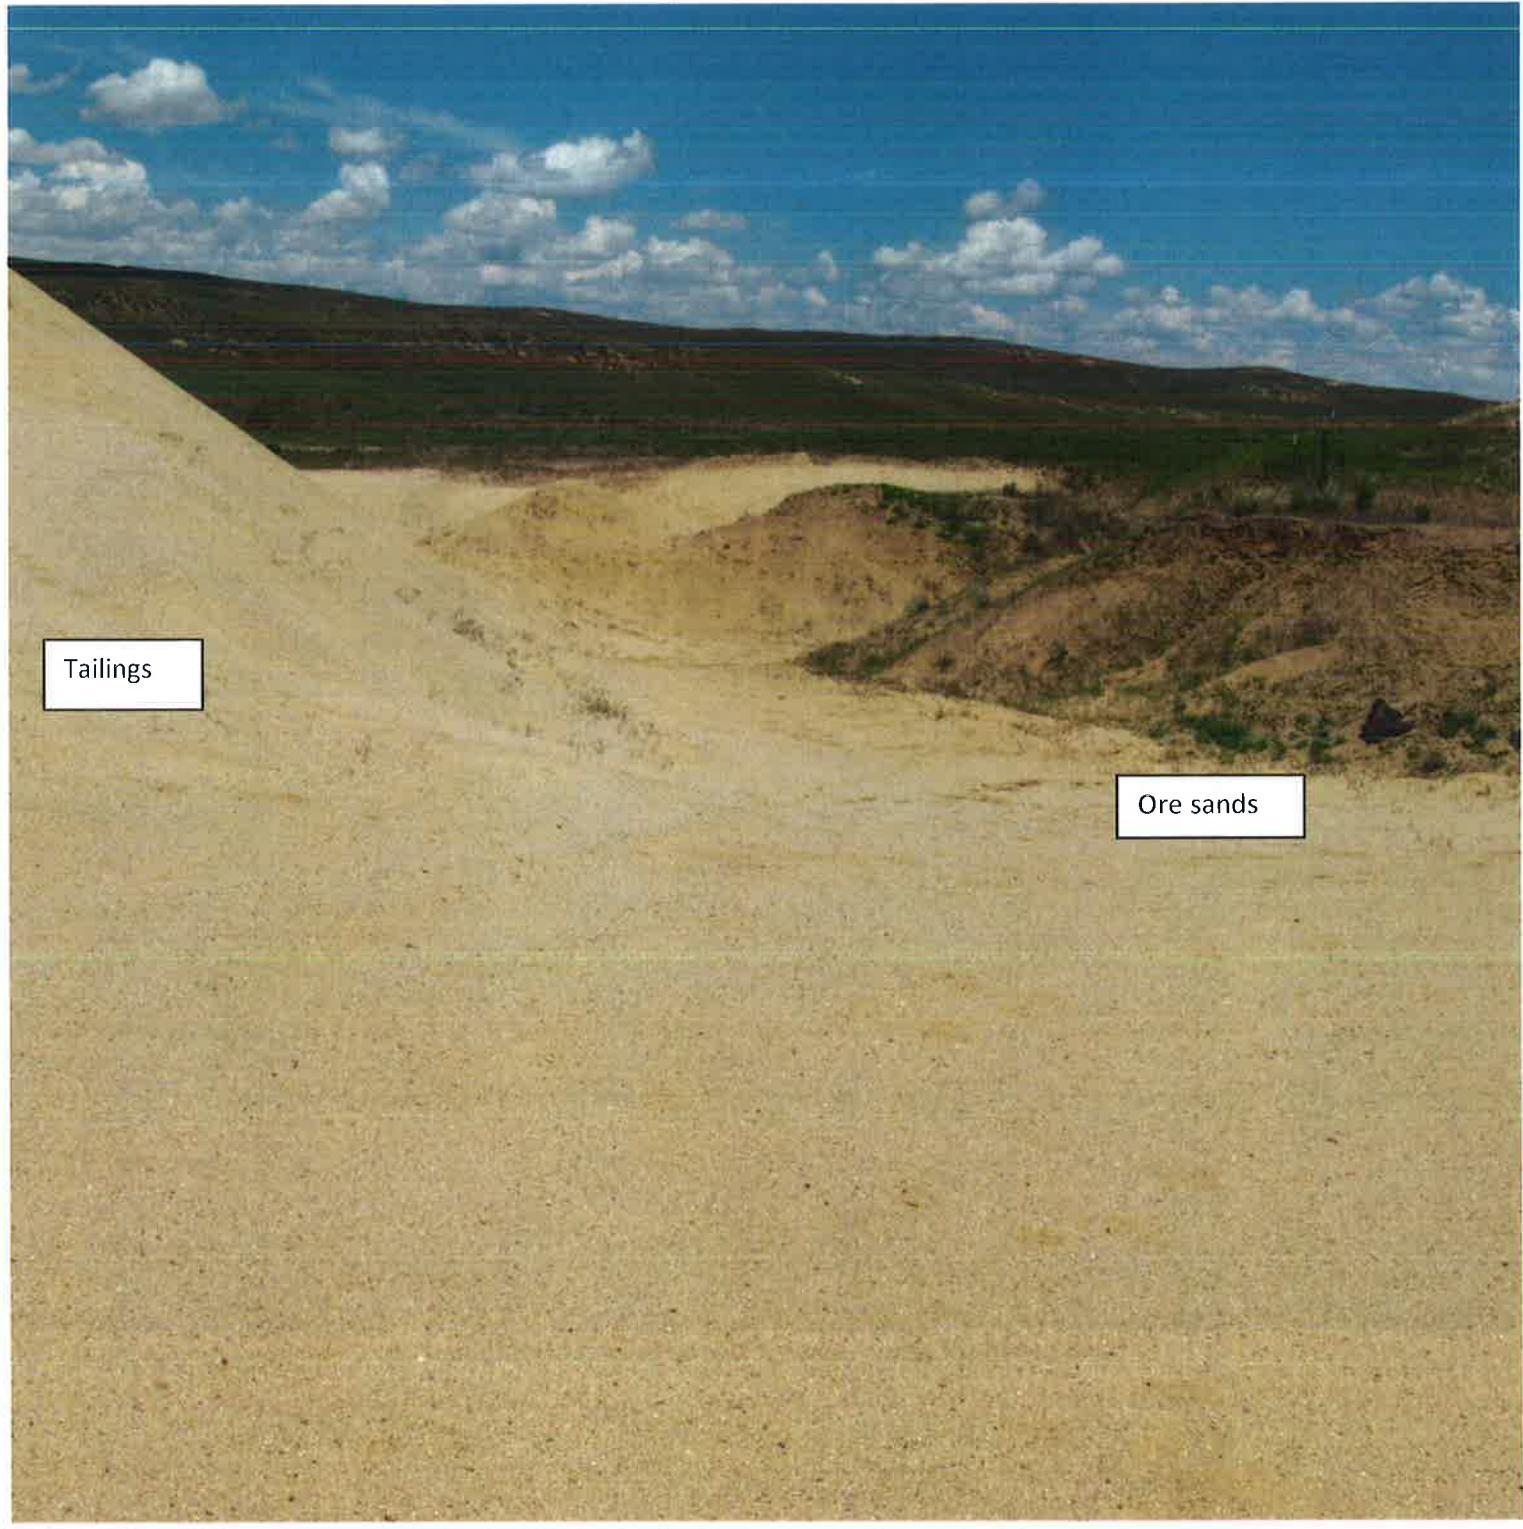
Tailings and ore sands

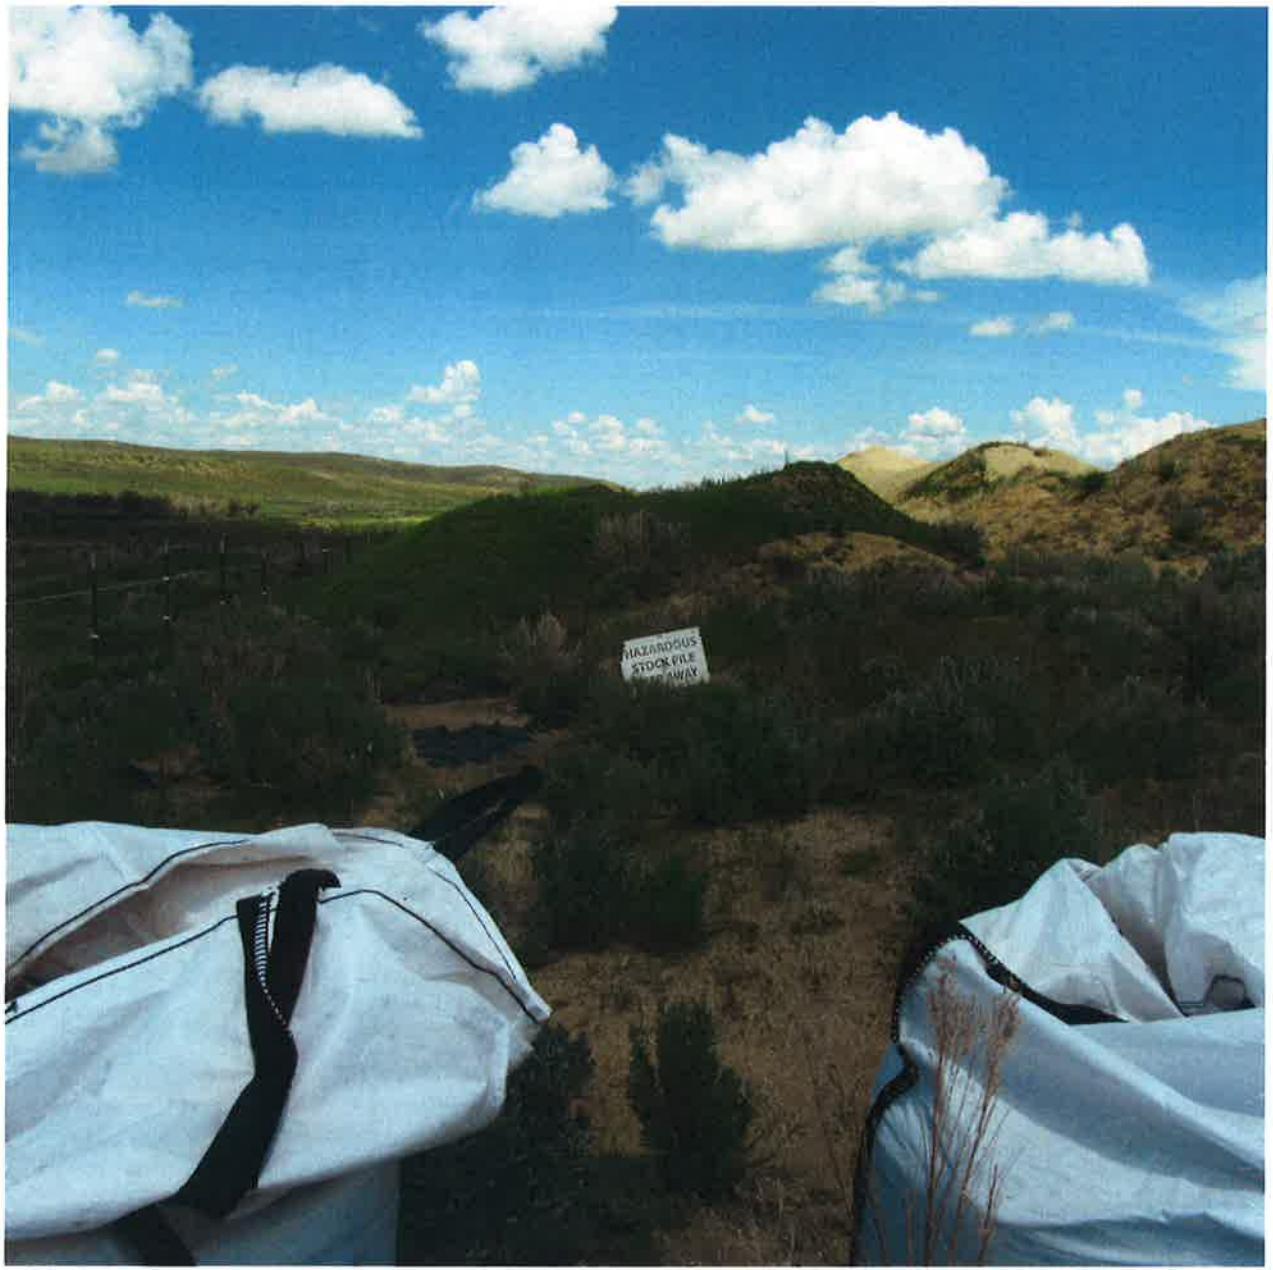
Totes of black sand. Note "Hazardous Stockpile – Keep Away" sign.

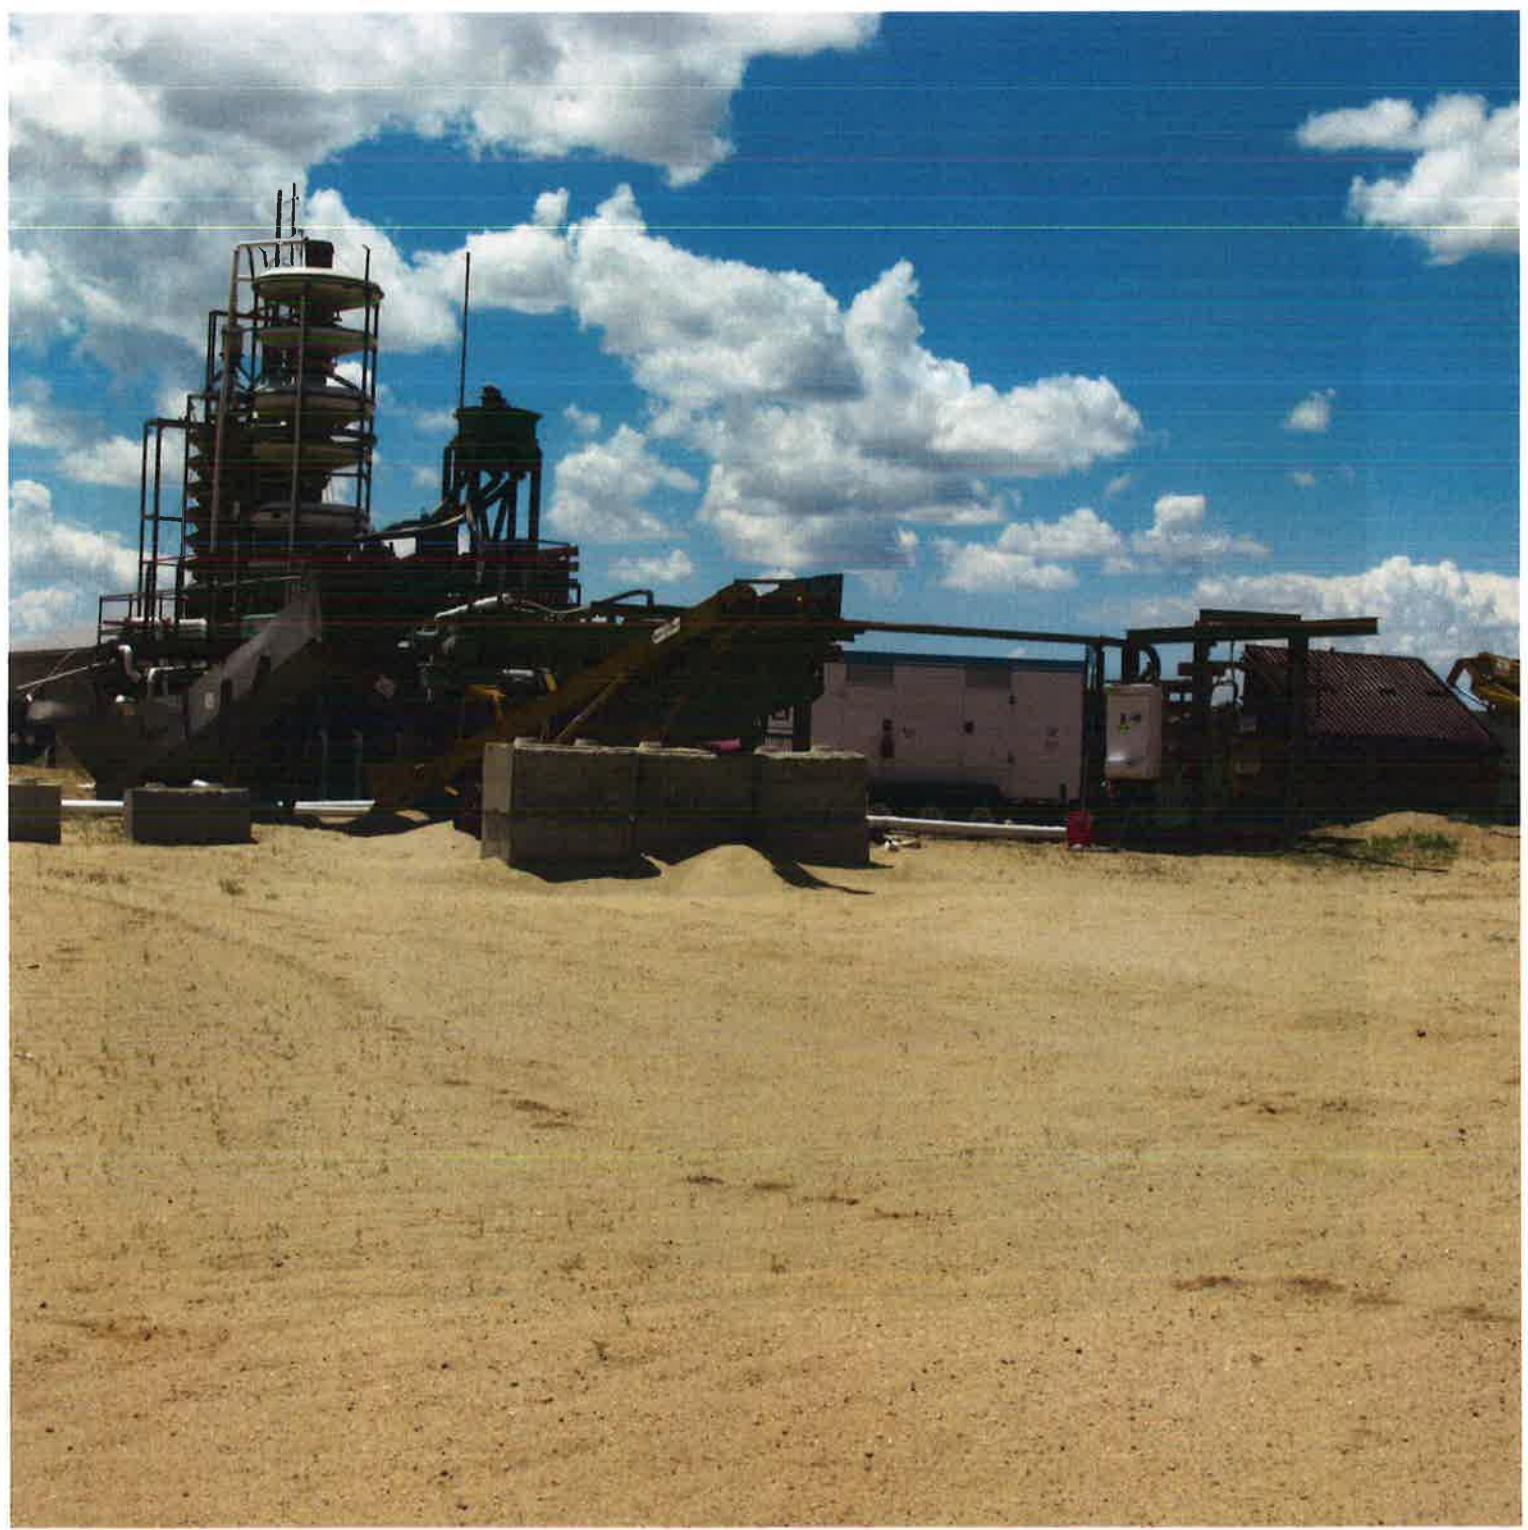
Conveyors, generator and spirals, looking South
