## MEMORANDUM

**Re: Adequacy Review of Exhibit 6.5 – Geotechnical Stability Adequacy Response  
Aggregate Industries; Tucson South Resource; File No. M-2004-044; AM-01**

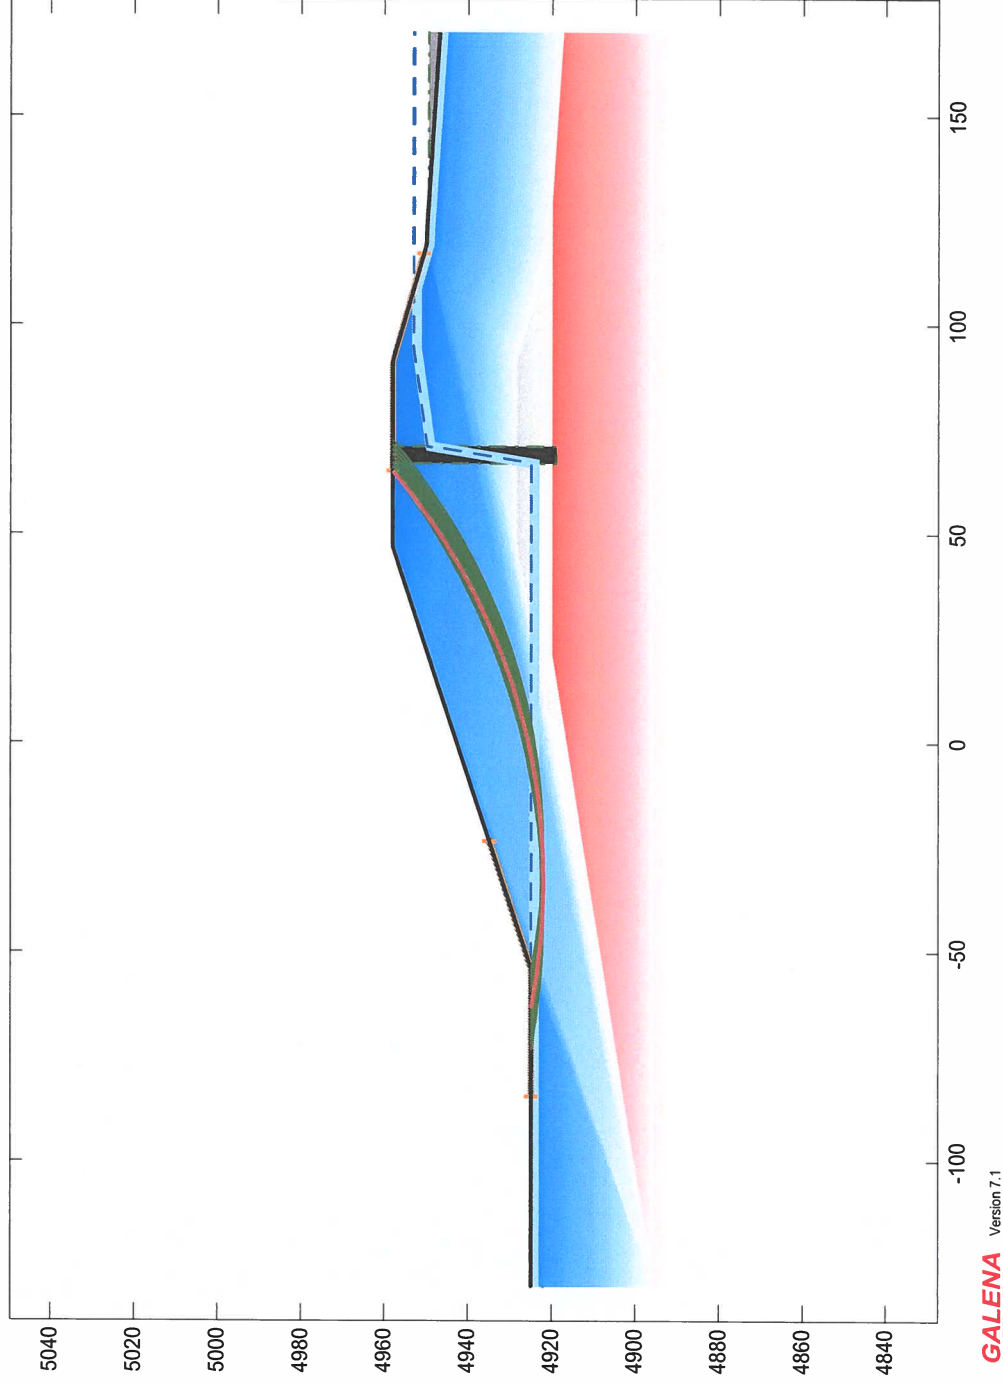
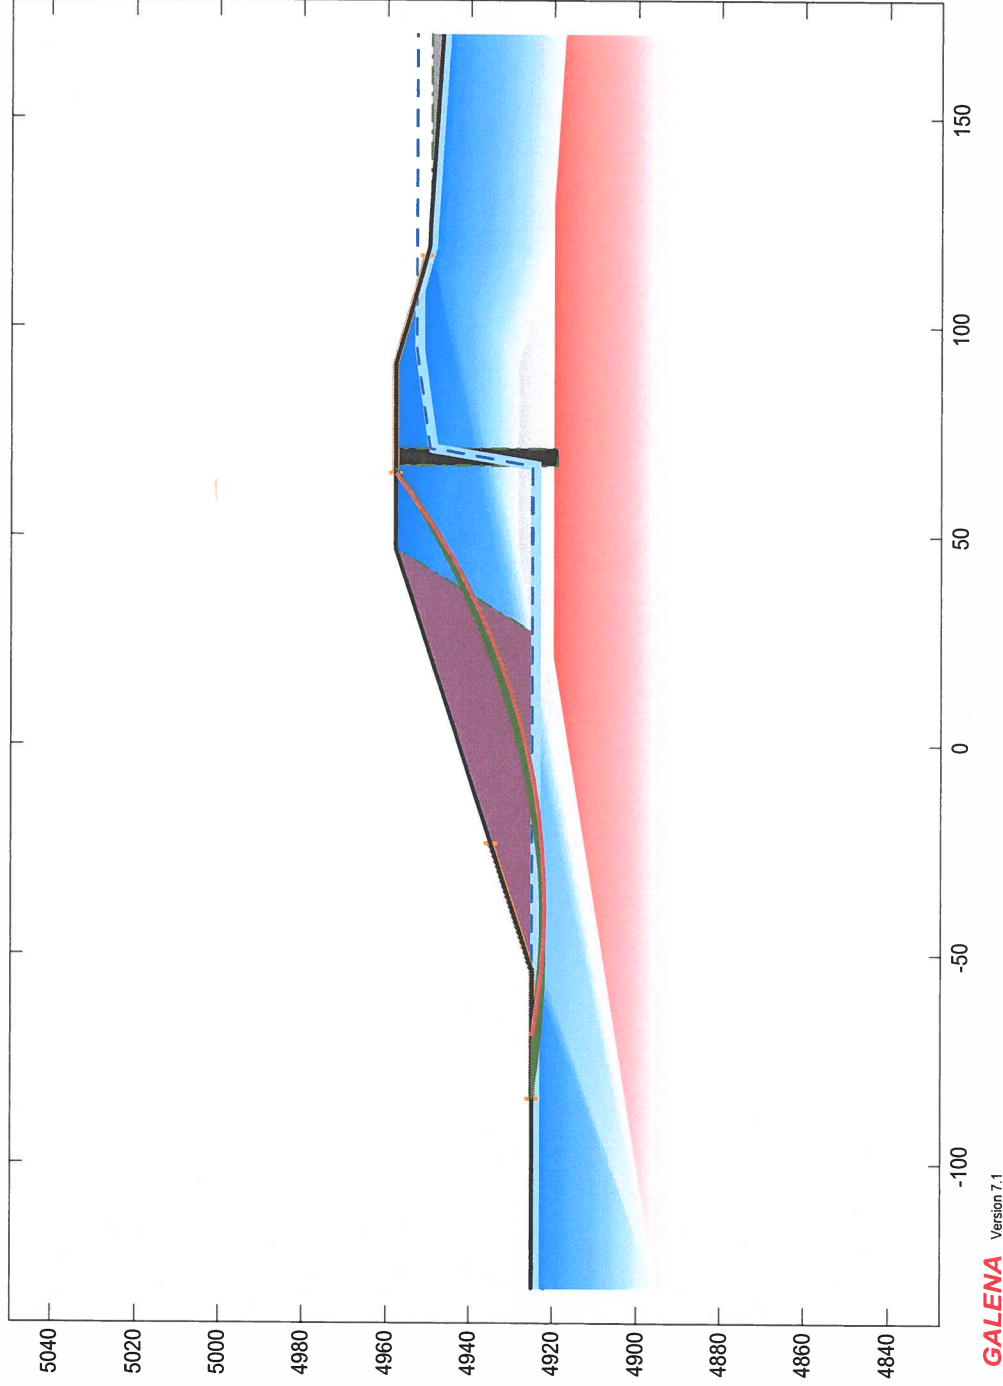
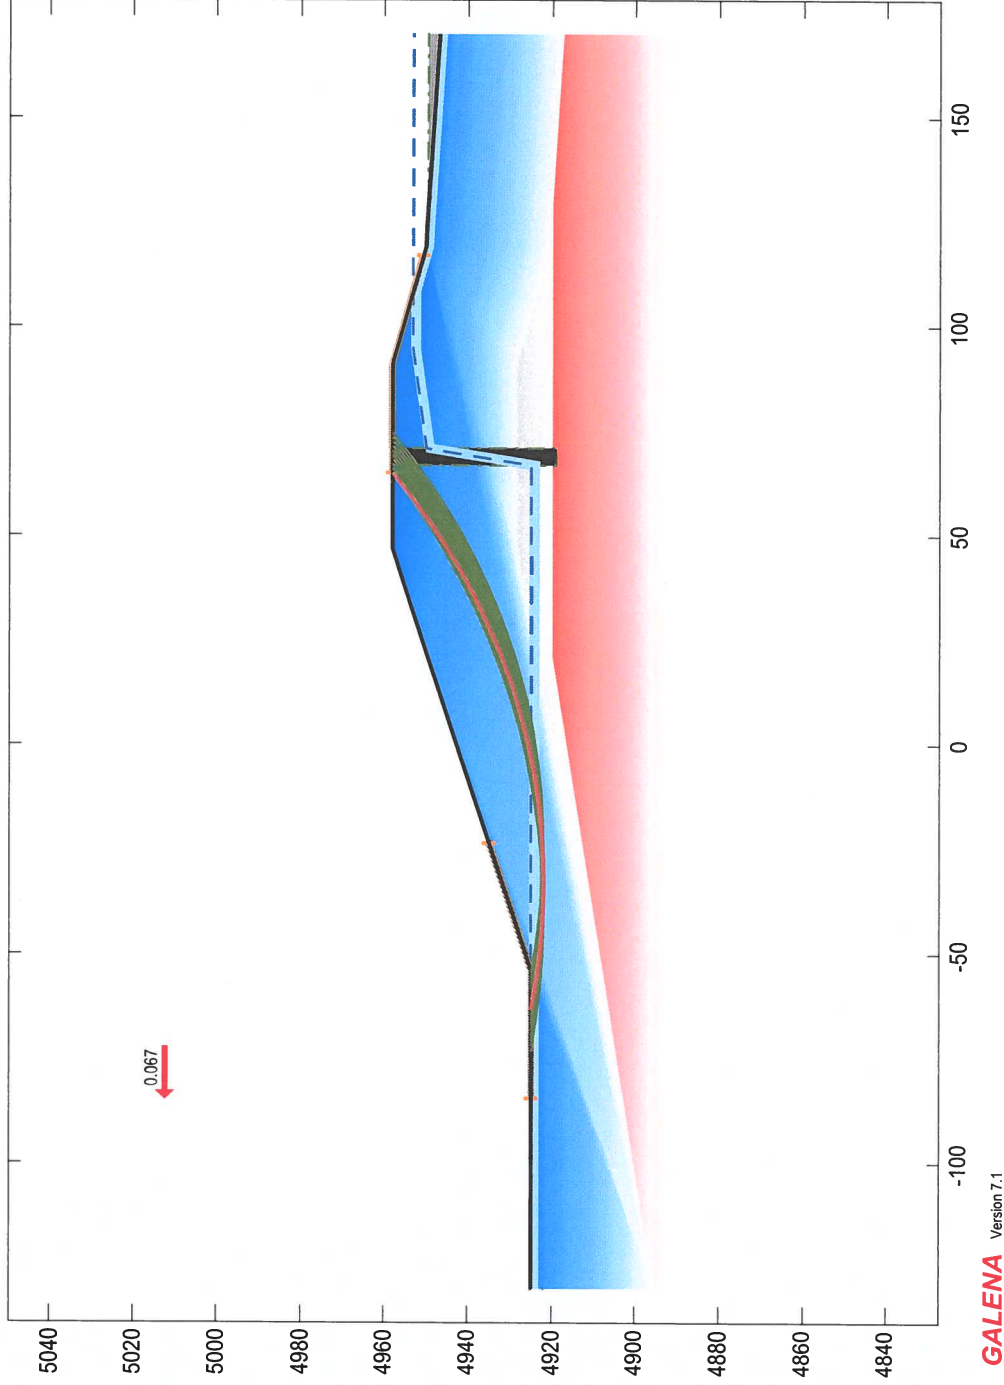
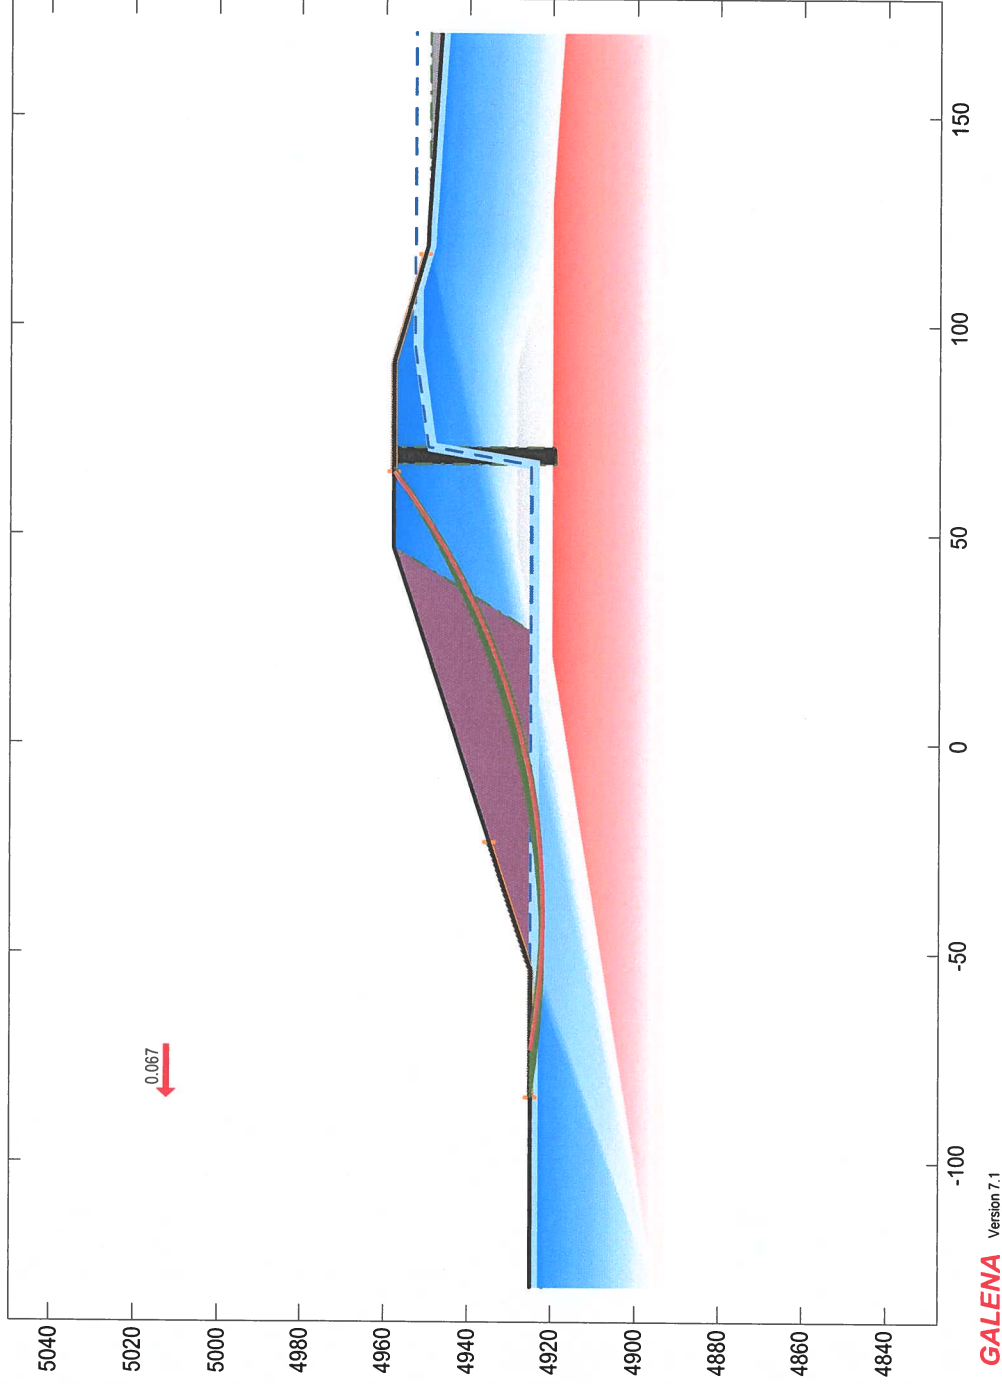
1. The Applicant modeled the Figure C analysis with a 44 feet offset from the top of bank (tob) of the South Platte River to the top of the mine slope. The Exhibit C-3 Map indicates the Applicant modeled a 42 feet offset. Please explain this discrepancy and revise the Figure C models and/or the Exhibit C-3 Map accordingly.

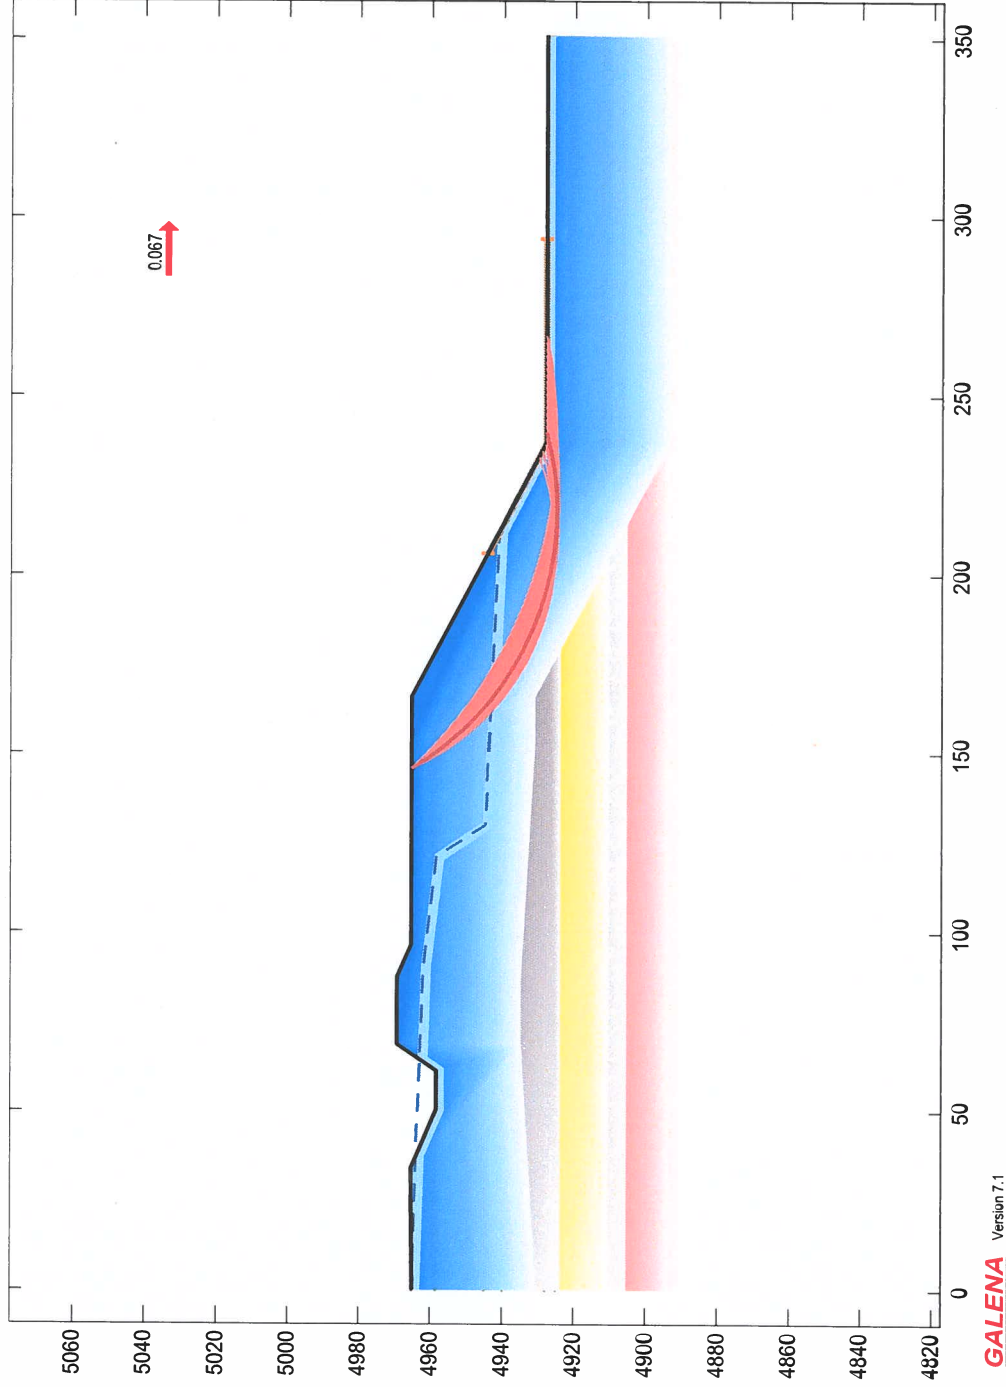
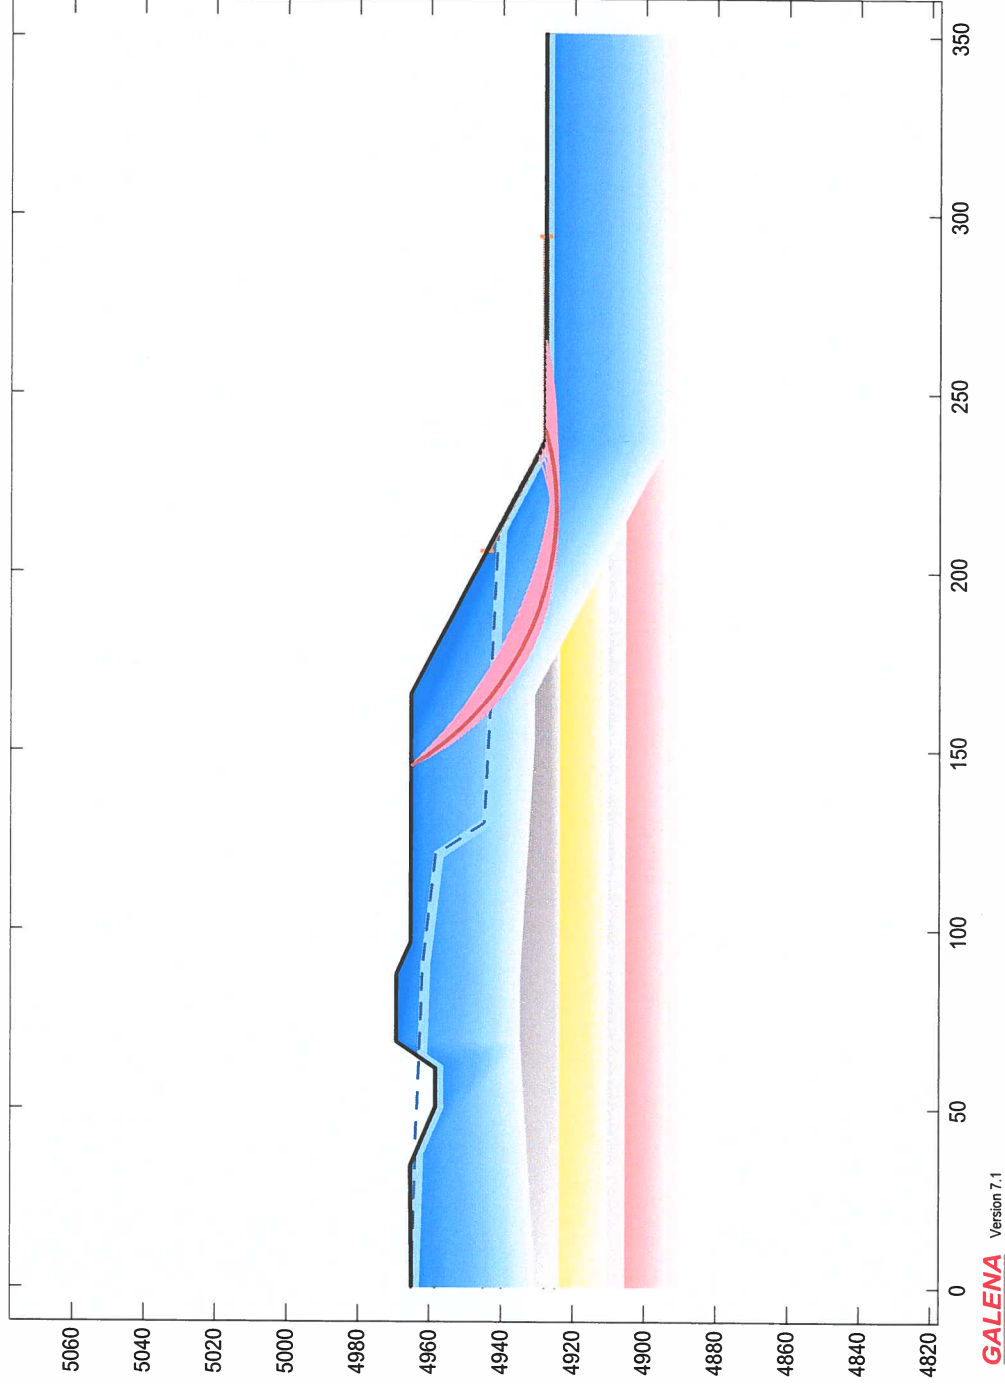
File: G:\My Drive\1 - My Projects Google\8 Galena - Stability Analysis Models\Tucson South\Tucson Figure J-2 Pseudostatic.gmf

| Brighton Return Ditch | Figure J-1 – Static | 1.58 | 1.07 |
| Brighton Return Ditch | Figure J-2 – Pseudostatic | 1.32 | 0.89 |

6. The Applicant modeled the Figure J analysis which produced a minimum FOS located 44 feet from the edge of the Brighton Return Ditch. The Exhibit C-3 Map indicates the Applicant modeled a 77 feet offset. Please explain this discrepancy and revise the Figure J models and/or the Exhibit C-3 Map accordingly.

The Division duplicated the Figure J models with the 77 feet offset from the edge of the Brighton Return Ditch. The models produced factors of safety of 1.07 – Static and 0.89 – Pseudostatic, which do not meet the required FOS. Please review the Applicant's and Division's models and reevaluate the proposed offset distance from the Brighton Return Ditch to conform to the FOS requirement of the MLRB.
