# MINERALS PROGRAM INSPECTION REPORT PHONE: (303) 866-3567

MINE NAME:	MINE/PROSPECTING ID#:	MINERAL:	COUNTY:
Priola Pit	M-2007-087	Sand and gravel	Adams
INSPECTION TYPE:	INSPECTOR(S):	INSP. DATE:	INSP. TIME:
Monitoring	Jared L. Ebert	July 17, 2019	08:30
OPERATOR:	<b>OPERATOR REPRESENTATIVE:</b>	TYPE OF OPERATION:	
Albert Frei & Sons Inc.	Ben Frei	112c - Construction Regular Operation

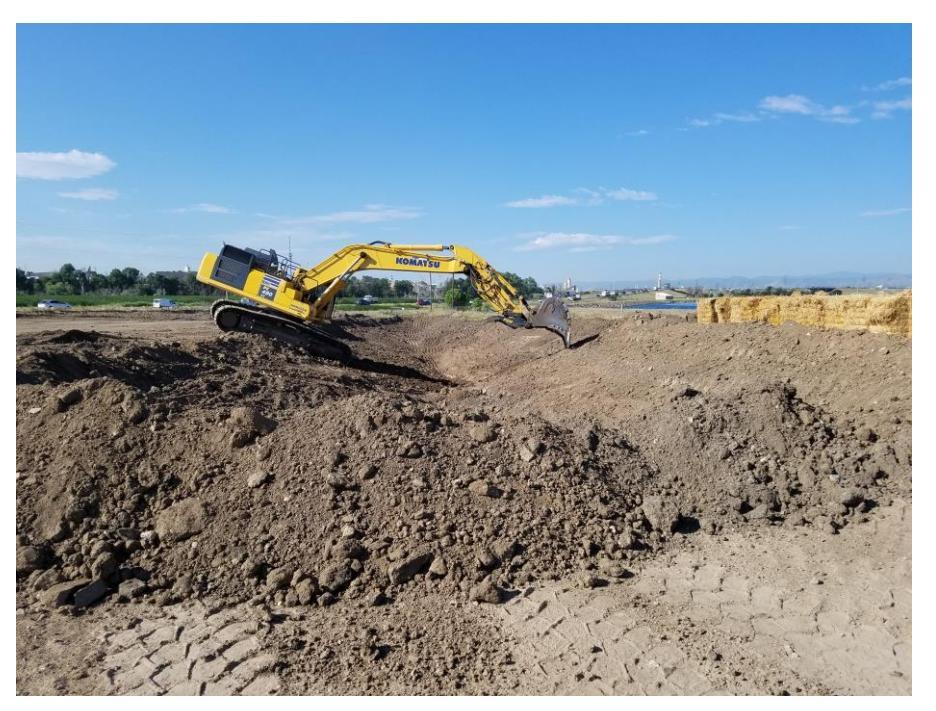
At the time of the inspection an excavator was digging a storm water basin near the entrance of the site at the south corner. A loader was completing some additional grading at the site. The top of the backfilled area was graded relatively level and the side slopes of the fill area have been graded to a 3H:1V ratio or less. A portion of the site has been zoned for industrial use located in the northeast corner of the permit area. A map depicting this area is enclosed with this report. Within the area zoned for industrial use, a small basin has been excavated. According to Mr. Frei, this area has been excavated to accommodate the landowner's continued use of the site for backfilling of offsite material as was discussed in Technical Revision No. 2 (TR02). It appears topsoil has been spread over the affected land.

The two small basins excavated at the site are not currently approved in the reclamation plan. AFS will need to file a technical revision to the reclamation plan to revise the post mine topography of the site to include these features.

Figure 1. Storm water basin construction, near south corner of the site.

**CORRECTIVE ACTIONS:** The operator shall submit a Technical Revision, with the required \$216 revision fee, to update and clarify the current approved reclamation plan to account for the construction of the two basins discussed in the report by the corrective action date.

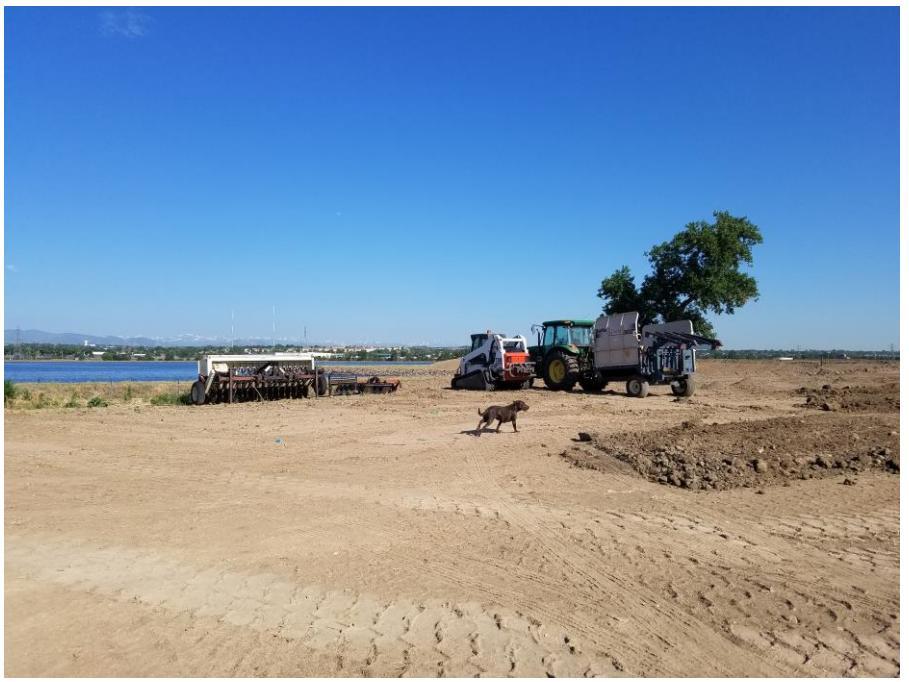
Figure 2. Reclamation equipment staged at the site.

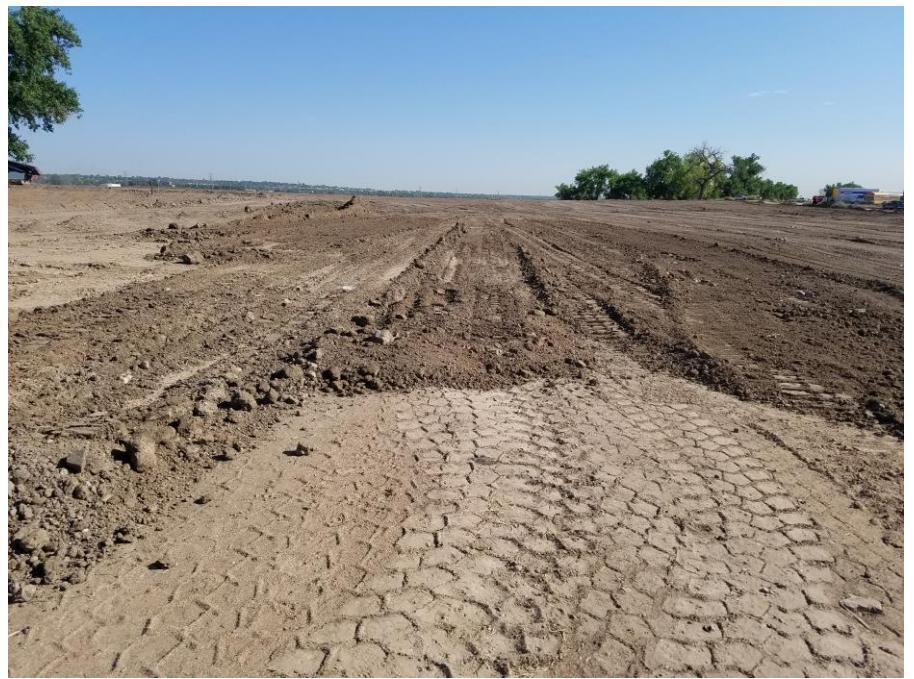
Figure 3. From the south end of the site looking north.

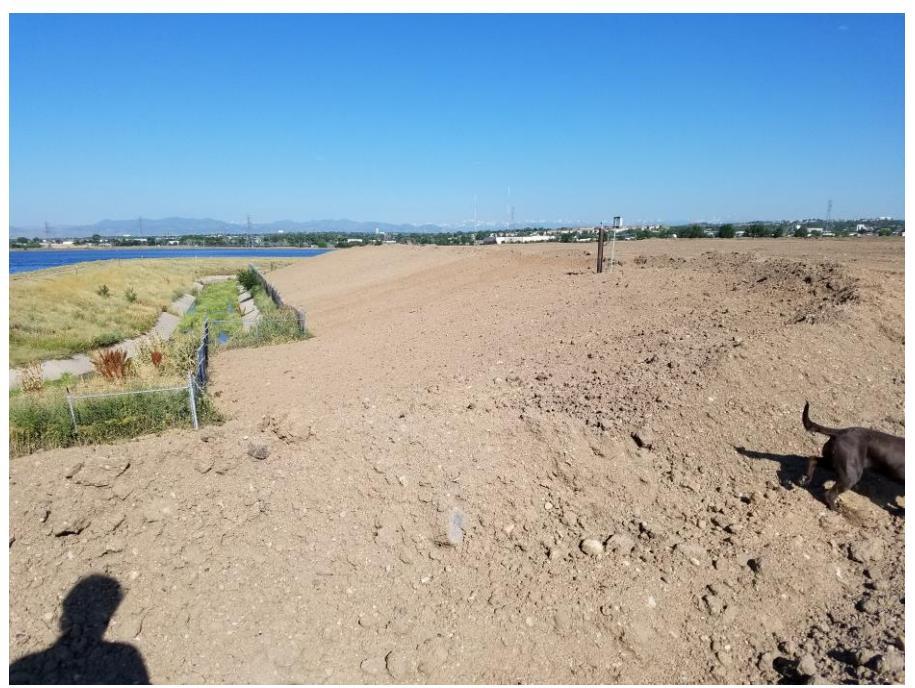
Figure 4. Regraded southern fill slopes.

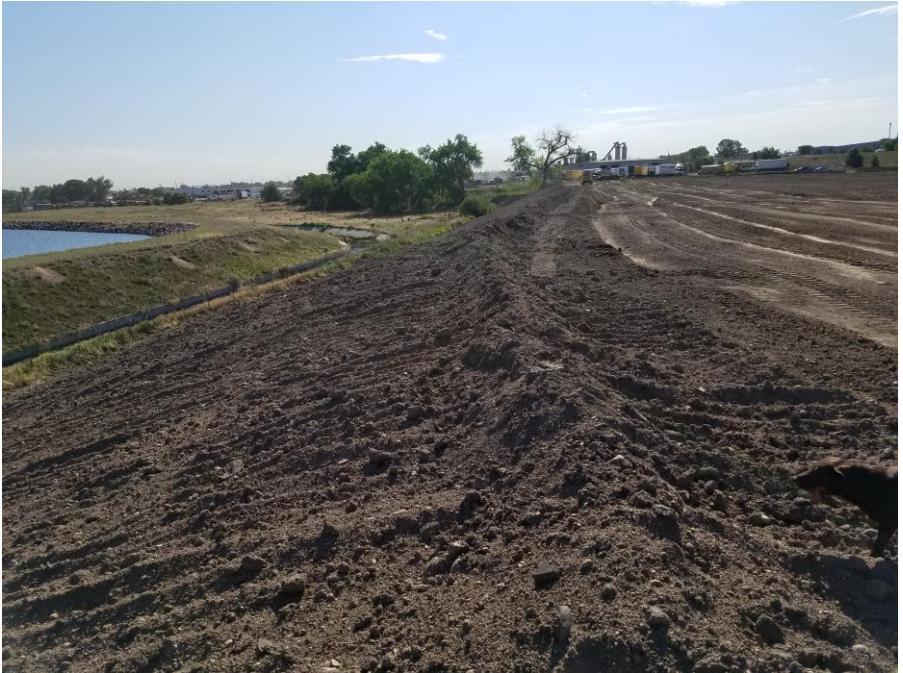
Figure 5. Regraded northern pit slopes.

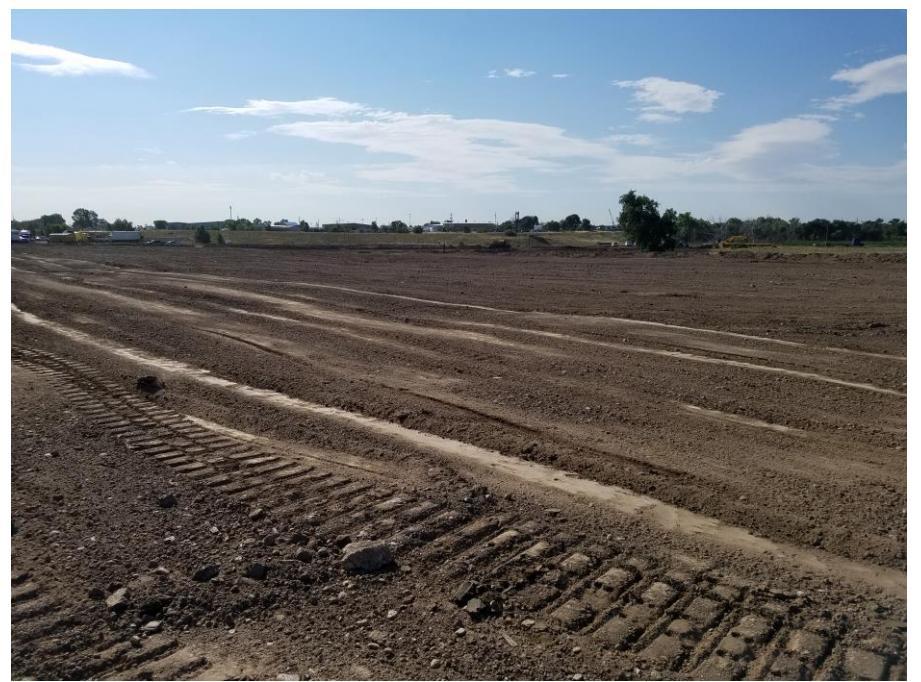
Figure 6. From the northern end of the site looking south.

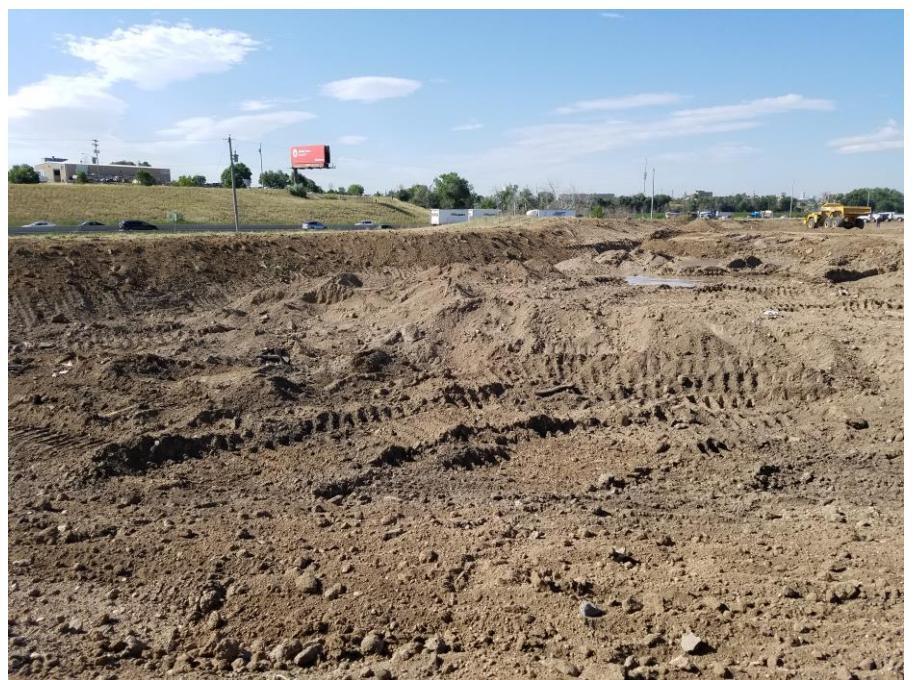
During the inspection, some non-inert debris such a plastic tubing and wood was within the new pit basin constructed in the industrial use area. The Division requested AFS remove this material from the site as it does not meet the definition of inert material in accordance with Rule 1.1(20). Mr. Frei subsequently removed this material and sent photographic documentation to this effect to the Division on the afternoon of July 17, 2019.

Figure 7. Pit basin located in north east portion of the site in the Industrial zoned area.

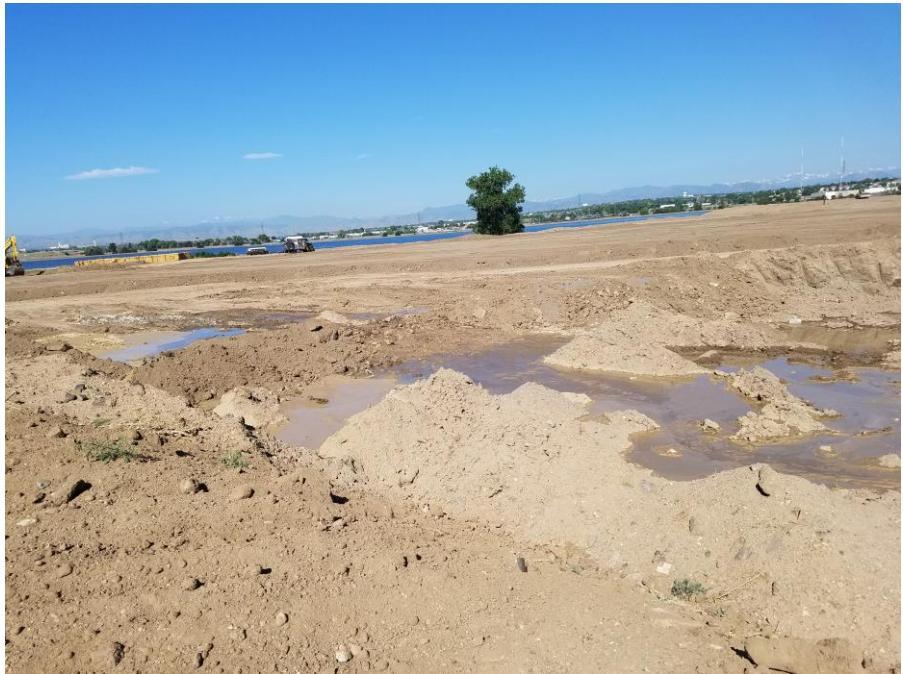
Figure 8. Landowner's fill within northeast basin.
