# MINERALS PROGRAM INSPECTION REPORT PHONE: (303) 866-3567

MINE NAME:	MINE/PROSPECTING ID#:	MINERAL:	COUNTY:
Flying Triangle Ranch Pit	M-2008-018	Sand and gravel	Moffat
<b>INSPECTION TYPE:</b>	<b>INSPECTOR(S):</b>	INSP. DATE:	INSP. TIME:
Monitoring	Amy C. Yeldell	July 18, 2019	14:40
OPERATOR:	<b>OPERATOR REPRESENTATIVE:</b>	TYPE OF OPERATION:	
Flying Triangle Ranch, LLC	None	112c - Construction Regular Operation	
<b>REASON FOR INSPECTION:</b>	BOND CALCULATION TYPE:	BOND AMOUNT:	
Normal I&E Program	Complete Bond	\$21,368.00	
DATE OF COMPLAINT:	POST INSP. CONTACTS:	JOINT INSP. AGE	NCY:
NA	None	None	
WEATHER:	INSPECTOR'S SIGNATURE:	SIGNATURE DAT	Έ:
Clear	Amy Geldell	August 29, 2019

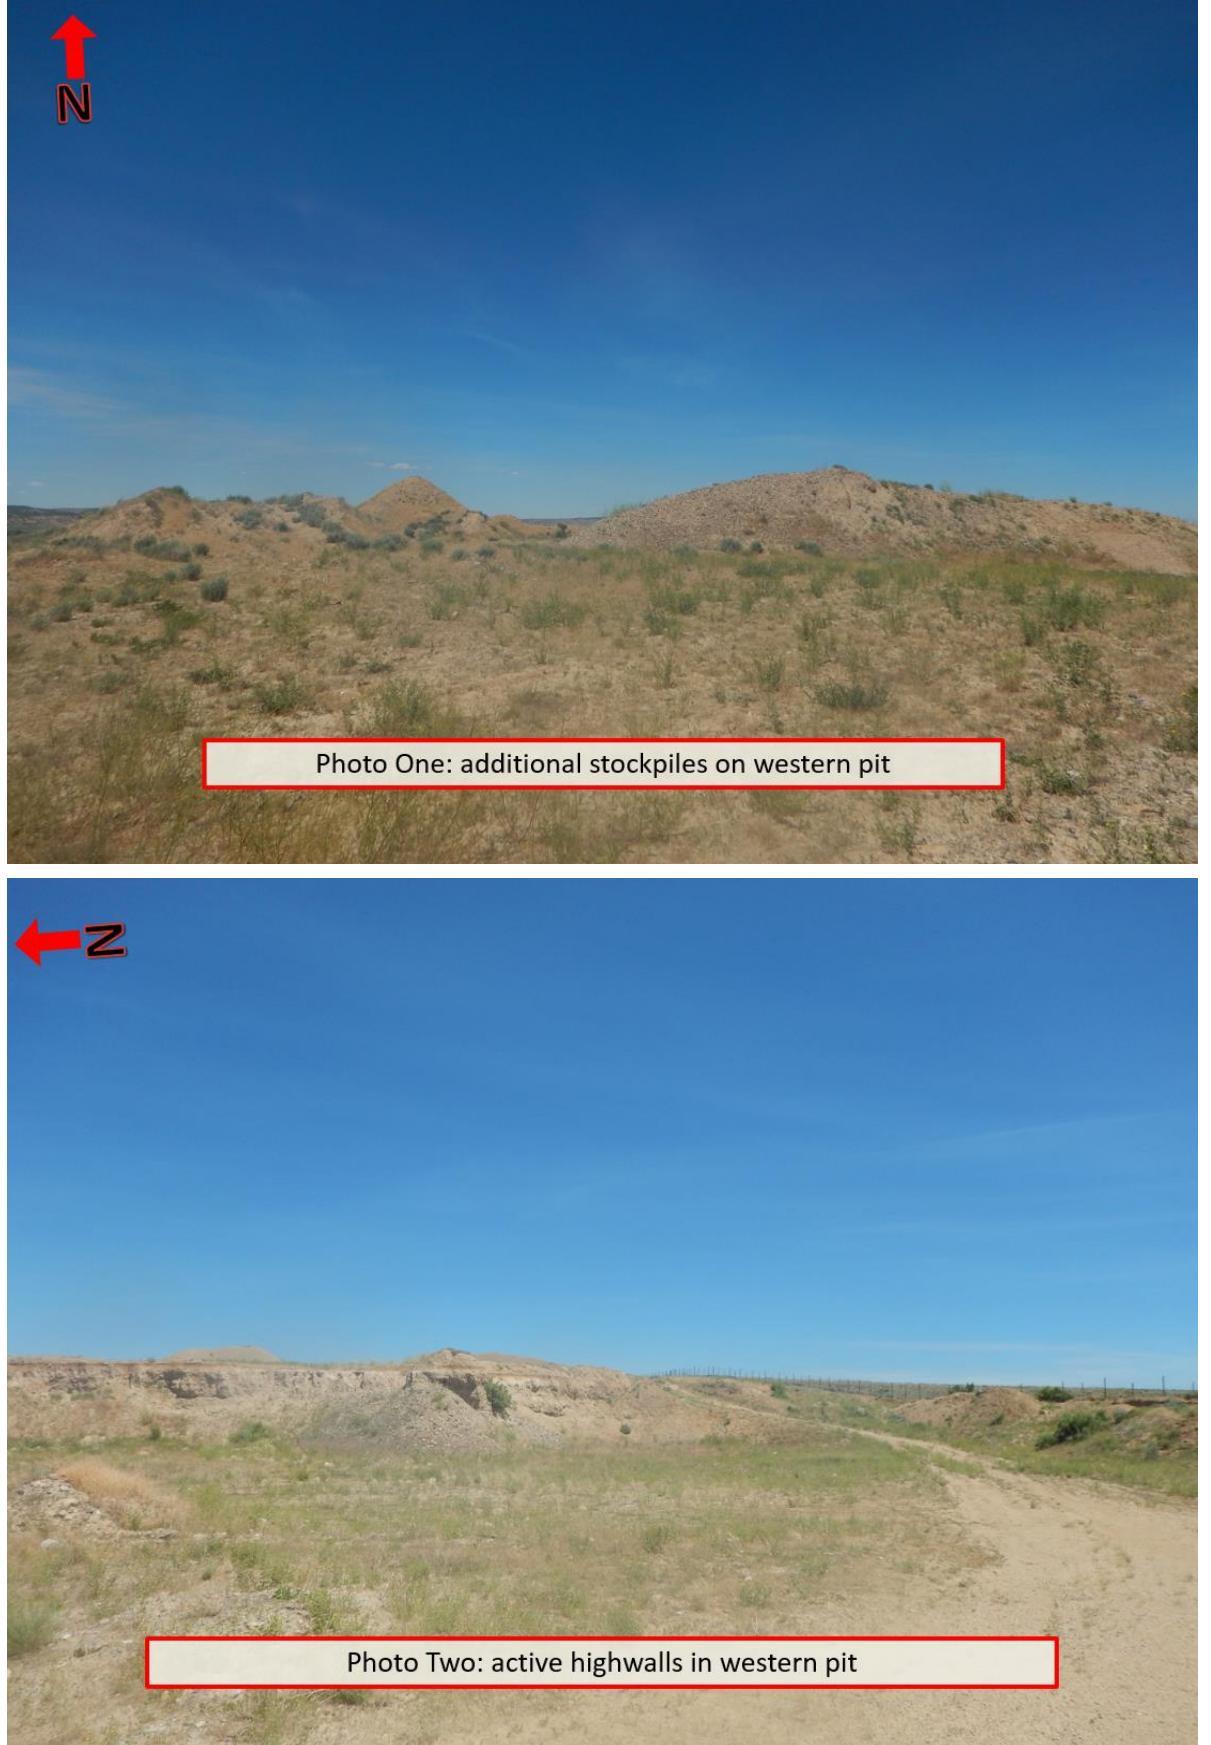
The mine sign was located on the western access road. The mine sign was down and should be reposted. The site remains free of the trash and miscellaneous debris cited as a previous inspection problem. No equipment or fuel is stored on site.

The site is comprised of three main areas. The western excavated pit, the middle stockpile area and the eastern undisturbed area. Little to no new surface disturbances since the previous inspection. Lots of volunteer vegetation due to site inactivity however the majority of which is noxious but not state listed weeds. Reclamation is encouraged in areas not being used.

The western pit area has excavated highwalls are approximately 8'-15' high. The pit floor has been excavated to an average of 10' below grade. One large stockpile is approximately 20' high and several other smaller stockpiles approximately are 15' high or less were observed. Slopes range from near vertical to 2:1. Overall there is no excessive erosion of threat for off-site damage. The southwestern portion of the pit has a berm to separate between the pit floor and the hillside.

The middle stockpile area has four main stockpiles that are approximately 15'-20' tall and vary volume. The floor is stable with a combination of weeds and native vegetation. All slopes are stable and appear to be 2:1 to less. A small trench is excavated to the east of the stockpiles and is approximately 8' deep.

The eastern portion is largely undisturbed. A two track runs along the fence and connects with the ranch road along the norther permit boundary. There is also a more distinct road cut along the contour that divided the eastern and western portions of the pit. There is a test pit in the undisturbed eastern portion that is approximately 10'x10'.
