**COLORADO Division of Reclamation, Mining and Safety** Department of Natural Resources

## MINERALS PROGRAM INSPECTION REPORT PHONE: (303) 866-3567

MINE NAME:	MINE/PROSPECTING ID#:	MINERAL:	COUNTY:
Chris Aaegeson Pit #2	M-2000-084	Gravel	Washington
INSPECTION TYPE:	INSPECTOR(S):	INSP. DATE:	INSP. TIME:
Monitoring	Brock F. Bowles	August 14, 2019	11:00
OPERATOR:	<b>OPERATOR REPRESENTATIVE:</b>	TYPE OF OPERATION:	
Washington County	Robert Frick	110c - Construction Limited Impact

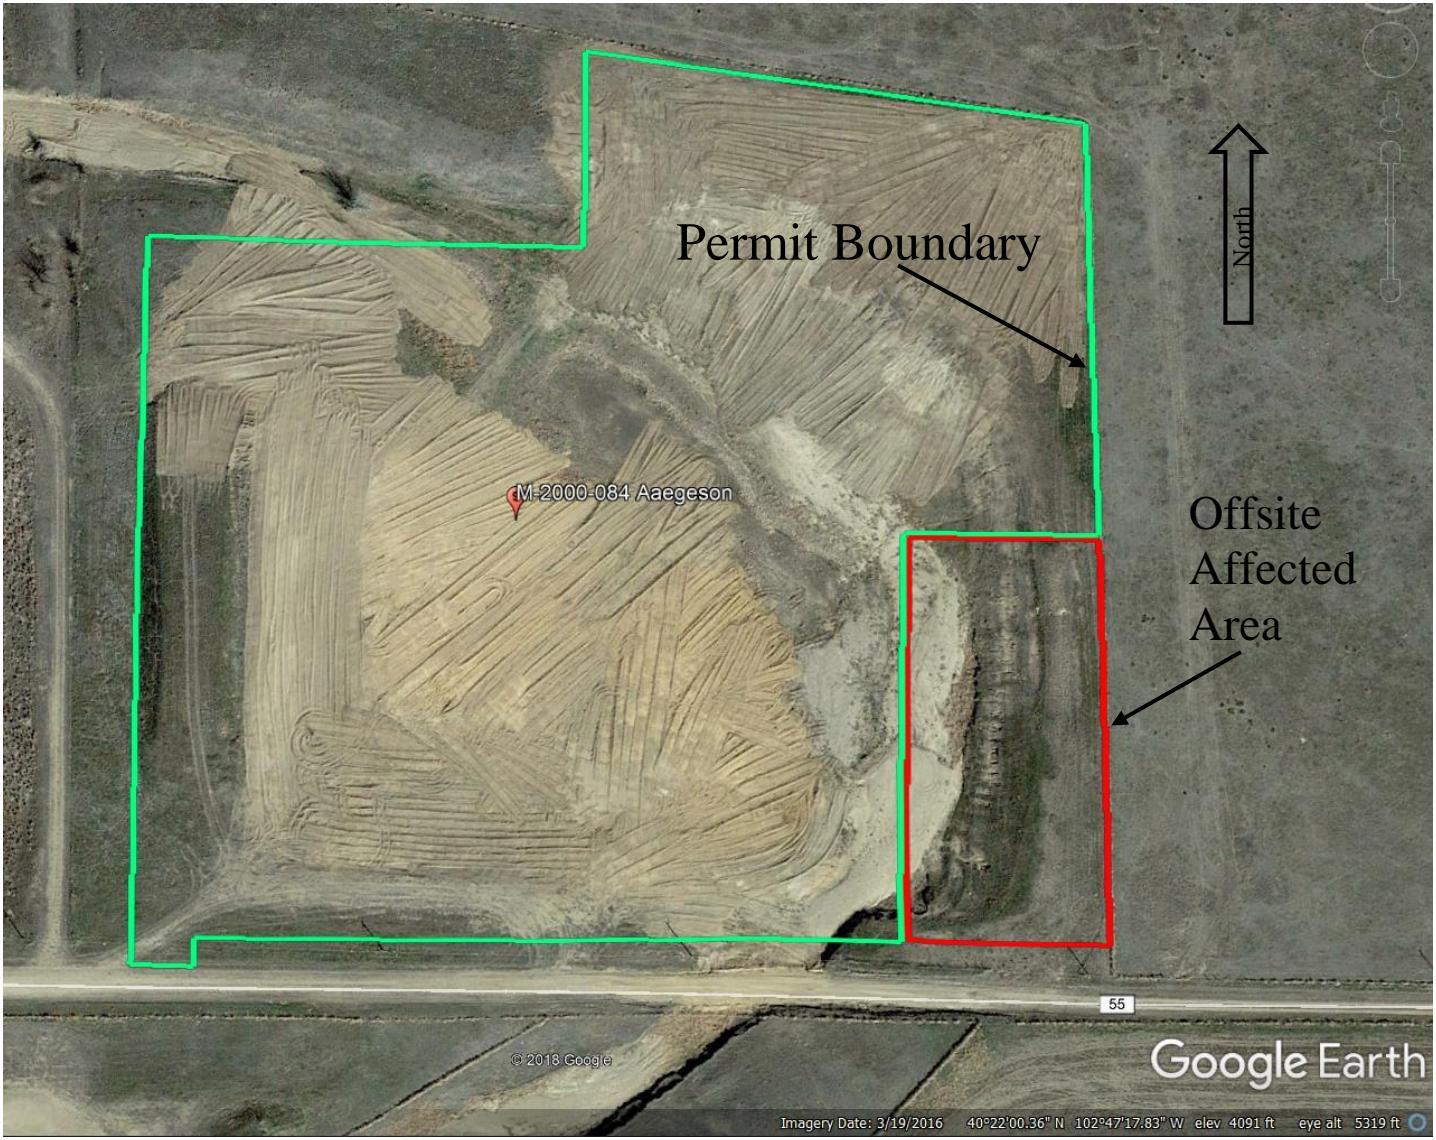
**PROBLEM/POSSIBLE VIOLATION:** Possible Violation: Land has been affected outside of the approved permit boundary. This is a possible violation at this time pursuant to C.R.S. 34-32.5-116(4)(i) for failure to protect areas outside of the affected land from slides or damages occurring during the mining operation.

During the inspection, it was noted that an area outside the permit boundary was disturbed as part of mine related activities. The area is located by the southeast corner of the permit area and measures 150' x 325' or 1.1 acres (see Figure 1 below). The nature of the disturbance is surface disturbance and it does not appear that any mining has taken place in this area. The disturbance appears to have been created while contouring the pit area to its final configuration during the reclamation process. The affected area was graded to blend in with the mine area and surrounding landscape. A few rills and gullies need to be repaired and the area will need to be seeded with the approved seedmix. This matter has been cited as a possible violation; please see the first page of the report for additional details.

Figure 1 – Location of Offsite Affected Area (outlined in red, 1.1 acres)

**CORRECTIVE ACTIONS:** This possible violation will require a hearing before the Mined Land Reclamation Board. The schedule and other details for the MLRB hearing will be provided under a separate document to be sent via certified mail to the operator.

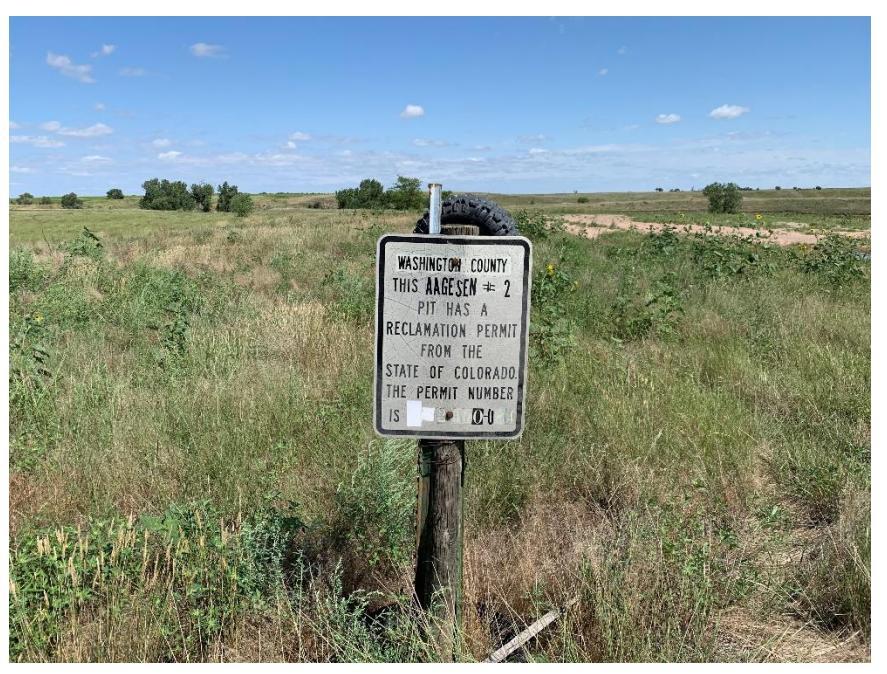
Entrance sign facing north

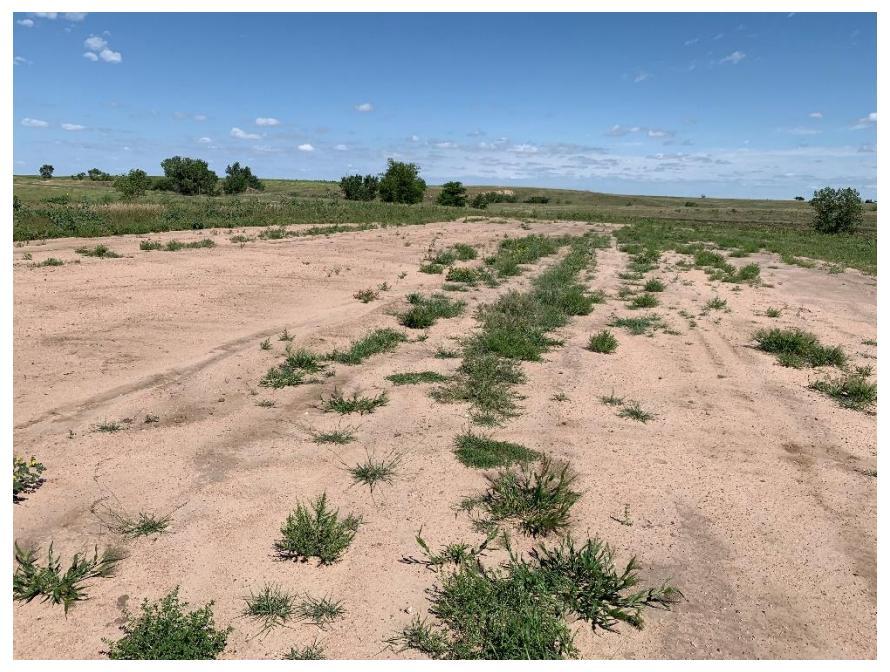
Topsoil stockpile footprint area facing north

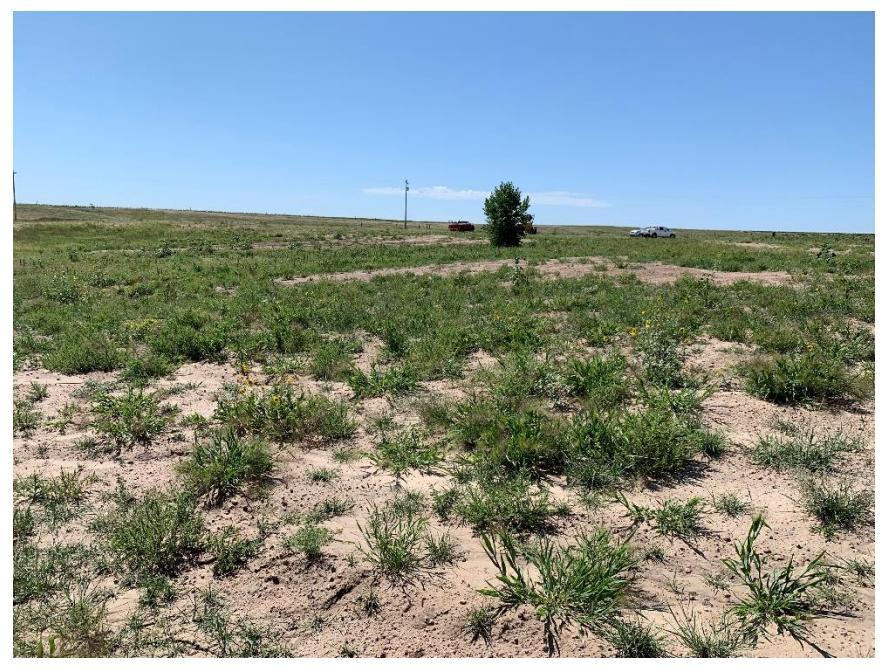
The slopes of the pit have been graded to 3H:1V. The topsoil pile has been re-distributed around the pit. Since the grading and topsoil re-distribution, heavy rains have caused some large rills and gullies across the reclaimed area. The rills and gullies will need to be repaired before seeding. A large sediment plume was noted in the creek bottom. The source of the sediment was from the county gravel road which is outside the permit boundary.

Vegetation was growing on the reclaimed area, but the vegetation was volunteer. The area has not been seeded with the reclamation seed mix yet. According to the County, final grading and seeding have been delayed due to an exceptionally wet summer.

Slopes graded 3H:1V and volunteer vegetation, facing south

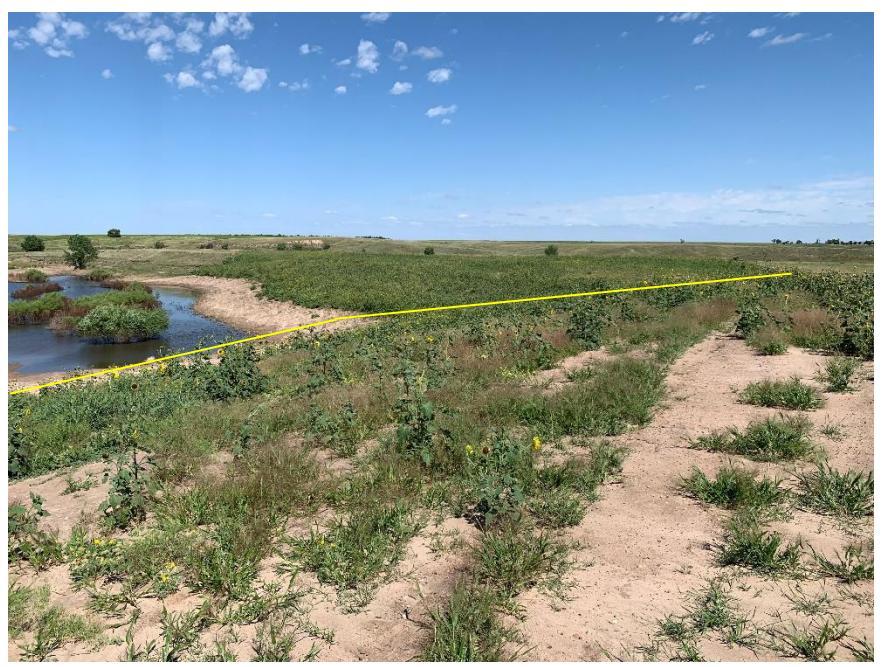
Approximate location of permit boundary, facing north. Foreground is outside permit boundary.

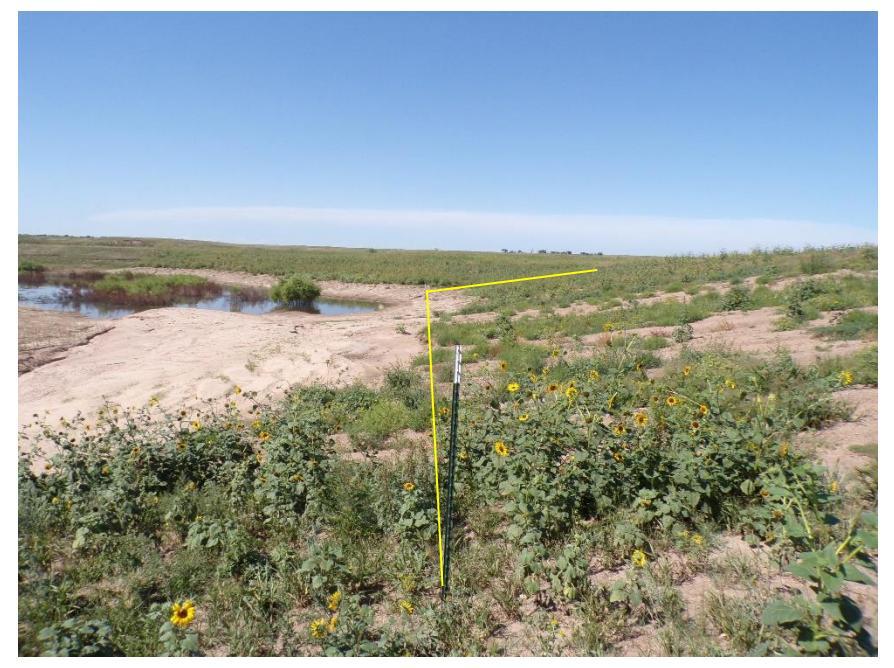
The mine identification sign was in place at the mine entrance and legible. Two permit boundary markers were missing in the northwest corner of the permit boundary. The County replaced the markers the day after this inspection and sent pictures to verify markers were installed before this report was written. The Division appreciates the County's prompt response to this issue. No mining activities were occurring during the time of the inspection. A road grader was parked on site.

Boundary markers installed by County, facing north. Area to right is outside permit boundary. Photo provided by County.
