### **Minerals Plan of Operations Inspection U.S. Department of the Interior Bureau of Land Management Royal Gorge Field Office**

<b>Date:</b> Oct 17, 2018	Operation Name: Zimmerman - El Rancho Bondo			
<b>Time:</b> 11:57	Operator: Tom Zimmerman			
Weather: Cloudy	Case Number: COC75265			
	CDRMS Number: M-2018-028			
Attendees	General			
BLM: A. Sanderson	<b>Operation</b> (s) are in compliance with documentation on file			
	$\boxtimes$ Yes $\Box$ No $\Box$ N/A			
<b>Operator(s):</b> Contacted, but not present				
	<b>Operation(s) and disturbance on-site coincide with the</b>			
Other(s): None	operations and access on file			
	$\square$ Yes $\square$ No $\square$ N/A

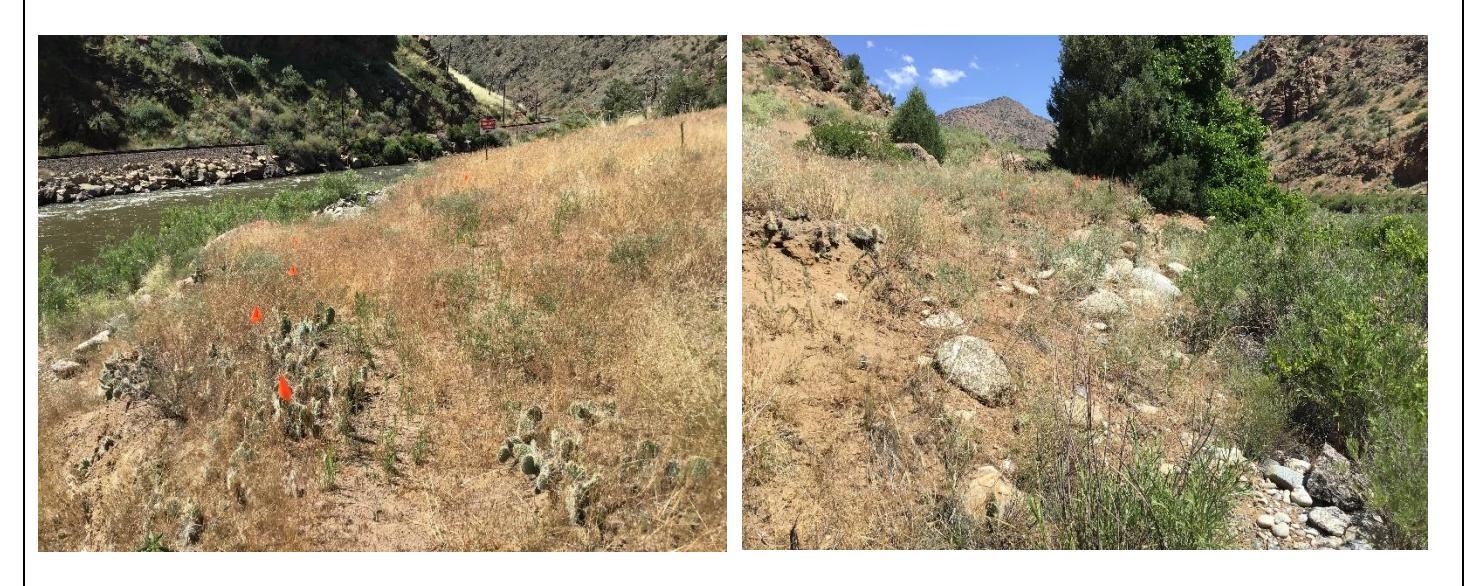
## Image 1:

Comment: Flagging emplace along western working area to decrease public safety hazards located ~50 to 100 from the river's edge.

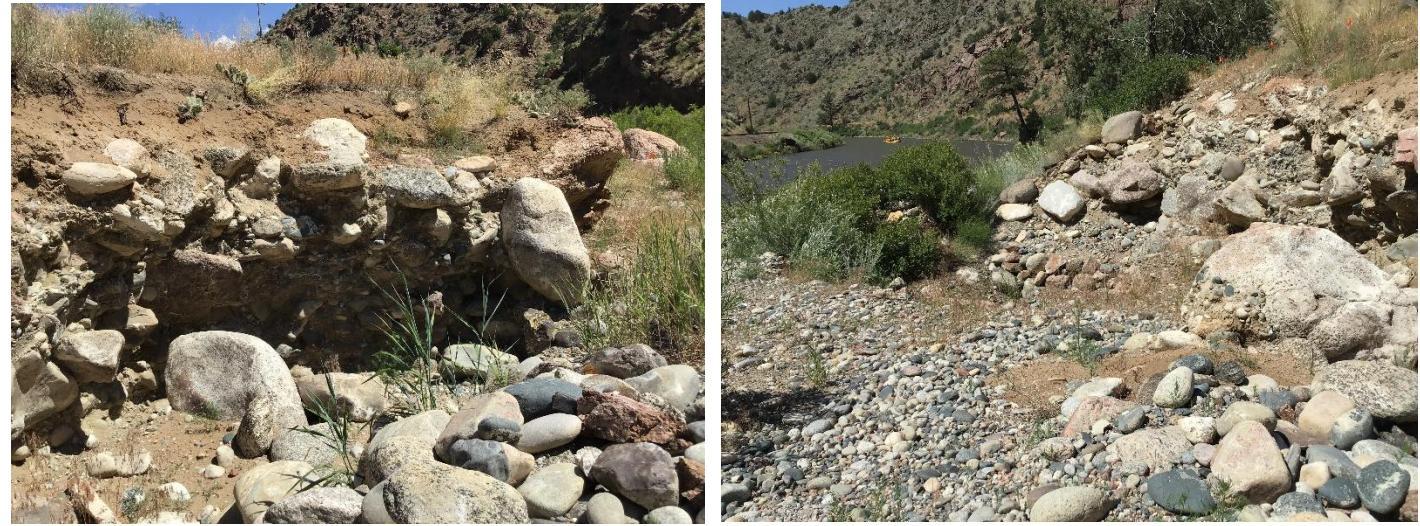
# Image 2:

Comment: Northern and Southern views of the active working face

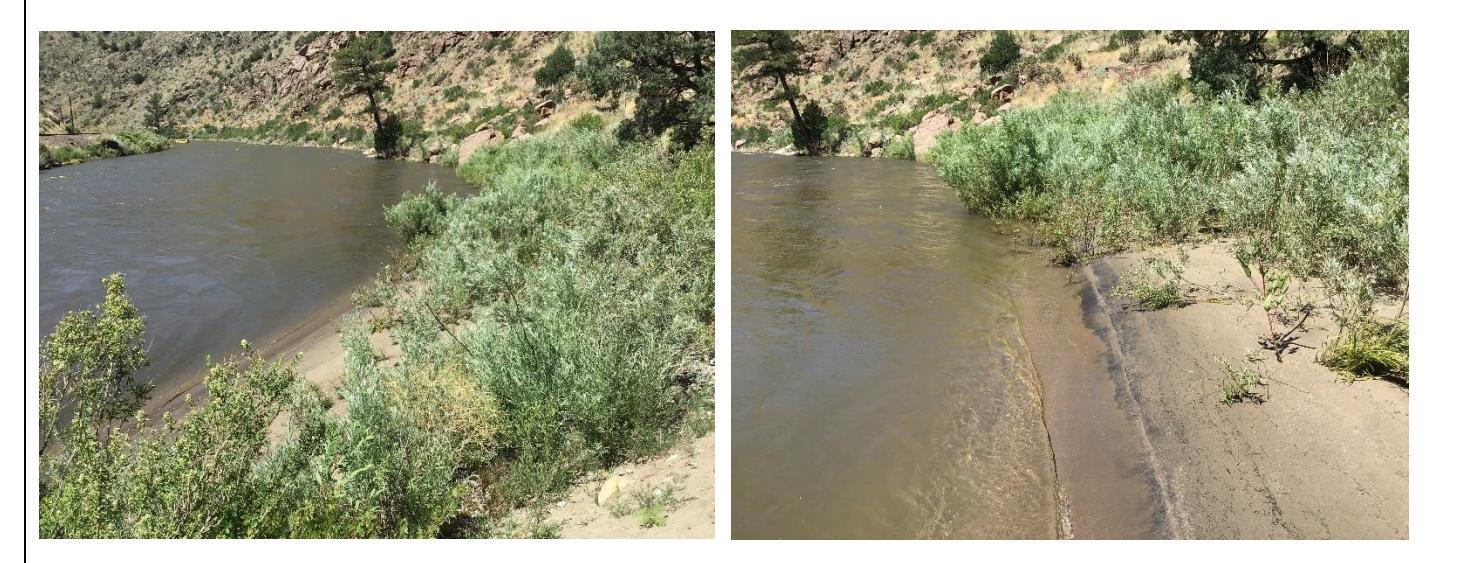
## Image 3:

Comment: Due to high water levels the island located on the southern portion of the claim is under water

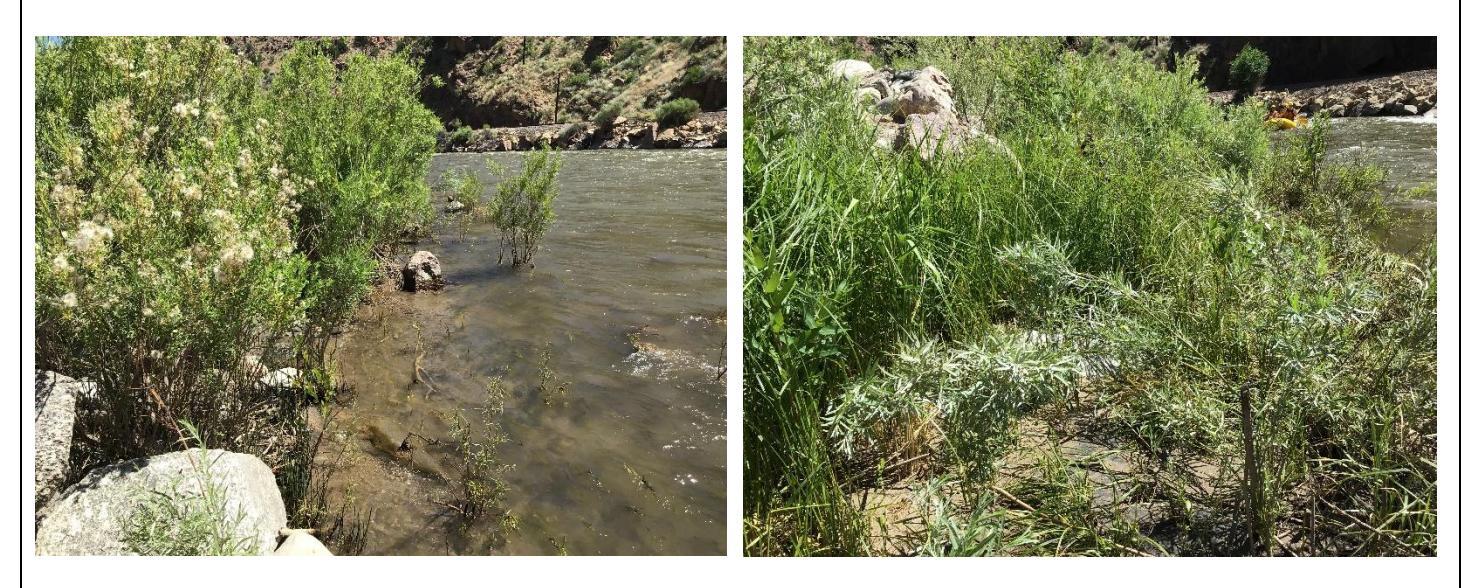
## Image 4:

- Operations are inactive until State compliance is met (CDPHE, Dishcarge and/or Stormwater Permits & CDRMS 110(1) permit)
- Dredging operations (Environmental Assessment, EA) are pending until State compliance is met.
- Arkansas River is extremely high due to recent snowmelt, therefore the previous bank stabilization work is under water along with the southern island. No recent bank erosion observed during the inspection.
- Beaver activity has dramatically decreased due to the high water level.
- No evidence of recent mining activity

Comment: The recent bank stabilization work has been either washed out or under water due to high water levels and/or river velocities.
