Minerals Plan of Operations Inspection U.S. Department of the Interior Bureau of Land Management Royal Gorge Field Office

Operation Name: 1st Benttonite			
Case Number: COC51303			
CDRMS Number: M-1977-231			
General			
Operation (s) are in compliance with documentation on file			
\blacksquare Yes \Box No \Box N/A			
Operation(s) and disturbance on-site coincide with the			
operations and access on file			
\blacksquare Yes \square No \square N/A

Inspection Purpose:	□ Pre-Operations	☑ General	□ Final	□ Trespass	□ Complaint

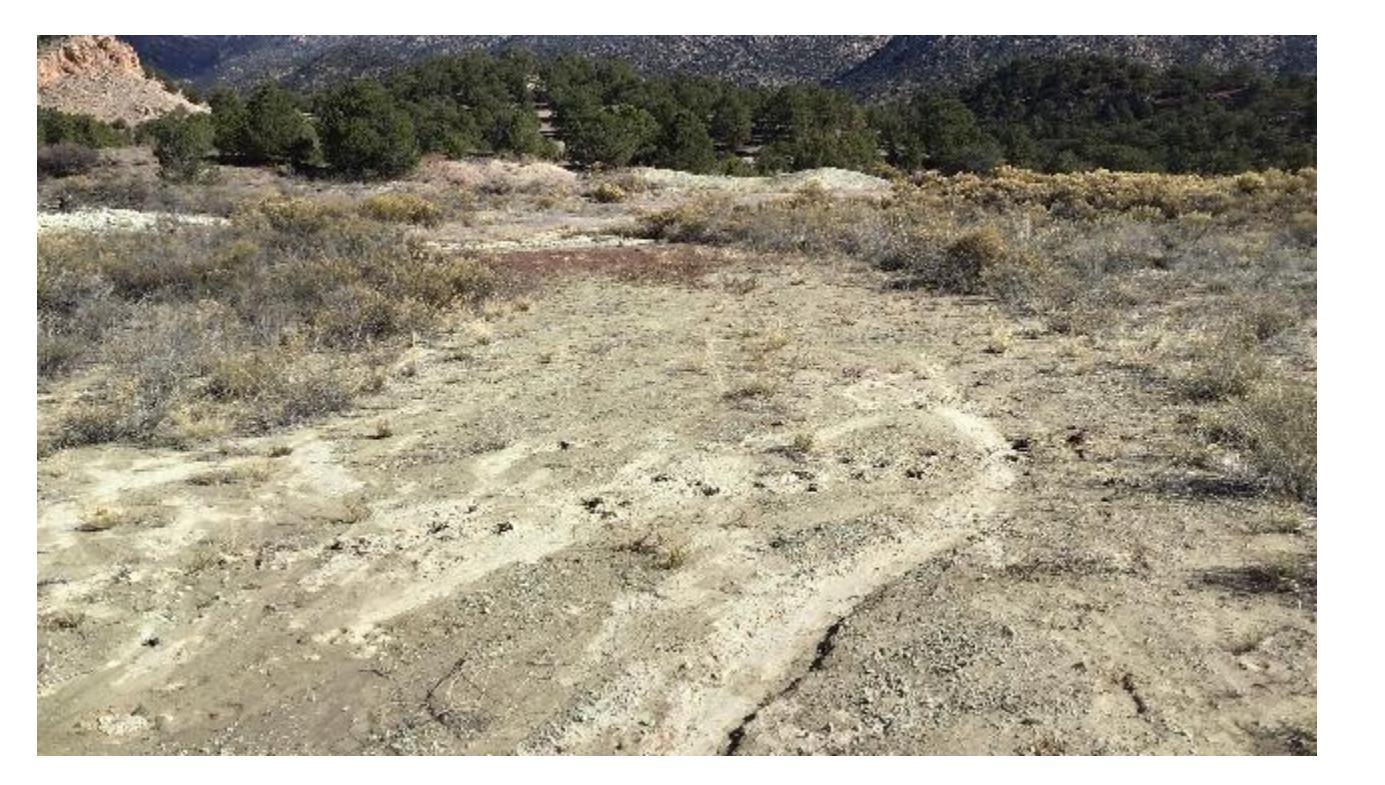
Image 6:

Comment: Eastern view of the staging floor; erosion along the eastern portion of the haul road

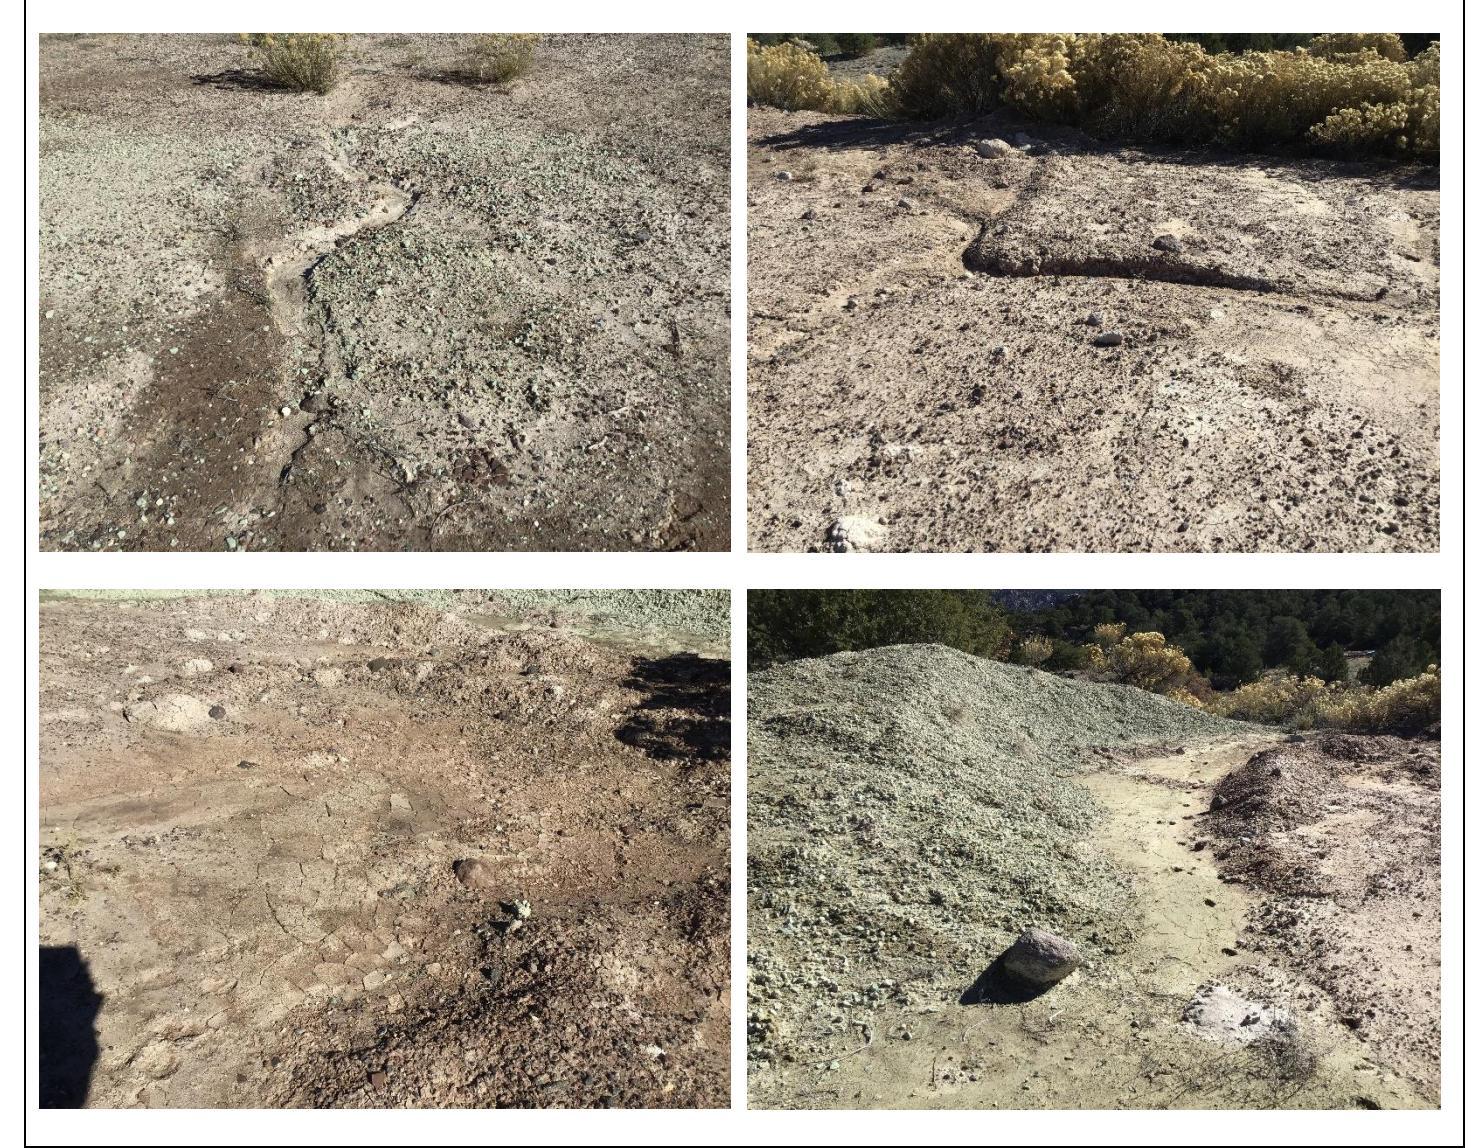
Image 7-10:

6.b. & 6.d. Minimal vegetation along the access road, haul roads (trending east to west), staging area and detention pond. The lack of vegetation has caused an abundant amount of erosion (e.g. riles, gullies, etc.) along the banks of the detention pond and roads.

Comment: Water erosion such as riles, gullies and mud cracks along the staging area

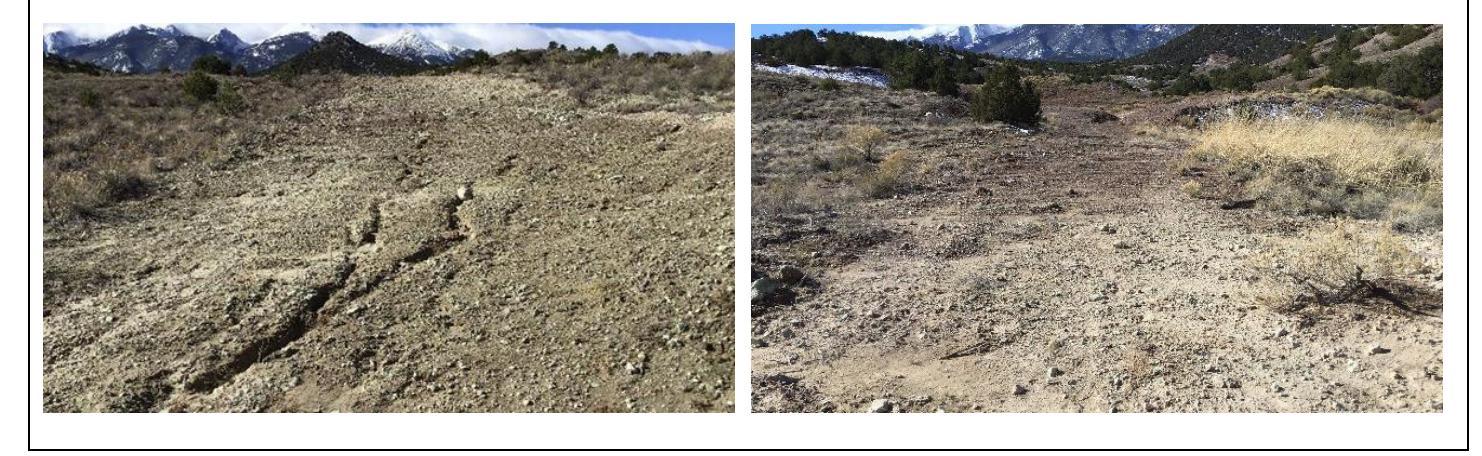
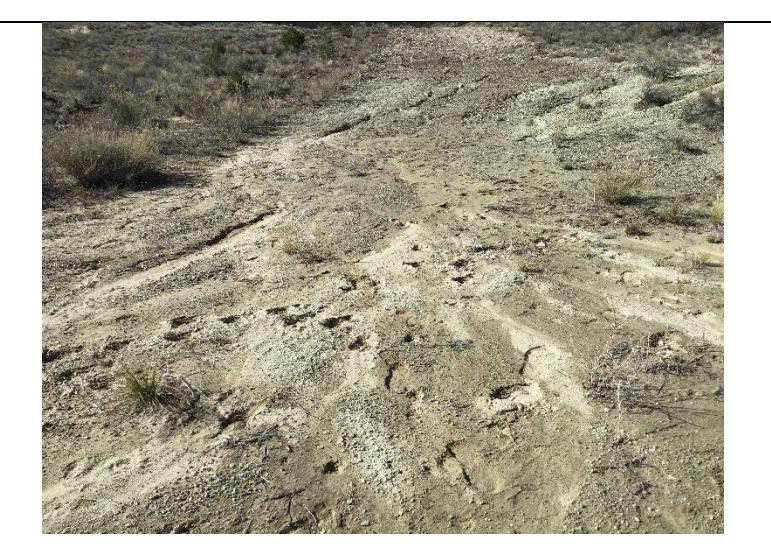
Image 11-13:

Comment: Western section of the road leading to the detention pond. Abundant amount of large riles from storm/meltwater runoff

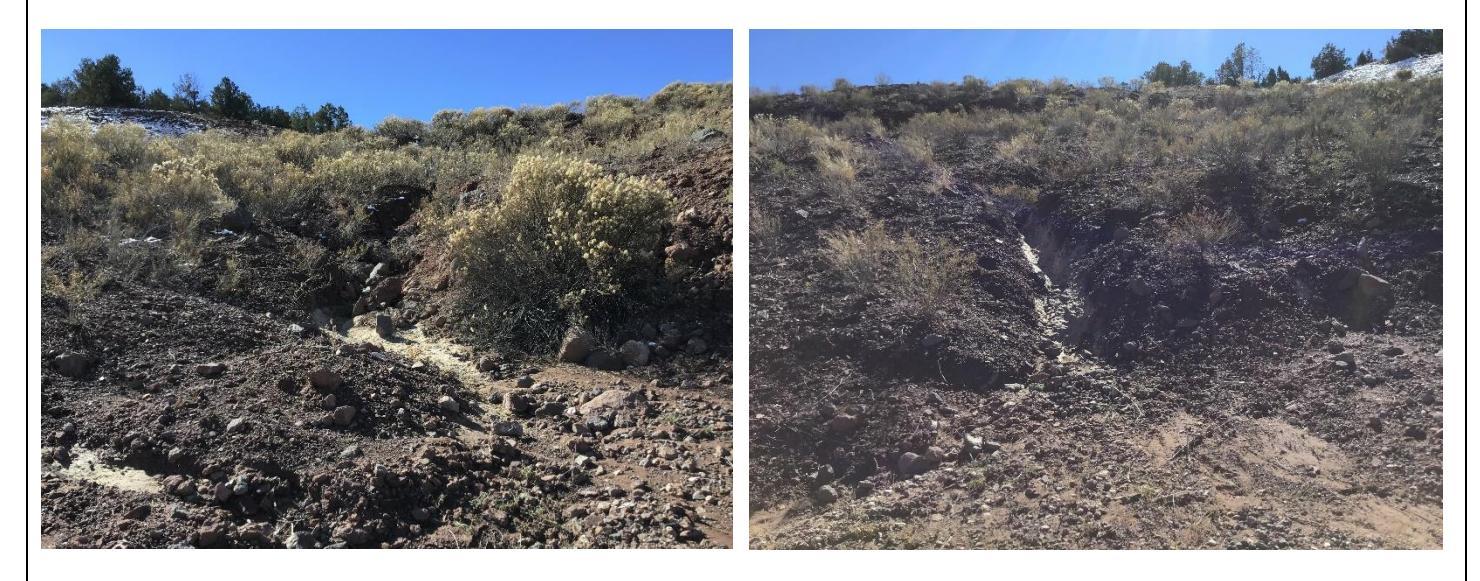
Image 14-15:

Comment: Eastern banks of the detention pond still contain massive gullies. More vegetation is present than the previous inspection. This erosion may be a natural occurrence due to the type of geologic material. **Image 16-18:**

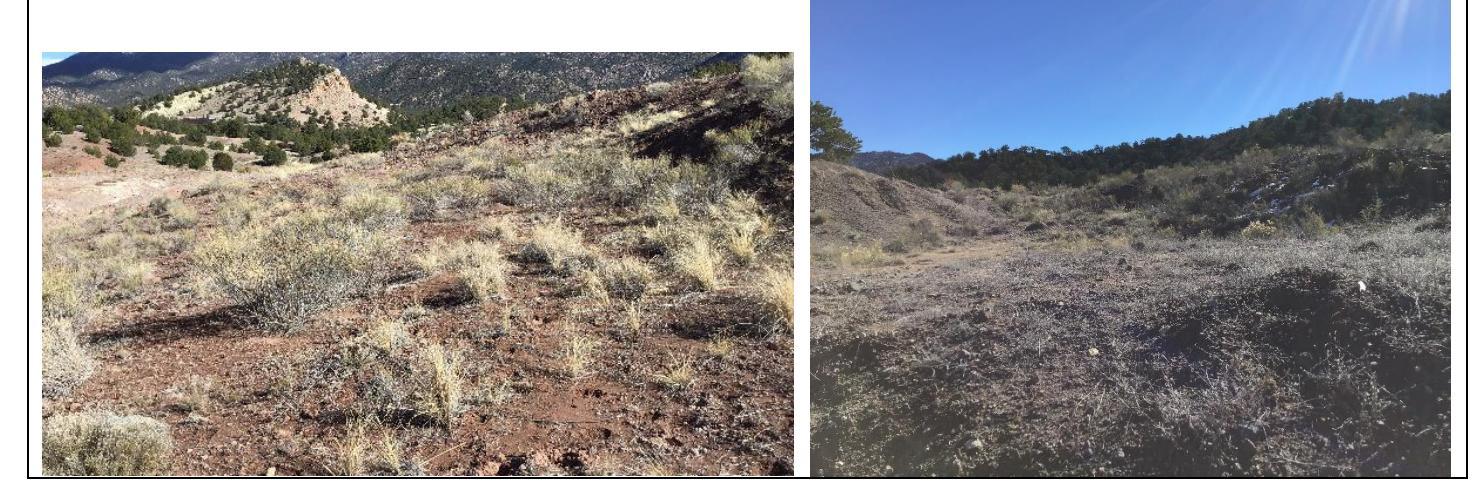
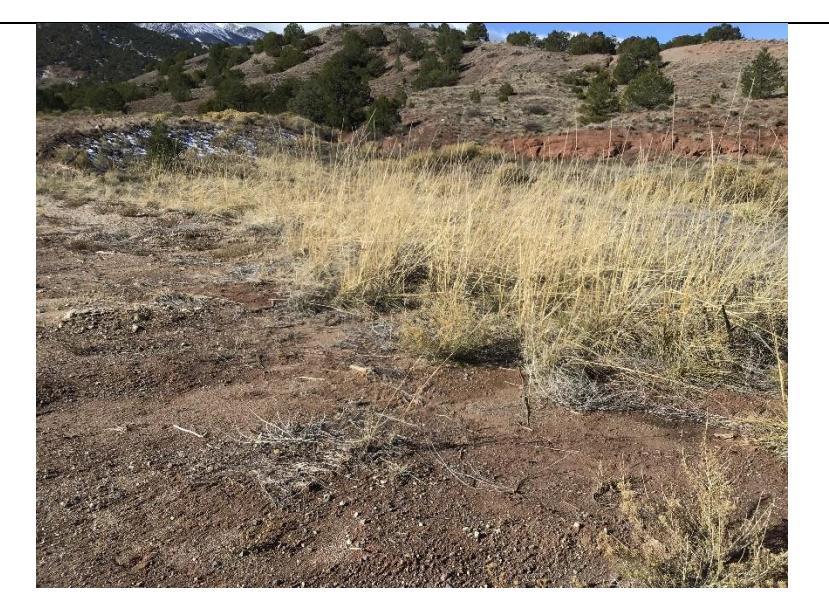
Comment: SE/E view of road near the highwall. The areas north and south of the access roads are adequately vegetated. Image 19-21:
